Incident Summary #II-1264711-2021 (#24310) (FINAL)

| SUPPORTING INFORMATION | Incident Date | October 4, 2021 | |

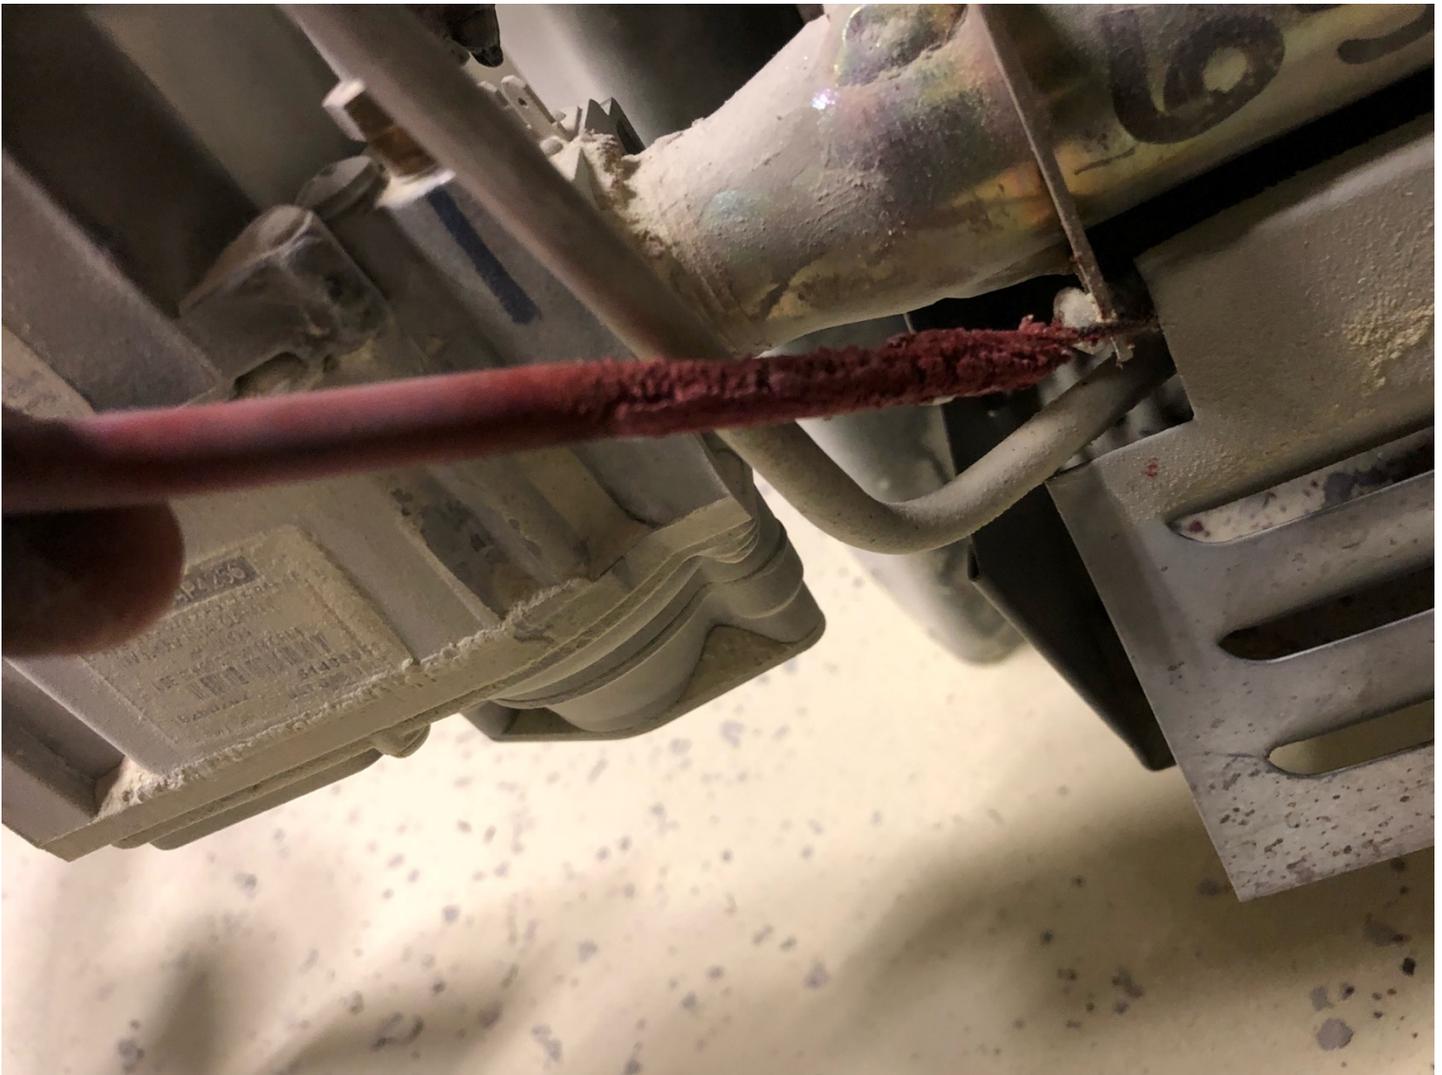
Image 1 – Showing fire damage to the flame safeguard wiring of the water heater and build up of residue on the gas valve. Taken by safety officer on site.

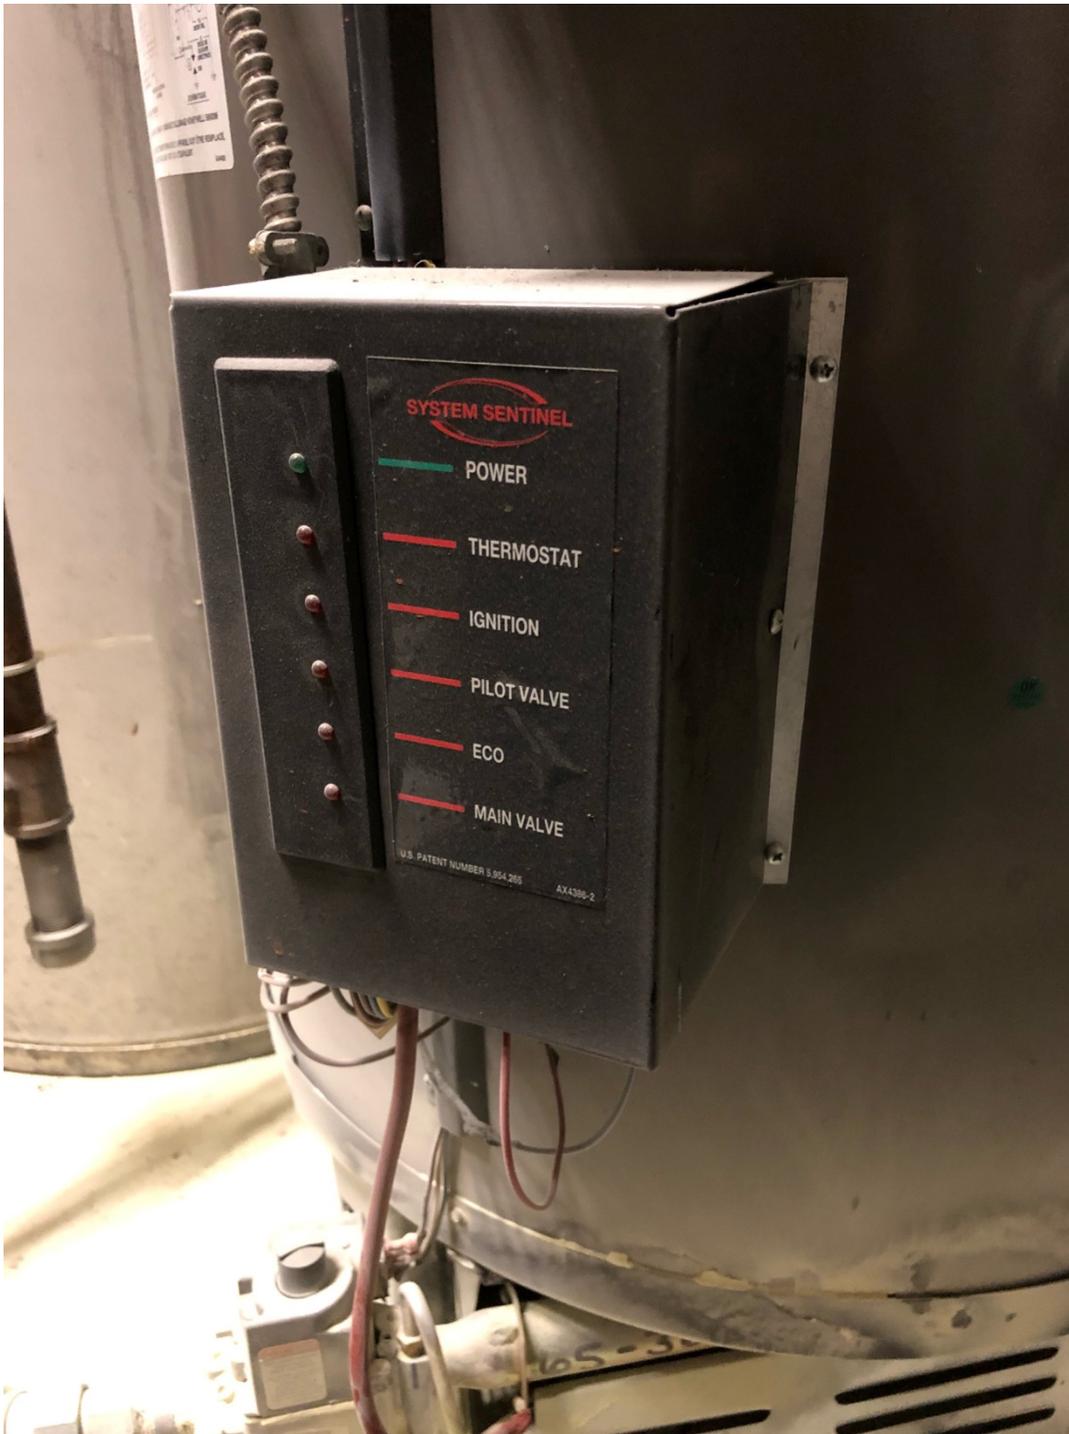
Image 2 – Showing the water heater that caught fire showing evidence of residue on the burner and bottom of the water heater. Taken by the gas contractor on site and submitted to Technical Safety B.C.

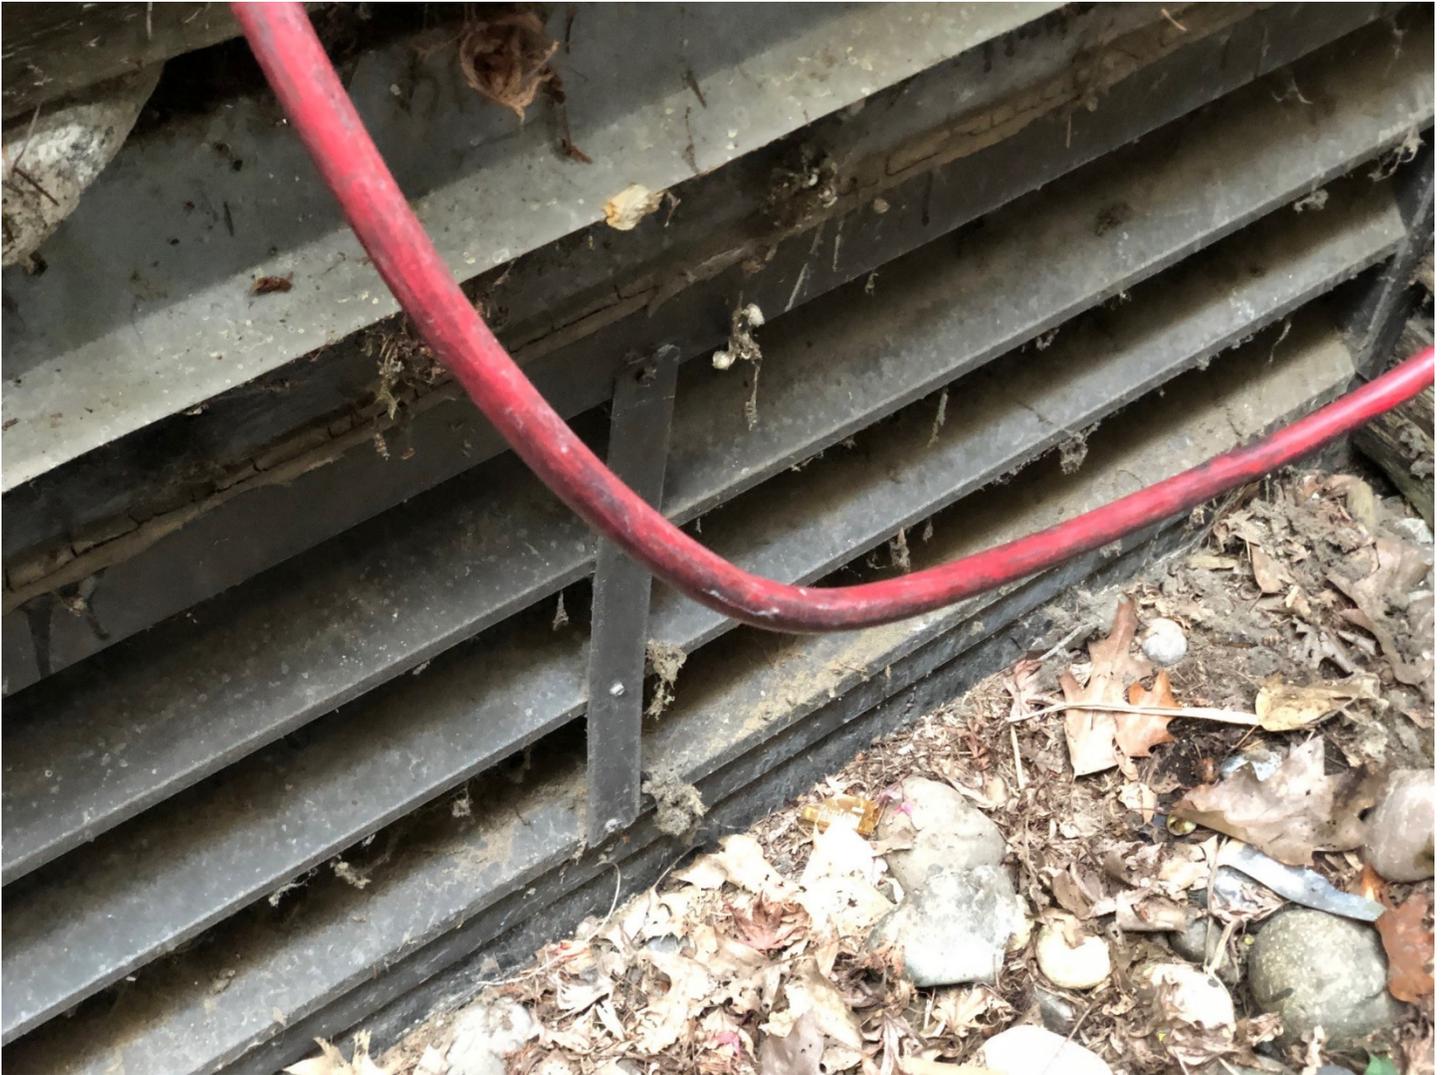
Image 3 – Showing the plugged outside air supply termination.

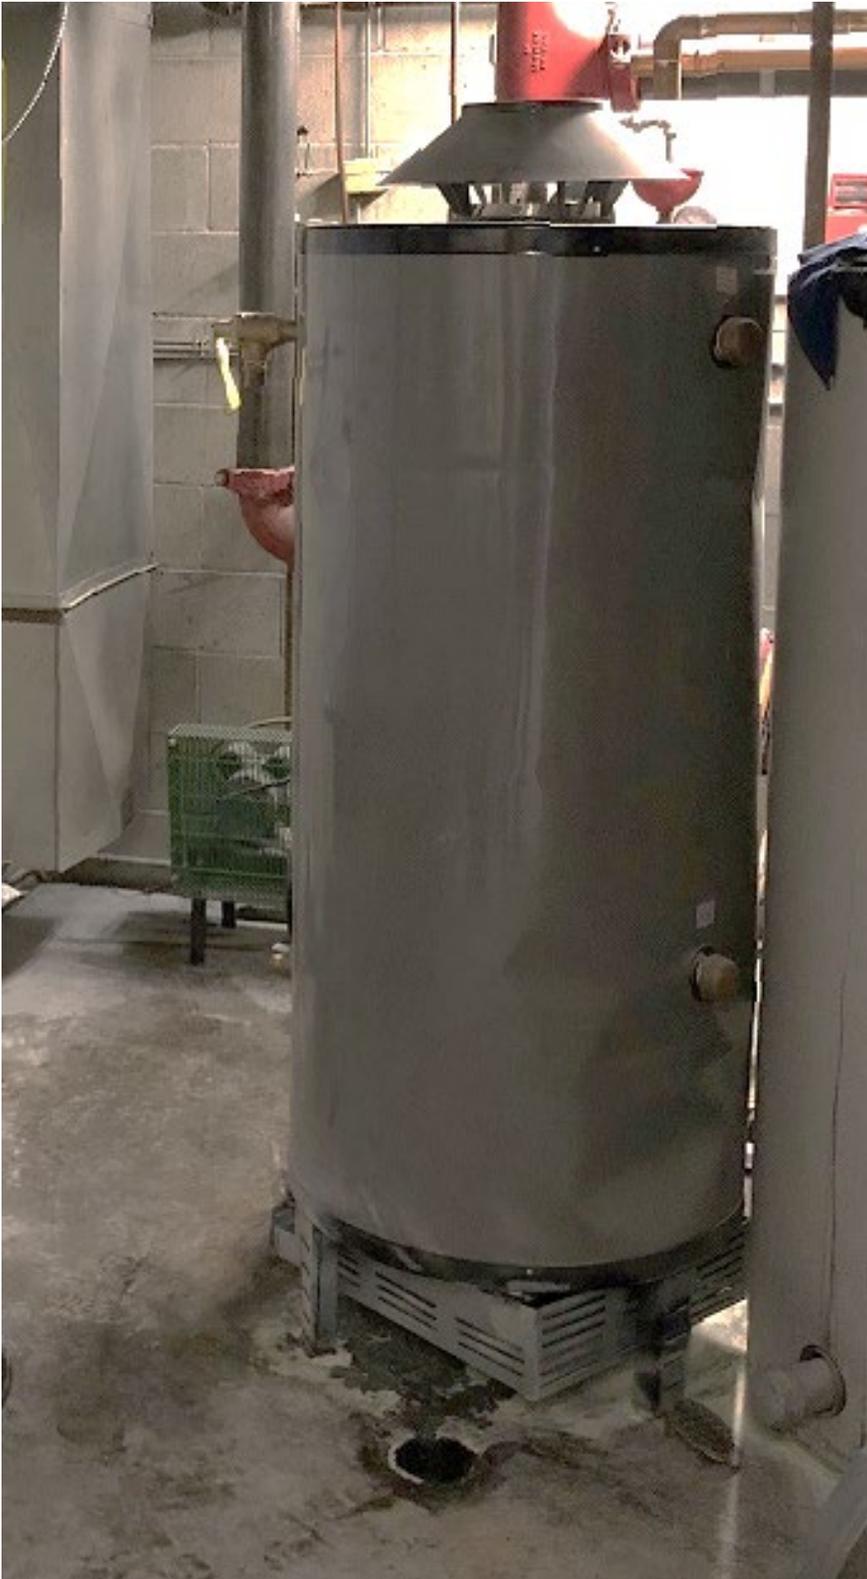
Image 5 – Showing the water heater after the fire with smoke damage and evidence of residue on the floor. Submitted by the gas contractor to Technical Safety B.C.

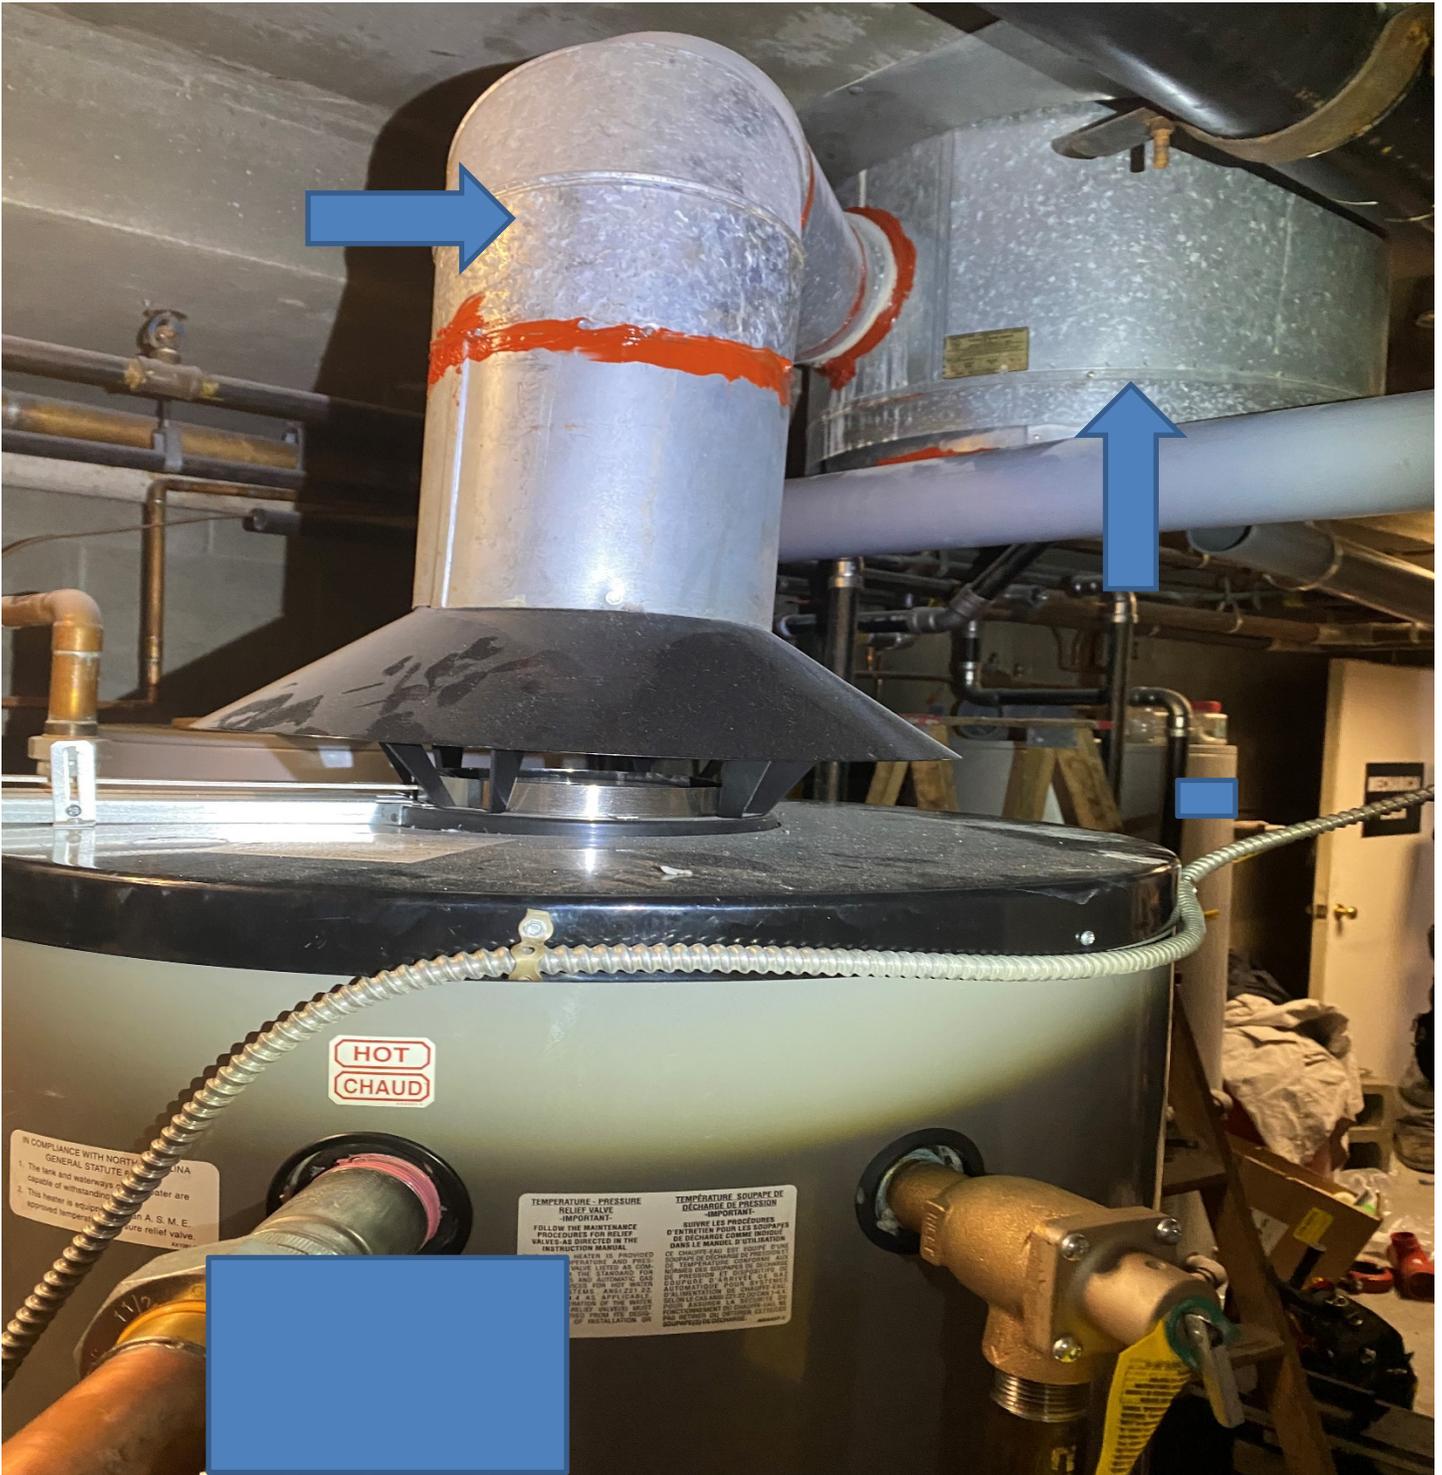
Image 6 - Showing the installation of the new temporary water heater venting in the exact same location and venting style as the water heater that caught fire. (Arrows showing the 8" C-vent making a non-compliant adaption to the 24" B-Vent).
