Incident Summary #II-1011141-2020 (#17213) (FINAL)

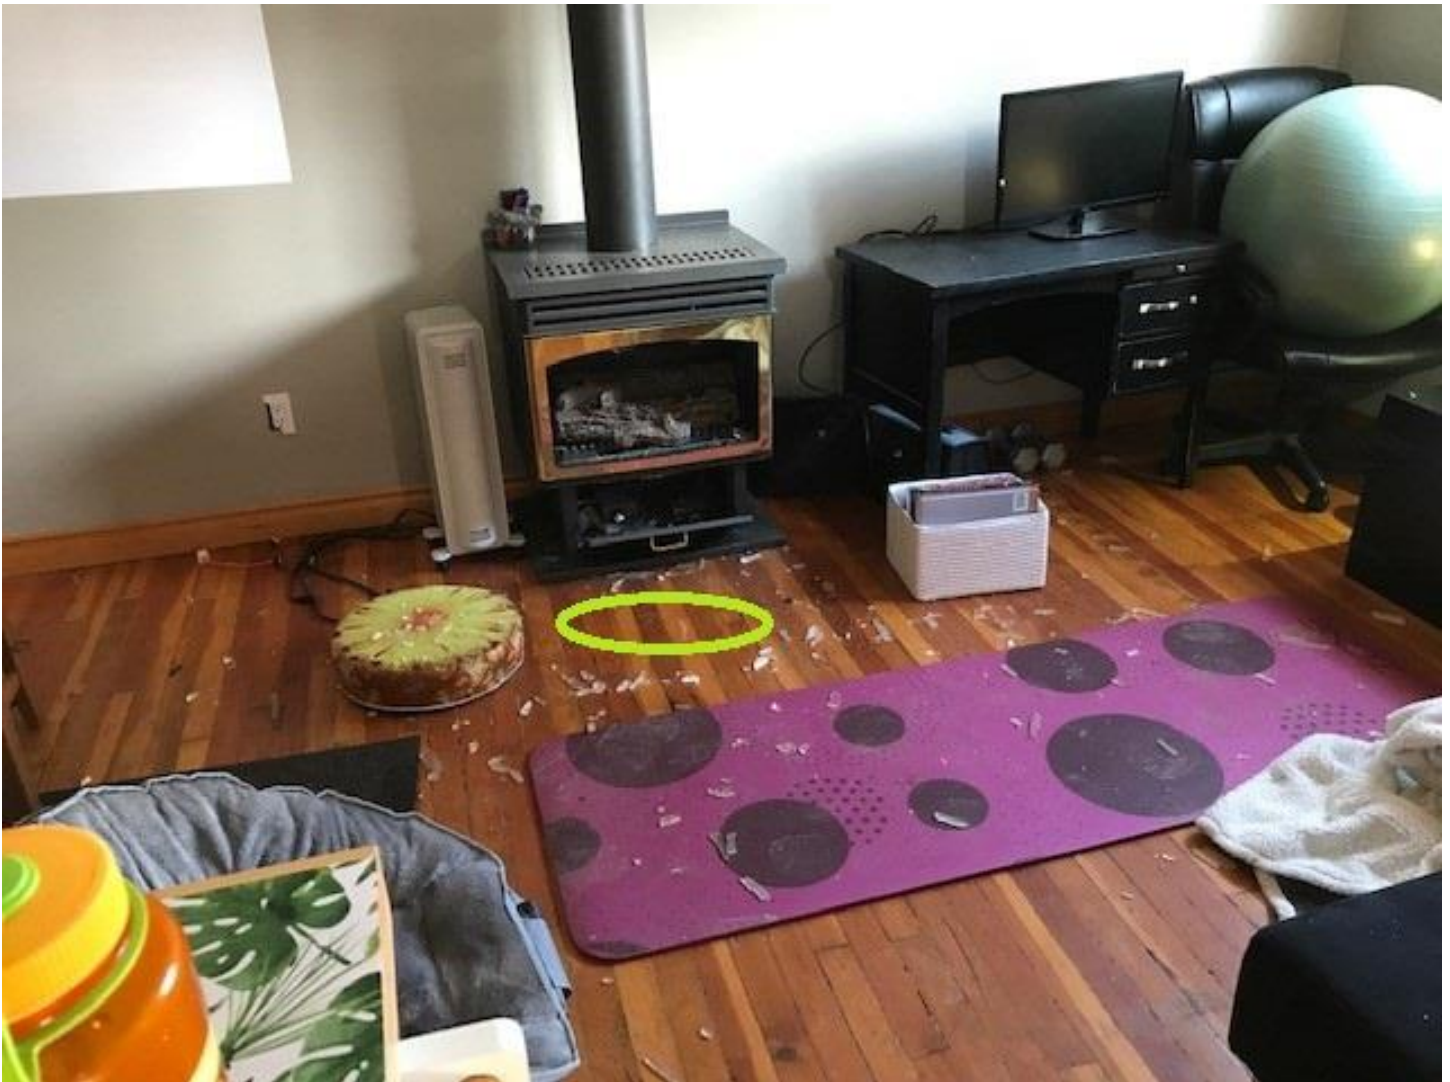
<p>Causes and contributing factors</p>	<p>The design of the explosion relief damper was insufficient to protect the glass from blowing out when exposed to the pressure from a delayed gas ignition.</p>

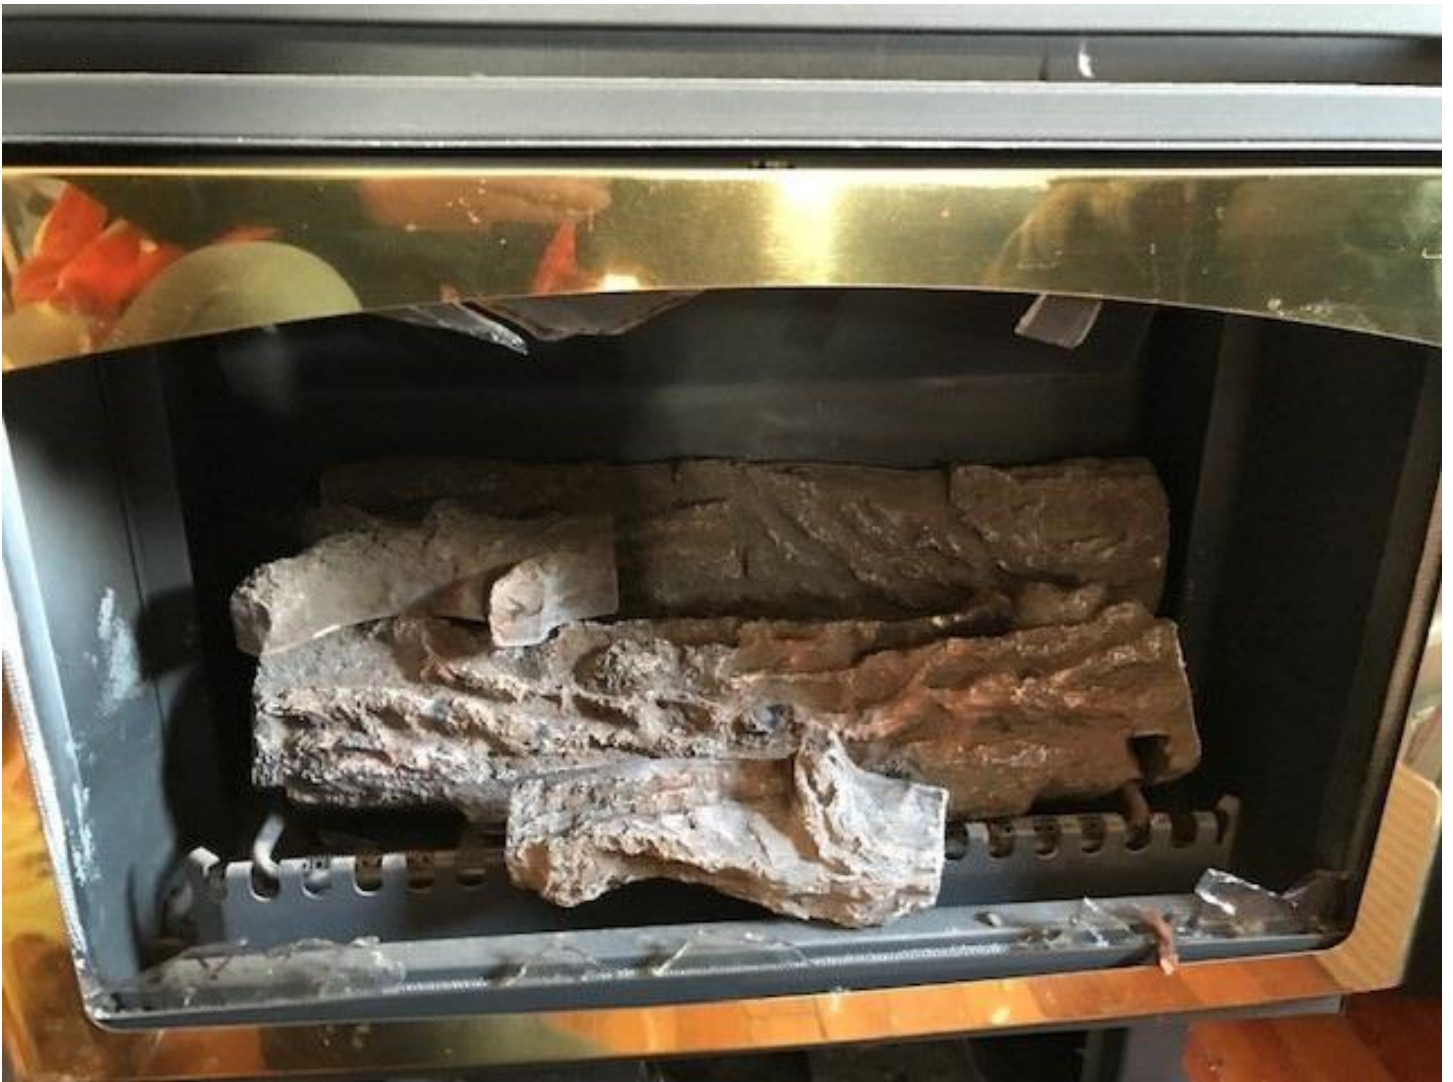
Yellow oval is where person was kneeling at time of explosion

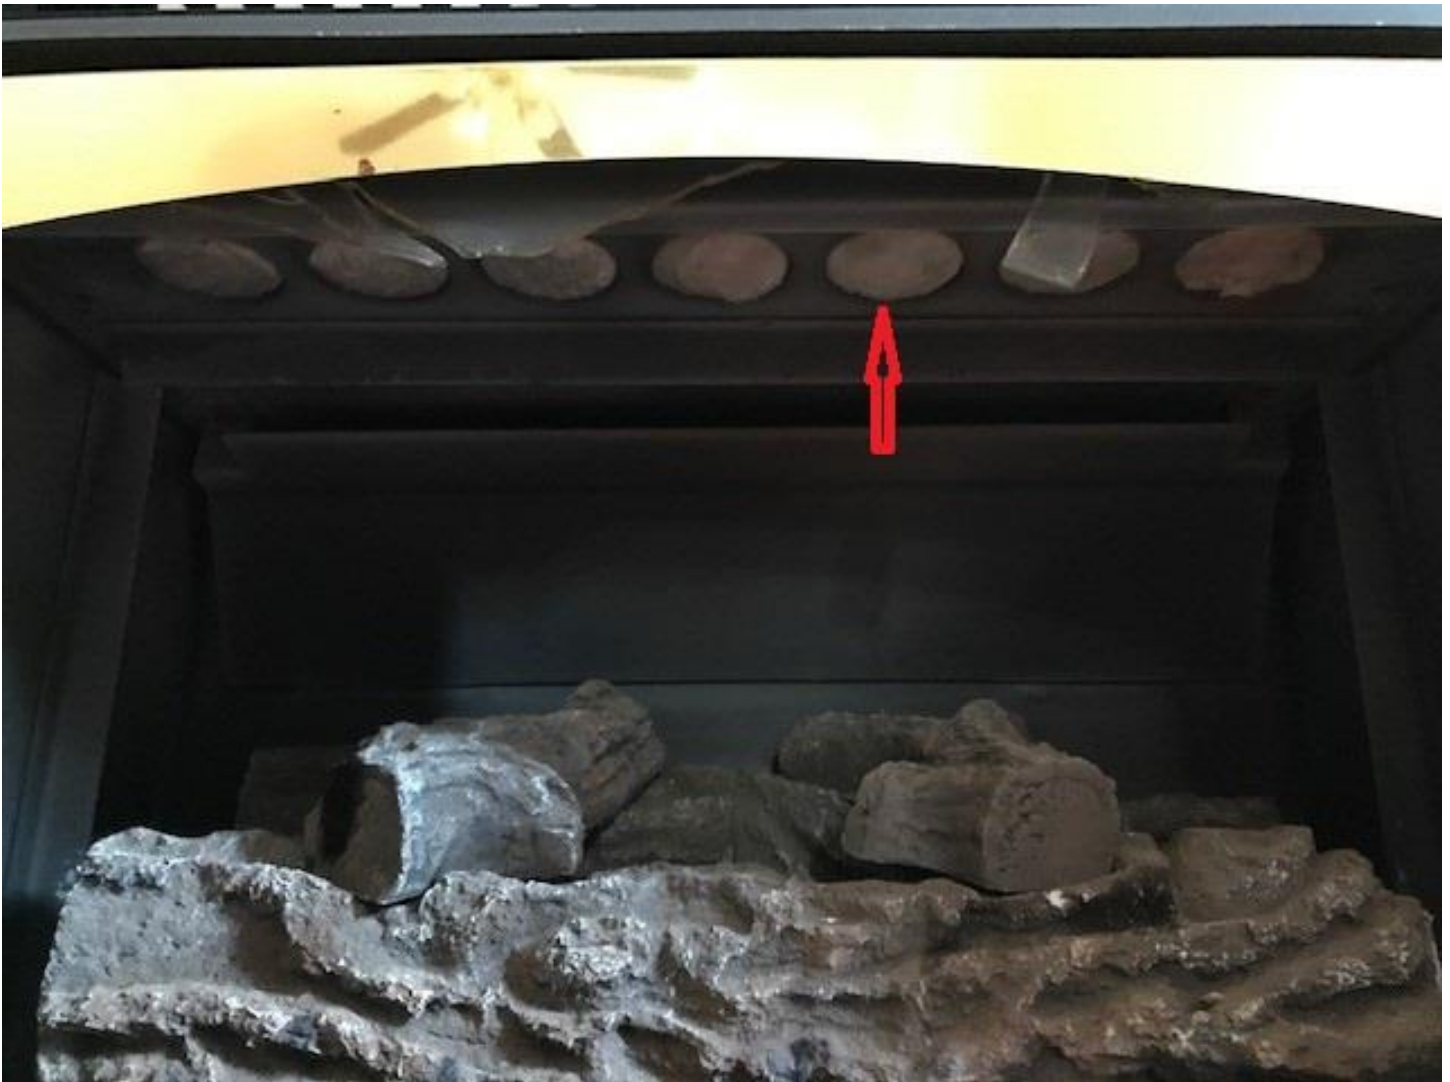
Red arrow indicates relief opening (7 ea)
