INVENERGY RENEWABLES CANADA DEVELOPMENT ULC

ENVIRONMENTAL IMPACT STATEMENT

SKINNERS POND WIND ENERGY CENTRE

PROJECT NO.: TE211027 APRIL 2023

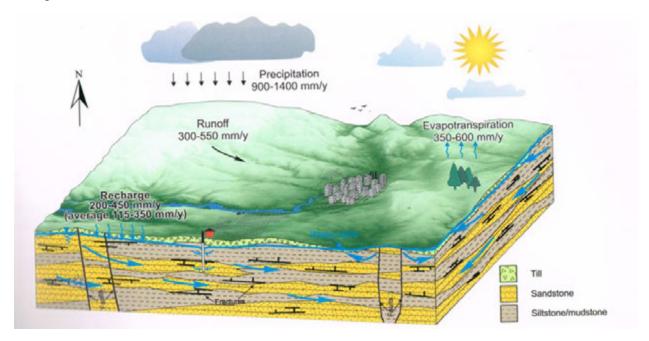
Figure 4.2: Schematic of water budget parameters for the Maritimes Basin

Figure 4.2 shows a schematic of the water budget for the Maritimes Basin adapted from Rivard *et al.*, (2008) and provided in Rivera (2014) as Figure 14.16. For PEI, the annual average recharge to groundwater can reach up to 300 to 400 mm per year. The figure also depicts the potential horizontal and vertical groundwater movement through sandstone units.

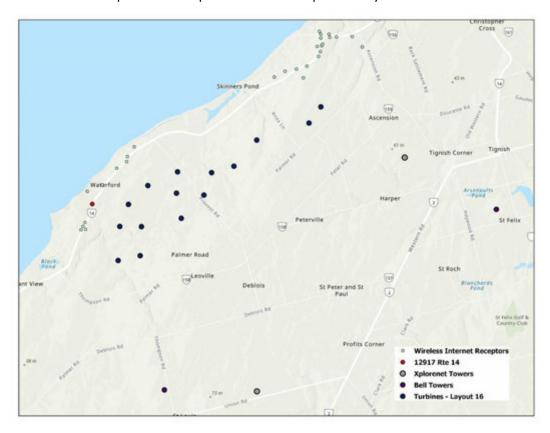
Figure 2 highlights turbine locations, identified wireless internet subscribers along Route 14, as well as locations of signal broadcasting towers. Receptors to the south and east of turbines were not surveyed given relative position to broadcasting towers.

For the project area, the point-to-point system of largest concern are wireless internet providers for rural areas. There are two known providers of wireless internet in the area: Xplornet and Bell. A survey of internet antennae was performed in parallel with a receptor survey.

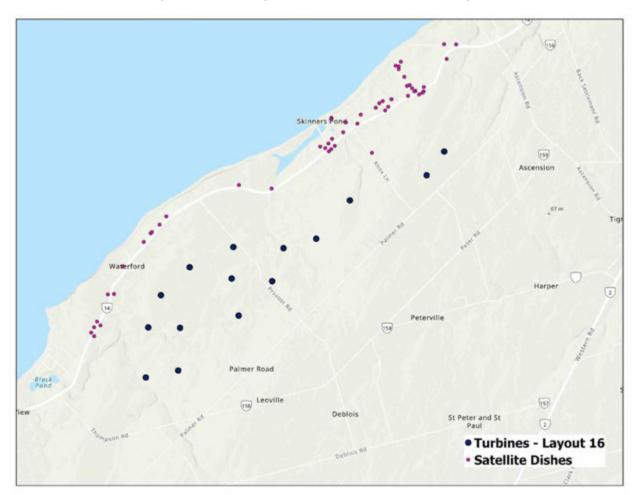
Figure 7. Satellite Dish Receptors

Satellite Stations include household satellite dishes used for TV. A survey of receptors with satellite dishes was undertaken in parallel with receptor and radio internet user surveys.

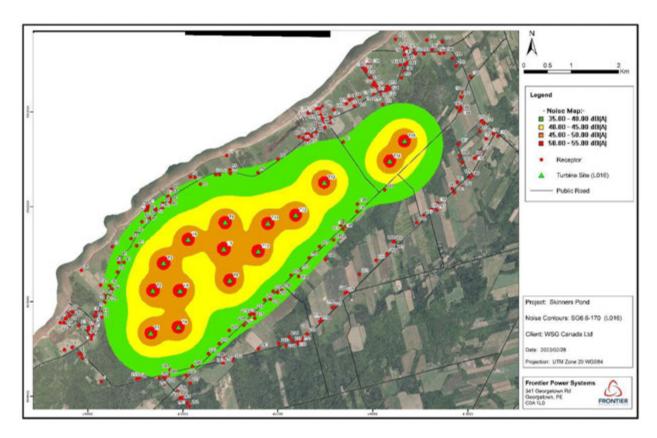
Figure 3. Noise Contour Map SG6.6-170

Predicted Noise Levels: Turbine Type SG6.6-170							
Recepto r ID	Sound Pressure Level (dB(A)	Recepto r ID	Sound Pressure Level (dB(A)	Recepto r ID	Sound Pressure Level (dB(A)		
1	30.16	91	35.70	181	30.31		
2	30.04	92	32.74	182	29.31		
3	30.02	93	32.17	183	30.58		
4	29.88	94	31.96	184	29.94		
5	29.37	95	31.81	185	30.94		
6	28.41	96	31.64	186	30.87		
7	32.18	97	31.52	187	30.86

Predicted noise level is less than 40 dB(A) at most receptor locations, with the exception of receptor 41 at 40.1 dB(A) and receptor 44 at 40.9 dB(A).

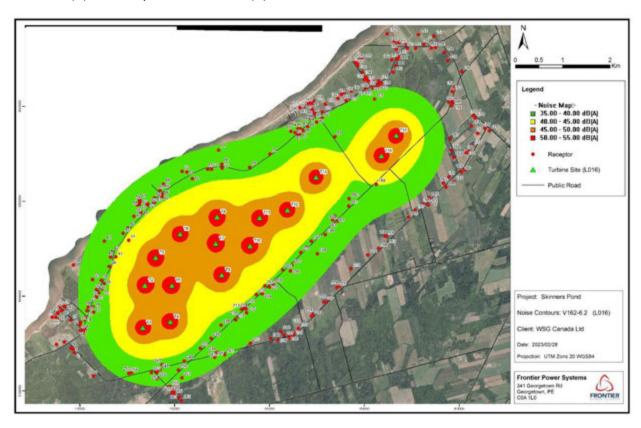
Figure 4. Noise Contour Map V162-6.2

Predicted Noise Levels: Turbine Type V162-6.2								
Receptor ID	Sound Pressure Level (dB(A)	Receptor ID	Sound Pressure Level (dB(A)	Receptor ID	Sound Pressure Level (dB(A)			
1	32.89	91	38.03	181	32.89			
2	32.79	92	35.32	182	31.96			
3	32.77	93	34.81	183	33.15
