## Incident Summary (Reference #5624387)

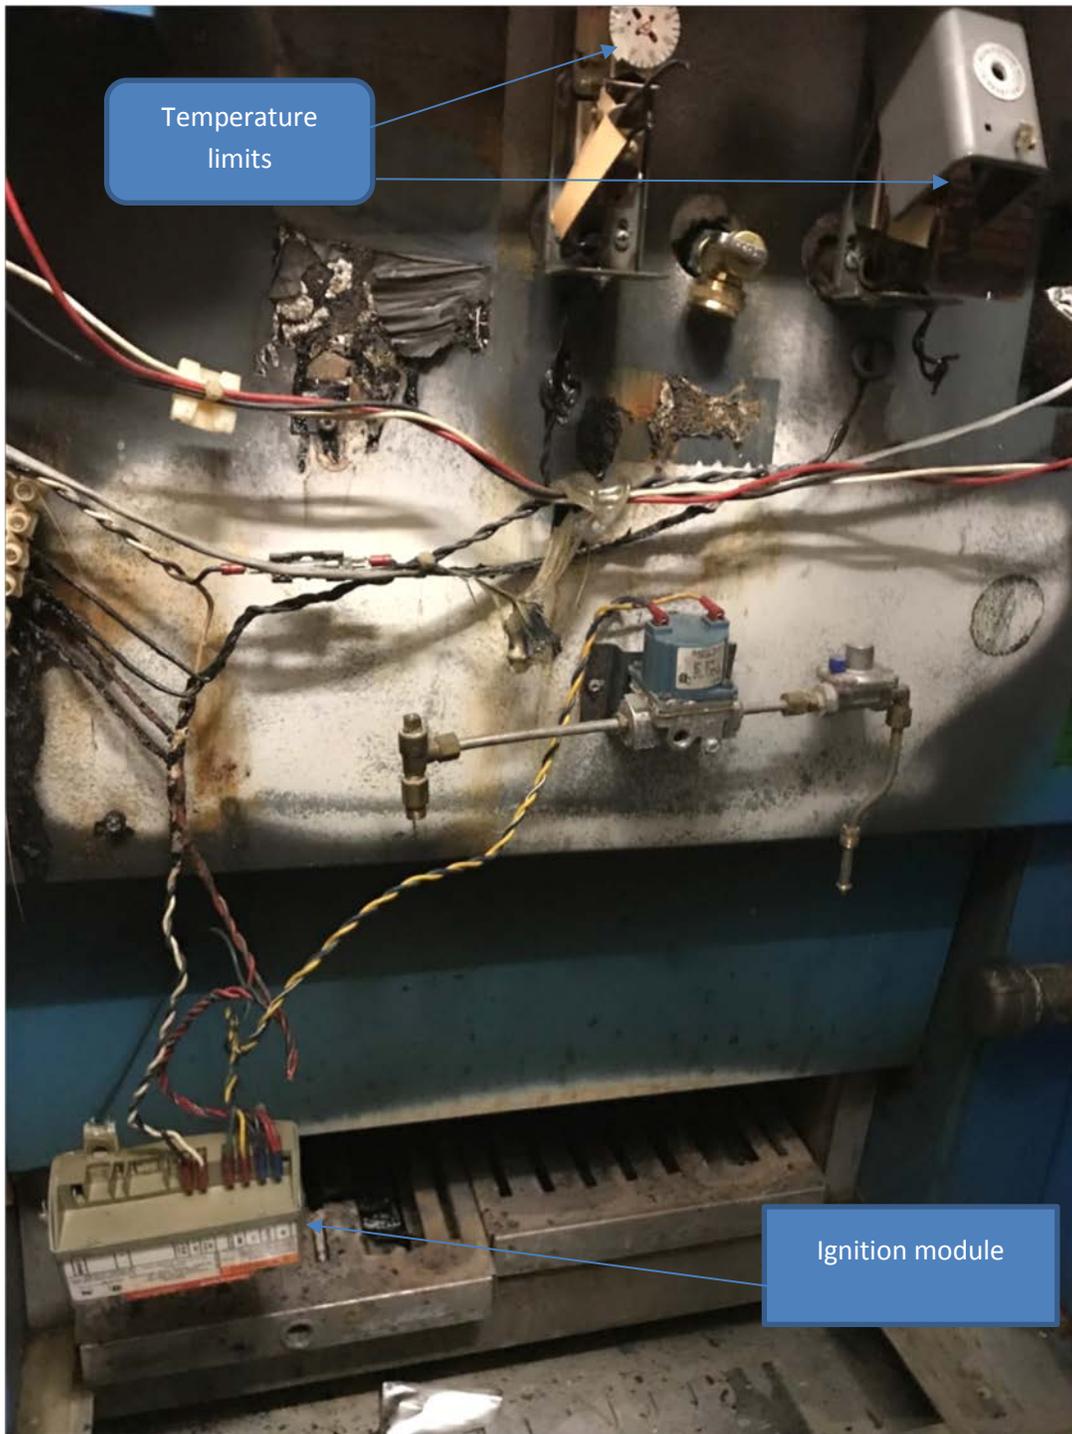
Photos or diagrams (if necessary)

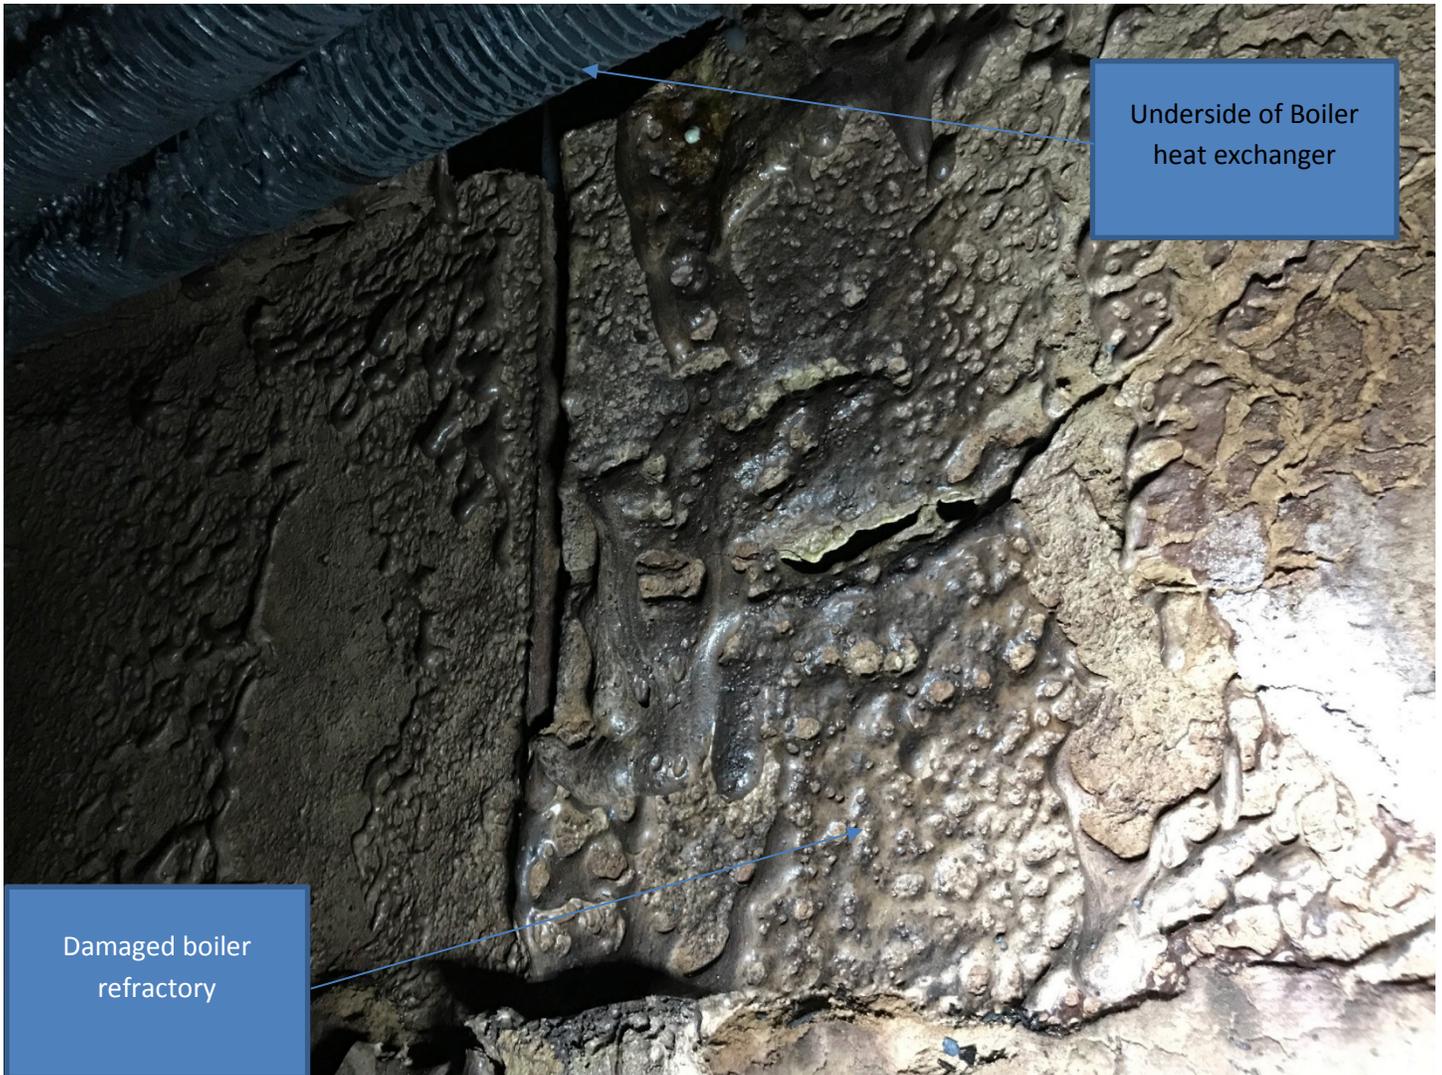
Underside of Boiler  
heat exchanger

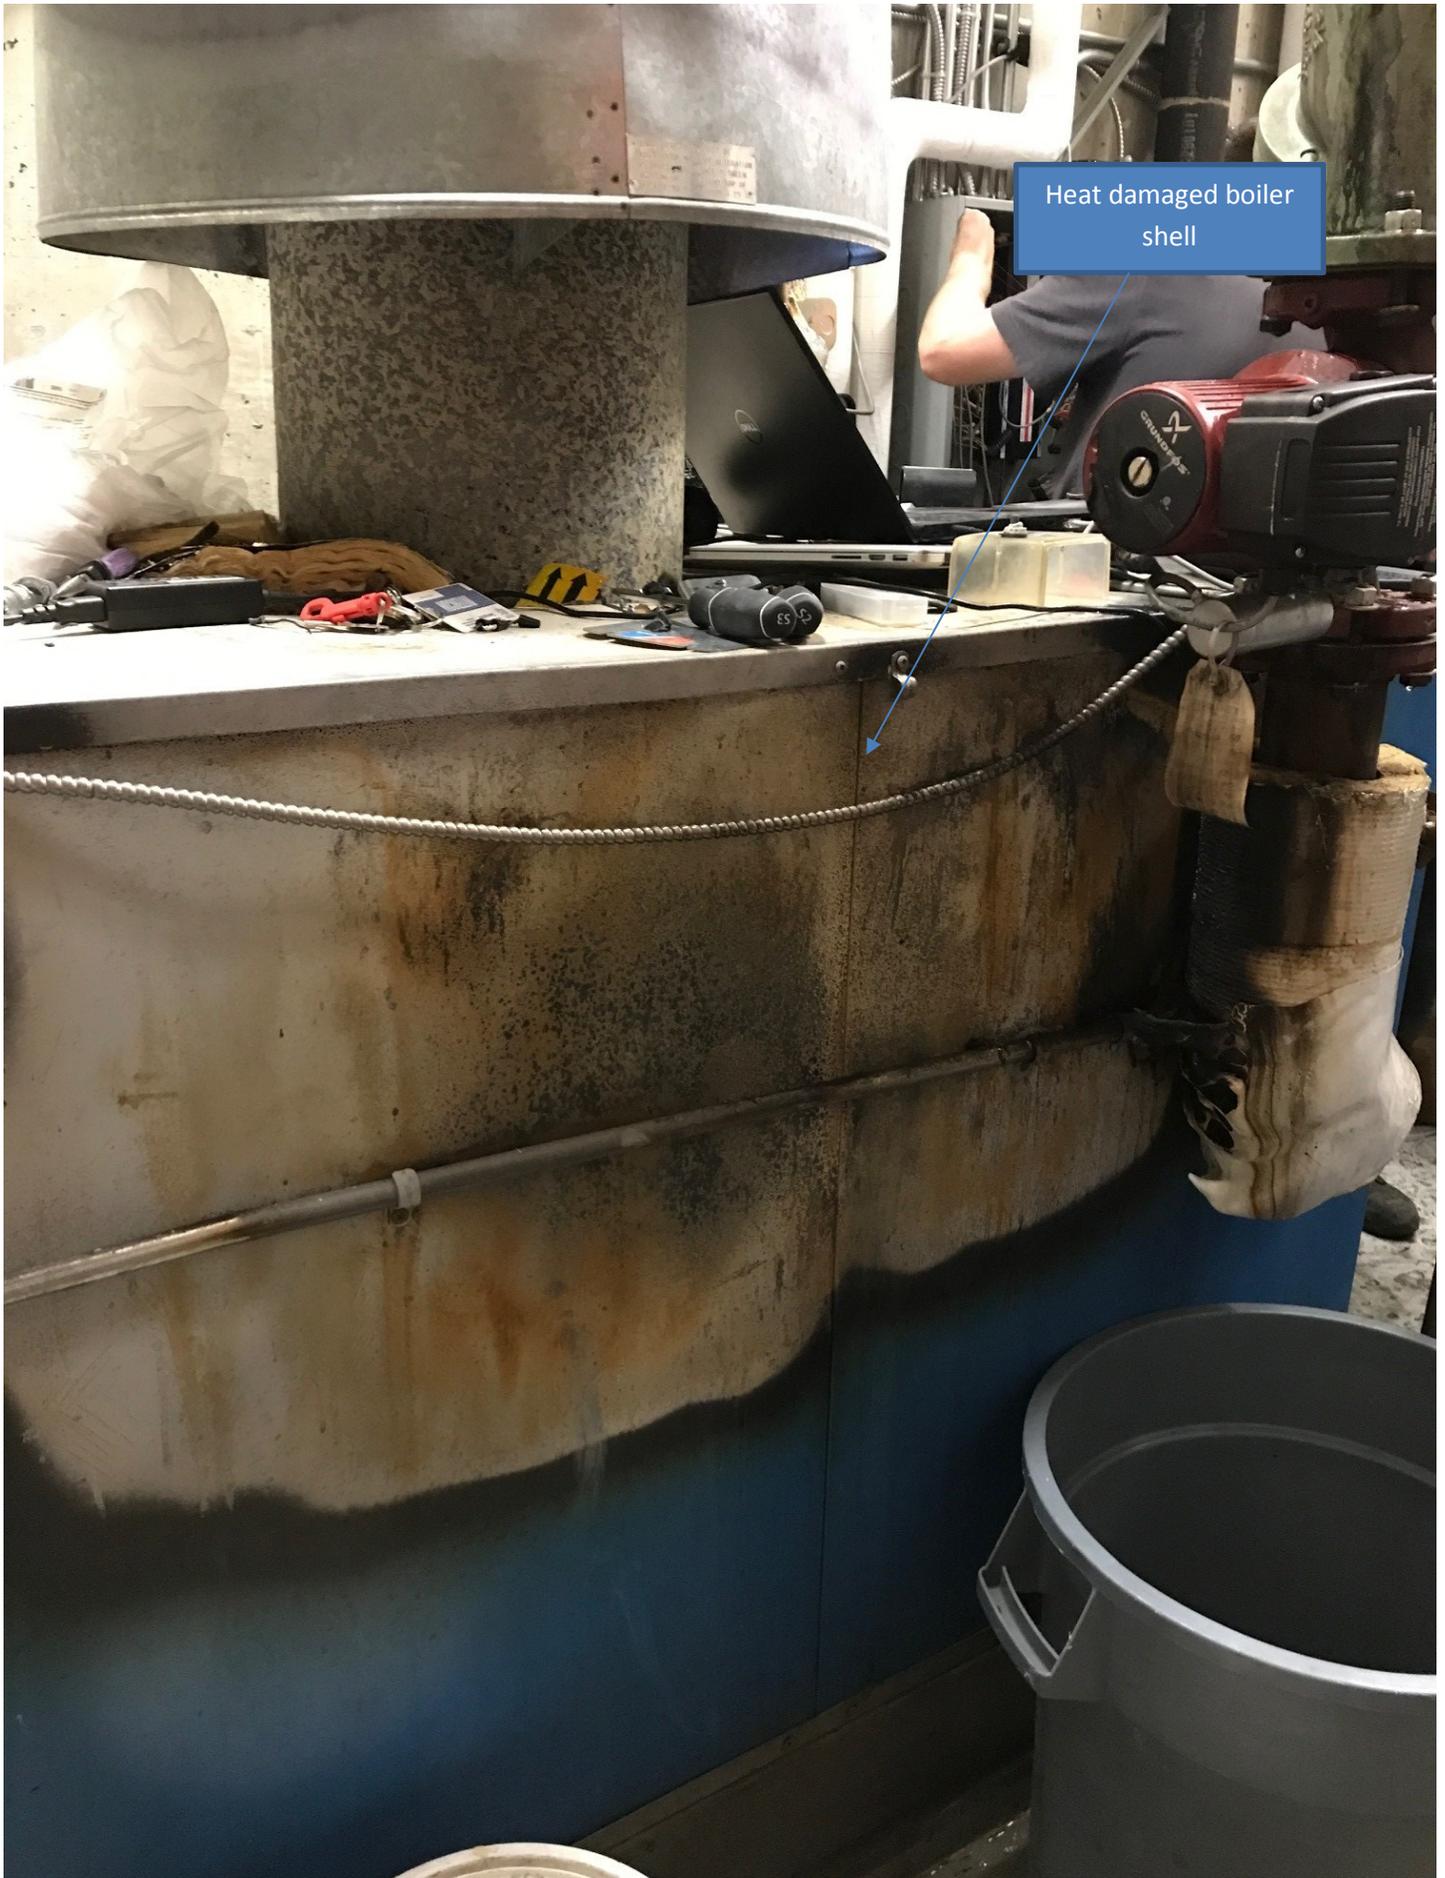
Heat damaged boiler  
shell
