Incident Summary #II-1317008-2022 (#25858) (FINAL)

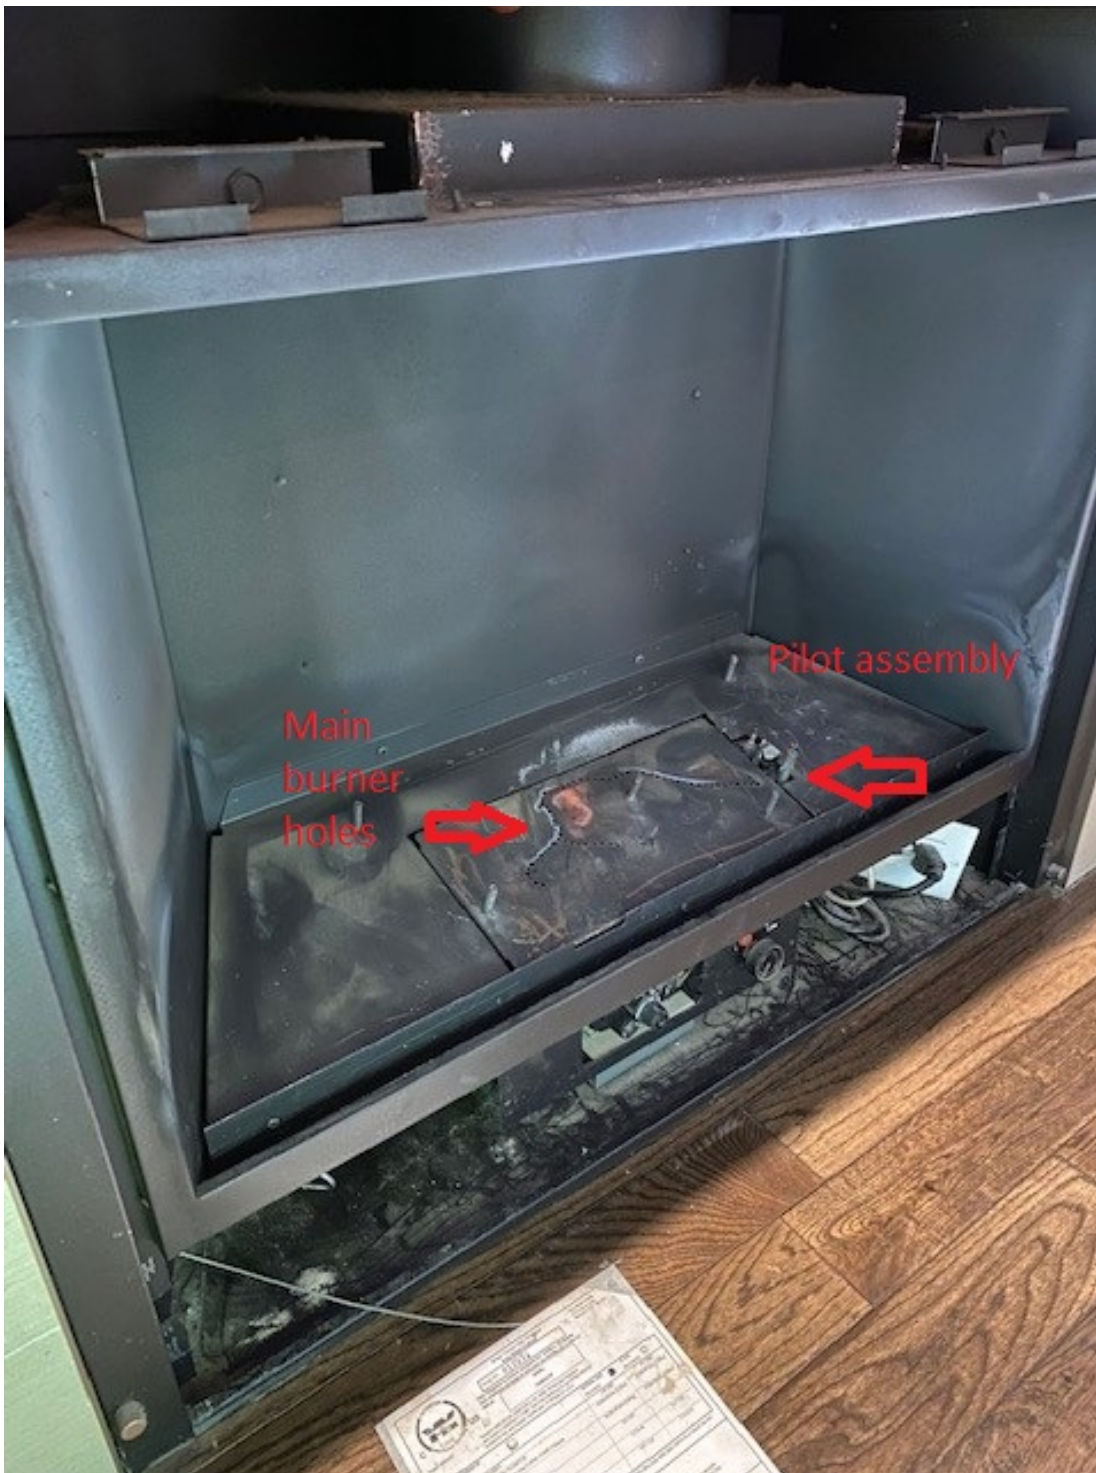
<p>When fuel accumulates before ignition occurs, a hard or explosive ignition can create a higher pressure in the combustion chamber than design allows and can result in the fireplace glass failing and being blown out into the room.</p>
<p>Facts and evidence</p>	<p>Interview with homeowner:</p> <ul style="list-style-type: none"> - The residence was purchased new by the current homeowner upon completion of construction in 2012. - The fireplace has not received any maintenance from a certified gas fitter since the installation of the fireplace in 2012 as described by the homeowner. - The homeowner became aware of an abnormal operation of the fireplace 3 to 4 days prior to the incident and described a randomly occurring “larger than normal flame” and when the larger flame was present, the fireplace “produced more heat than normal”. - The pilot flame and safeguard components were not suspect <p>Interview with the gas fitter:</p> <ul style="list-style-type: none"> - The gas fitter used a manometer to measure the pressure of the fuel delivered from the appliance gas valve to the main burner. The gas fitter found that the fuel pressure was not stable and would pulse or flutter. - The pressure of the gas supplied to the appliance gas valve was within manufacturers specification. - After the gas fitter replaced the appliance gas valve and the front glass, the gas fitter then tested the fireplace for safe operation. The main burner flame was stable, and the fireplace operated correctly. - In speaking with the manufacturer, it was confirmed the original gas valve was installed in this model of fireplace around the time this fireplace was built.

<p>Causes and contributing factors</p>	<p>It is likely that a malfunctioning gas valve led to a hard light off situation causing an explosive ignition of the main burner that blew out the fireplace glass.</p>

Image 1 - The condition of the fireplace at the time of inspection. The homeowner had removed the fireplace logs and had vacuumed up the glass on the floor and interior of the fireplace before inspection.

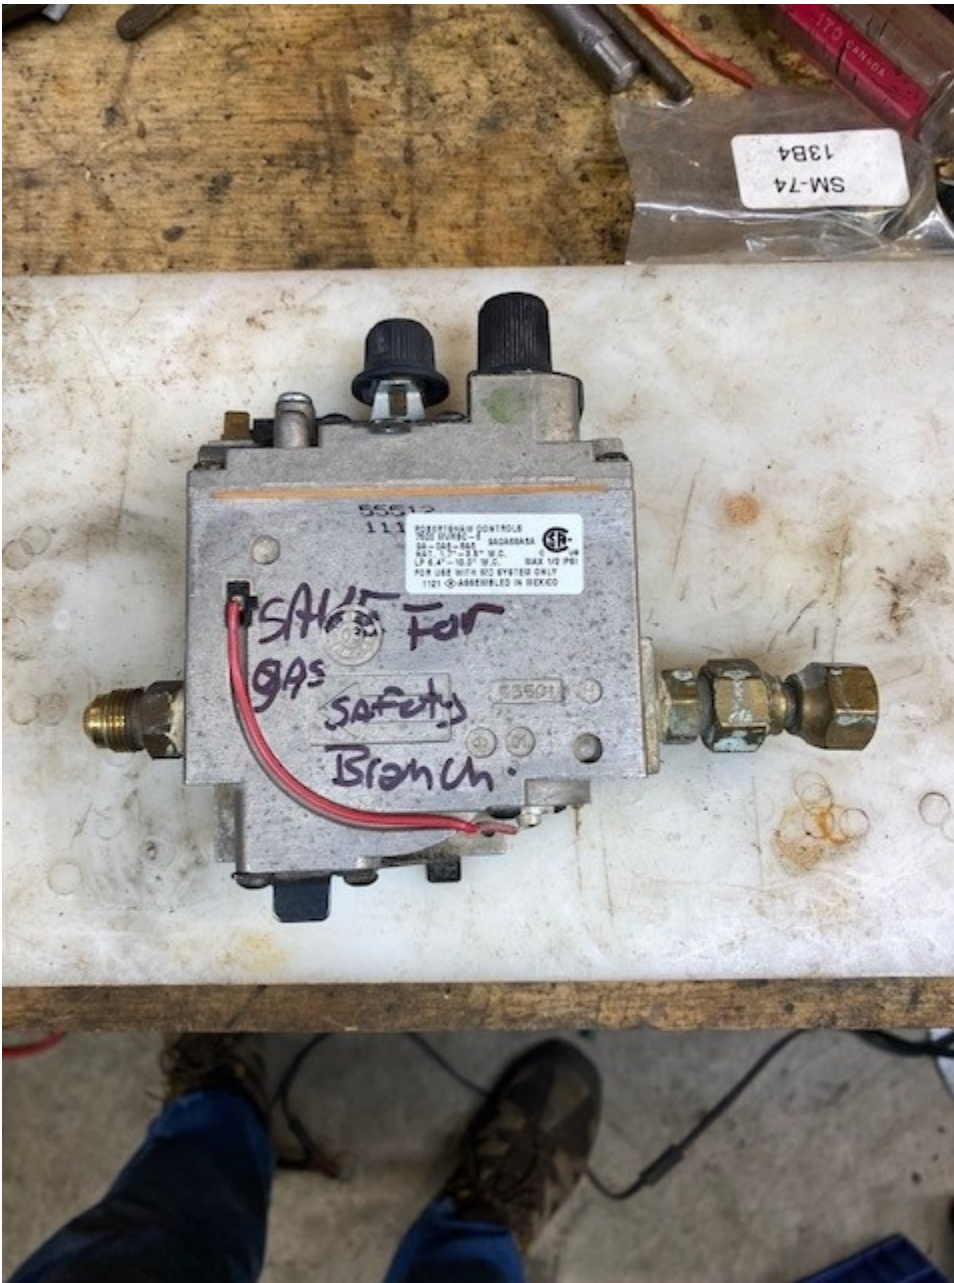
Image 4 - The original gas valve as provided to Technical Safety BC by the contractor who repaired the fireplace.
