## Incident Summary (Reference #5578579) (Final)

| | Regulated industry sector | | Passenger Ropeways- Above-surface ropeway. | |
| | Damage | Damage description | Broken tension system winch ratcheting mechanism casting. | |

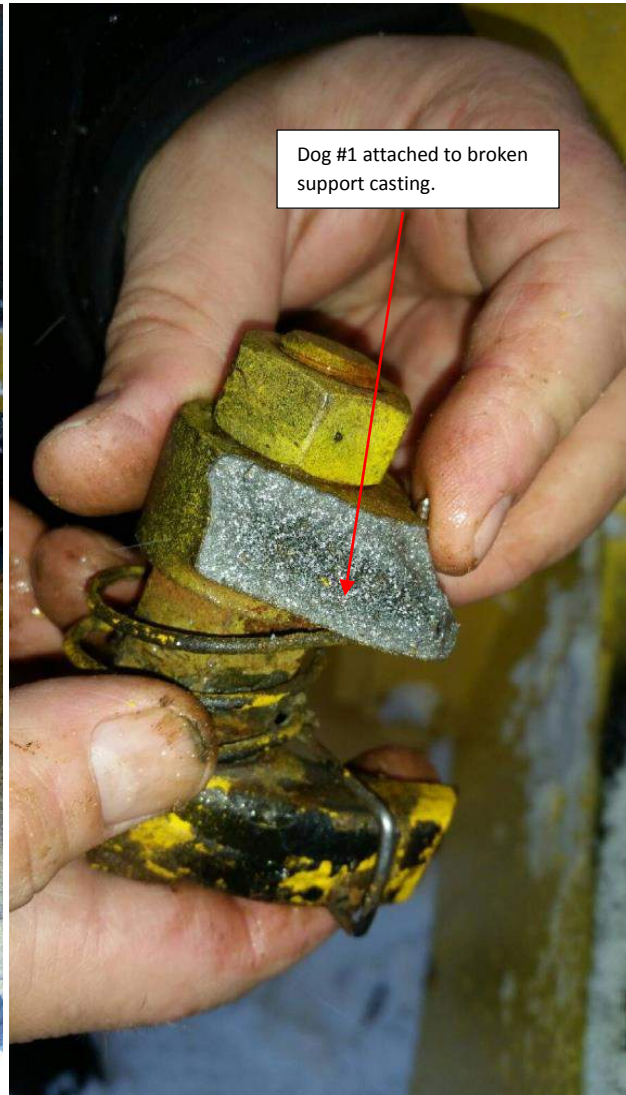
| CONCLUSI | Failure scenario(s) | | When the winch was manually reversed the casting that supported the number one anti-rollback dog failed. The failure could have been the result of some external force that caused damage to the casting in this area in the past. When the casting failed the load was abruptly transferred to the number two anti-rollback dog. The impact to the | |

| | | number two dog caused the dog retaining circlip to fail allowing the dog to become disengaged with anti-rollback ratchet teeth. The load was then abruptly transferred to the third anti-rollback dog. The inertia gained by passing the first two anti-rollback dogs allowed the winch to continue to unwind. The speed of the winch was being controlled by the internal winch brake. The winch stopped when the counterweight touched the ground in the bottom of the counterweight enclosure. |

| | Causes and Contributing Factors | The probable cause of the incident is external damage or a flaw in the design or quality of the casting that allowed it to fail under load. The winch movement however could have been arrested had the second anti-rollback dog retaining circlip not failed. Routine inspection of the winch may have identified these deficiencies and avoided this incident. |

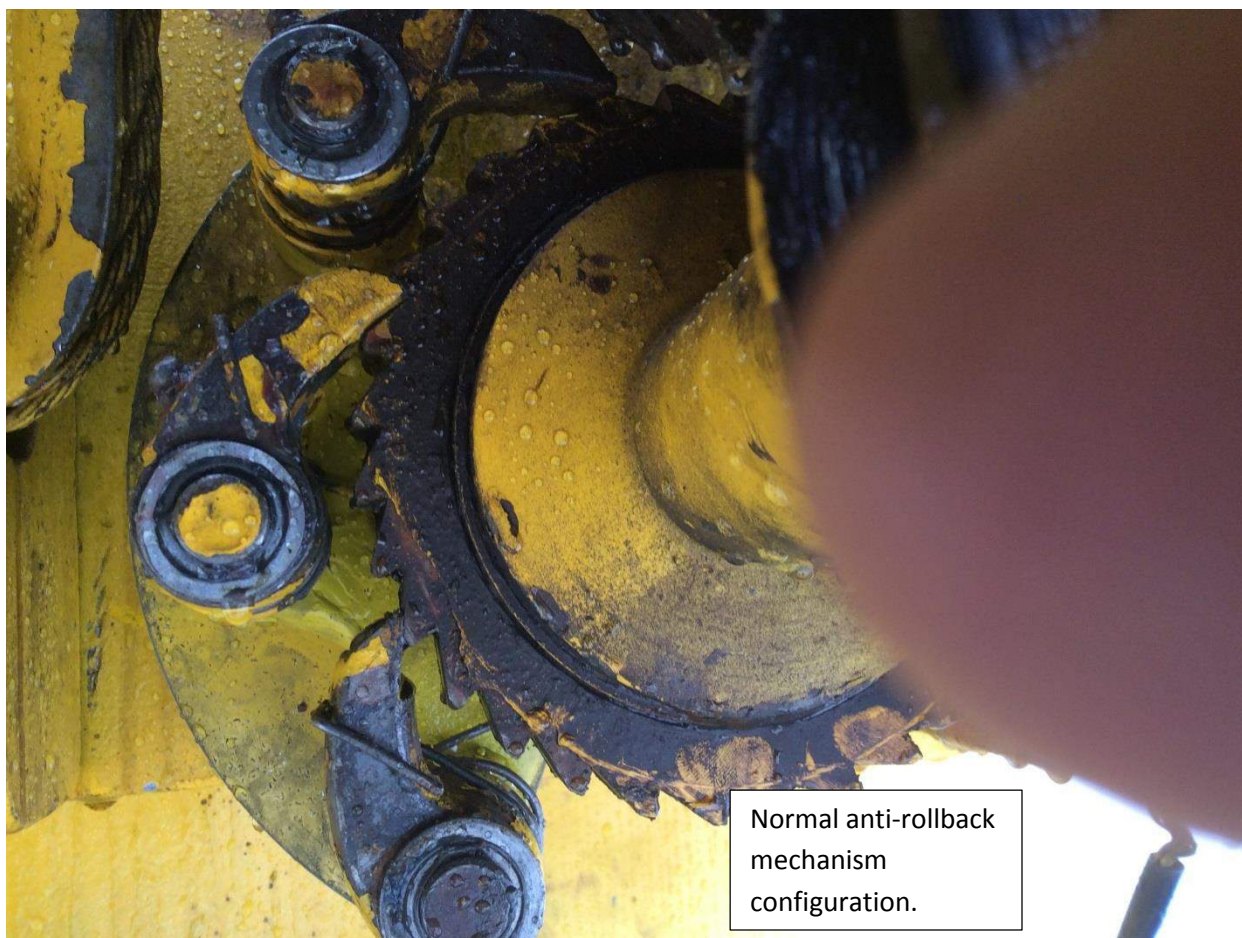
Normal anti-rollback  
mechanism  
configuration.
