Incident Summary #II-1147517-2021 (#20823) (FINAL)

SUPPORTING INFORMATION	Incident Date	February 13, 2021	
	Location	Castlegar, BC	
	Regulated industry sector	Electrical - Low voltage electrical system (30V to 750V)	
	Impact	Qty injuries	0
		Injury description	None
		Injury rating	None
	Damage	Damage description	Main distribution panel board and associated branch wiring dwelling sustained fire and heat damages.
		Damage rating	Moderate
	Incident rating	Moderate	
Incident overview	Main distribution 100-amp 120/240-volt panel board and associated branch wiring in a single family dwelling sustained fire and heat damages when a surge suppressor installed in the main distribution panel board ignited.		
INVESTIGATION CONCLUSIONS	Site, system and components	A 120/240-volt surge suppressor was installed in a branch circuit position in a 100-amp 120/240-volt single phase panel board. The panel board was installed in a basement area of a single-family dwelling. The surge suppressor is fitted with components that are intended to suppress momentary over-voltage conditions, or voltage surges thereby protecting those components installed on the load side, or downstream, of the surge suppressor

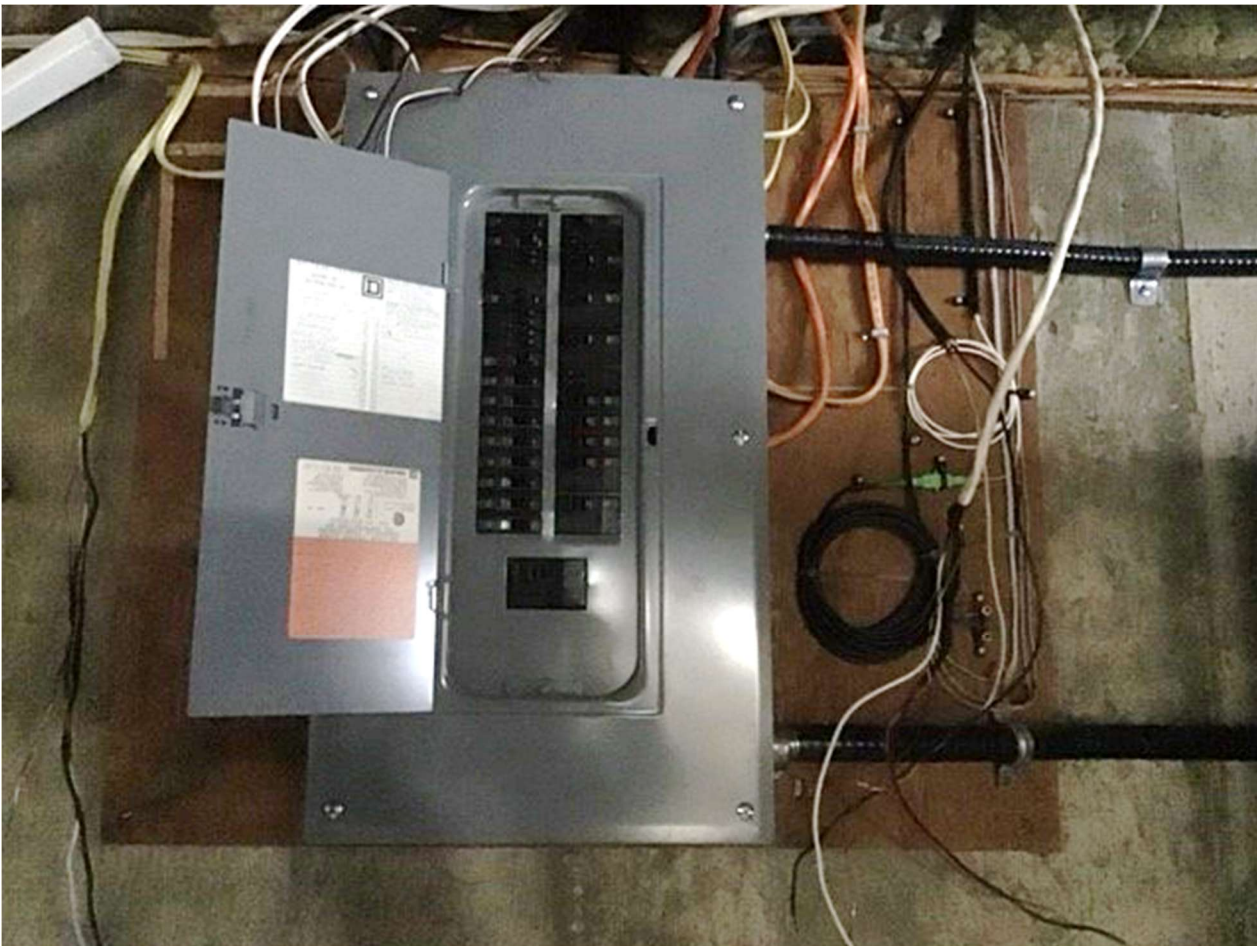
Main dwelling panel board, installed on basement level

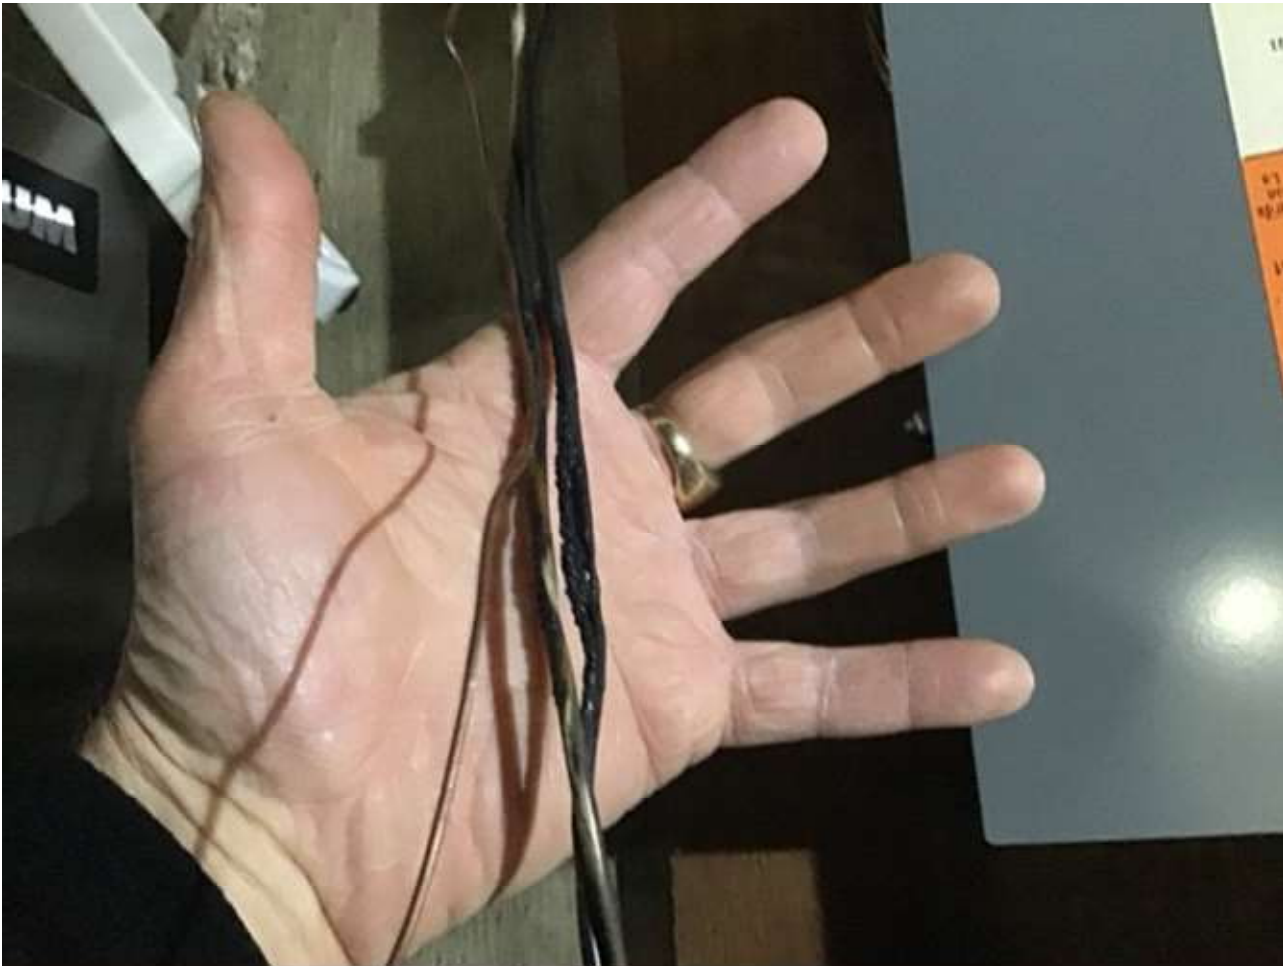
Burnt branch wiring conductor insulation

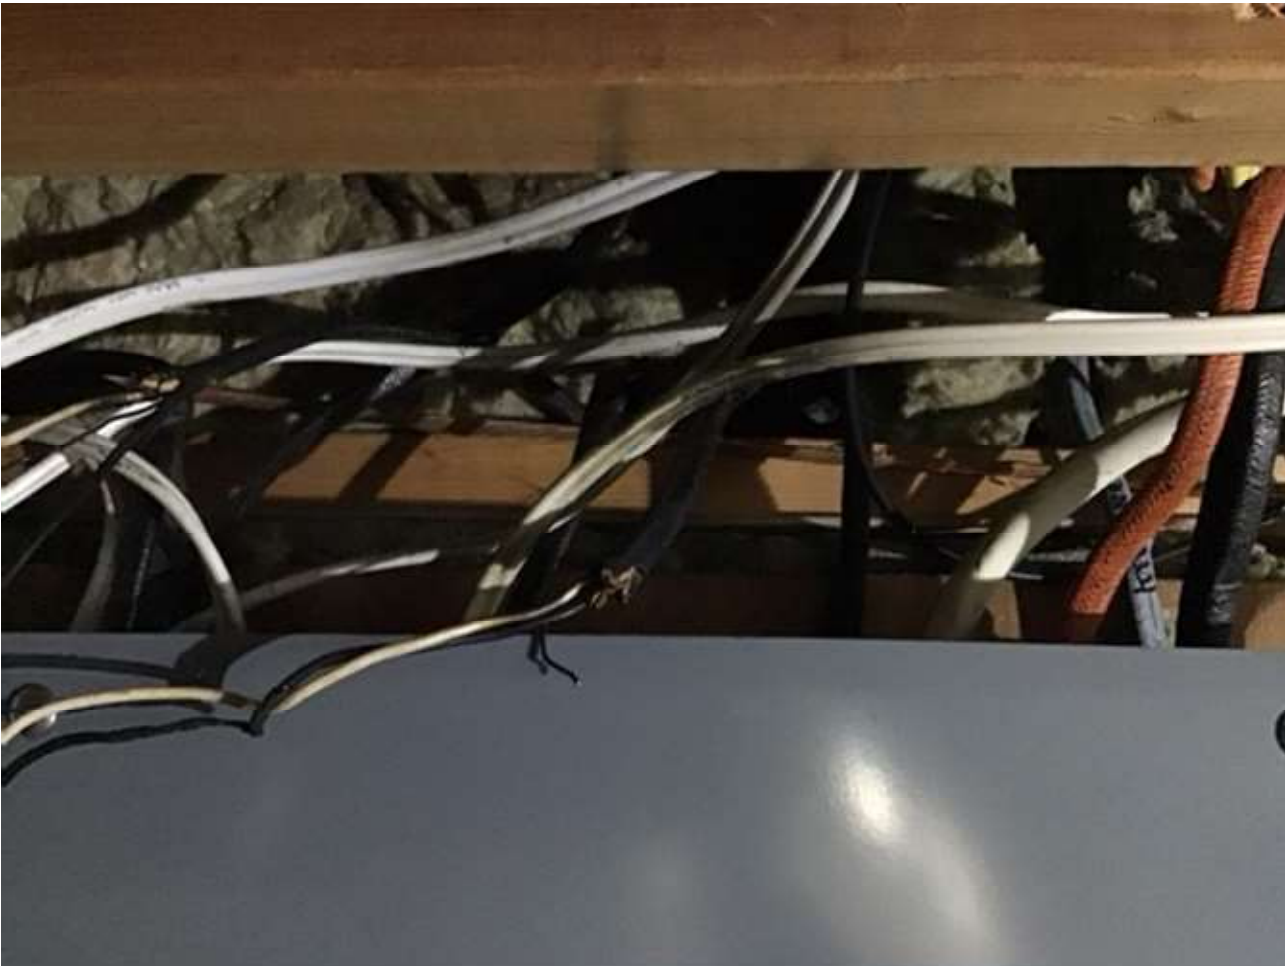
Burnt branch wiring cable insulation above panel board

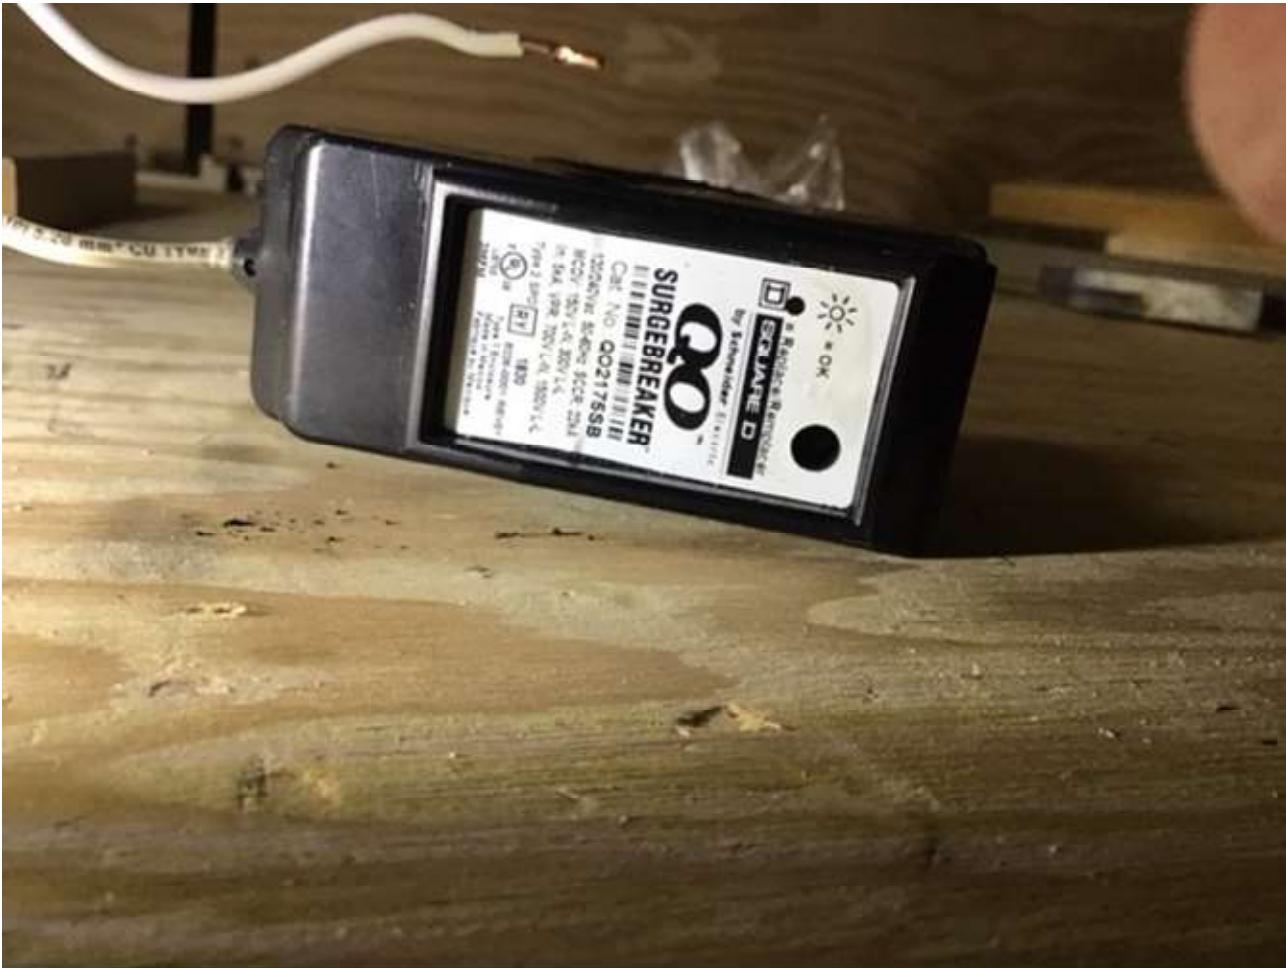
<p>Examination of the surge suppressor and panel board revealed that the surge suppressor ignited during momentary over-voltage conditions. The over-voltage values impressed on the service equipment and surge suppressor were very likely a result of a faulty, failing electric supply authority pole mounted transformer. The surge suppressor enclosure is constructed of polymer, plastic material. The burning surge suppressor enclosure ignited adjacent polymer, plastic panel board components, adjacent branch wiring conductor insulation, and adjacent branch wiring cable insulation.</p>
Causes and contributing factors	<p>All evidence indicates that the electric service equipment was impressed with voltage values that exceeded the service equipment electric ratings and the surge suppressor protection capability. The loud 'bang' noticed by the dwelling owner was likely the surge suppressor internal components rupturing on an over-voltage, electric arcing event. The electric arcing ignited the combustible surge suppressor components and enclosure and created a fire incident inside the panel board.</p>

Square D Surgebreaker Suppressor QO2175SB 120/240v 5ka – top view

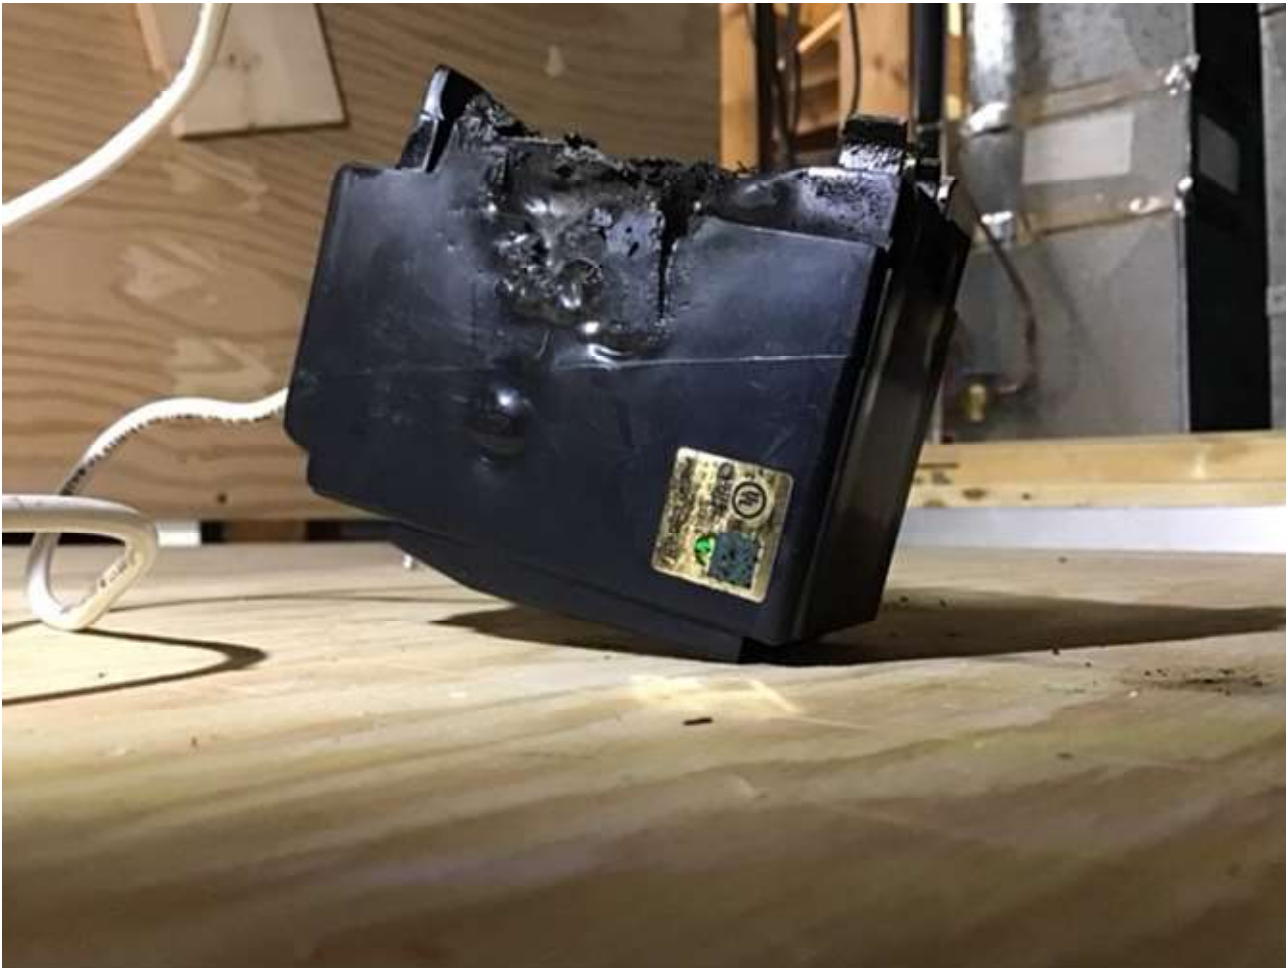
Square D Surgebreaker Suppressor QO2175SB 120/240v 5ka – side view

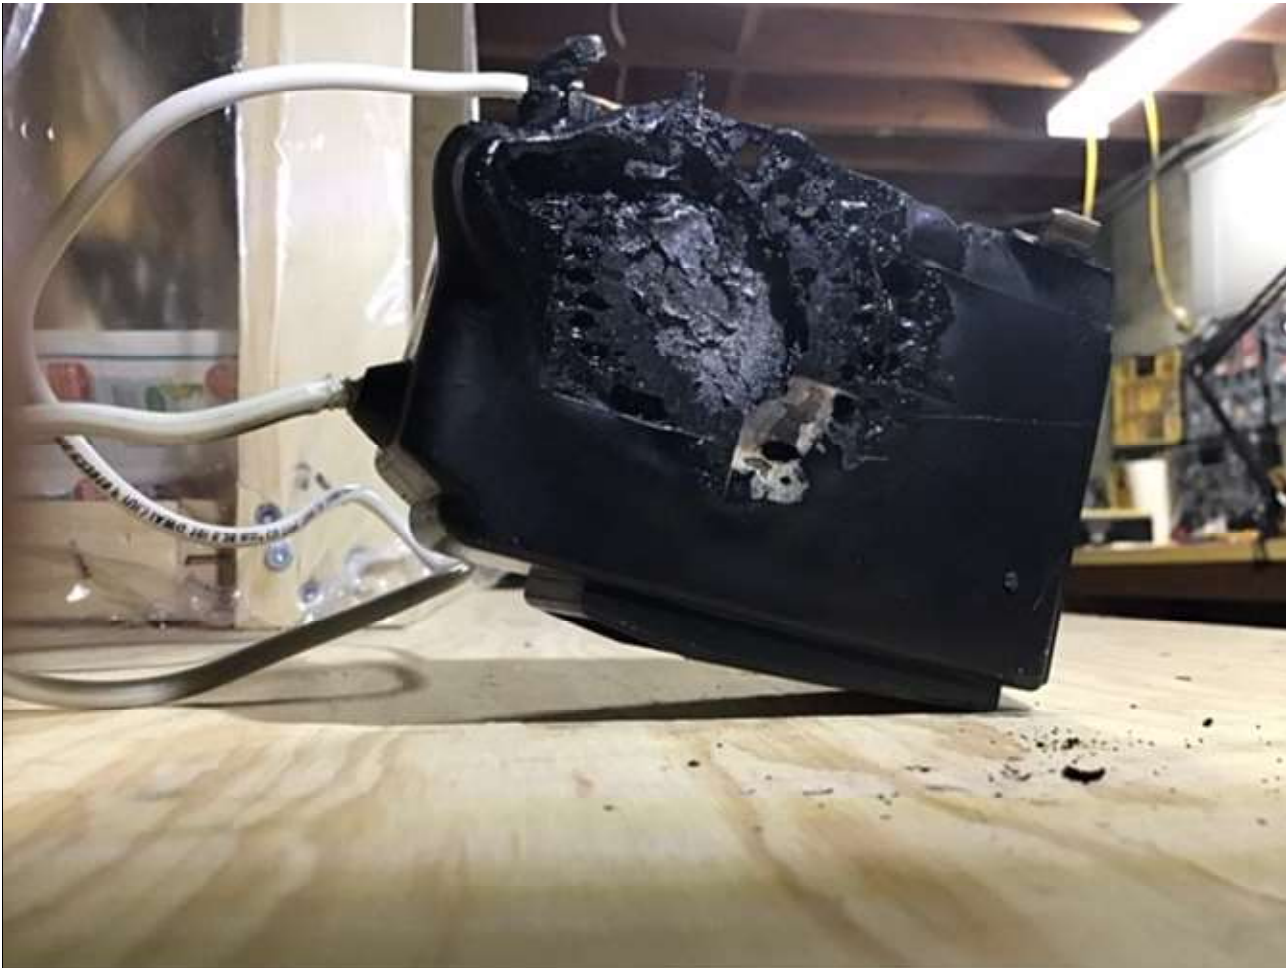
Square D Surgebreaker Suppressor QO2175SB 120/240v 5ka – other side view

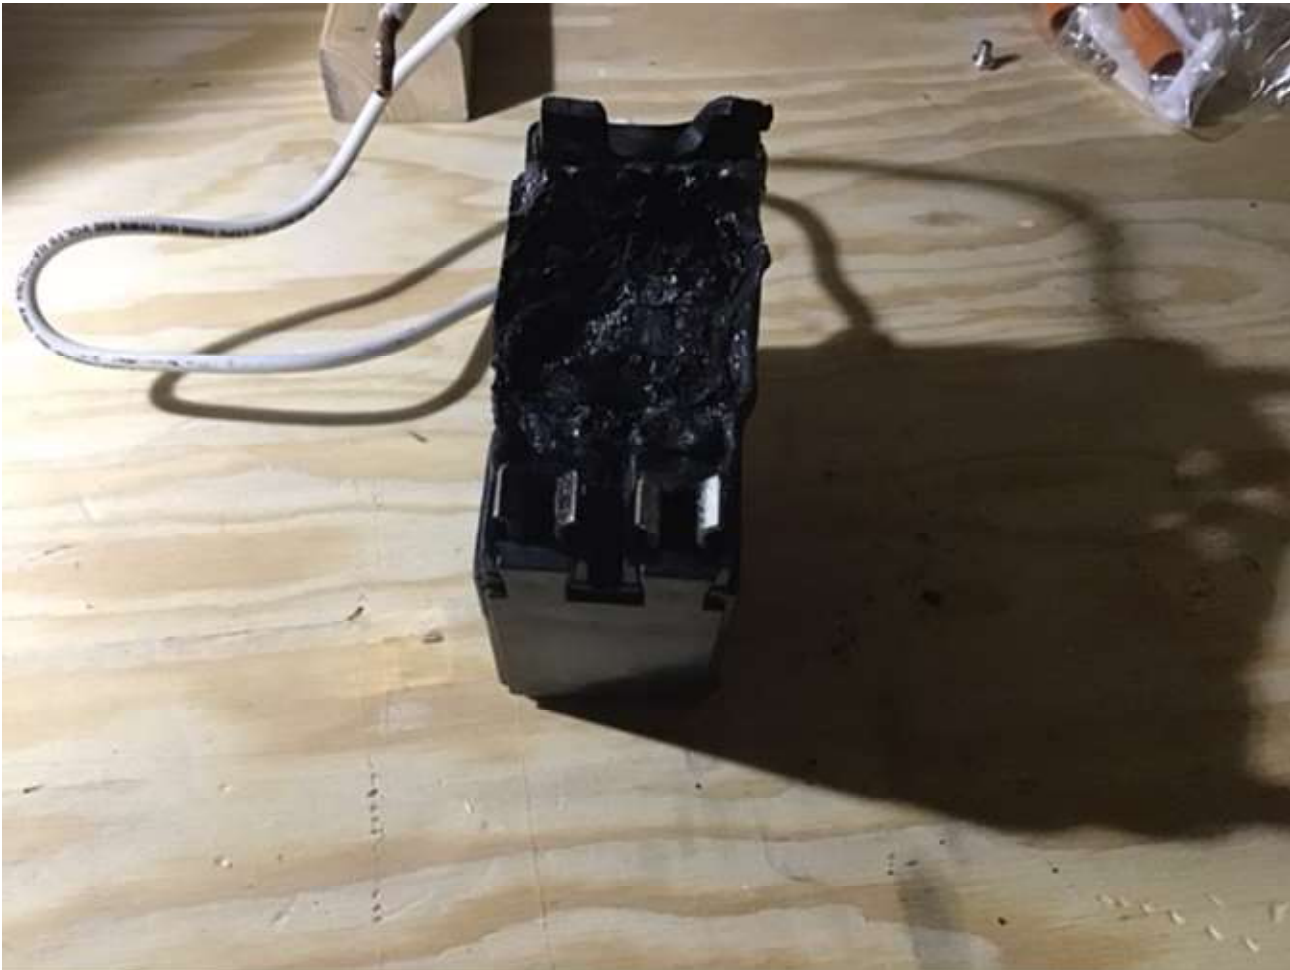
Square D Surgebreaker Suppressor QO2175SB 120/240v 5ka – back view
