Incident Summary #II-1113068-2020 (#20115) (FINAL)

SUPPORTING INFORMATION	Incident Date	November 27, 2020	
	Location	Abbotsford.	
	Regulated industry sector	Electrical - Low voltage electrical system (30V to 750V)	
	Impact	Qty injuries	0
		Injury description	N/A
	Damage	Injury rating	None
		Damage description	Components of the electric fireplace warped and melted. The surrounding wood framing burnt.
		Damage rating	Minor
	Incident rating	Minor	
Incident overview	An electric fireplace was installed in a renovated dwelling. When the fireplace was turned on for the first time for testing purposes, the fireplace caught on fire.		
INVESTIGATION CONCLUSIONS	Site, system and components	<p>The fireplace is designed to work with either 120 volts or 240 volts. The internal wiring for 120 volts has yellow jumper wires from the manufacturer connecting terminals together. When the fireplace is intended to be used by 240 volts, the yellow jumpers are to be removed according to manufacturer's instructions.</p> <p>Regulations require electrical apprentices performing electrical work to be supervised by a qualified individual.</p>

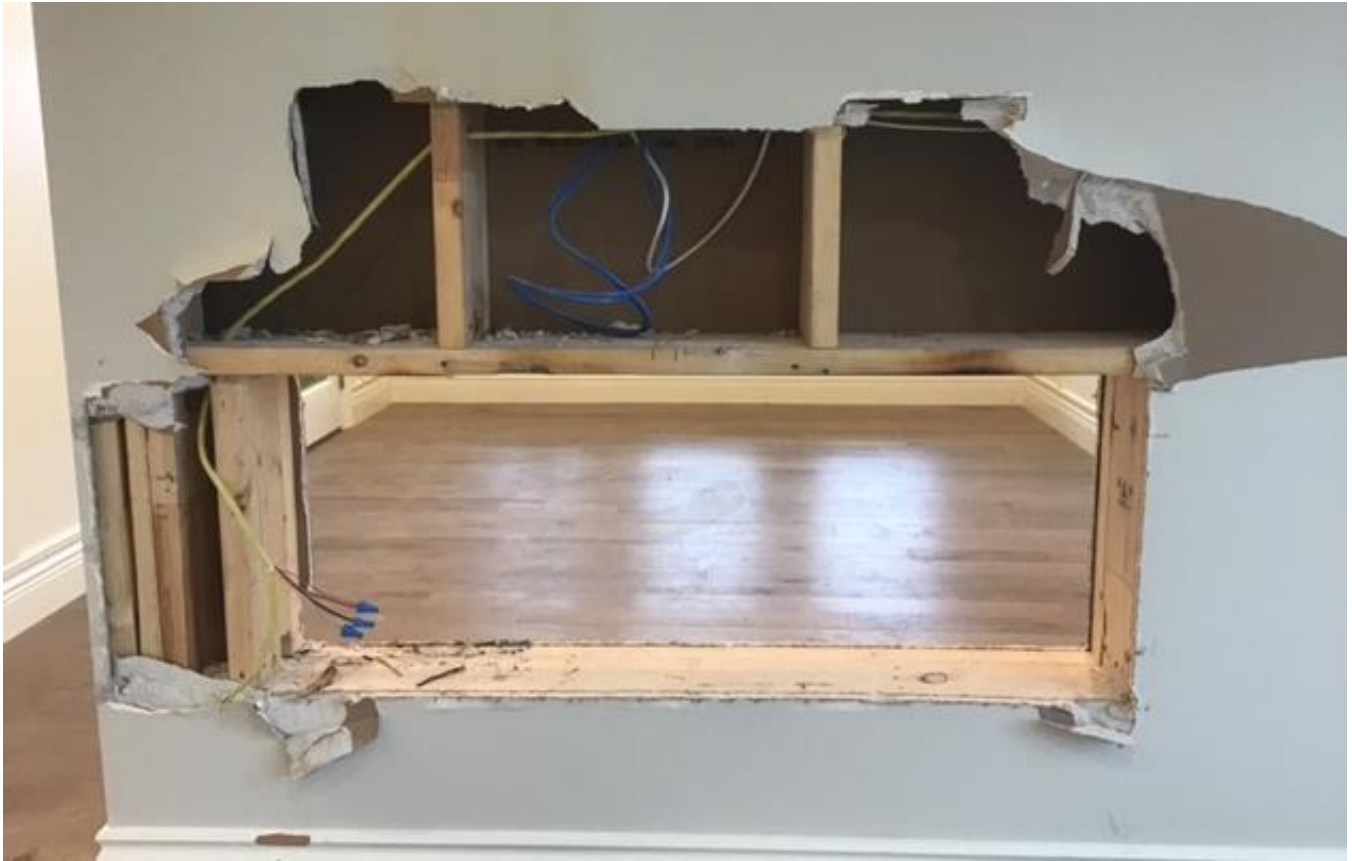
Photo 1: Location where the electric fireplace was installed.

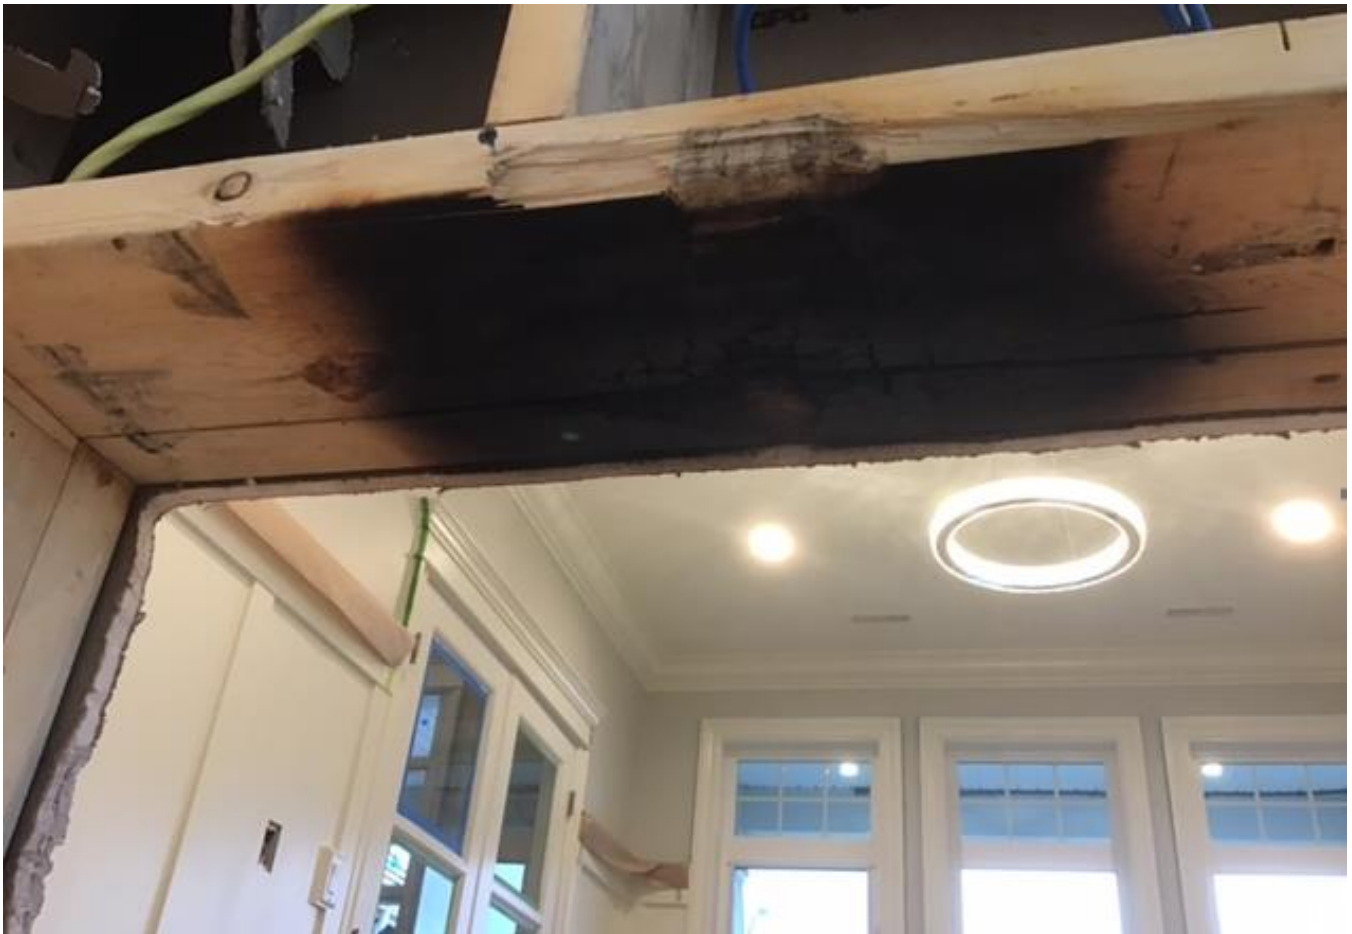
Photo 2: Damage to the wooden framing surrounding the fireplace location.

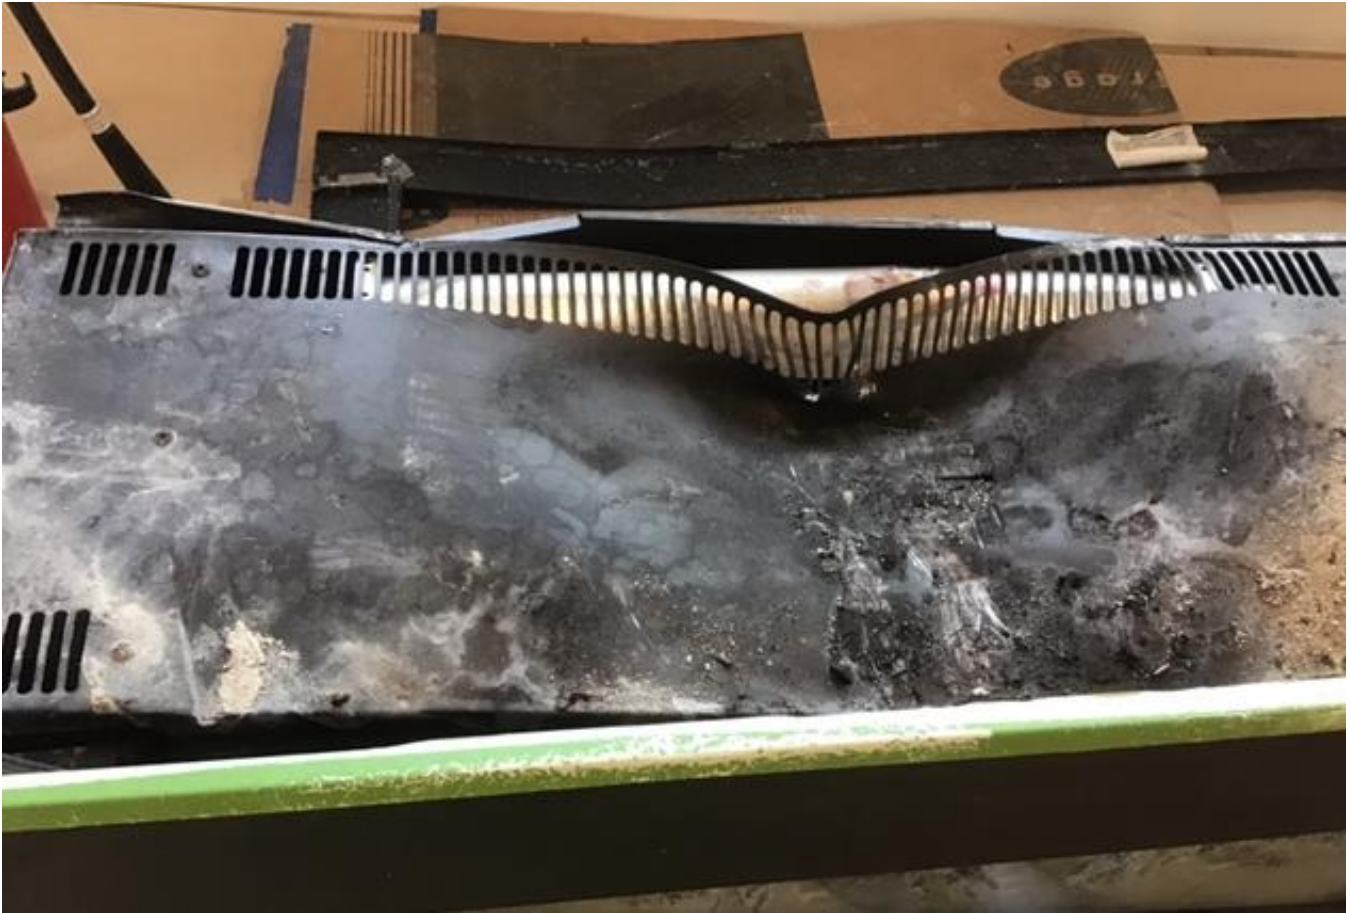
Photo 3: Damage to the top of fireplace.

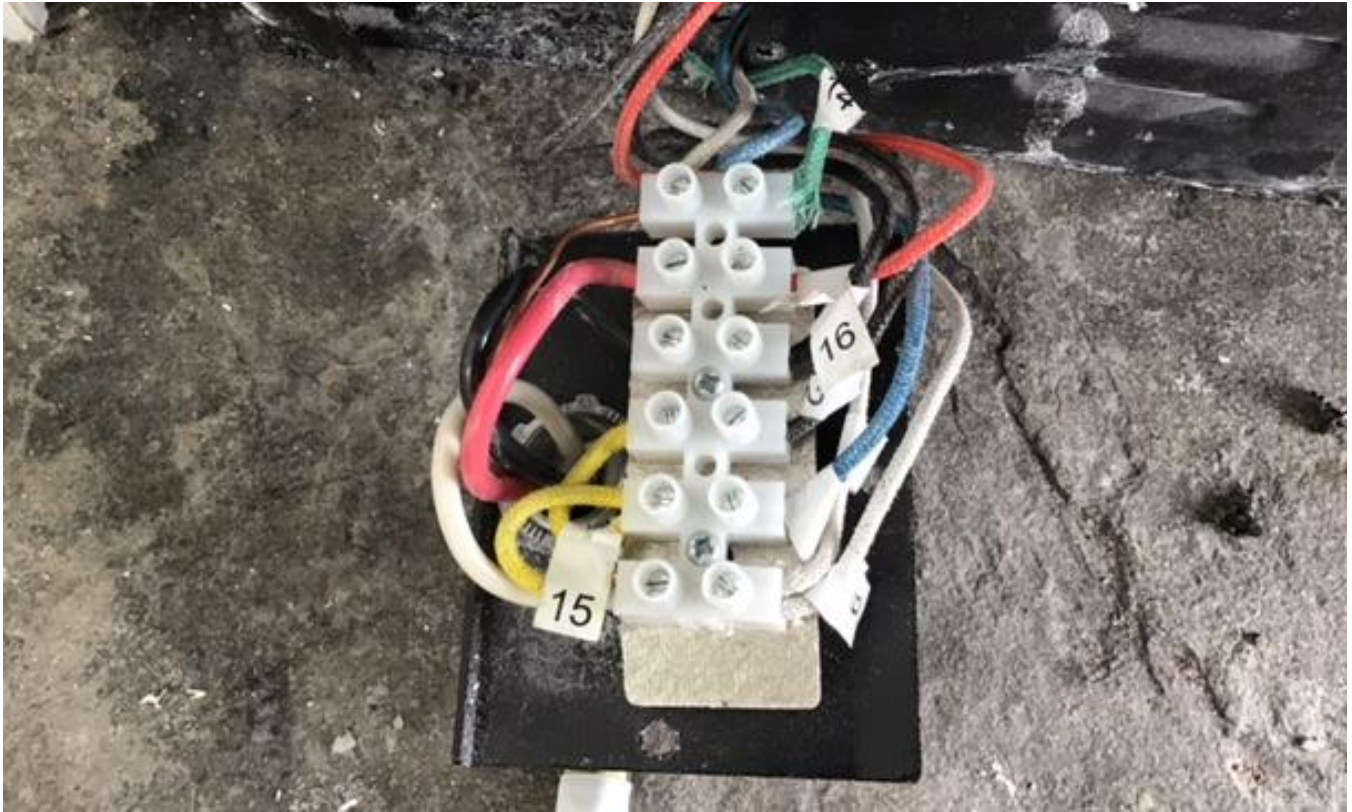
<ul style="list-style-type: none"> - The fire originated from the internal components of the fireplace. - The yellow jumper wires were still installed on the terminal block. (Photo 7) <p>Electrical contractor statements:</p> <ul style="list-style-type: none"> - The qualified individual instructed the electrical apprentice to remove the yellow jumper wires. - The fireplace was energized for the first time at the time of the incident. - The fireplace breaker was left in the “on” position when the contractor left. - The homeowner came downstairs after the electrical contractor left and found the fireplace on fire. <p>Manufacturer’s installation manual:</p> <ul style="list-style-type: none"> - It instructs the installer to remove the yellow jumper wires for 240 volt installations. (Photos 4,5,6)
<p>Causes and contributing factors</p>	<p>The apprentice not removing the yellow jumper wires from the terminal block is the cause of the incident.</p> <p>A contributing factor is that the qualified individual responsible for overseeing the apprentice’s work did not check the connections prior to energizing the fireplace.</p>

Photo 7: Yellow jumpers installed on fireplace terminal block.
