## Incident Summary #II-1502482-2023 (#31134) (FINAL)

| SUPPORTING INFORMATION | Incident Date | January 30, 2023 | |

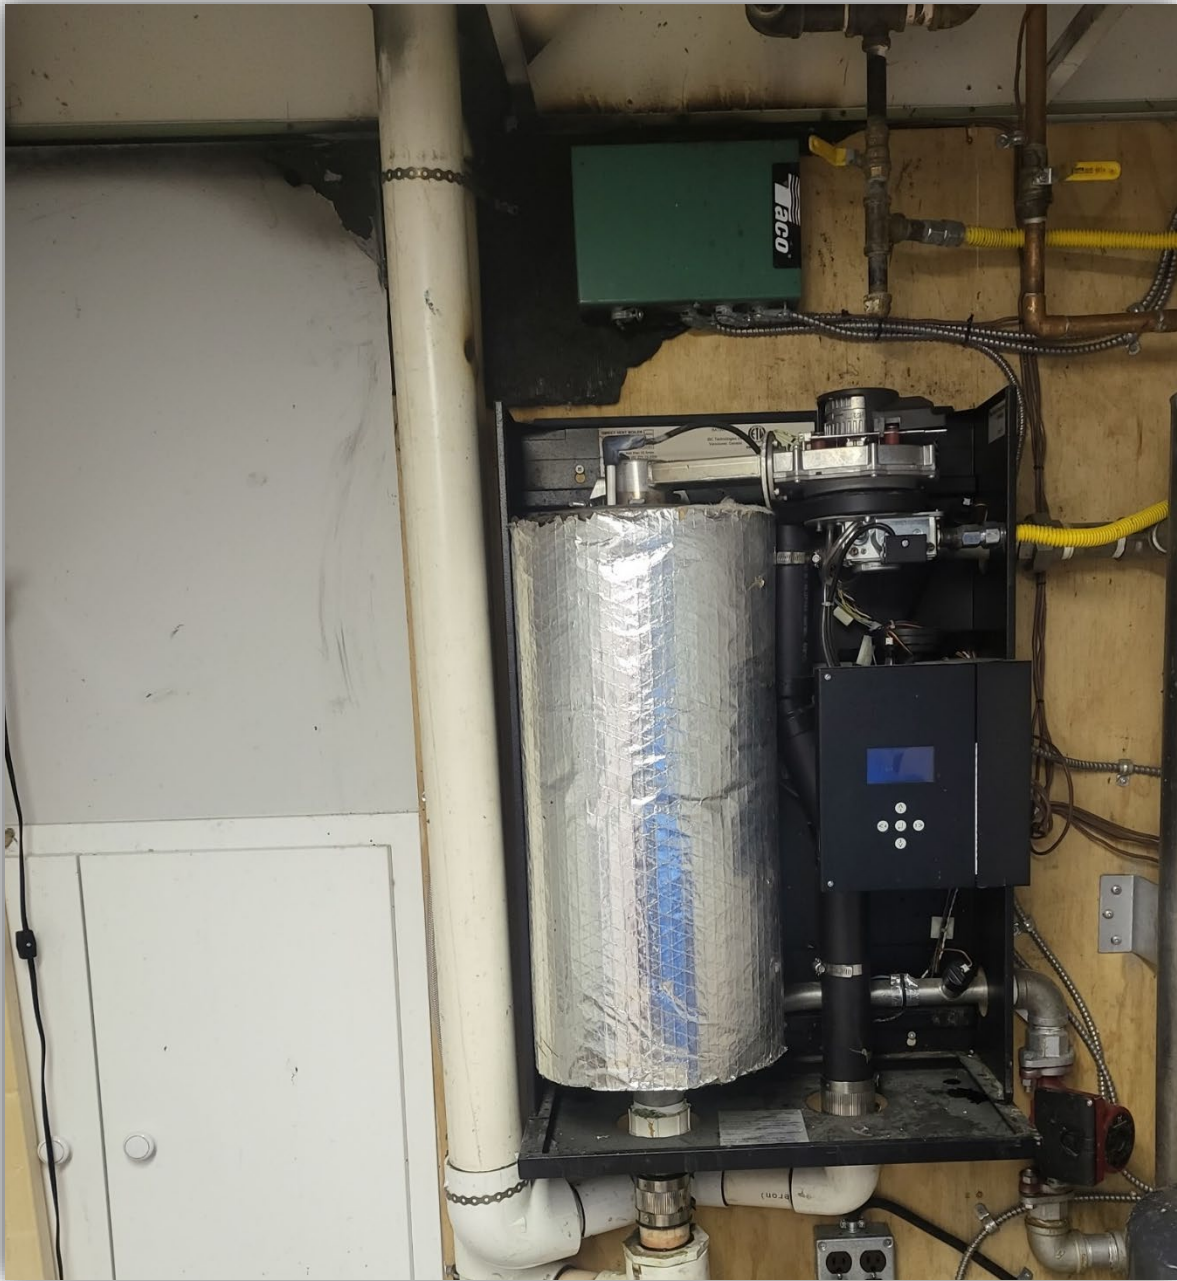
Photo 1 – Boiler with fire damage at top left corner.

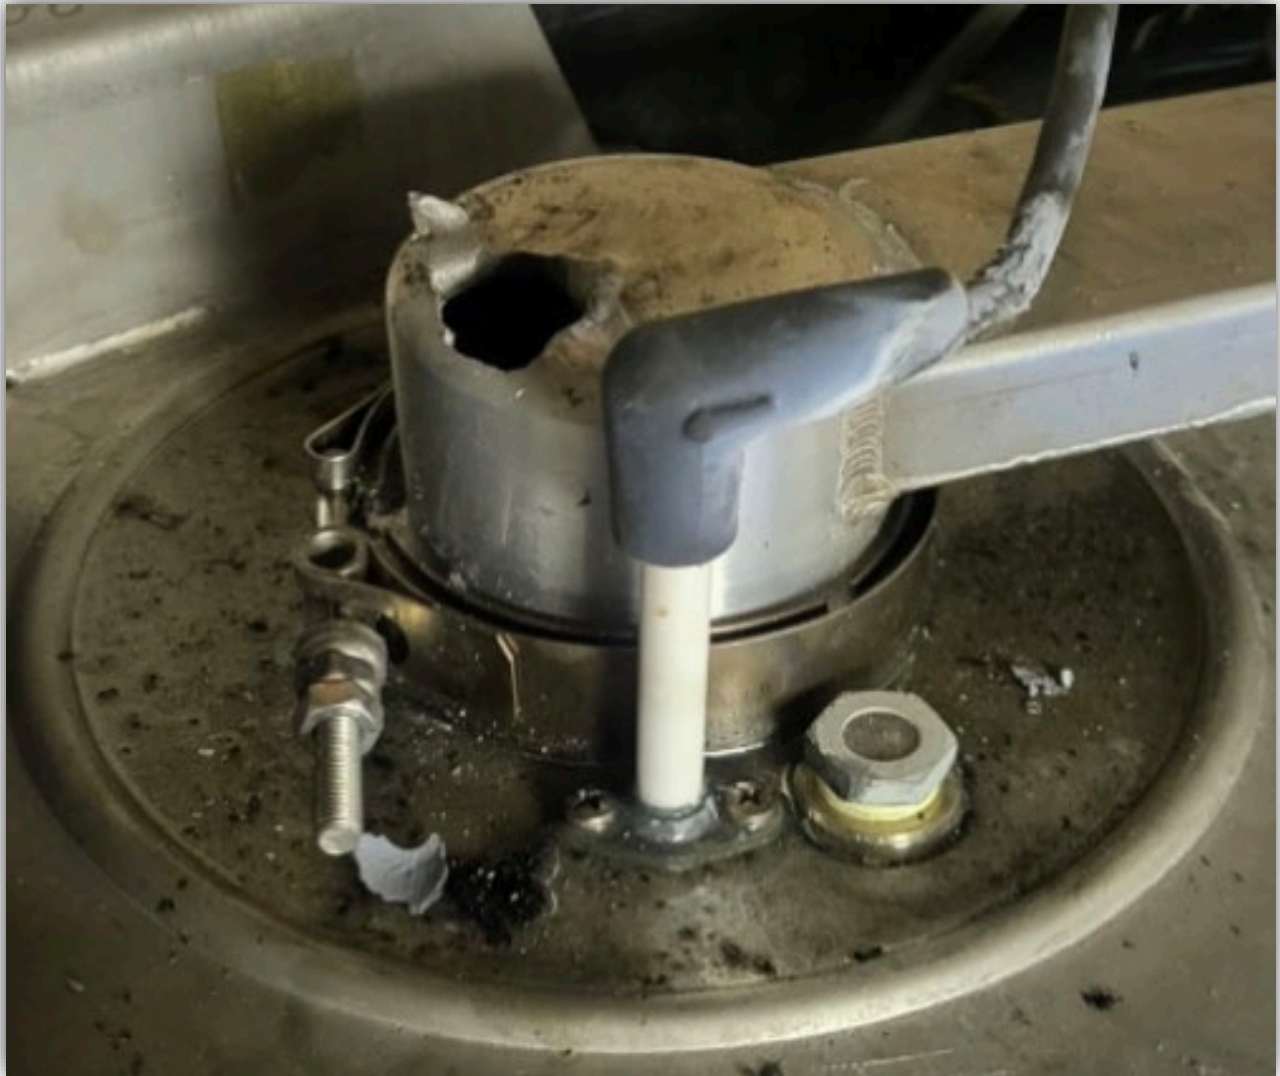
Photo 2 – Fan coupler with hole blown out of the top.

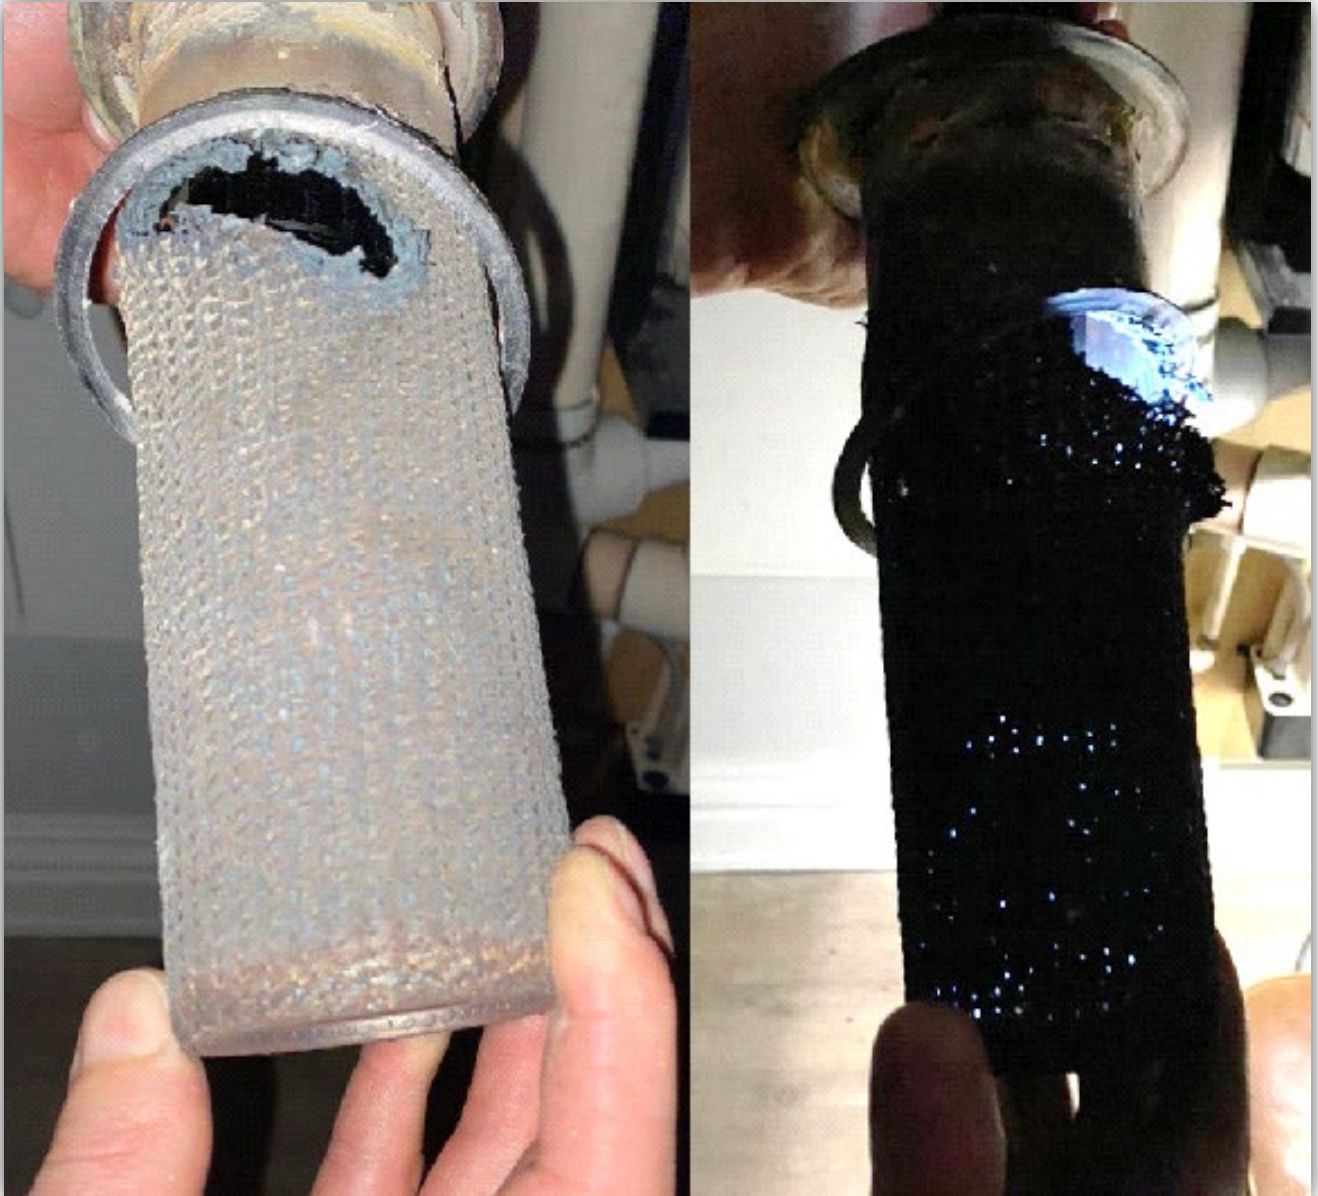
Photo 3a – Boiler burner mesh with hole.

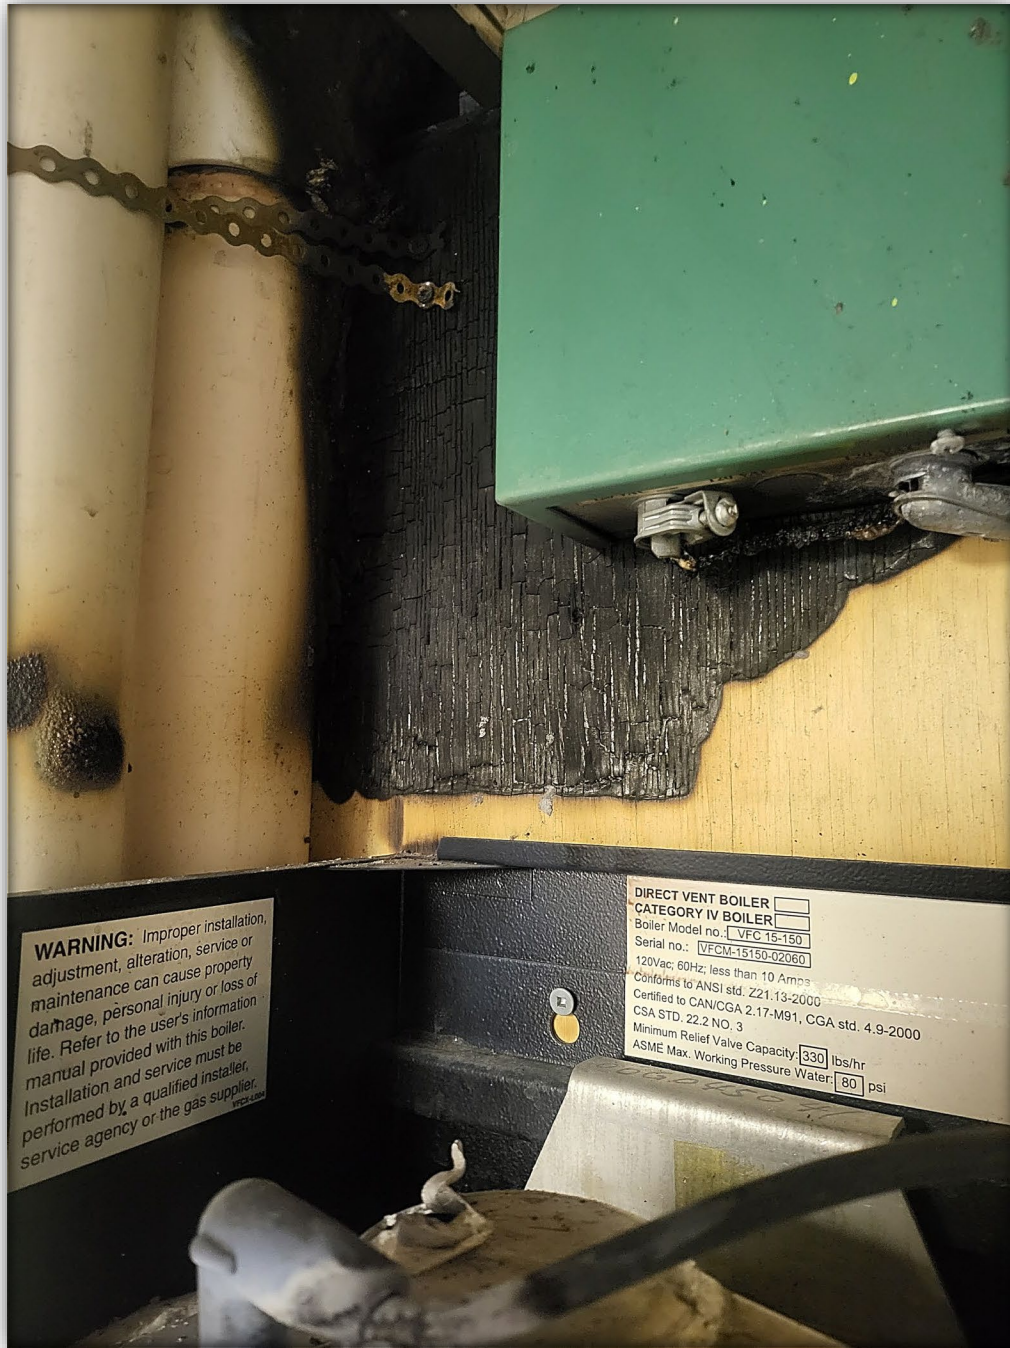
Photo 4 – Boiler nameplate and closeup of fire damage.

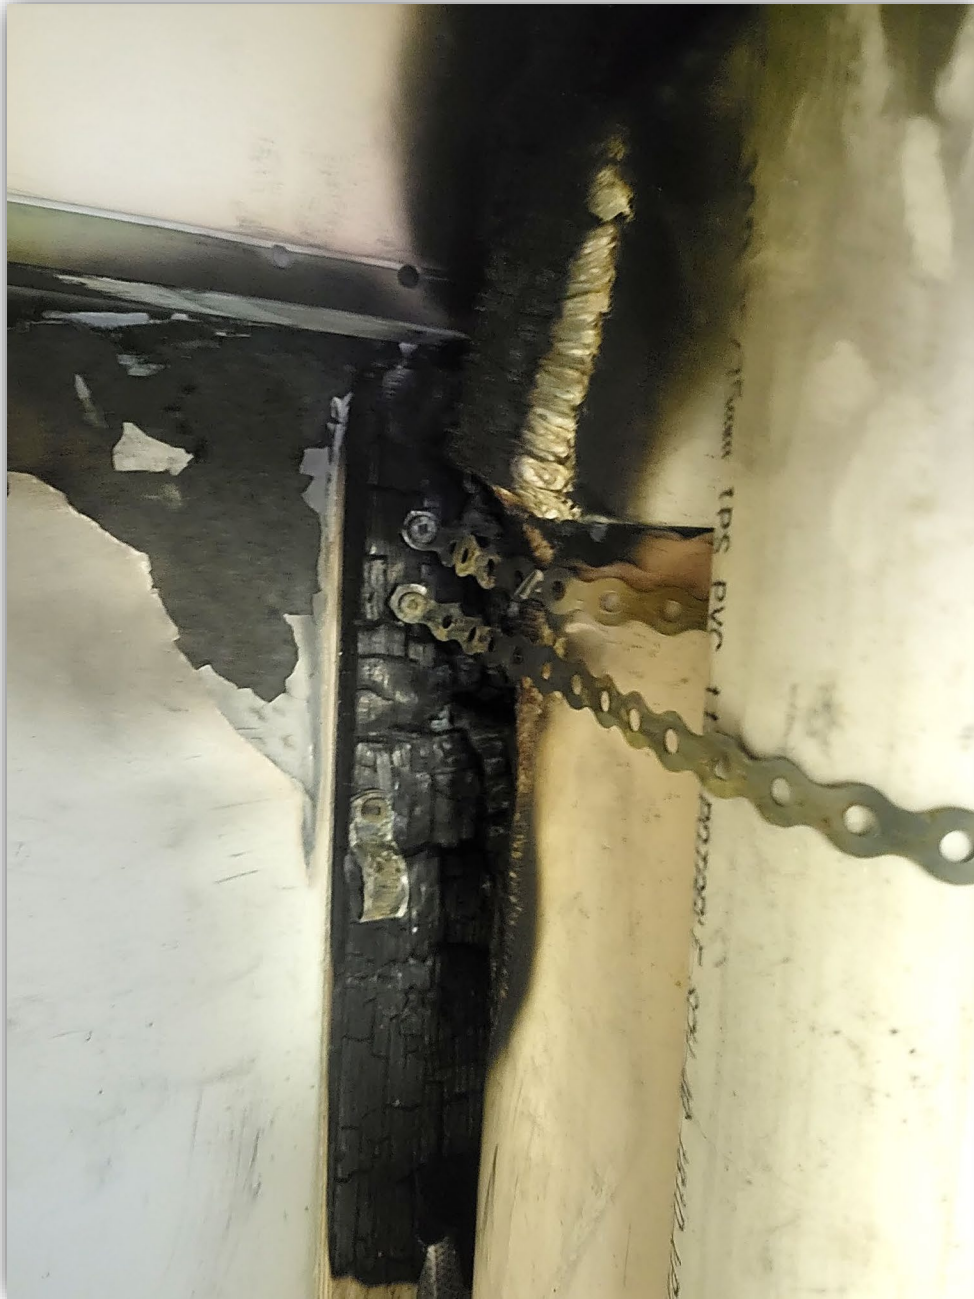
Photo 5 – Venting system fire damage.

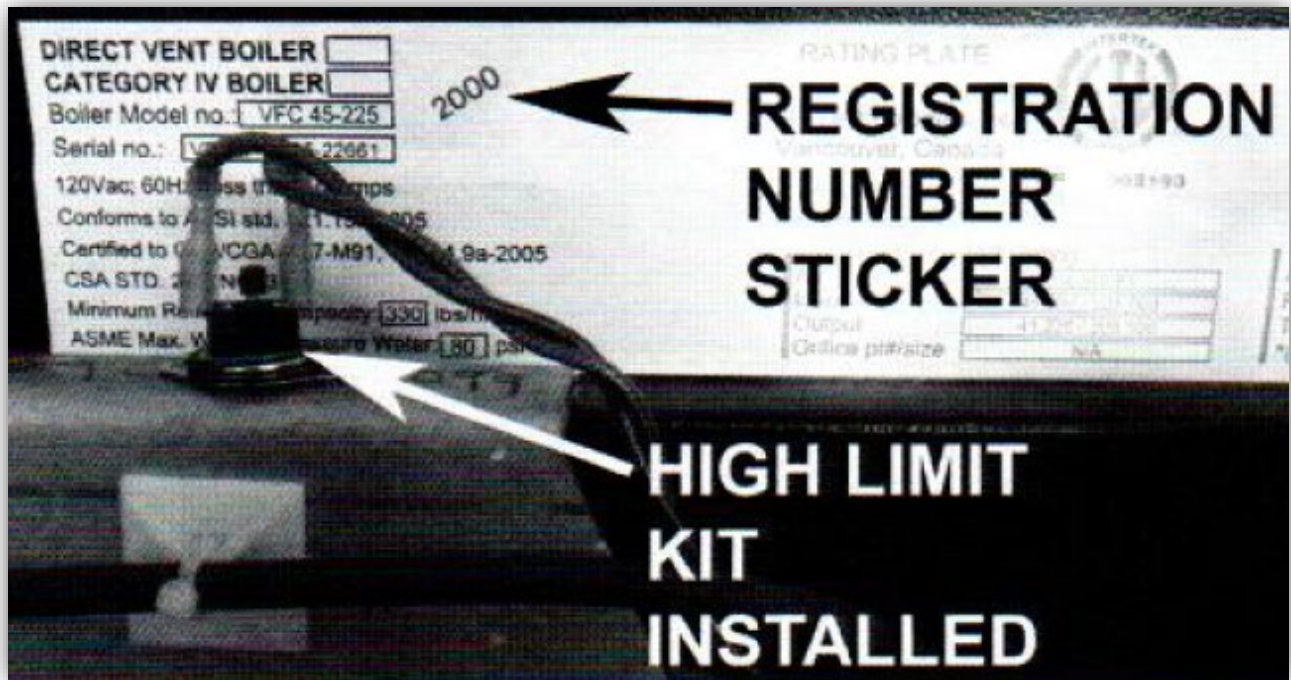
Photo 6 – Close up of a high limit kit installed. Photo from the boiler manufacturer bulletin.
