Incident Summary #II-878242-2019 (#14245) (FINAL)

SUPPORTING INFORMATION	Incident Date	July 11, 2019	
	Location	Langley	
	Regulated industry sector	Gas - Propane system	
	Impact	Qty injuries	2
		Injury description	1 st injury was a teacher from inside the school with a reported respiratory issue and was transported to hospital for observation. 2 nd injury was the gas fitter who was performing the work and he received 1 st degree freezer burn on his right leg between his knee and ankle and he was transported to hospital for treatment and then released.
		Injury rating	Minor
	Damage	Damage description	Approximately 560 litres of liquid propane spilled to atmosphere in less than one minute.
		Damage rating	Moderate
	Incident rating	Moderate	
	Incident overview	The gas fitter was performing a propane tank exchange and fuel transfer in the yard of a elementary school located beside a service road on the north west corner of the school property (refer to photos #1 and # 5). When setting up to transfer the propane from the old tank to the new tank the gas fitter accidentally allowed all the fuel to escape from the old propane tank into the atmosphere.

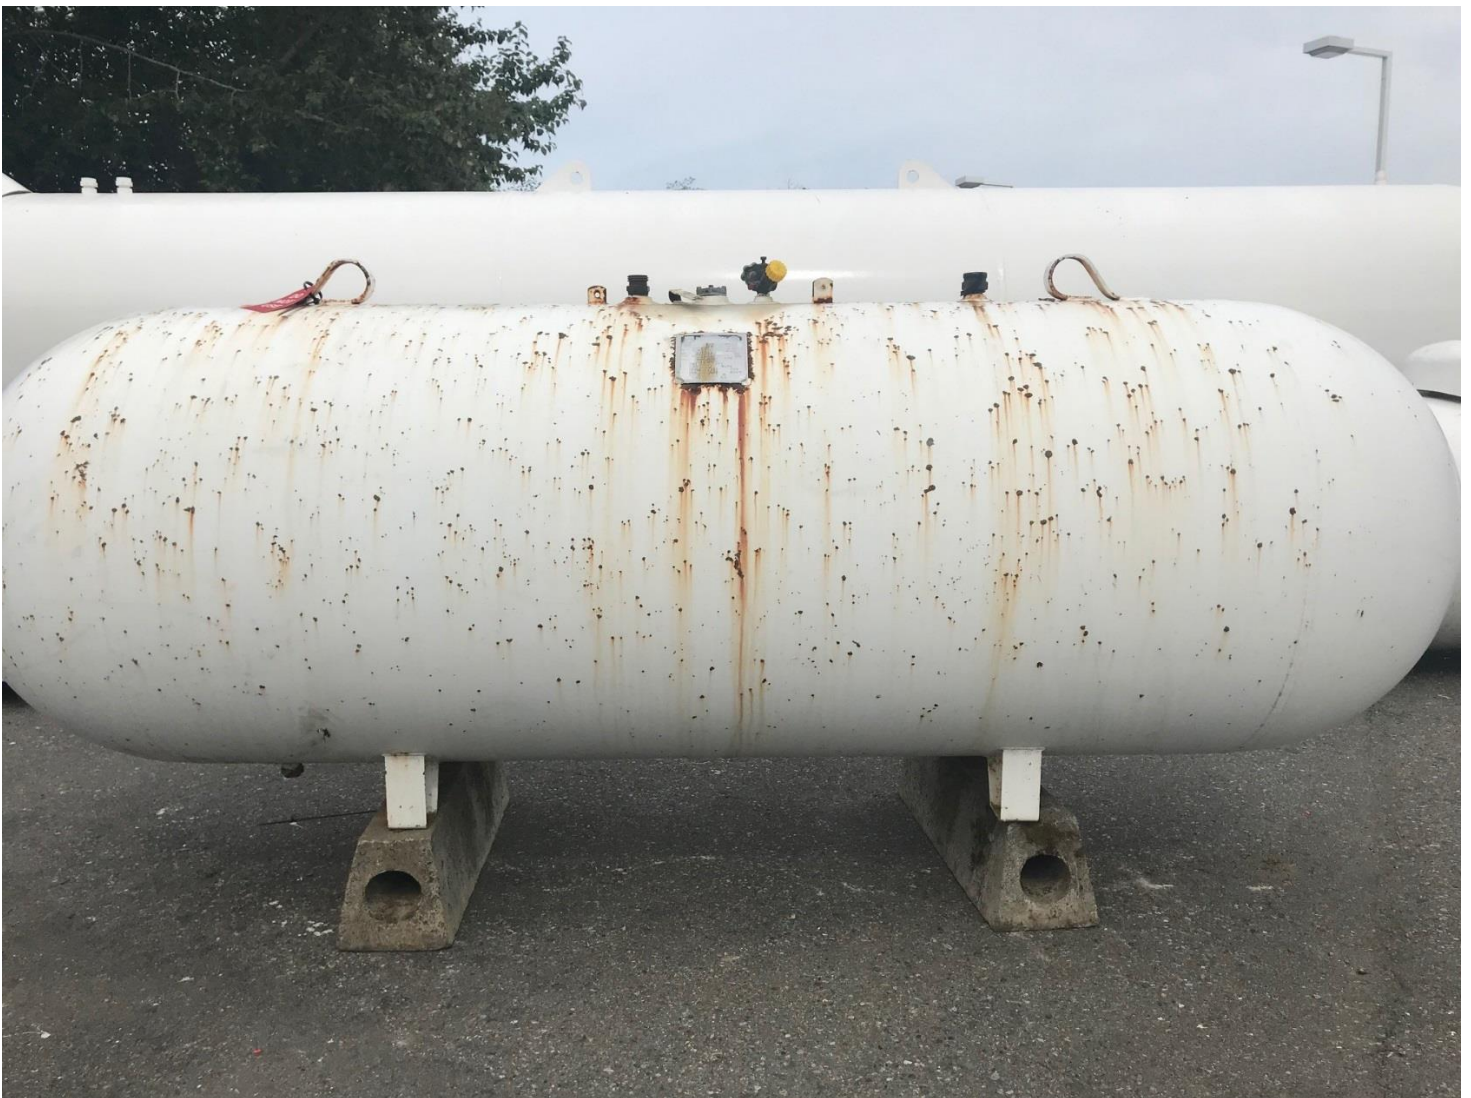
Photo #1: 500 US water gallon propane tank in propane company's yard.

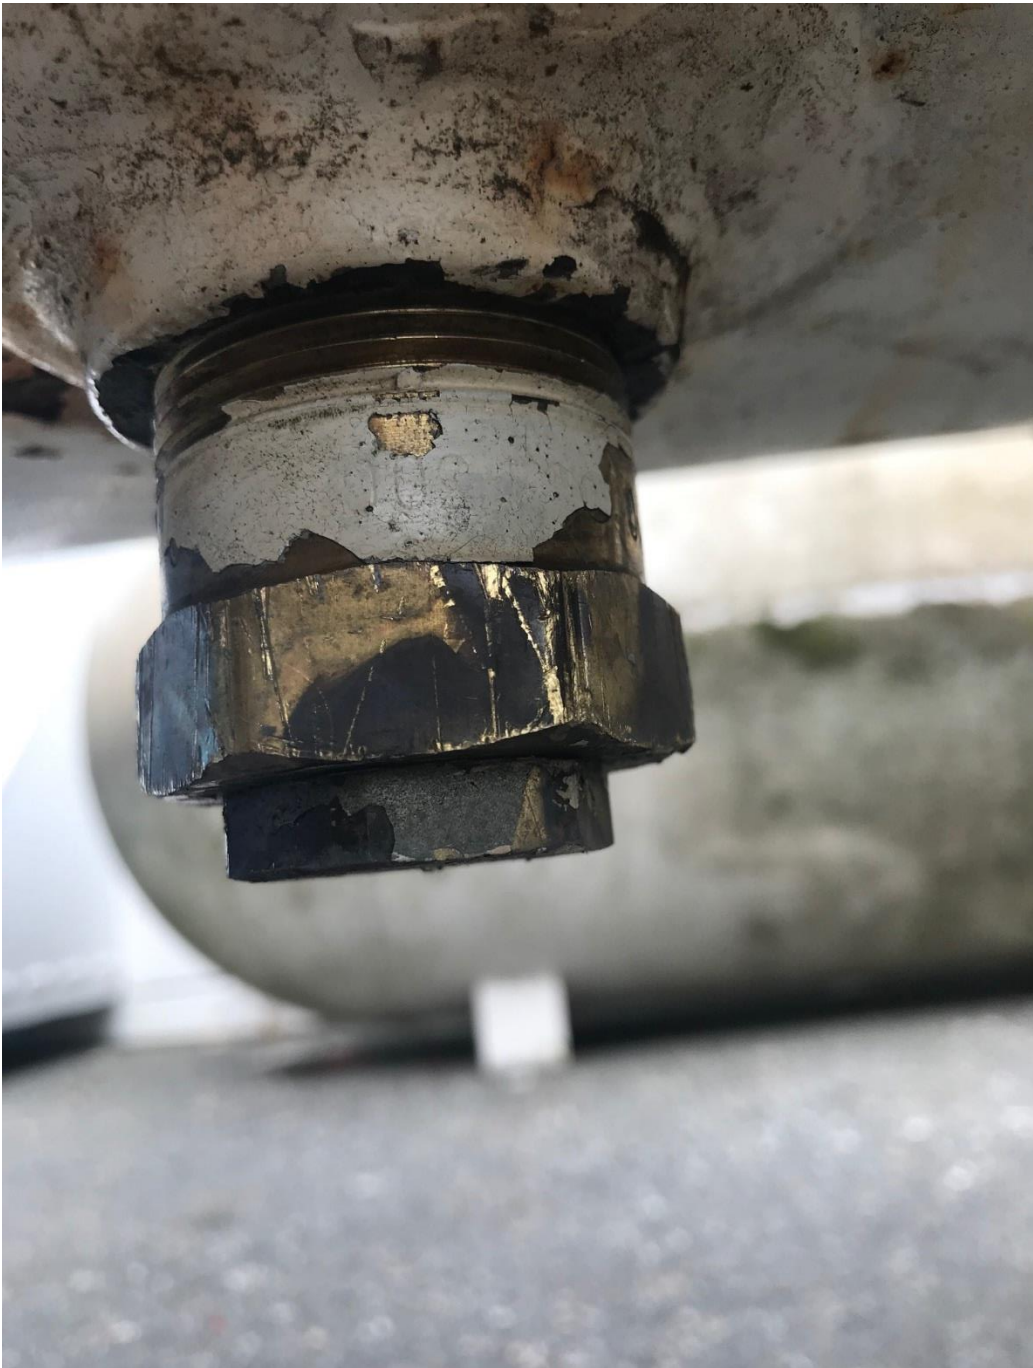
<p>connecting to the evacuation valve on the old tank and transferring the fuel to the new tank.</p> <p>The gas fitter was using one 24" pipe wrench and when he was trying to loosen the cap on the evacuation valve, he was actually loosening the entire evacuation valve from the 500 gallon propane tank. The gas fitter loosened the evacuation valve until it blew out of the tank body causing a uncontrolled liquid propane spill of approximately 560 liters of fuel. (refer to photo # 3) The gas fitter needed to be using two wrenches to perform this work, one to control the evacuation valve and the other to remove the cap.</p>
<p>Facts and evidence</p>	<p>Supervisor interview and tank / valve inspection</p> <ul style="list-style-type: none"> - Supervisor described his worker as having five years of gas fitting experience, but with only 4 months experience in the propane industry working for them. - Training procedure when working using an evacuation valve was one on one job training and job shadowing . - Worker had been shown how to perform liquid transfers using an evacuation valve and had been doing the work function successfully on his own in the field. - There were no written procedures that the worker was trained with and all liquid transfer training when using an evacuation valve was done in the field - The old propane tank and evacuation valve at the propane company's yard were inspected. It was determined that the evacuation valve was in safe working condition, and based on the time it took for the tank to empty, that the entire evacuation valve had been removed from the propane tank in error resulting in the propane release. - <p>Gas Fitter interview</p> <ul style="list-style-type: none"> - Confirmed that his injuries were to his lower extremities 1st degree burns to his right leg below the knee and tender and redness to his left leg. - He was aware that there was an operating daycare on site and waited until the children had been dropped off and safely inside before he started to exchange the old propane tank with the new one. - Due to the location of the old tank the gas fitter used a crane truck to lift the old tank onto the truck bed so he could connect to the evacuation valve and transfer the propane to the new tank. - Before starting, the gas fitter confirmed that the tank was 30% full (560 litres) of propane liquid. - Using one 24" pipe wrench he attempted to remove the cap from the evacuation valve and after turning the valve two or three times the evacuation valve blew out of the propane tank causing a significant uncontrolled spill of liquid propane (refer to photo # 3). - After realizing that the situation was out of control, he went to the daycare and spoke to staff through the window and told them to close all the windows and doors and remain inside until the situation was safe. - The school principle came out and the gas fitter informed him to keep the school staff and students away from the area. - The school principle informed him that the fire department had been called.

Failure to properly utilize two wrenches to safely hold the evacuation valve in place while attempting to remove the evacuation cap allowed the fitting to be removed from the tank resulting in the uncontrolled release of liquid propane.

Photo #2: Evacuation valve on old propane tank.

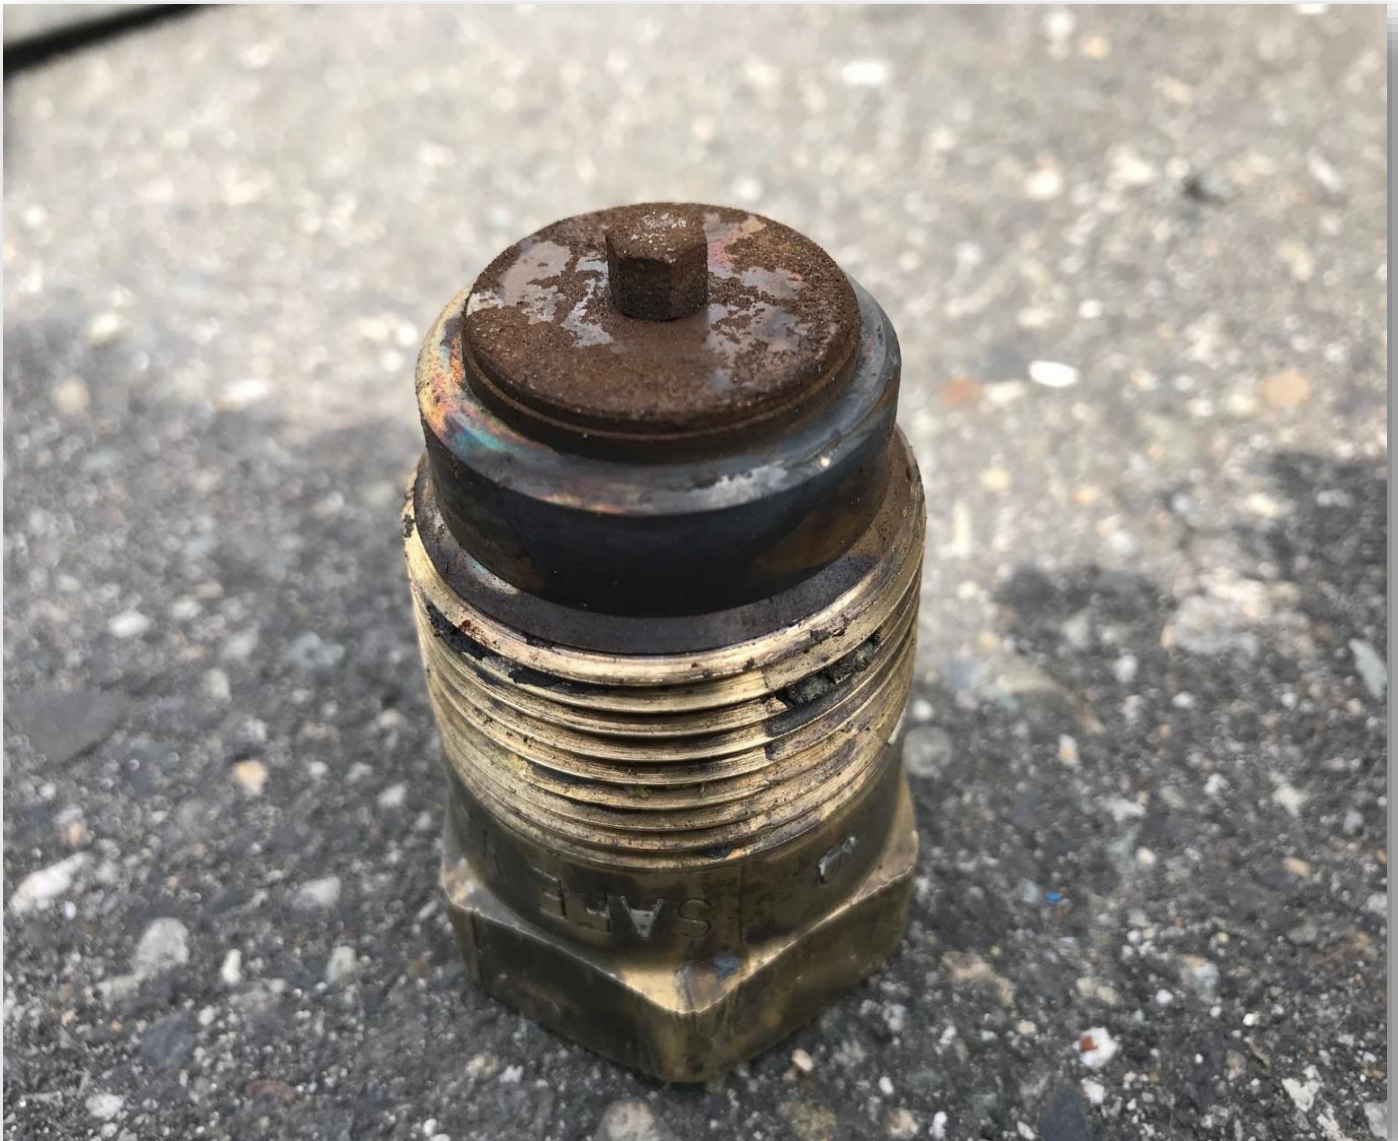
Photo #3: Evacuation valve's internal seal. Photo shows that the seat is not damaged on the evacuation valve.

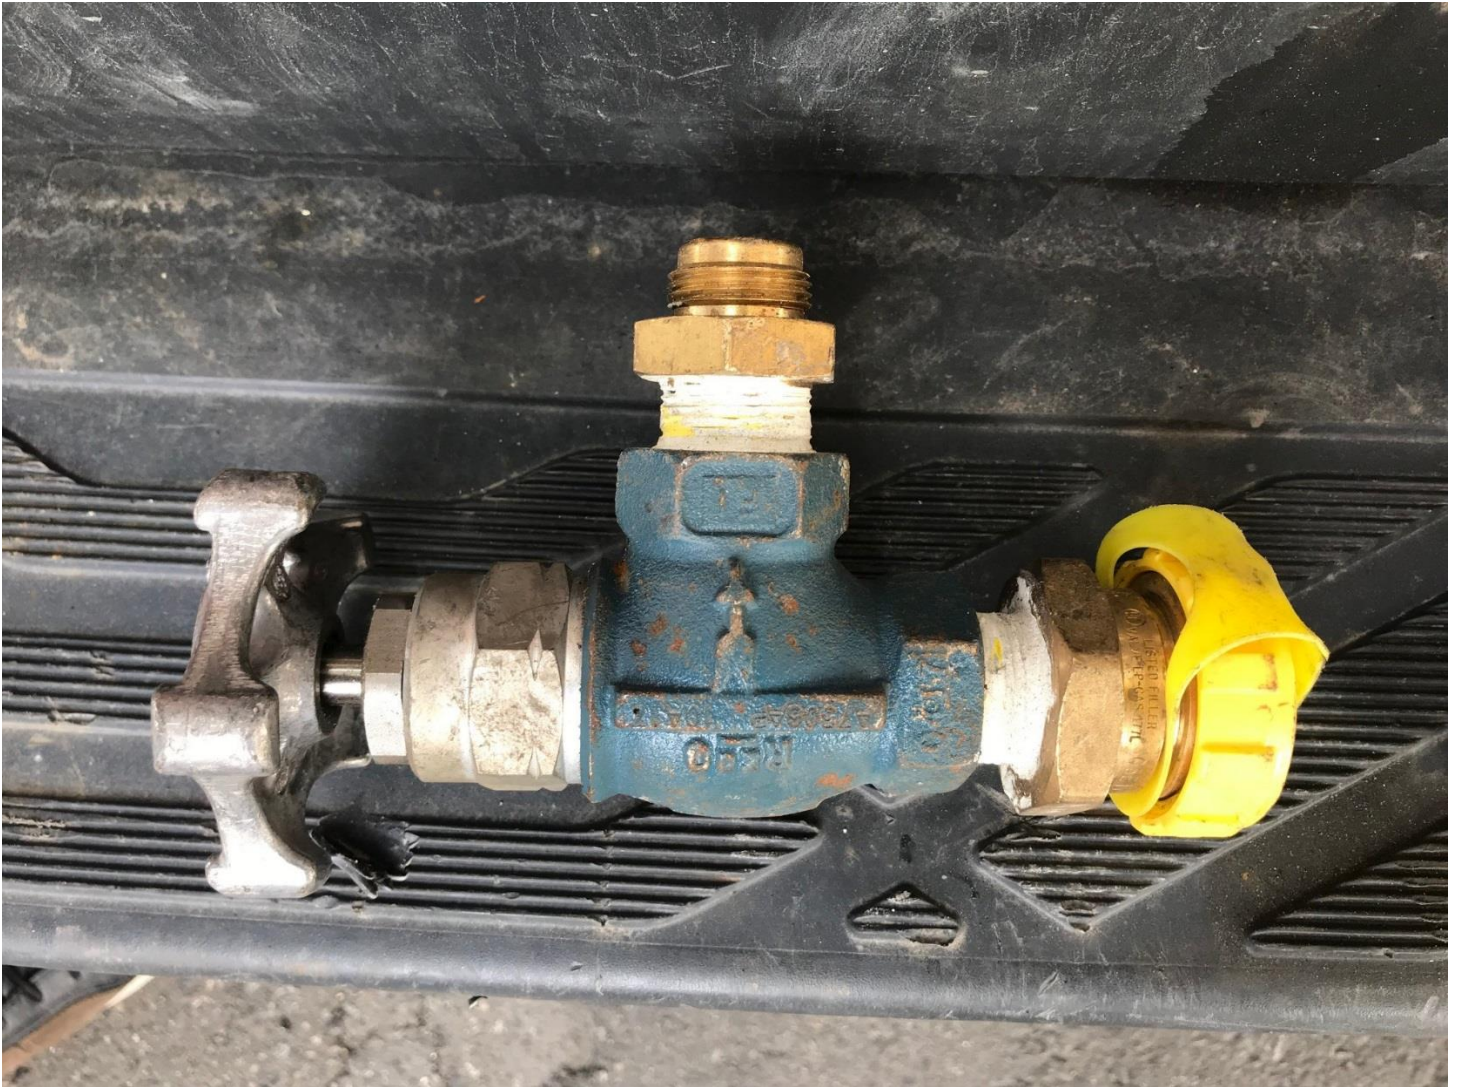
Photo #4: Evacuation valve adaptor and shut off valve. This is the shut off valve and adaptor used to connect to the evacuation valve on the existing tank that needs to have propane liquid removed.

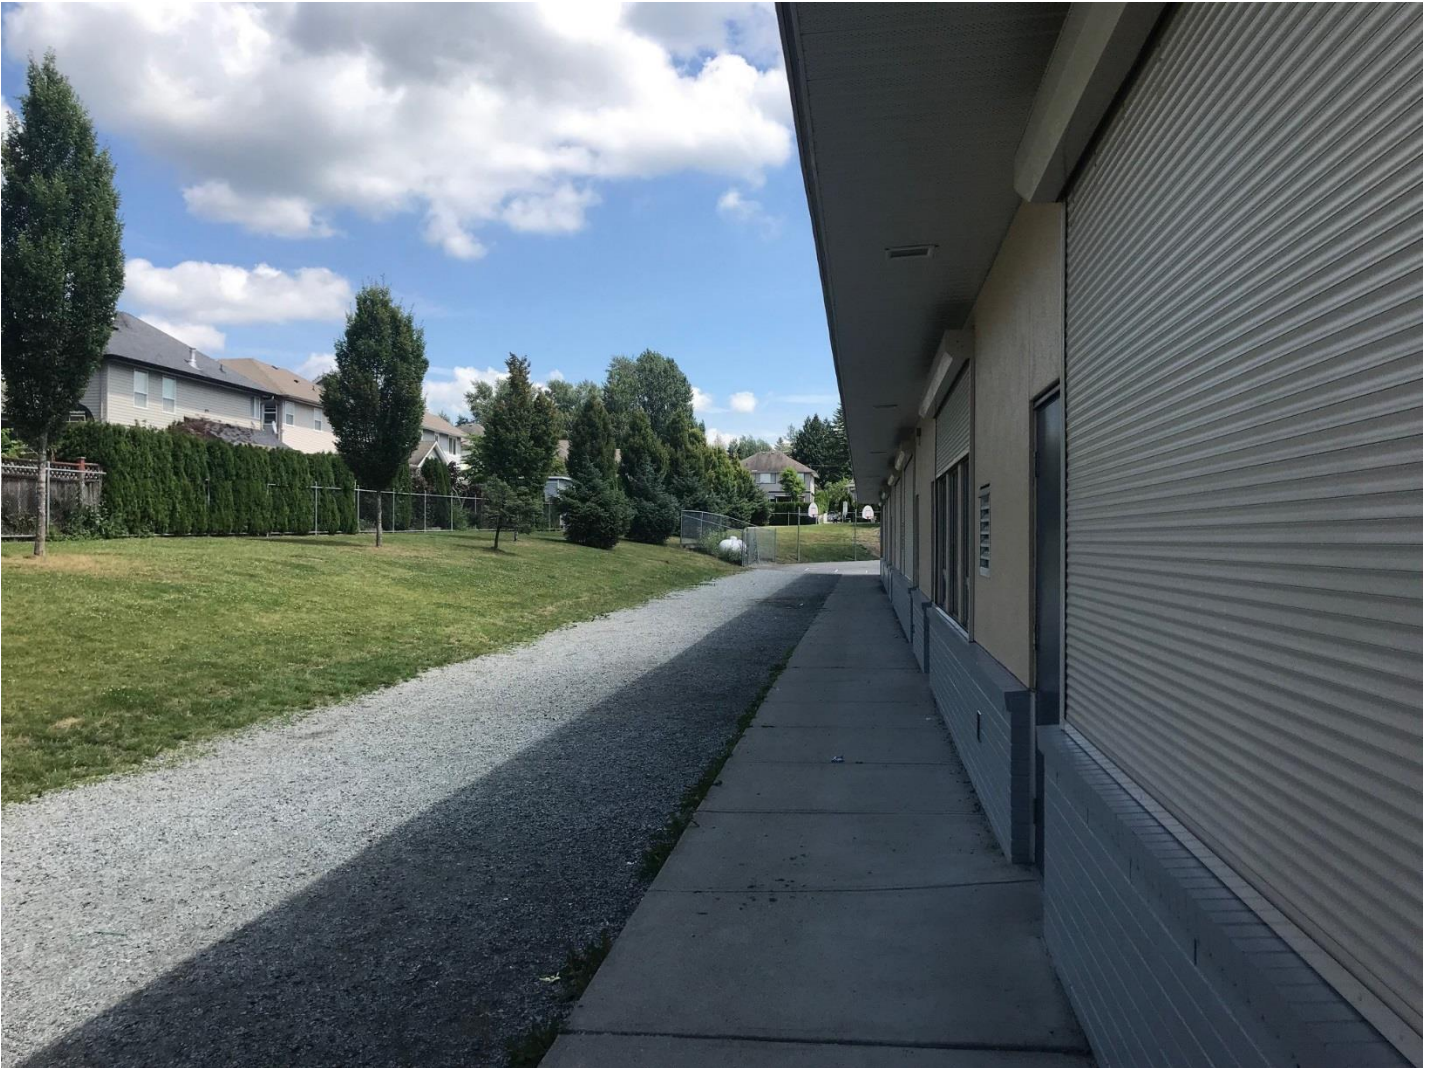
Photo #5: Propane tank location at school.
