## Incident Summary #II-1047379-2020 (#18948) (FINAL)

SUPPORTING INFORMATION	Incident Date	August 3, 2020	
	Location	Tulameen	
	Regulated industry sector	Gas – Propane system	
	Impact	Qty injuries	2
		Injury description	Two individuals deceased
		Injury rating	Fatal
	Damage	Damage description	N/A
		Damage rating	None
Incident rating	Severe		
Incident overview	Two individuals were found inside a shower building on a recreational property unresponsive. The building was equipped with a propane-fueled on-demand tankless water heater. The water heater was installed inside a small shower building. The heater vented combustion products into the building where it also received its combustion air supply, producing high levels of carbon monoxide as the combustion air was consumed.		
INVESTIGATION CONCLUSIONS	Site, system and components	<p>The incident occurred on recreational property. The property consisted of a lot containing a metal storage container, a wooden bunkhouse, and a wooden shower building (Image 1). The site has electrical services provided by the city and gas provided by portable propane cylinders. The shower building was constructed of wood with insulated walls, a tight-fitt

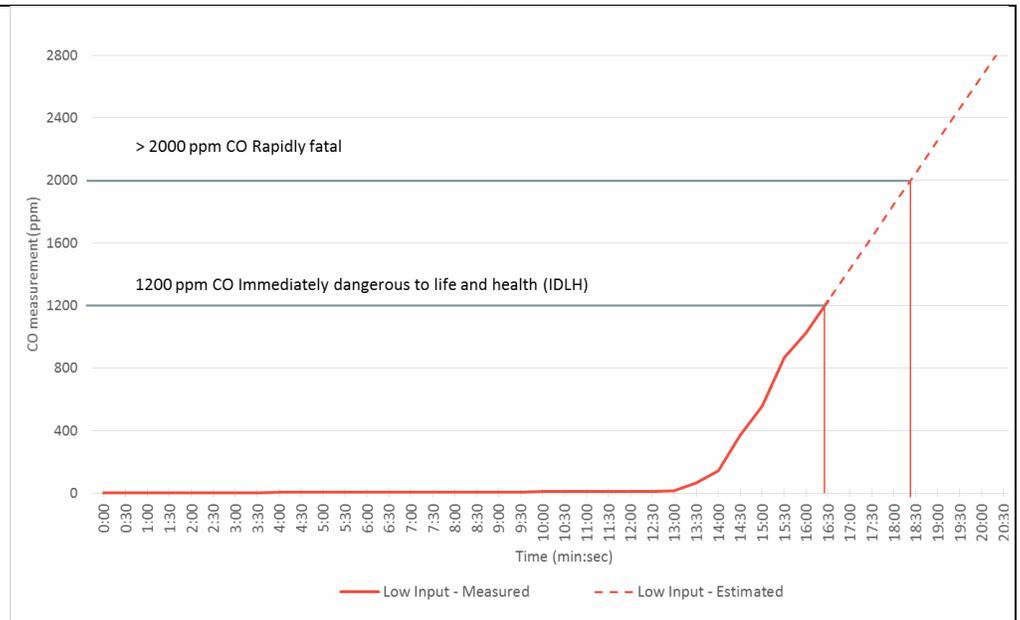
Figure 1 – Carbon monoxide concentrations inside the shower room with gas input on “low”

While the burner did not initially produce hazardous levels of carbon monoxide at the low input setting, testing showed that the environment inside the shower room remained stable for the first 13 minutes of operation then rapidly elevated over the next four minutes to levels immediately dangerous to life and health. This is due to the depletion of oxygen in the room from the operation of the gas burner.

The depletion of oxygen in the room caused incomplete combustion and a rapid increase in the carbon monoxide levels of the flue gas. With the heater input set to low, test data indicates that rapidly fatal concentrations of carbon monoxide were in the room within 18 minutes and 22 seconds. The test results illustrate what reasonably occurred in this incident.

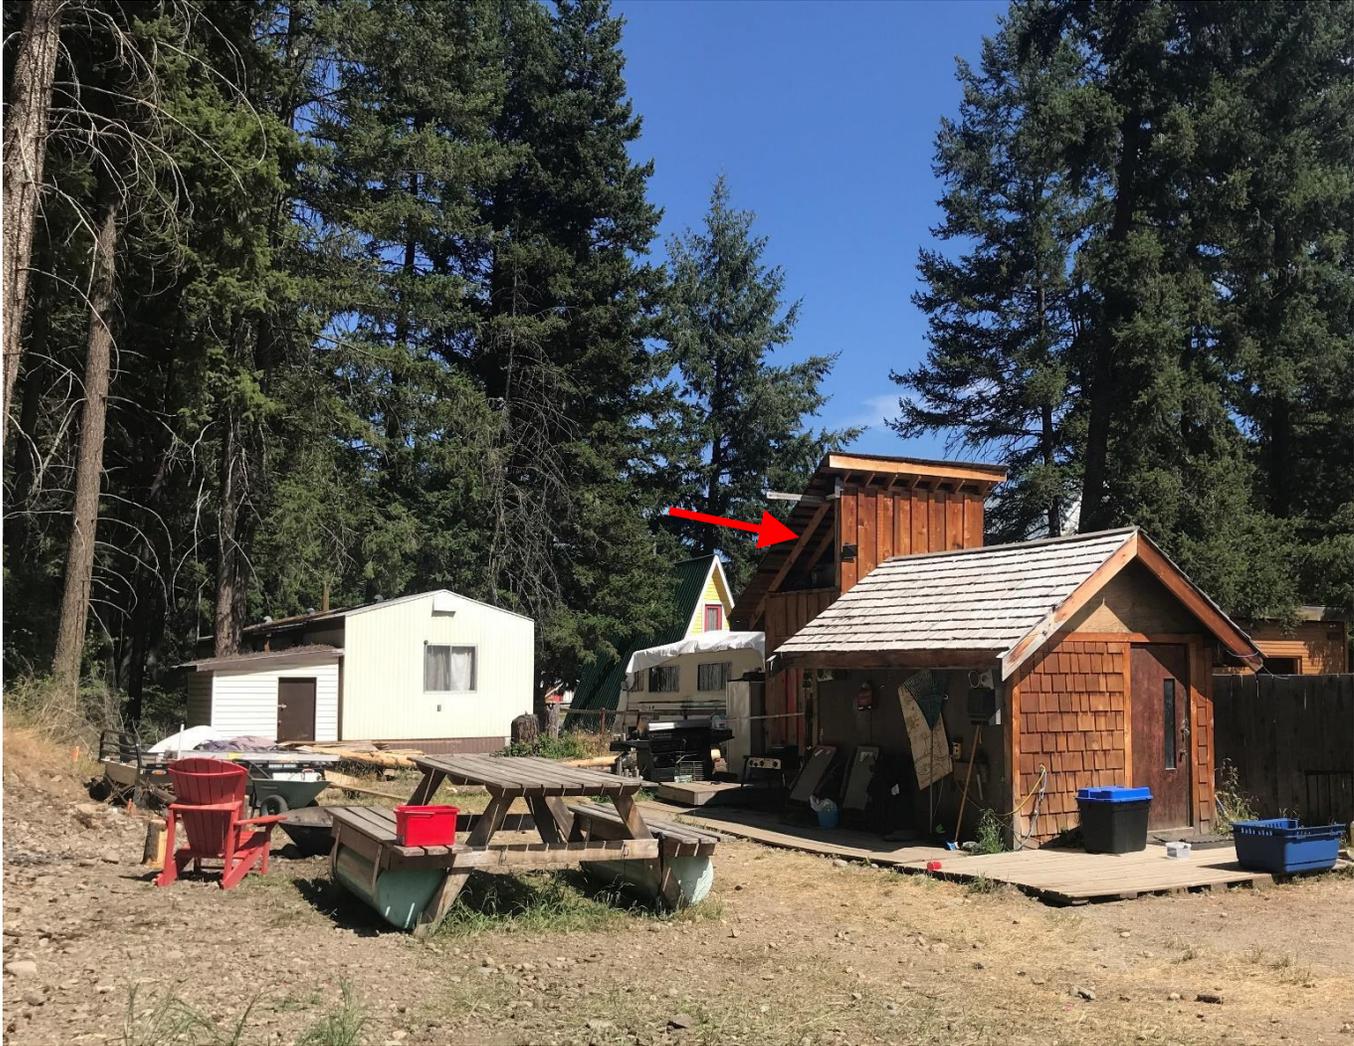
**Image 1** – Recreational lot with a wooden bunkhouse (foreground) and the taller wooden shower building immediately behind (arrow).

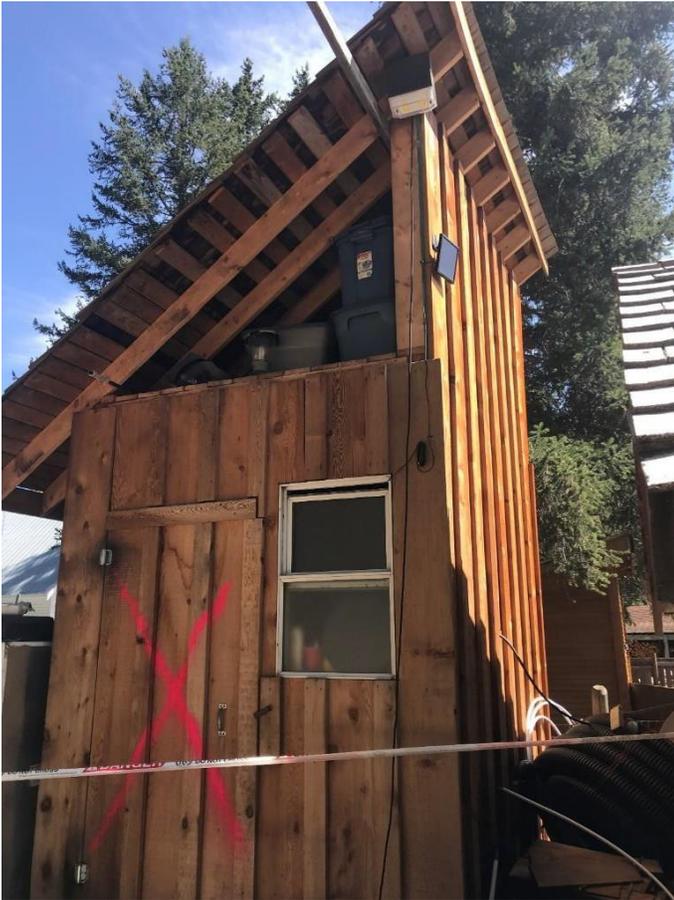
**Image 2** (left) – Exterior of shower building showing door and window

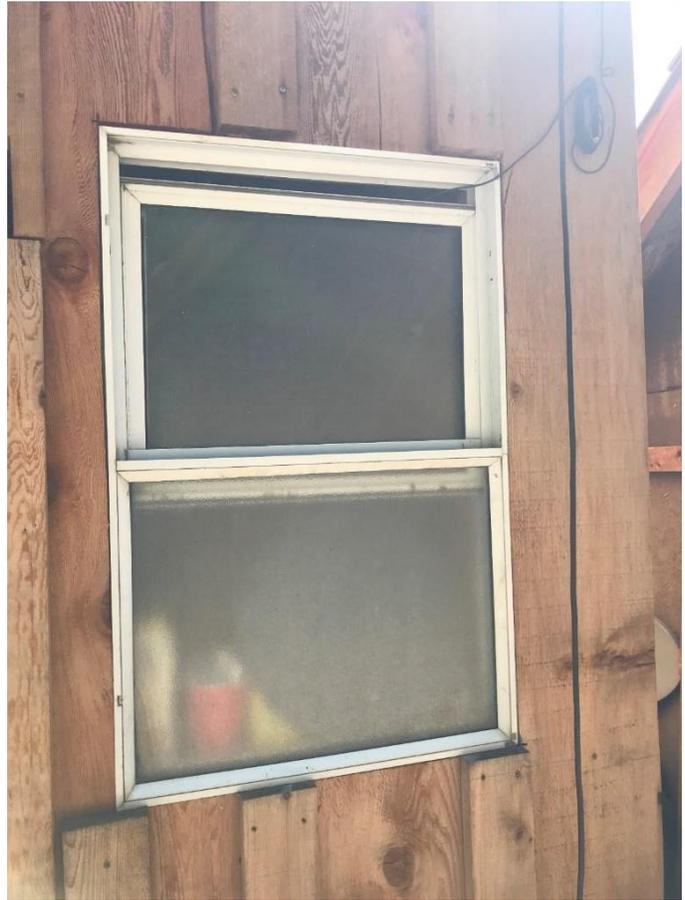
**Image 3** (right) – Window with one inch opening and electrical wire from solar panel to motion light inside the shower room

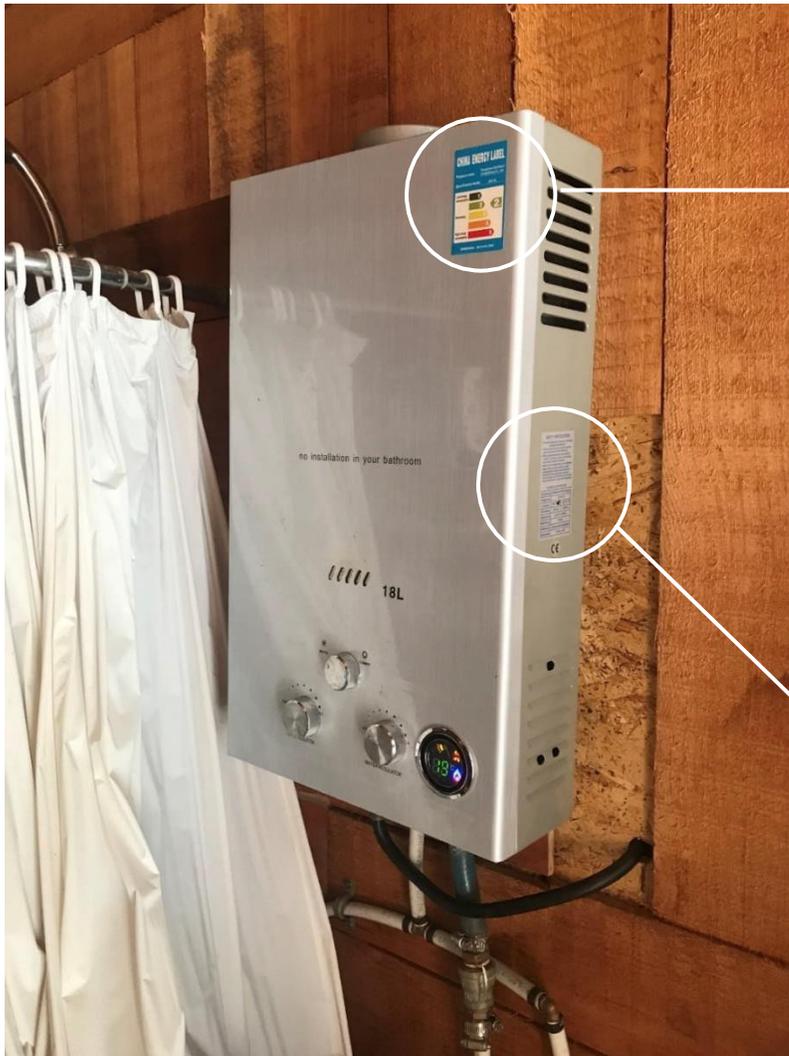
**Image 4** (above) – Water heater installed inside shower building without flue vent piping

<p>Failure scenario(s)</p>	<p>The shower room on the property was entirely enclosed, and other than the door and window, there were no other openings in the room for air intake or ventilation. The water heater was installed inside the room and did not vent the flue gases to the outdoors. The installation was contrary to the warnings on the front and side of the water heater along with the heater’s installation manual (Image 9).</p> <p>While the water heater was operating it circulated the flue gases containing carbon monoxide into the mostly-unvented space (Diagram 1) that was also supplying combustion air supply for the appliance. Once the available oxygen supply was reduced, this caused an increase in the rate of carbon monoxide production due to incomplete combustion of the fuel, which rapidly elevated the concentration of carbon monoxide in the room.</p> <p>Two individuals were inside the room with the shower running. After approximately one hour they were found inside the room and unresponsive.</p>

Installation of the propane-fueled water heater indoors, without a supply of combustion air for the burner or venting of the flue gases to the outdoors, resulted in a rapid accumulation of carbon monoxide inside the shower room, creating a hazardous environment within minutes of the shower being turned on.

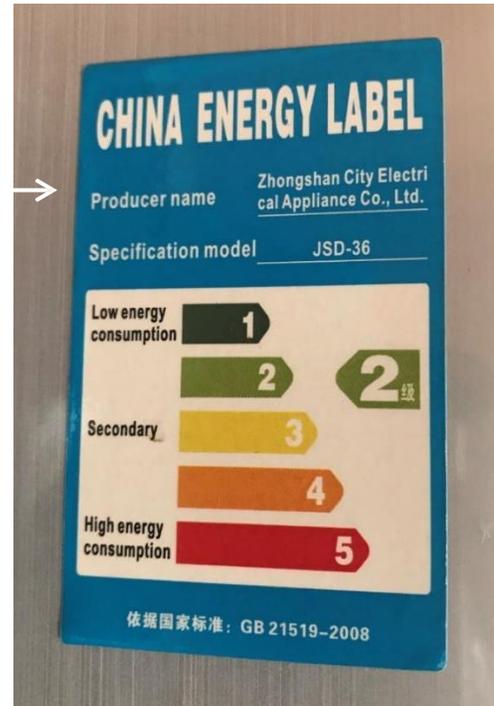
**Image 5** (top right) – Product tag on the front of water heater showing manufacturer name and model number

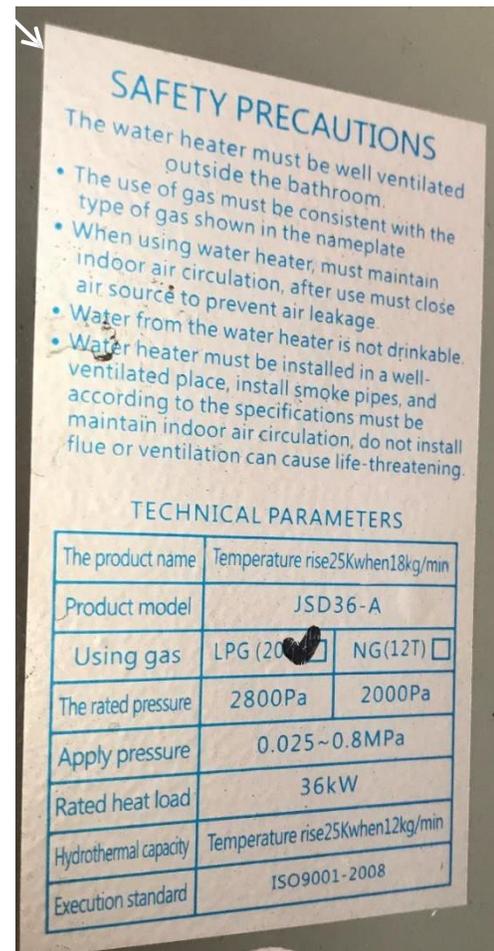
**Image 6** (bottom right) – Product tag and safety precautions on side of water heater

The safety precautions listed on the product tag attached to the side of the water heater stated: “The water heater must be ventilated outside the bathroom” (Image 5). The water heater had a prominent marking across the front of the cover which stated: “No installation in your bathroom” (Image 8). The heater installation manual stated that the “Gas water heater shall be installed outside” (Image 9).

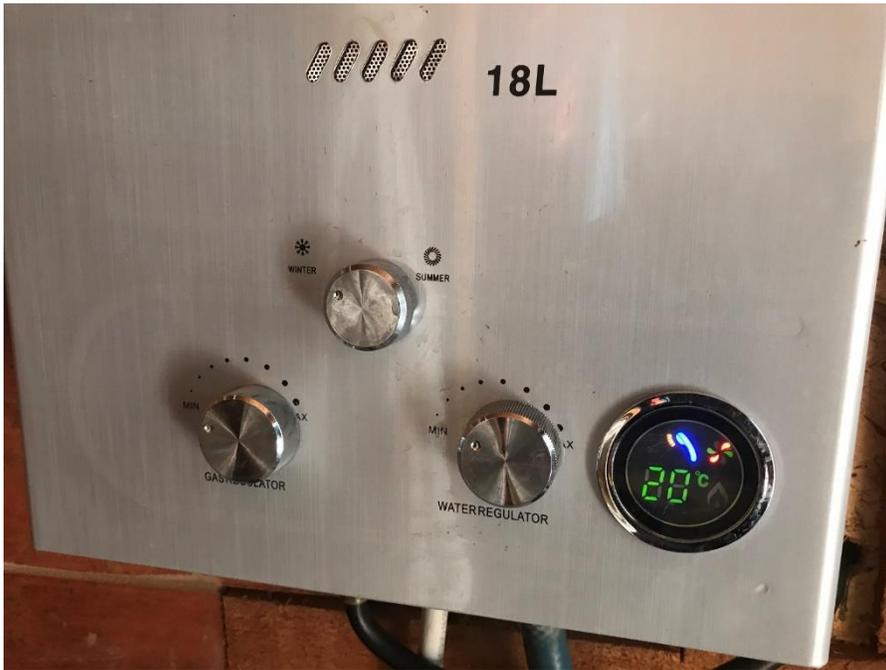
**Image 7** (left) – Control knob placements in front of the water heater. Knob positions as found on site.

Left knob labelled “gas regulator”.

The only water supply to the shower nozzle was from the water heater. The temperature of the water was adjusted using the “gas regulator” dial on the front of the machine, which was found at the lowest temperature setting. It can be reasonably assumed that the heater was set to low during the incident.

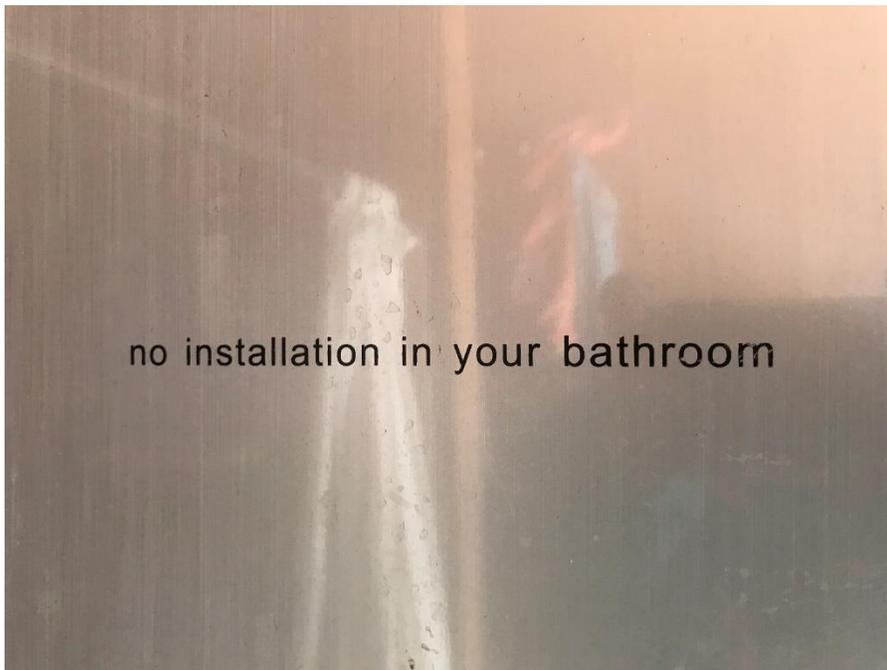
**Image 8** (left) – Text (markings) on the front of the water heater cover reads “no installation in your bathroom”

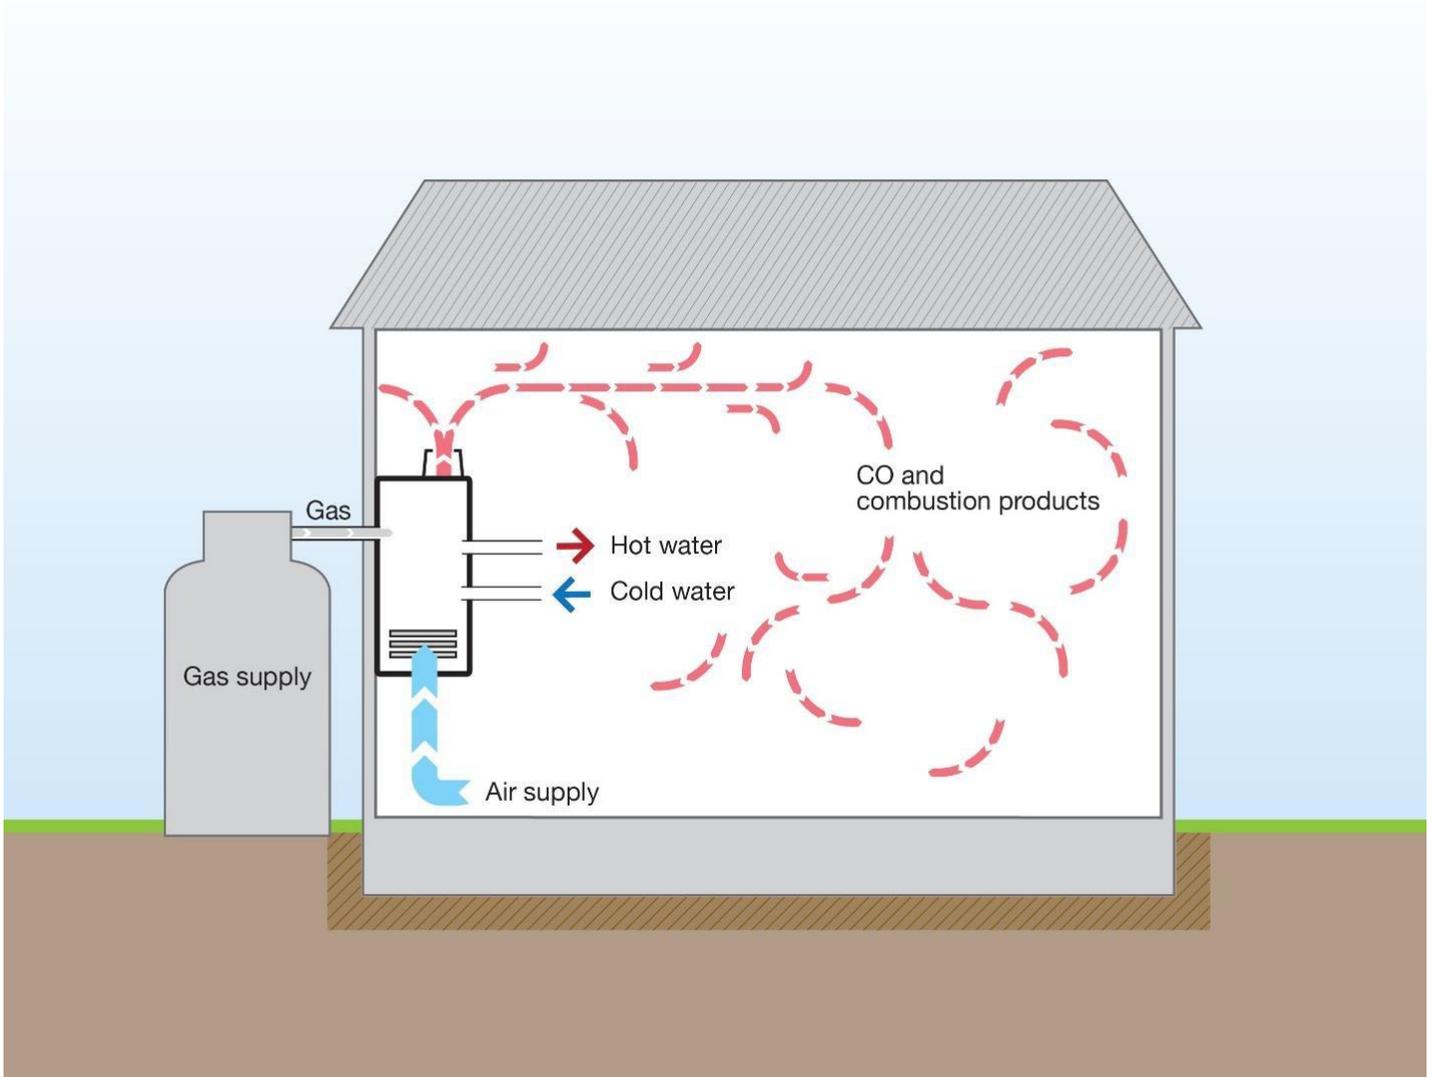
**Diagram 1** – Illustration showing an on-demand water heater installed in an enclosed building without flue venting or combustion air openings. Combustion products and carbon monoxide filling the building and contaminating the air supply to the gas burner.

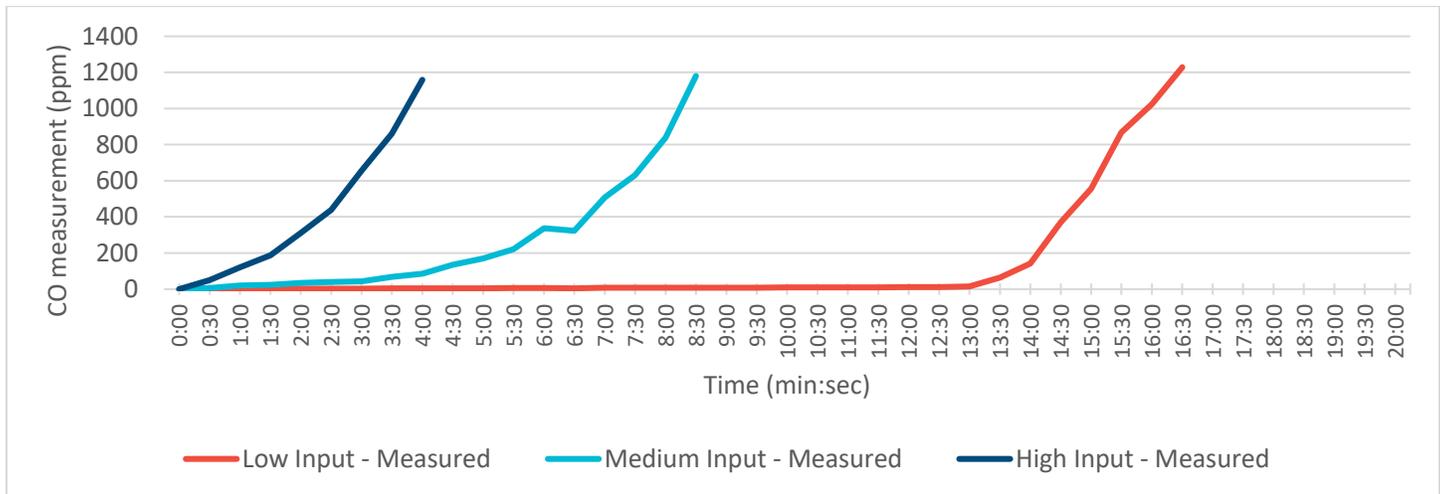
Figure A1 – CO Measurements at High, Midpoint and Low Input Positions (Tests B-1, B-2, and B-3)

As described above, the tests continued until the instrument reached its maximum reading level. The plateau represents this scenario where the instrument could not register readings higher than 1260 ppm. For example, in the low input test, the instrument reached 1260 ppm at the 17-minute mark and the gas supply was shut off at 19 minutes. The door to the shower building was opened at 20 minutes and as fresh air entered the room, CO readings declined. The test concluded at 27 minutes.

Test B: Carbon Monoxide (CO) concentrations inside the room while the heater was operating. The shower building’s door was closed and the window was put back to its as-found position with a one-inch opening. The detectors sampling wand was inserted in the window opening and the air samples were drawn from the end of the wand approximately 12 inches inside the window opening at a height of approximately 6 feet from the floor inside the room. Measurements were recorded every 30 seconds after the burner was fired and the door was closed. The tests continued until the instrument reached its maximum reading level above its operating range and the measurements abruptly stopped increasing. The fuel was then shut off to the heater from the outdoors and the readings were continually monitored until the CO levels began decreasing and it was safe to open the door to ventilate the space. Test results are graphed in Figure A1.

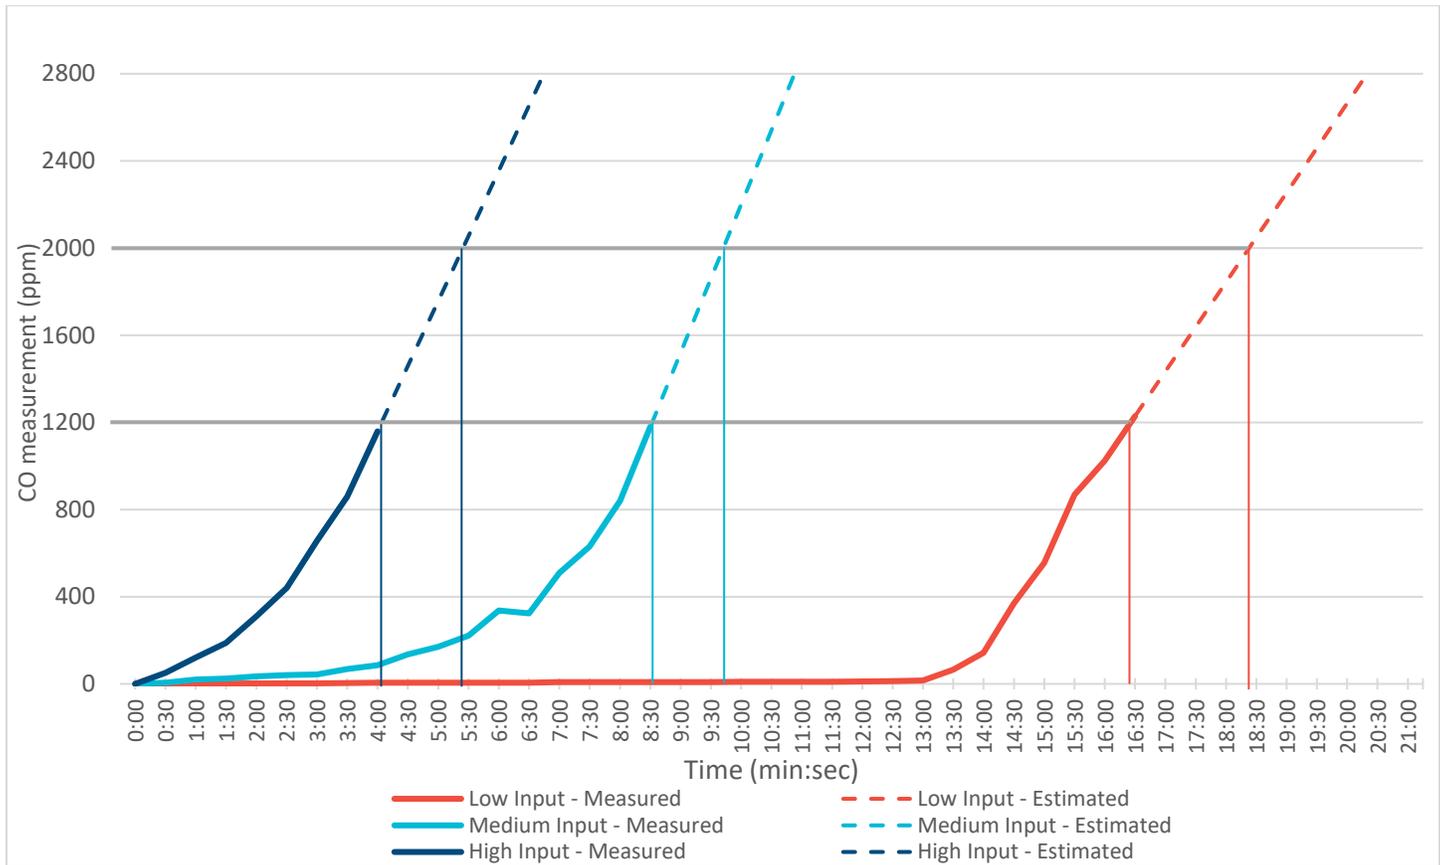
Since the test instrument was not able to take readings higher than 1260 ppm, linear extrapolation was used to estimate when the CO concentration in the shower room would reach levels described to be immediately dangerous to life and health (IDLH) and rapidly fatal (1200 ppm and 2000 ppm respectively) at each test scenario. Figure A2 shows the test data and the extrapolated CO values.

Figure A2 – Test Data with Linear Extrapolation

1. The water heater's gas regulator was found set in the low position. At the low position, concentrations of 1200 ppm CO were likely reached at 16 minutes and 22 seconds, and concentrations of 2000 ppm CO were likely reached at 18 minutes and 22 seconds. This is consistent with the timeline described by witnesses.
2. If the regulator was set higher than the lowest setting, CO concentrations described as being fatal could have been reached sooner, within approximately 5 minutes and 24 seconds.
