## Incident Summary (5613597)

SUPPORTING INFORMATION	Incident Date		March 24, 2017	
	Location		Ashcroft, BC	
	Regulated industry sector		Gas	
	Impact	Injury	Qty injuries	4
			Injury description	Four family members deceased: 1 male, 1 female, and 2 male children. Family dog also deceased.
			Injury rating	Fatal (suspected carbon monoxide exposure)
	Damage		Damage description	N/A
			Damage rating	None.
	Incident rating		Severe.	
	Incident overview		After responding to a 'request for wellbeing check' at a home, RCMP officers discovered that four occupants of a home were deceased. RCMP requested that BCSA investigate the residence for carbon monoxide exposure.	
INVESTIGATION CONCLUSIONS	Site, system and components		<p>The water heater is tankless, meaning cold water is heated instantly by a high output propane burner when a hot tap is opened. The products of combustion (vent gases) are designed to be vented safely to the outdoors through an approved vent system.</p> <p>An approved vent system was not installed and attached to this water heater.</p>

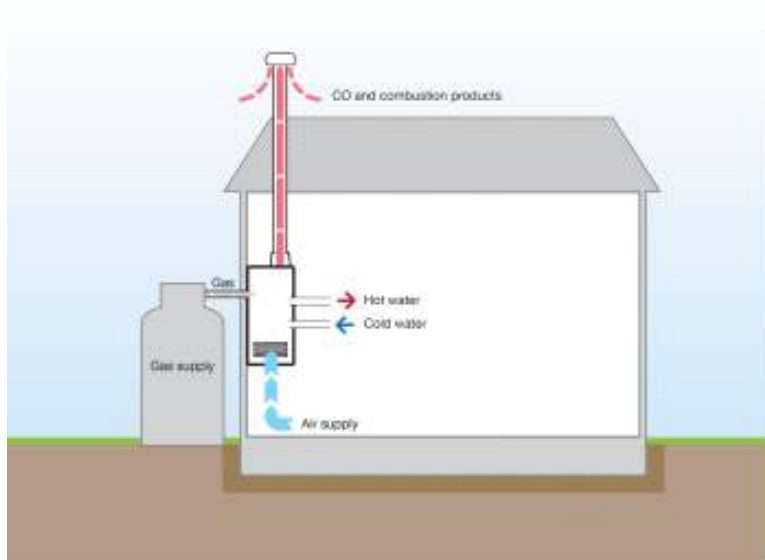
Tankless water heater properly vented.

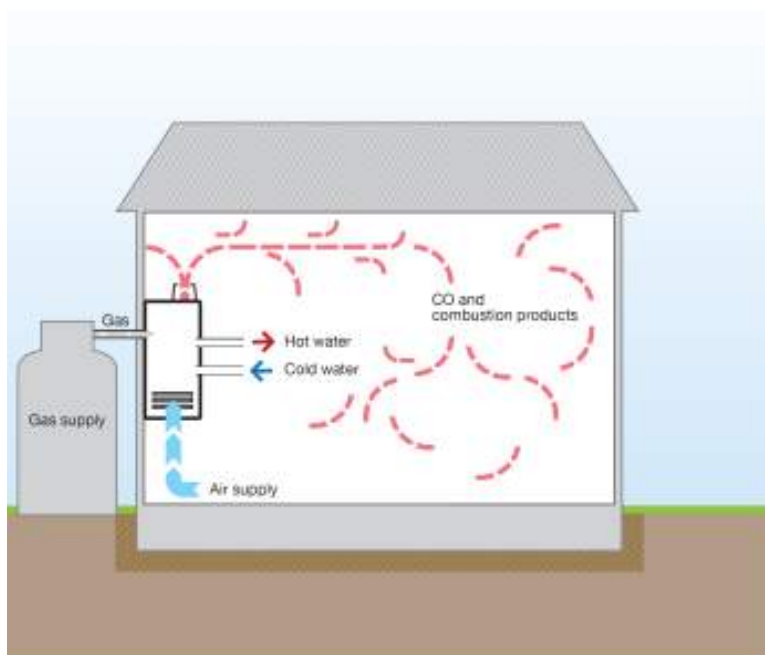
Tankless water heater not properly vented.

Failure scenario(s)		<p>The water heater was installed inside the residence without a vent system attached. As a result all vent gases were released within the occupied living space of the home. The water heater's heat exchanger had become partly blocked with soot. The blockage of the heat exchanger limited the vent gases from moving freely away from the combustion chamber resulting in incomplete combustion at the burner. This produced a carbonizing flame and vent gases high in carbon monoxide.</p> <p>The home owners had returned to the residence after being away on vacation and found the kitchen sink drain was frozen. In an attempt to thaw the ice blockage, a garden hose was attached to the bathtub faucet. The outlet of the garden hose was then pushed up the outdoor exposed kitchen drain pipe, the hot water was then turned on, and ran continuously. The extended operation of the water heater led to the hazardous levels of carbon monoxide inside the home.</p>

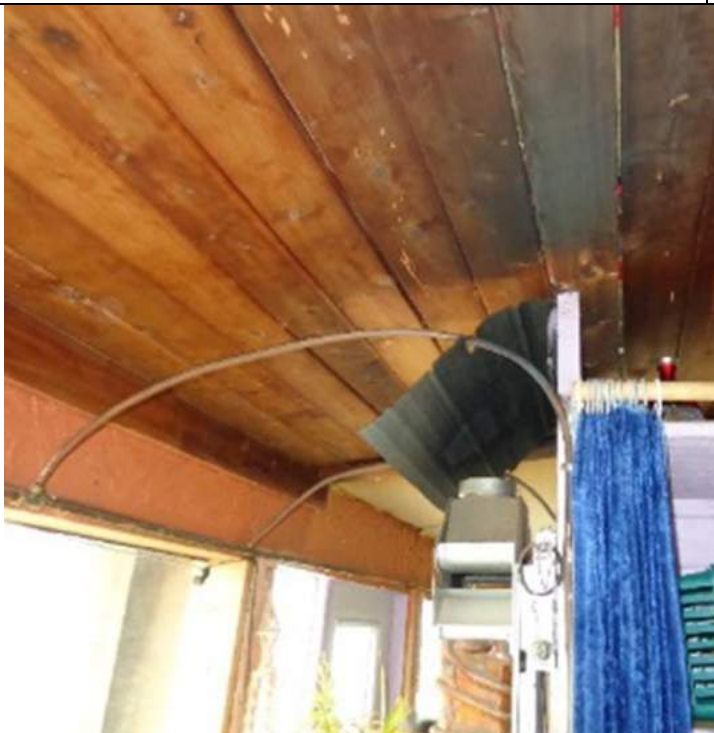
Vent outlet of water heater note soot on ceiling

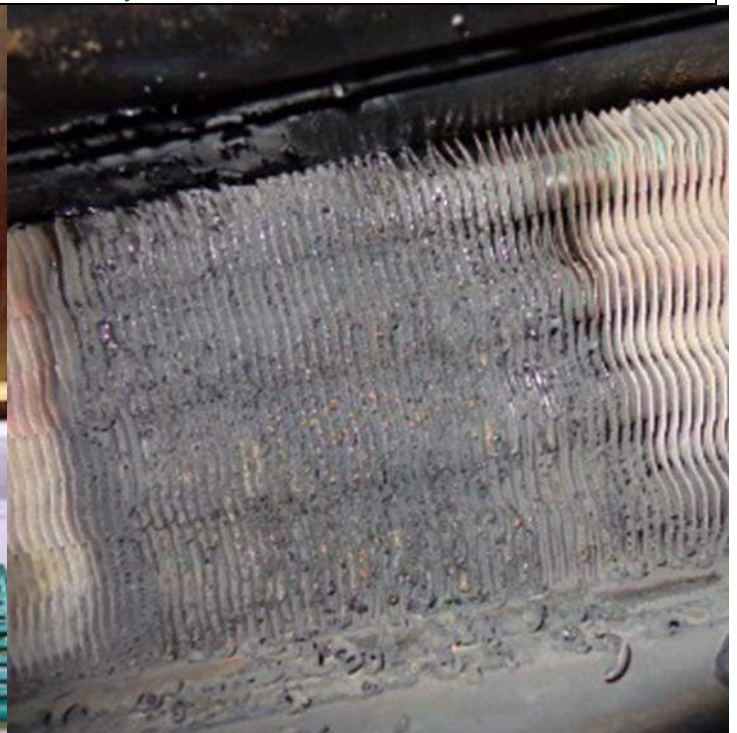
Soot blocked middle section of water heater heat exchanger

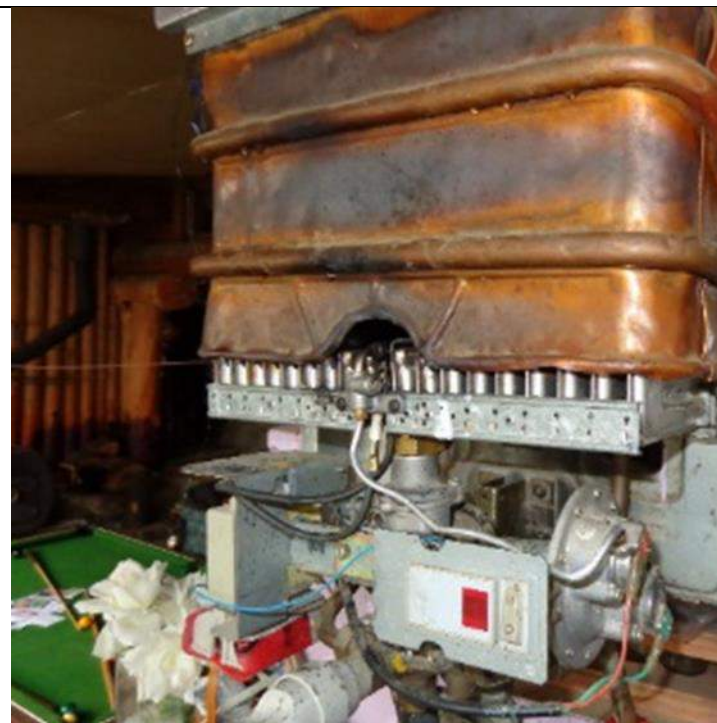
*water heater burner and controls section*

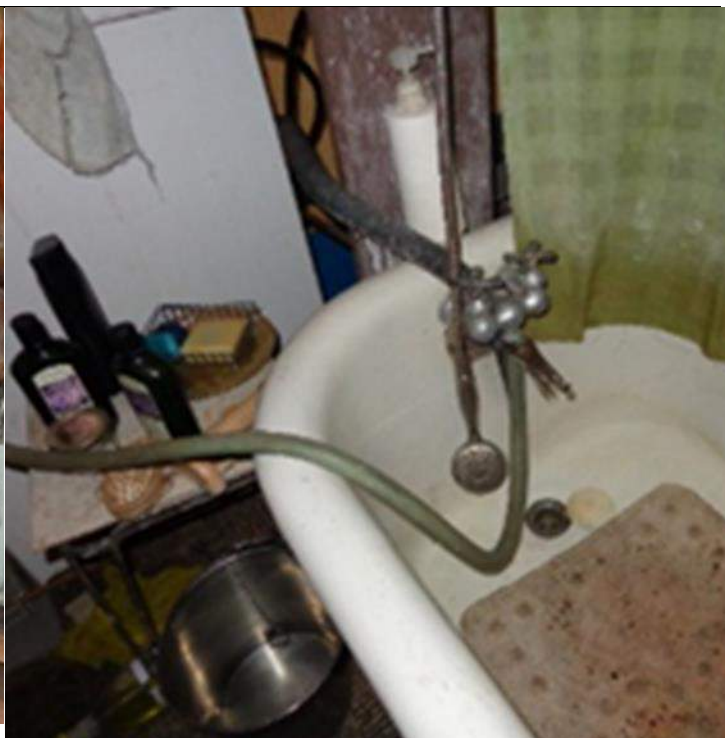
*Garden hose attached to bathtub faucet hot tap turned on.*

Facts and evidence		<p>The make and model of the tankless water heater was not confirmed. There were no labels, rating plates or approval marks found on the water heater. The cover for the water heater was missing and could not be found. The physical characteristics of the water heater indicate the manufacture is likely Bosch, model WR400. Visual inspection of the water heater found the heat exchanger was approximately 50% restricted. The blockage of the heat exchanger limited the vent gases from moving away from the combustion chamber resulting in incomplete combustion at the burner producing toxic carbon monoxide. In an attempt to thaw the ice blockage a garden hose was attached to the bathtub faucet. The outlet of the garden hose was then pushed up the outdoor exposed kitchen drain pipe, the hot water was then turned on,</p>

<p>and ran continuously. The fact the appliance was not vented to the outdoors, meant that toxic gases were released to the occupied space while the water heater burner was operational. The Ashcroft Fire Chief tested the vent gas products during the water heater operation. Carbon monoxide gas tested at the appliance vent outlet rapidly climbed to toxic levels exceeding 2000 parts per million.</p>
<p>Causes and contributing factors</p>	<p>The water heater was installed inside the home without a vent system attached, the extended operation of the water heater led to the hazardous levels of carbon monoxide.</p>

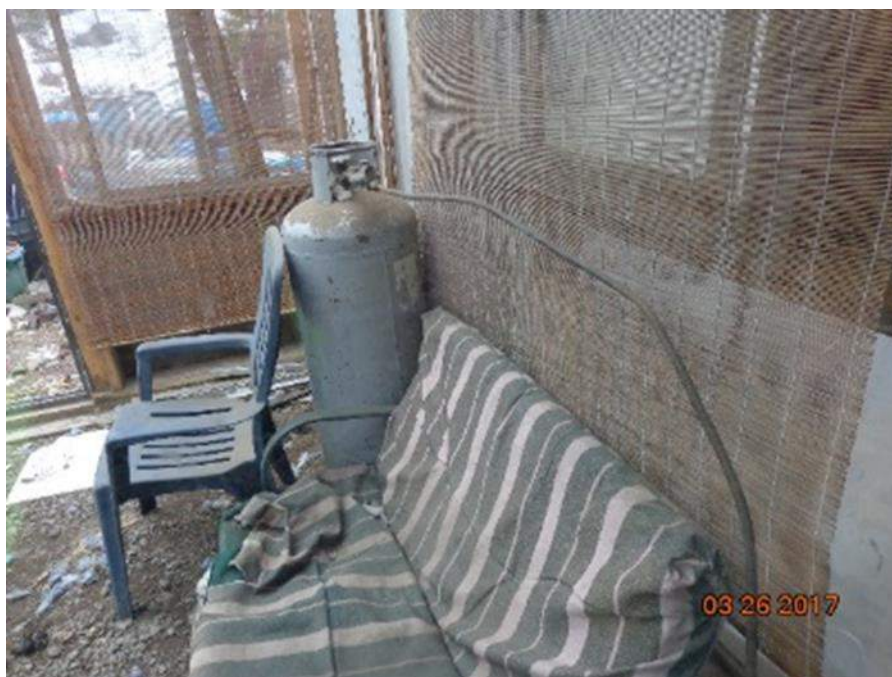
*100 pound propane tank attached to water heater*
