## Incident Summary #II-1592365-2023 (#37652) (FINAL)

SUPPORTING INFORMATION	Incident Date	August 15, 2023	
	Location	Port Coquitlam	
	Regulated industry sector	Electrical - Low voltage electrical system (30V to 750V)	
	Impact	Qty injuries	0
		Injury description	N/A
		Injury rating	None
	Damage	Damage description	Damage to the branch circuit conductors and smoke alarm outlet box resulting in a burning smell and smoke within the single-family dwelling.
		Damage rating	Minor
Incident rating	Minor		
Incident overview	The fire department was called to respond to this site on two separate occasions after the homeowner reported a burning smell coming from the top floor hallway smoke alarm. In both cases, the fire department attended, observing evidence of the electrical system shorting in the top floor smoke alarm outlet box causing charring of the branch circuit conductor insulation and the smoke alarm outlet box.		
INVESTIGATION CONCLUSIONS	Site, system and components	<p>The area was experiencing above seasonal temperatures (heat wave) at the time of the incident. A portable air conditioner was plugged into the same branch circuit as the smoke alarm.</p> <p>General use 2-Wire 15Amp br

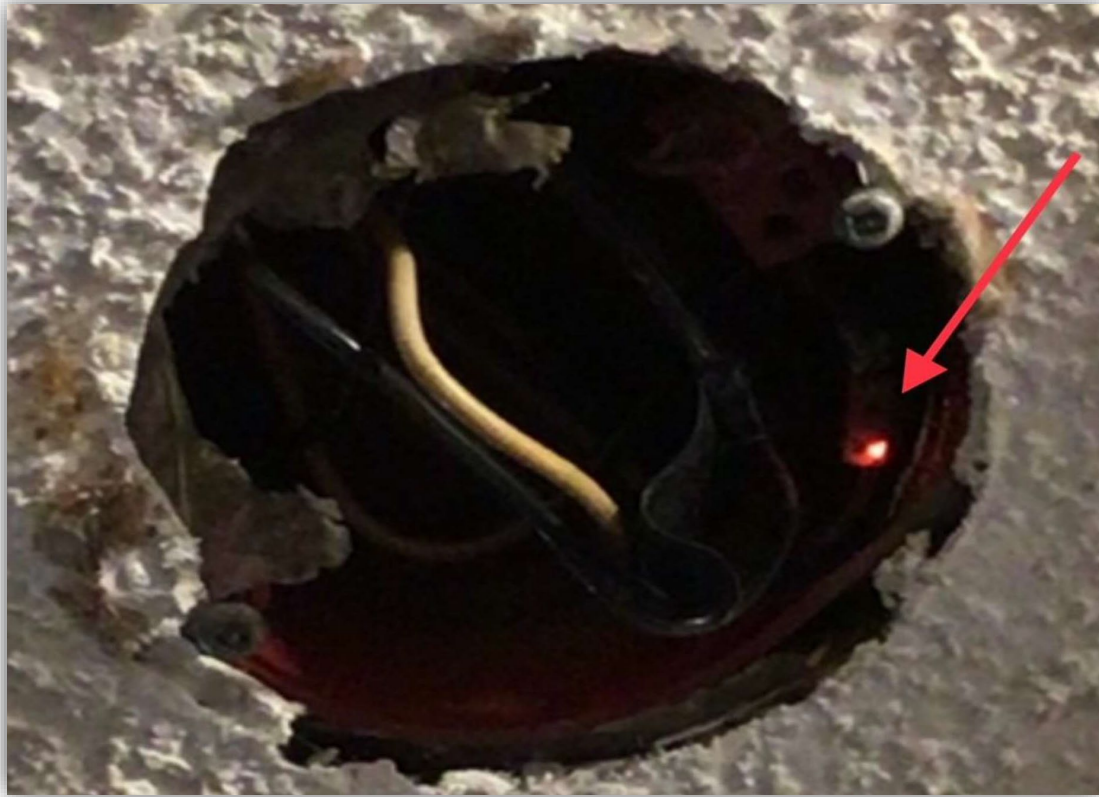
Image 1 - The red-hot branch circuit neutral conductor splice (crimped connection) at the time of the incident within the smoke alarm box (*Image provided by homeowner*).

<p>Causes and contributing factors</p>	<p>It is probable that the incident was caused by a loose branch circuit conductor connection in the smoke alarm outlet box, possibly made worse by a high wattage portable air conditioner running for a prolonged period of time, during the heat wave which may have contributed to overloading of the branch circuit.</p>

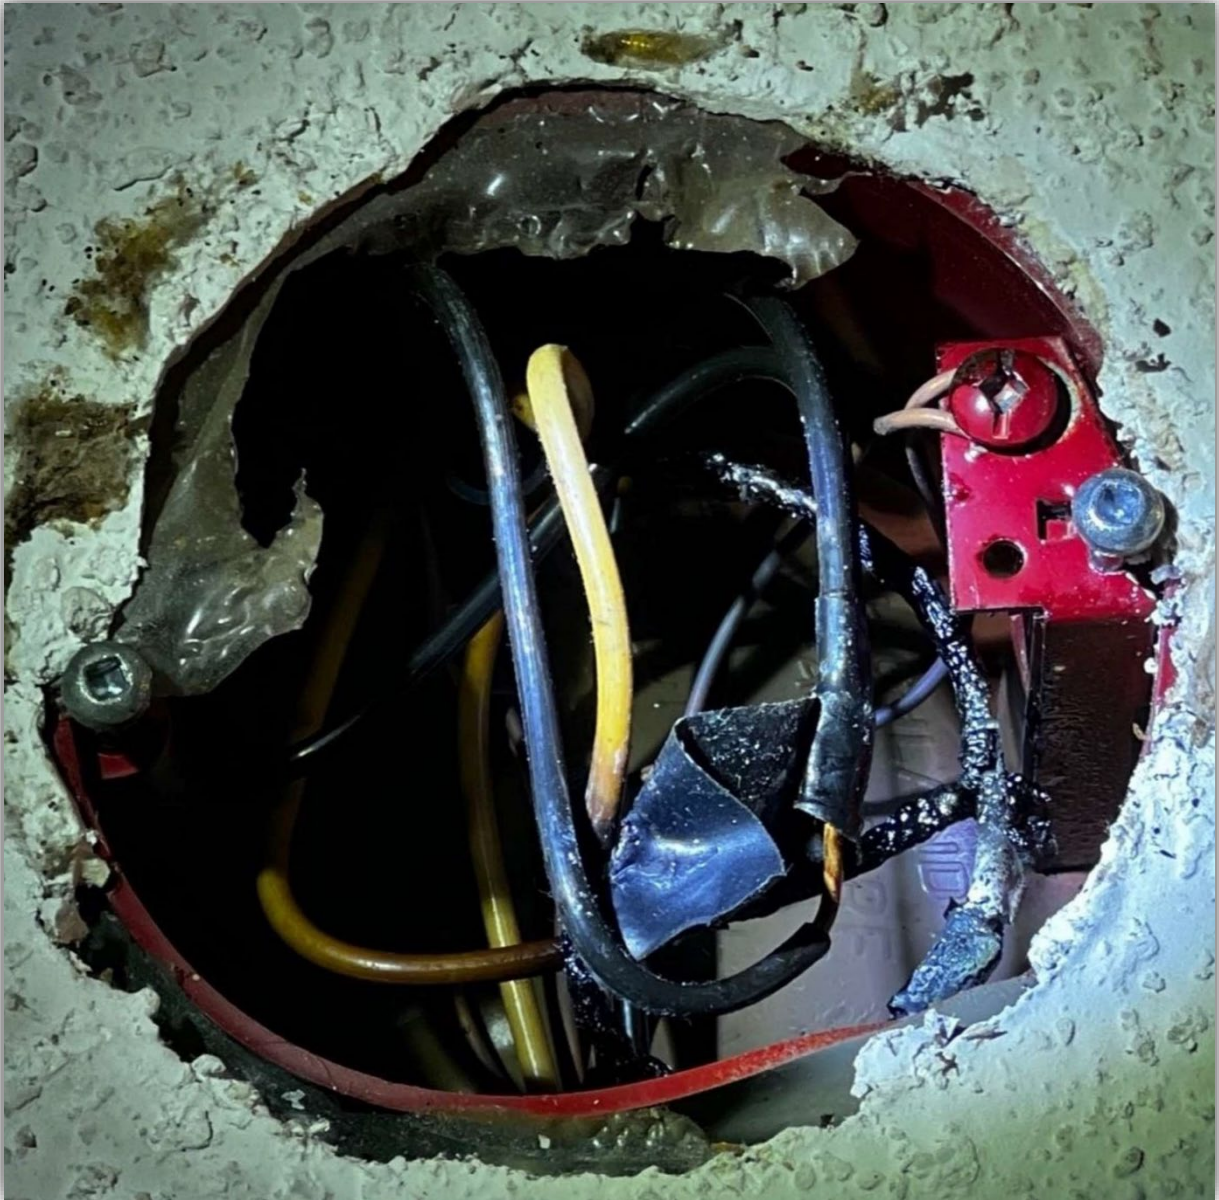
Image 2 - Box after the power to the circuit was turned off (*Image provided by homeowner*).

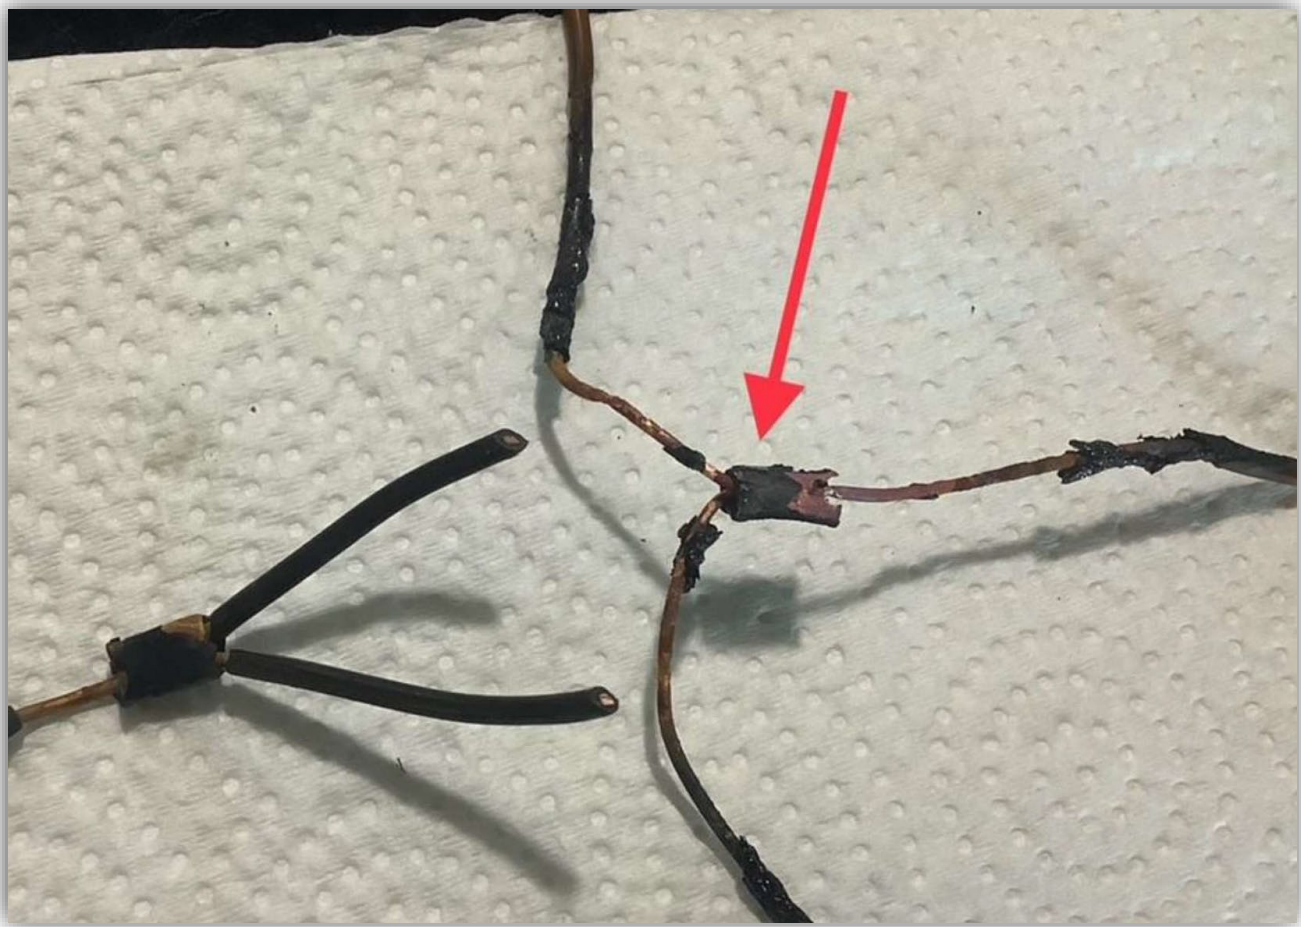
Image 3 - Damaged to the removed conductors. [RED] The crimped electrical connection that was red-hot in [Image 1](#).

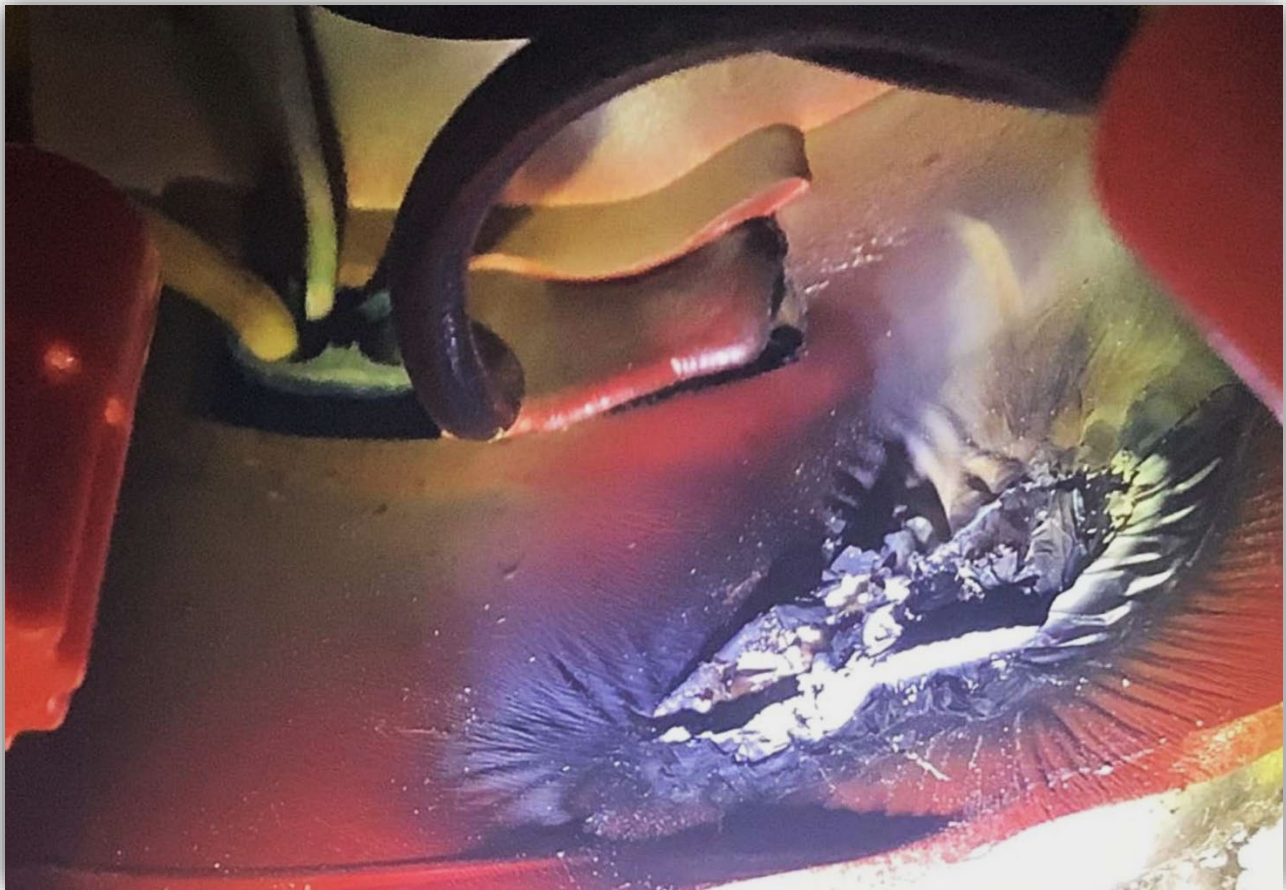
Image 4 - Damage to the smoke alarm outlet box.

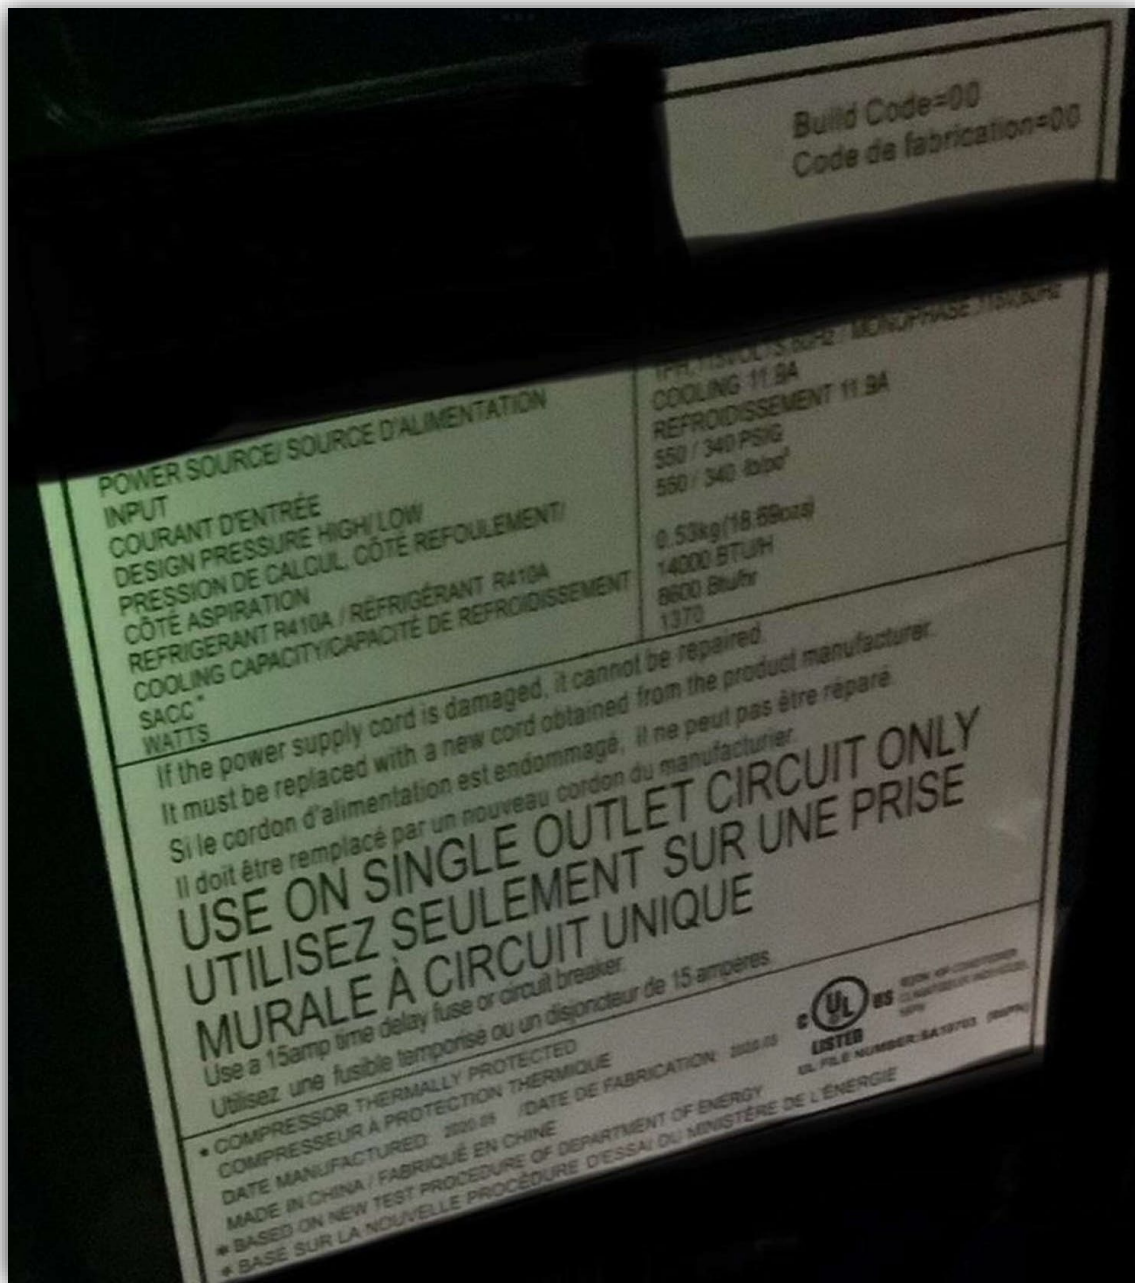
Image 5 - Nameplate located on the side of the portable air conditioner.

<p>Failure scenario(s)</p>	<p>The area where the incident occurred was experiencing higher than normal temperatures. The homeowner plugged in a portable air conditioner rated at 11.9Amp into a general use 15Amp receptacle located in the main top floor bedroom that was not on a dedicated circuit. Due to the high temperature the portable air conditioner was in constant use to provide relief from the heat throughout the top floor of the home. The homeowner indicated there was a burning smell coming from the top floor hallway smoke alarm and called the fire department. It was identified that the branch circuit connections in the smoke alarm outlet box may not have been made up tight at the time of installation or may have become loose overtime and were on the same branch circuit as the receptacle the portable air conditioner was plugged into. The branch circuit was possibly overloaded while the portable air conditioner was in use.</p>
