Incident Summary #II-790702-2018 (#18758) (FINAL)

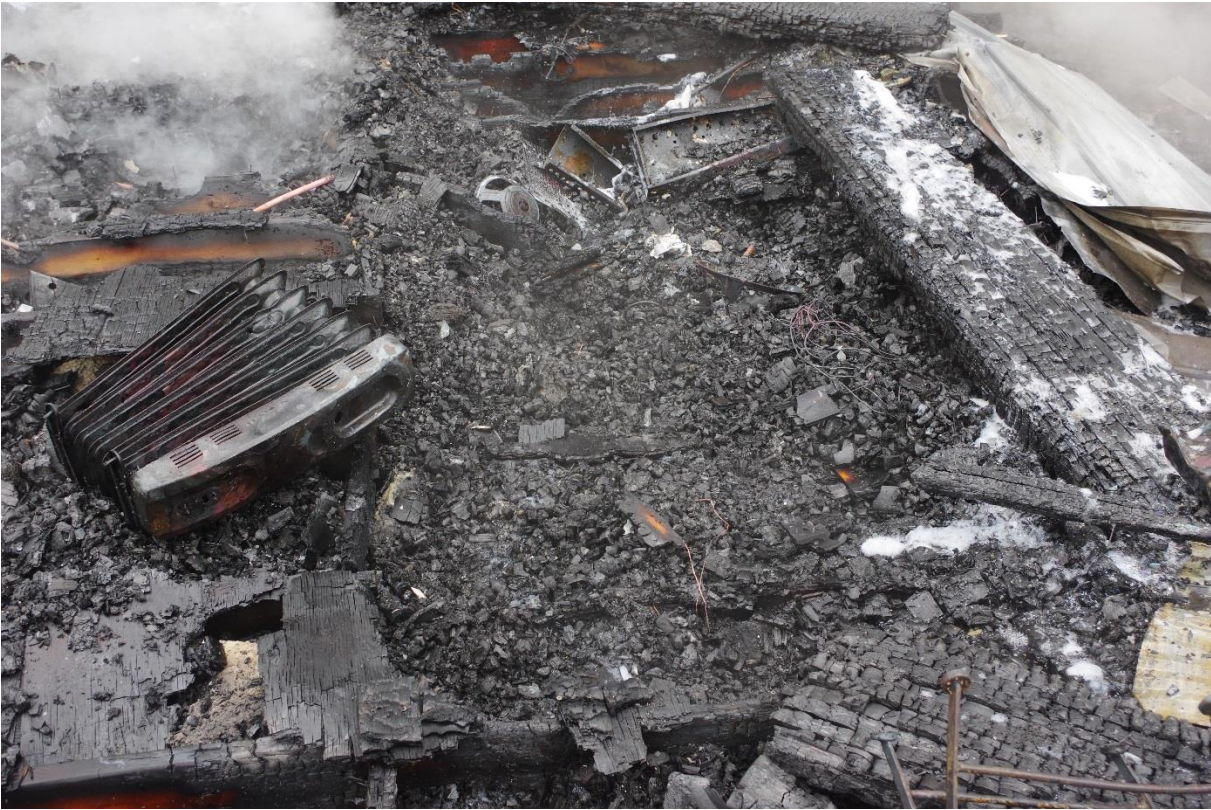
Northend corner of dining area, destroyed heater remains laying on ground

<p>Causes and contributing factors</p>	<p>The incident and cause of this fire is based mainly on statements provided by witnesses along with prior photos of site provided as the state of the fire was destroyed beyond the ability to confirm any 'definite' certain cause. The heater location was found located in the vicinity of where the initial statement provided a visible location of the fire origin.</p> <p>It is 'likely' that given all the evidence that the fire was started at the location where the heater cord was plugged into the wall outlet and not the heater itself. The heater was operating at full power of 1500 watts for an extended period of time and created either a hot cord connection, possible poor receptacle connection or a combination of both which failed and ignited the cedar structure around the receptacle location</p>

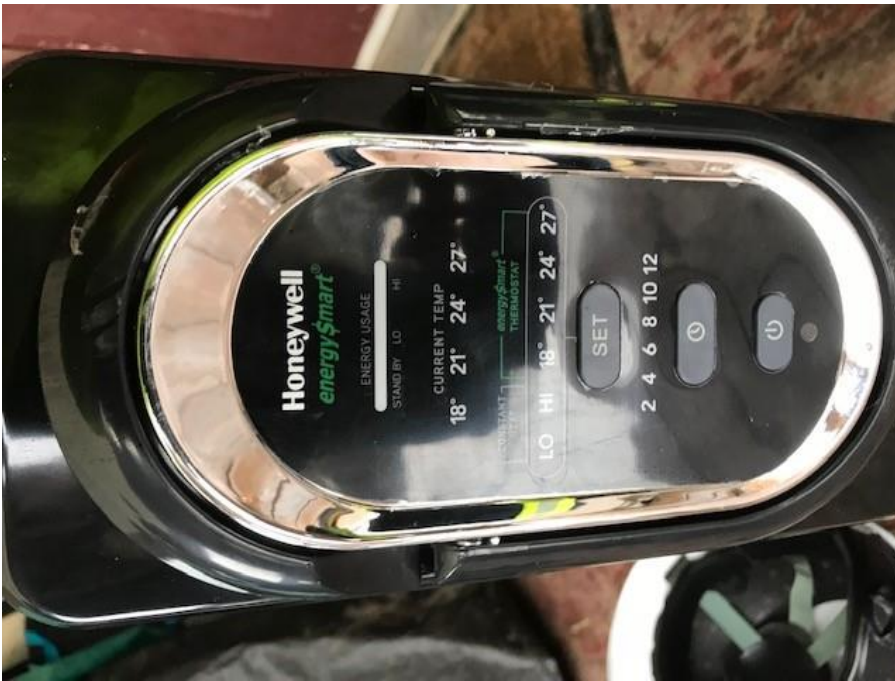
Second heater owner purchased, same as unit in question

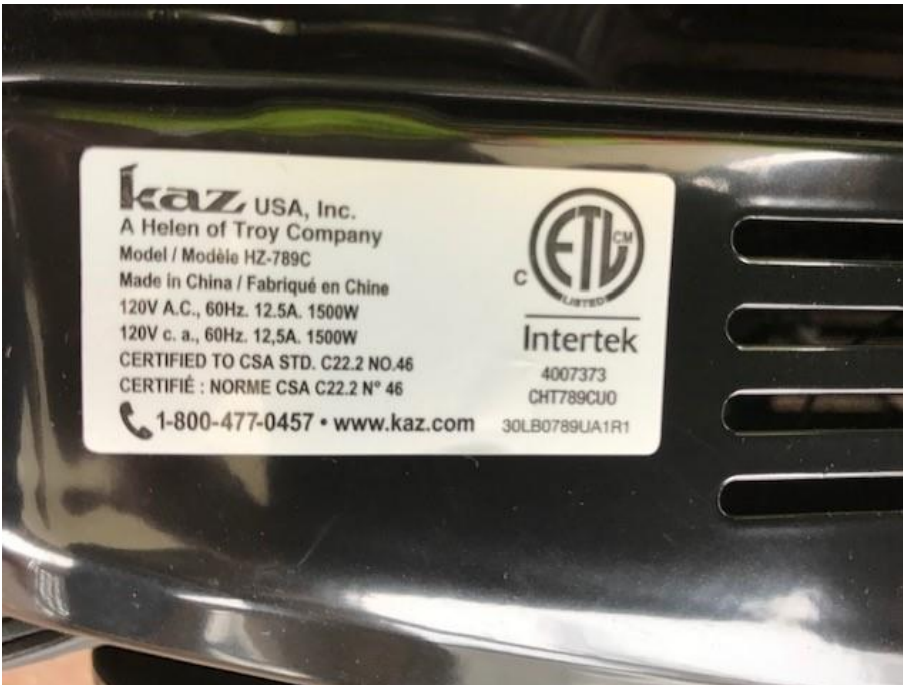
Heater nameplate

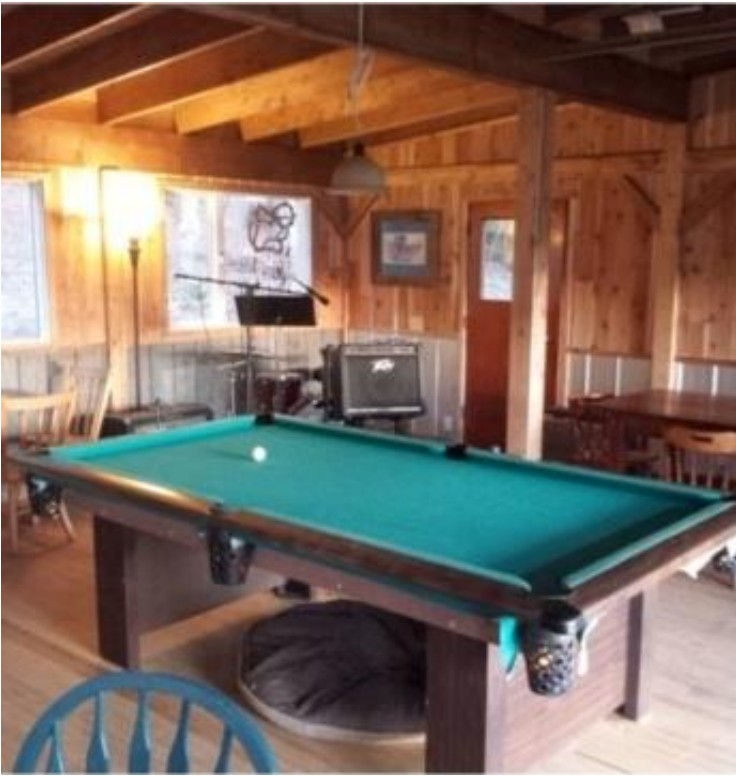
Back northwest corner of dining area

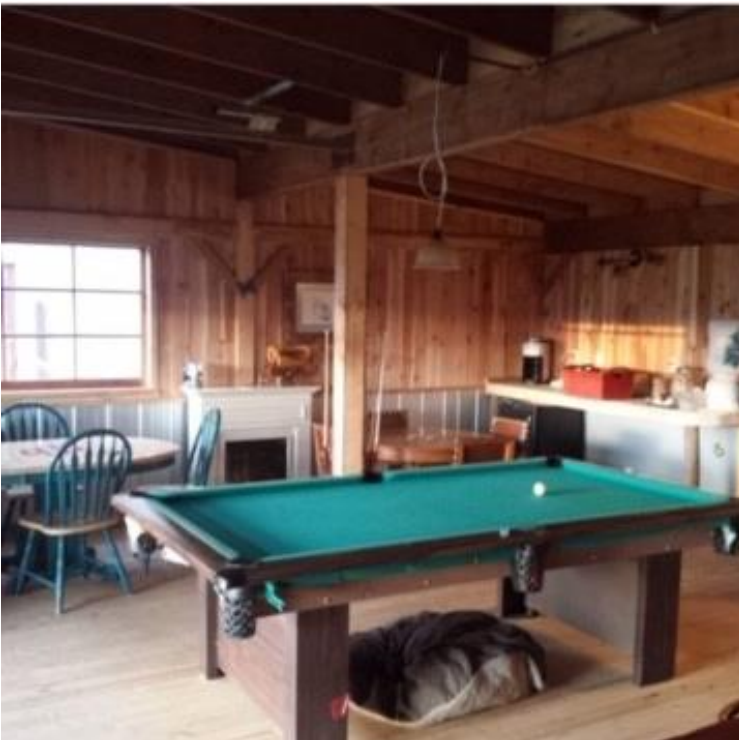
Back southwest corner of dining area

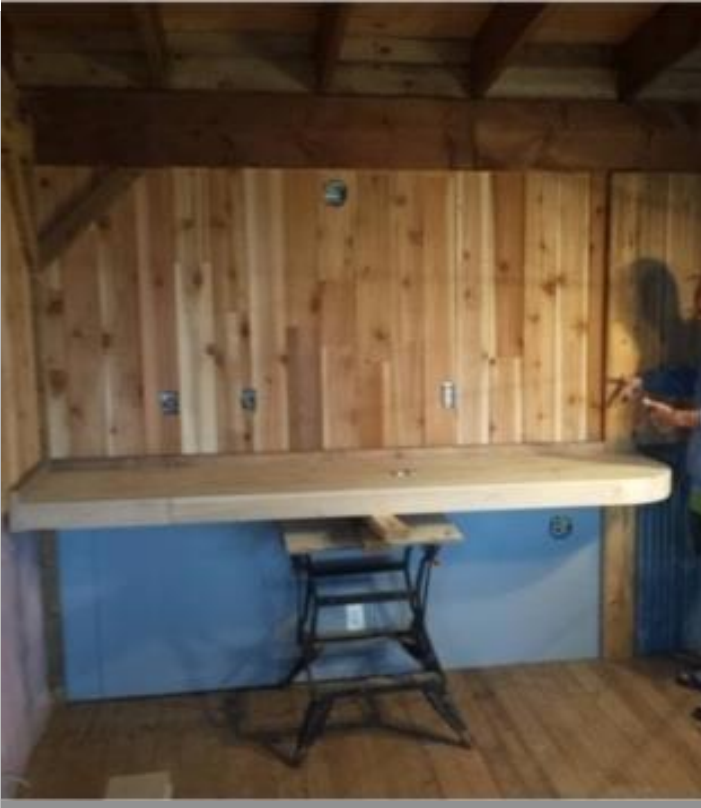
Front Northeast corner of dining area, approx. location of heater

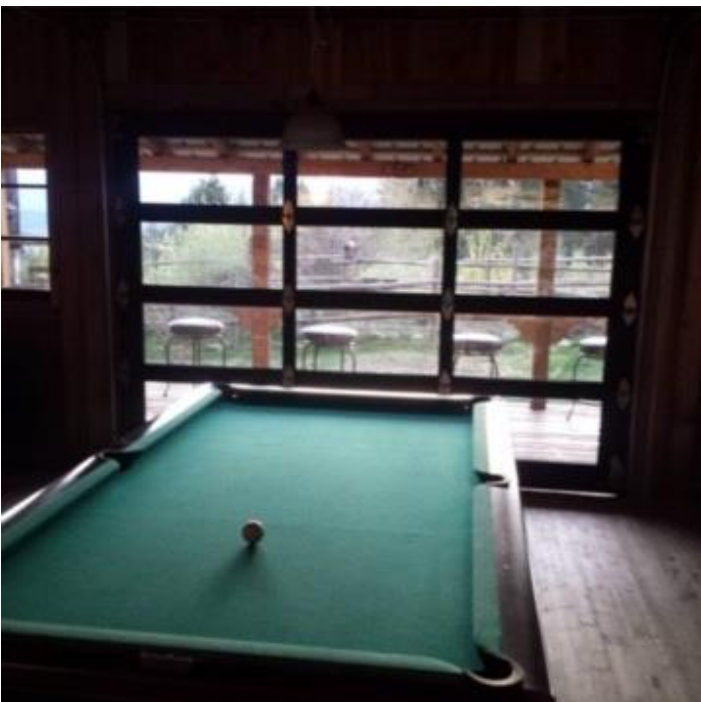
Front south east side of dining area
