Incident Summary #II-1616967-2023 (#40199) (FINAL)

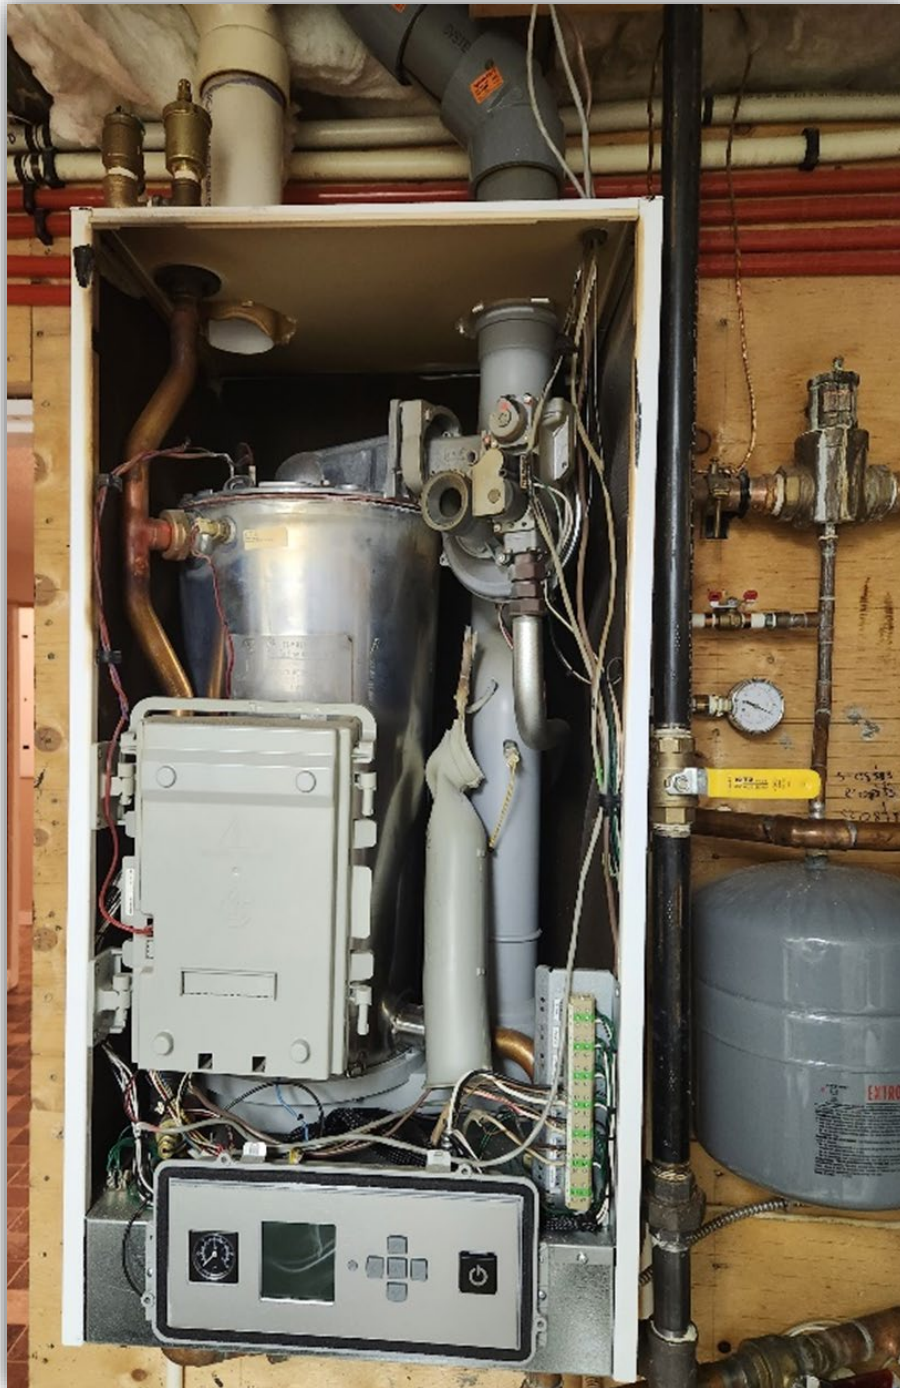
Image 1 – Boiler with the front cover removed.

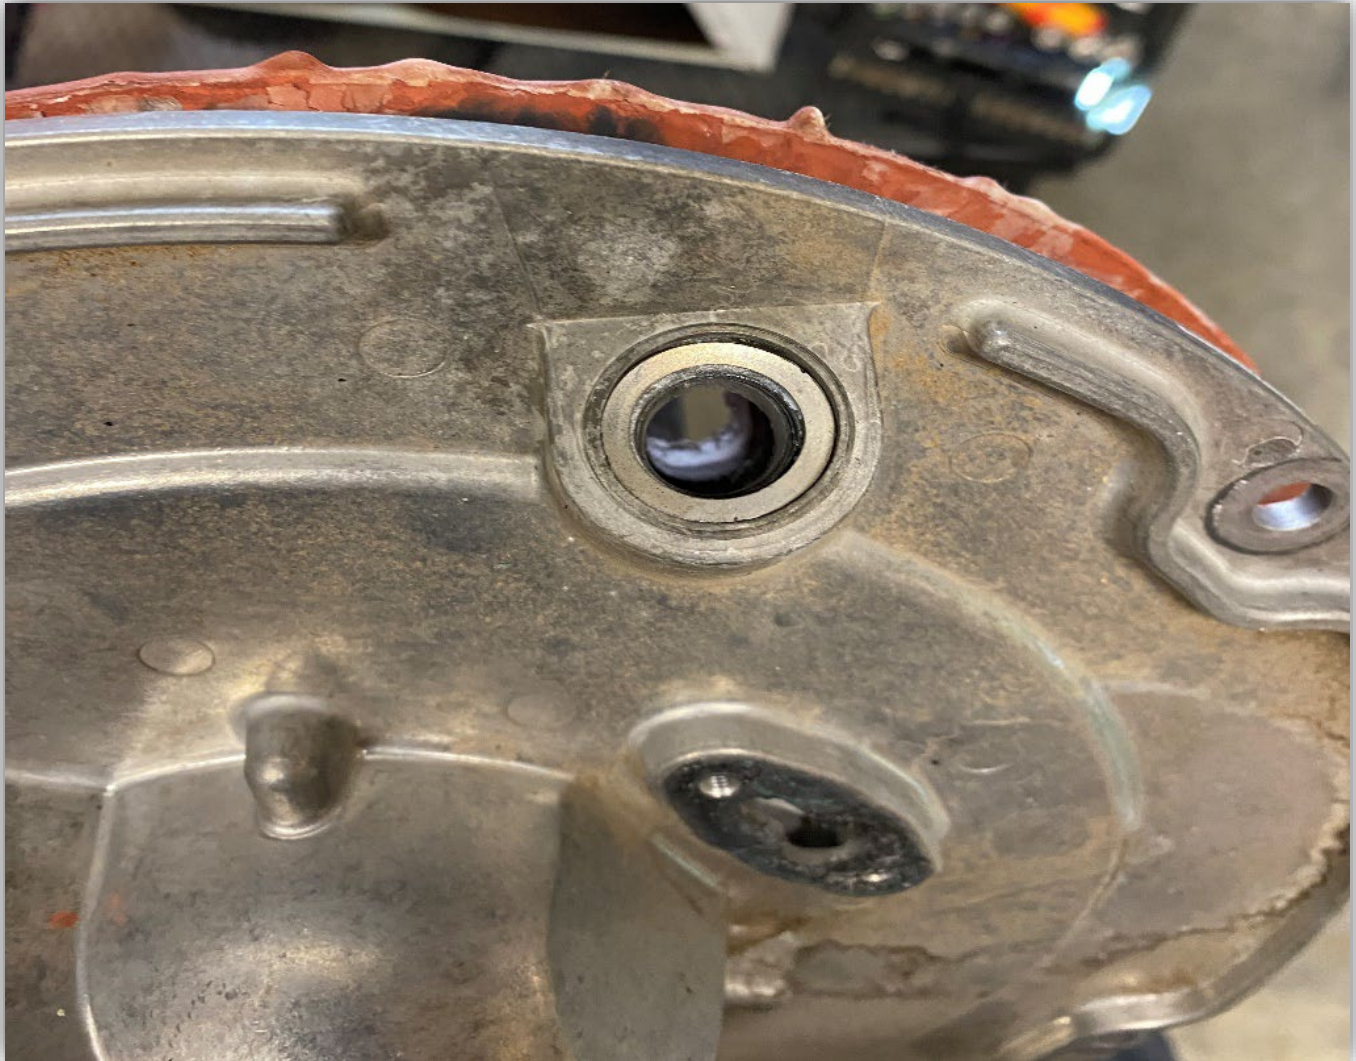
Image 3 - Broken sight glass located in the lid of the heat exchanger and damaged lid.

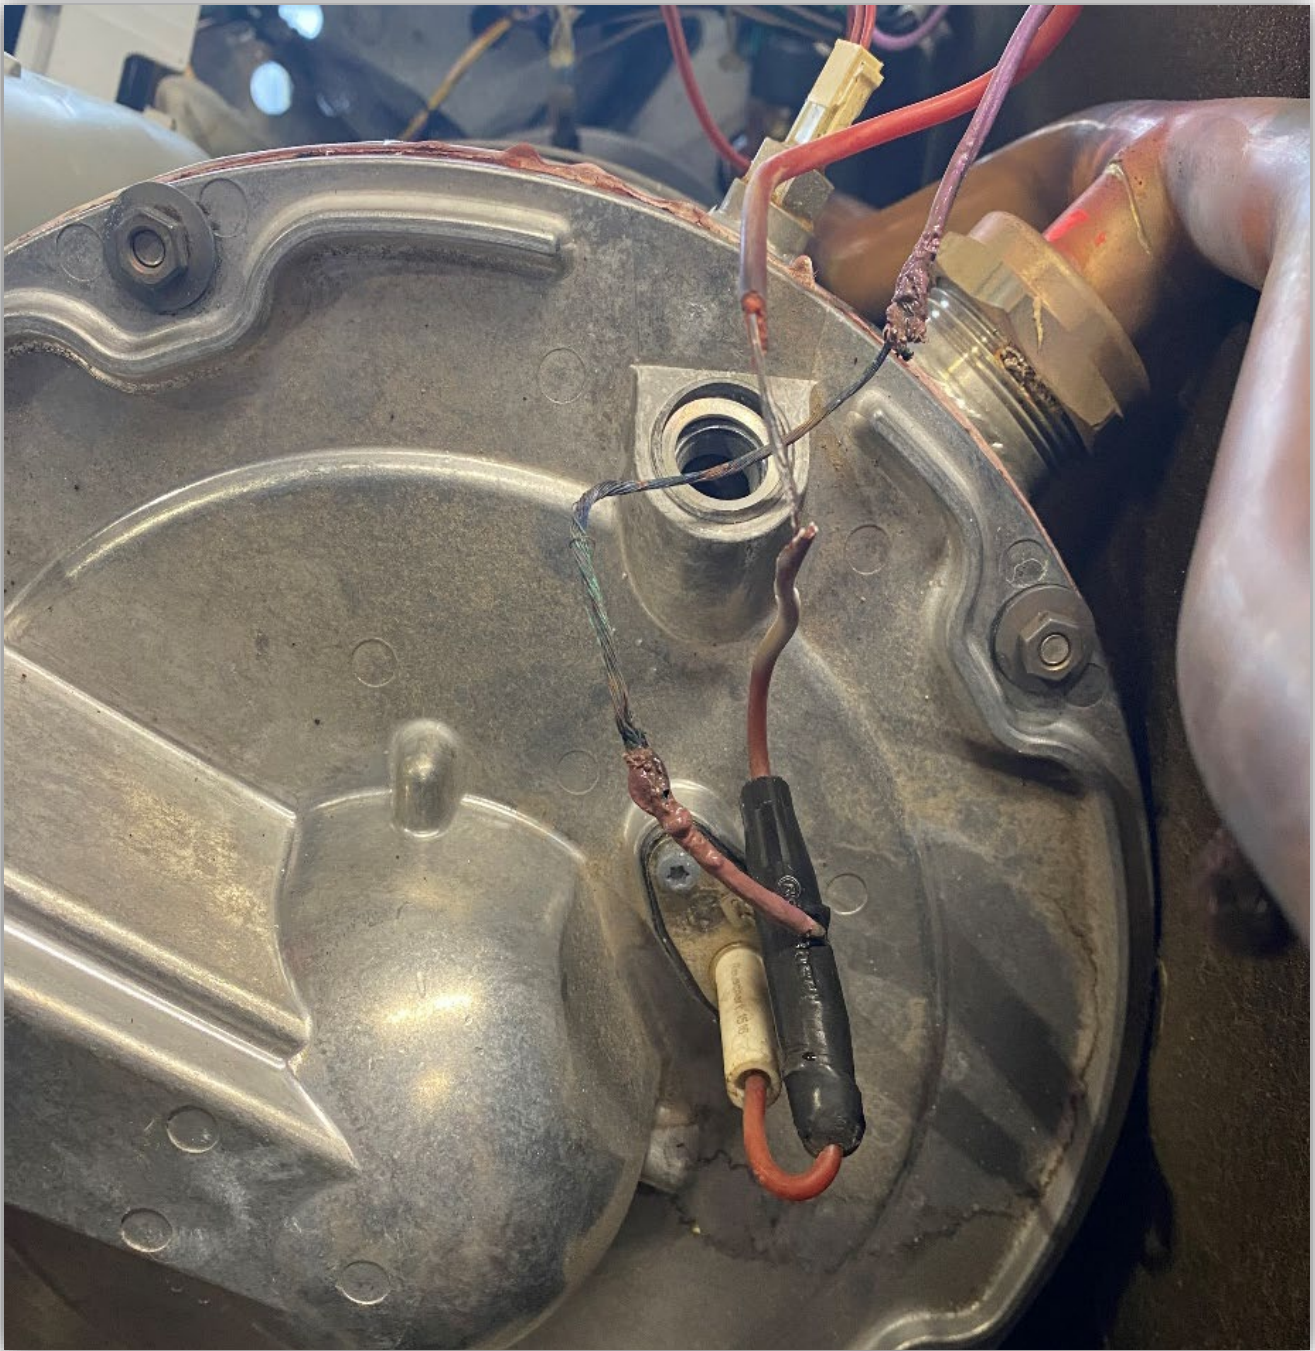
Image 4 - Melted ground wires.

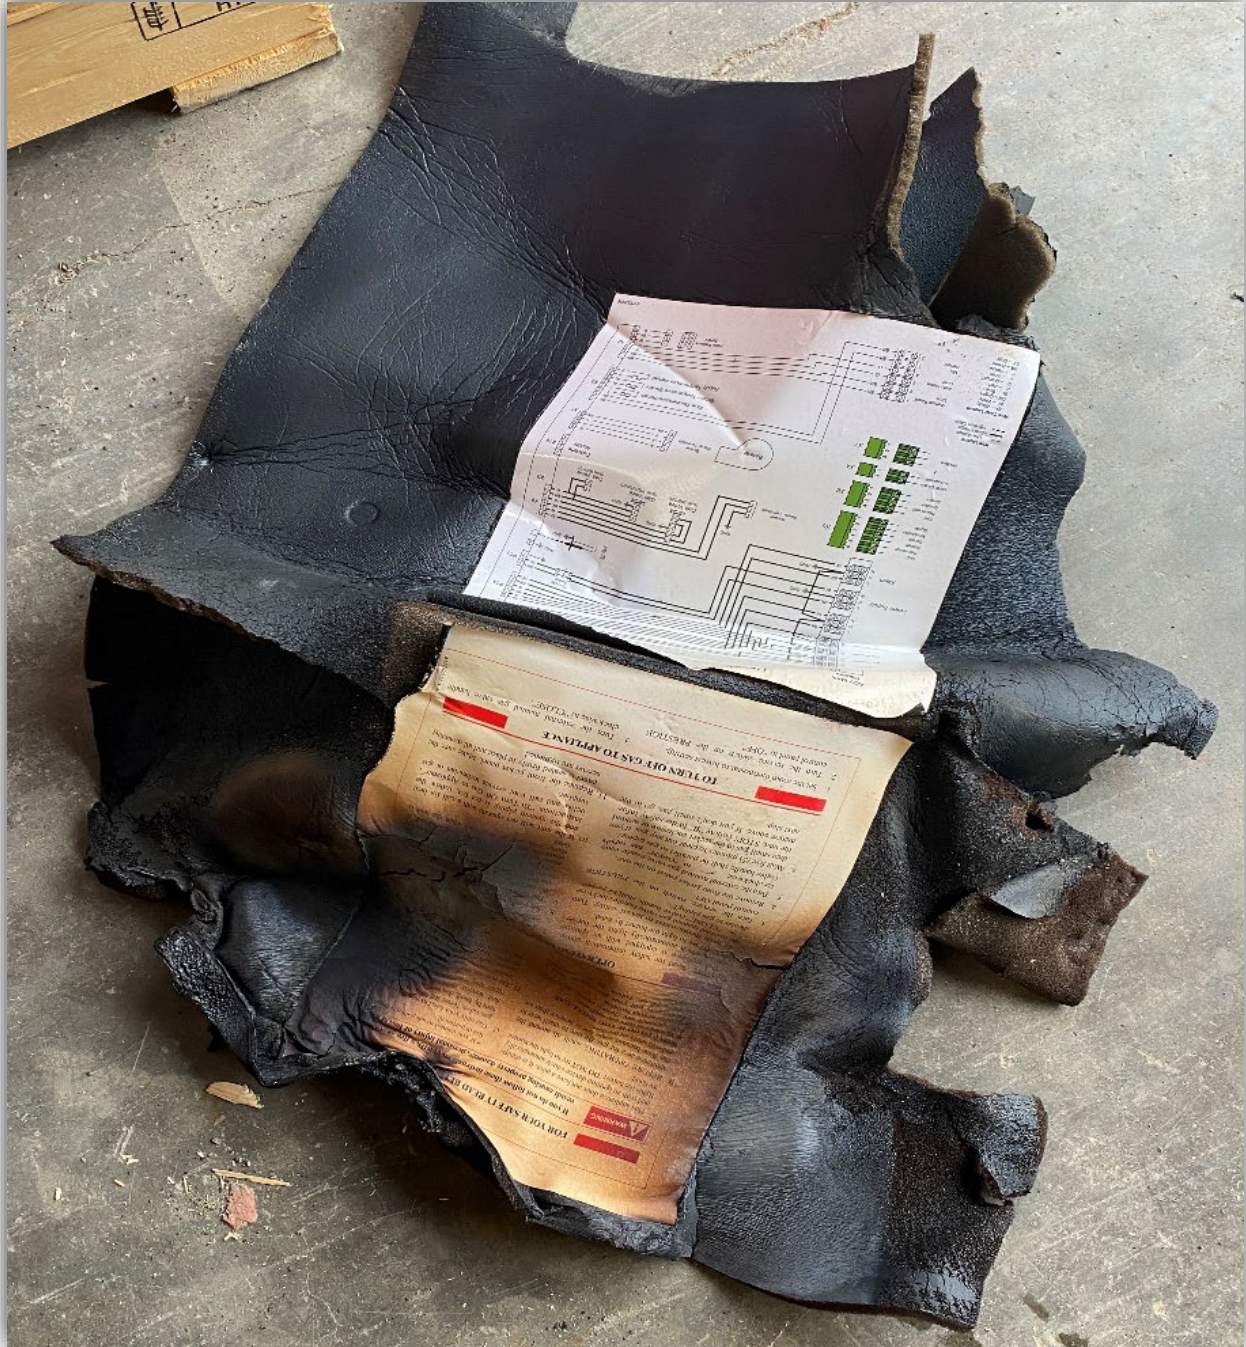
Image 5 – Damaged cabinet insulation.
