Incident Summary #II-1525688-2023 (#33731) (FINAL)

SUPPORTING INFORMATION	Incident Date	March 23, 2023	
	Location	Richmond	
	Regulated industry sector	Boilers, PV & refrigeration - Refrigeration system	
	Impact	Qty injuries	0
		Injury description	None
		Injury rating	None
	Damage	Damage description	An internal failure of a heat exchanger had ammonia gas leak through and absorb into the circulating liquid brine for the underfloor loop. The ammonia within the liquid brine spilled out of the expansion tank where it pooled within an open sump in the mechanical room. The heat exchanger needed to be replaced as it was not repairable.
		Damage rating	Minor
Incident rating	Minor		
Incident overview	The failure of the exchanger (Image 1) was internal between the ammonia hot gas side and the calcium chloride liquid brine side. This caused ammonia gas to escape and be absorbed by the brine side and escape out of an open to atmosphere expansion tank. (Image 2). The heat exchanger was isolated and stopped the flow of ammonia gas over to the brine side and as a result there was no underfloor brine heating available to the ice rinks affected as the pump was locked out and isolated.

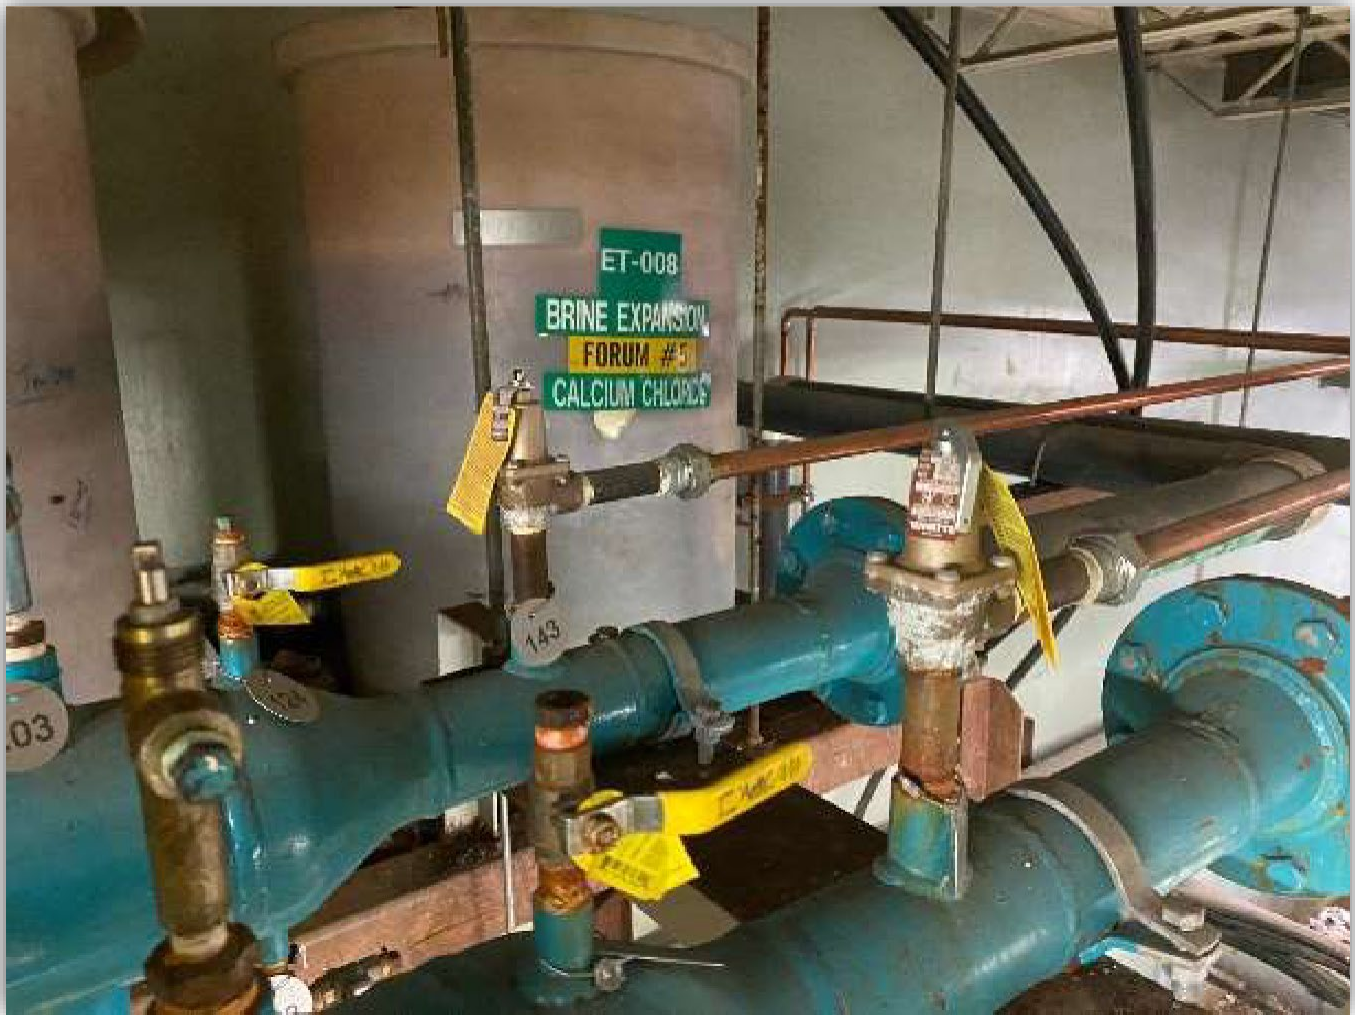
The heat exchanger failure due to internal corrosion that was most likely caused by a failure to maintain brine chemical residual levels and system levels allowing oxygen to enter the system and attack the internal metal surfaces. Brine system levels did not physically cover all internal surfaces and Ph levels were allowed to drop below 7 that caused an acidic brine to attack all internal metal surfaces.

Image 1 - Failed heat exchanger Isolated and awaiting replacement.

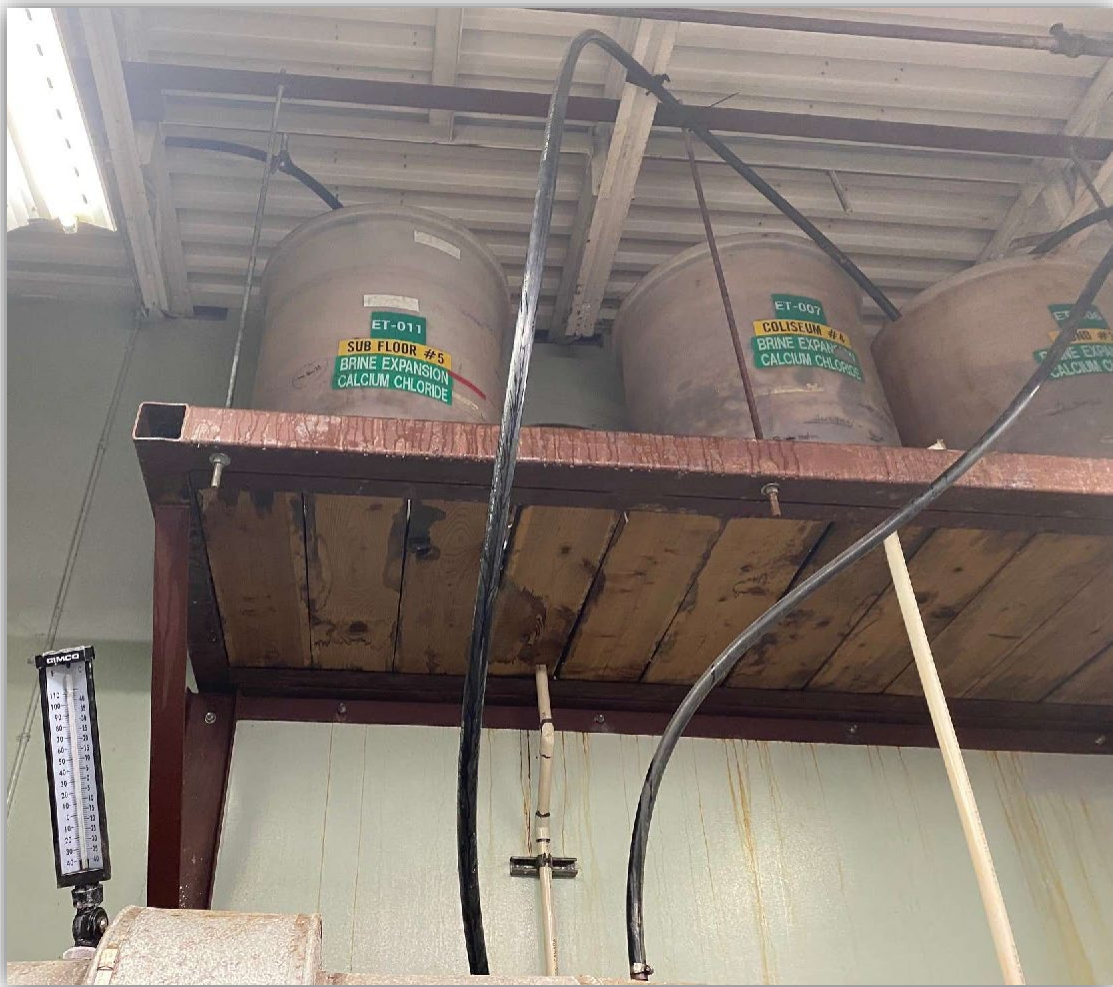
Image 2 - Open expansion tank for the brine where ammonia gas escaped into the mechanical room and liquid brine spilt down below to an open sump.

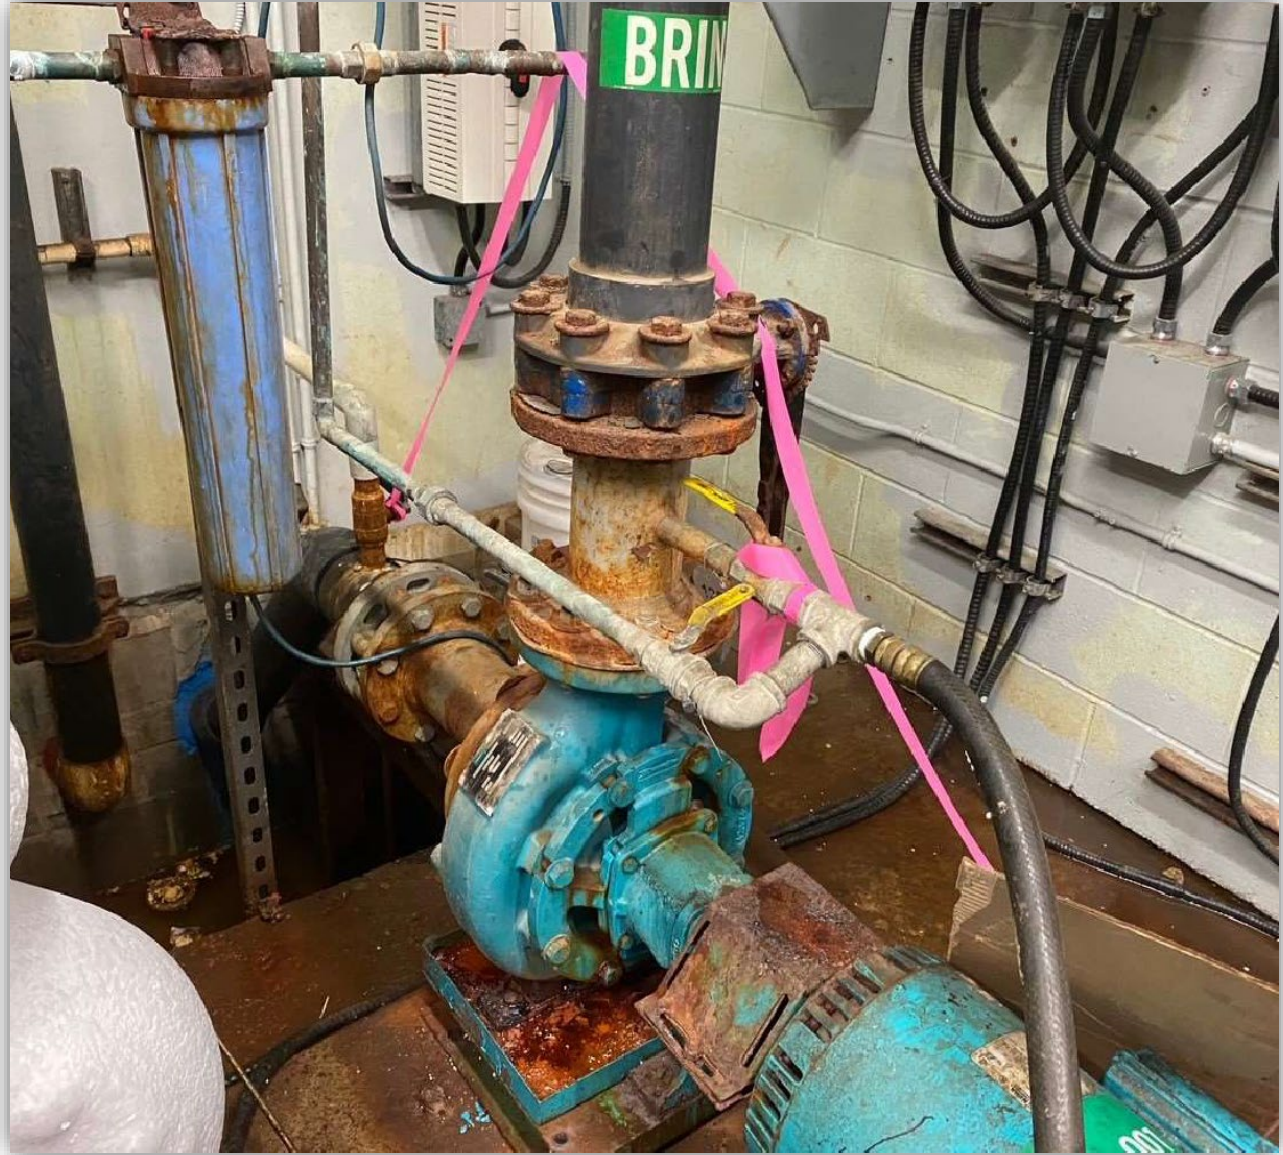
Image 3 - Isolated and locked out brine circulating pump.
