## Incident Summary #II-155531-2023 (#35654) (FINAL)

SUPPORTING INFORMATION	Incident Date	May 27, 2023	
	Location	Salmon Arm	
	Regulated industry sector	Gas - Propane system	
	Impact	Qty injuries	1
		Injury description	First degree burns to the lower part of their body and were admitted to the hospital for medical treatment.
		Injury rating	Moderate
	Damage	Damage description	Some charring and burning of combustible materials around the area of the open gas line inside the trailer.
		Damage rating	Minor
	Incident rating	Moderate	
Incident overview	A worker was inside a mobile food trailer with propane fueled cooking appliances. While attempting to light the pilot light of a gas appliance, a gas leak occurred from an open gas line which ignited causing burns to the individual.		
INVESTIGATION CONCLUSIONS	Site, system and components	<p>Gas systems for mobile outdoor food service equipment including food trailers are required to be installed by certified gas contractors under installation permits.</p> <p>In 2018 the propane gas system in the trailer was originally installed by a certified gas contractor under an installation permit. The installed gas equipment included a deep fryer,

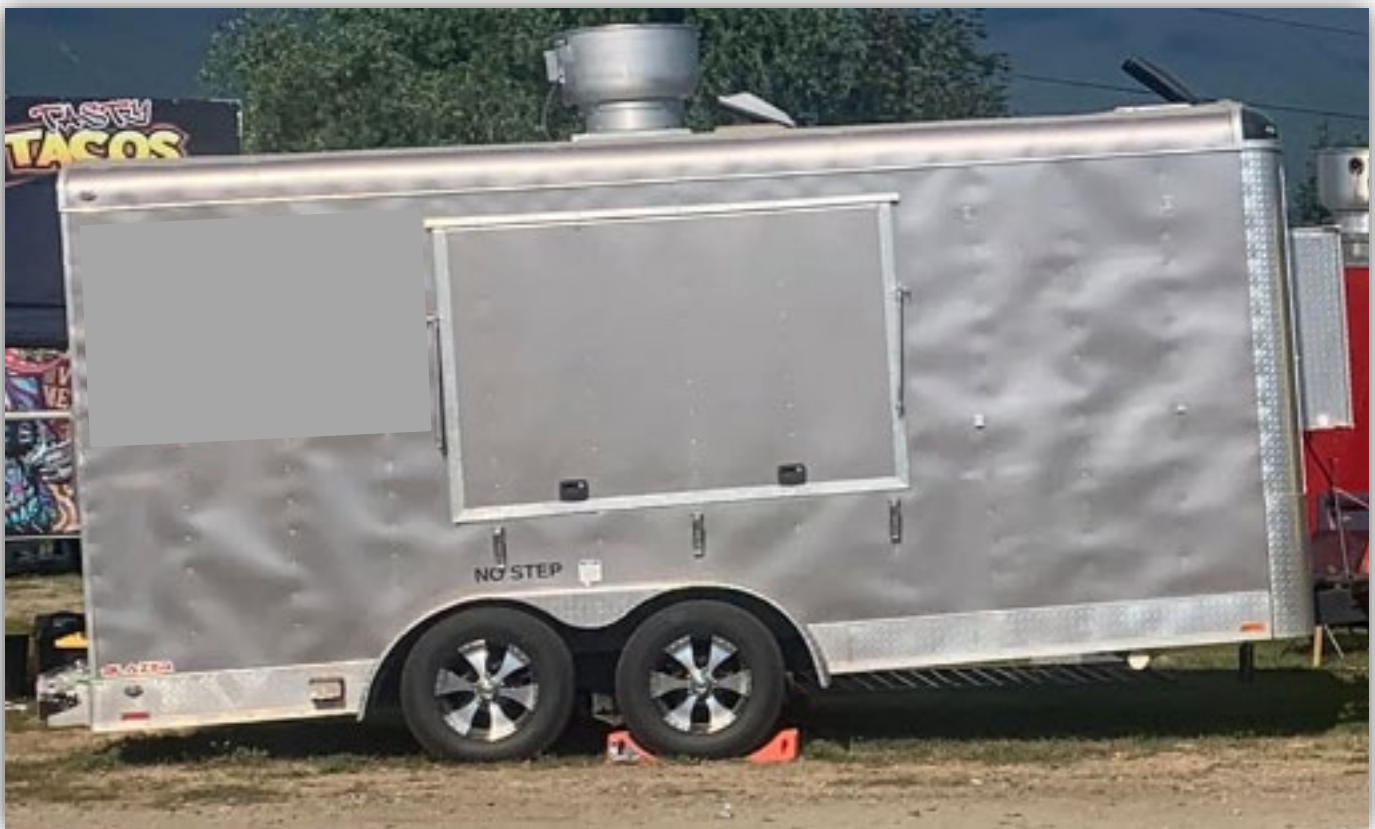
Image 1 – Mobile food trailer.

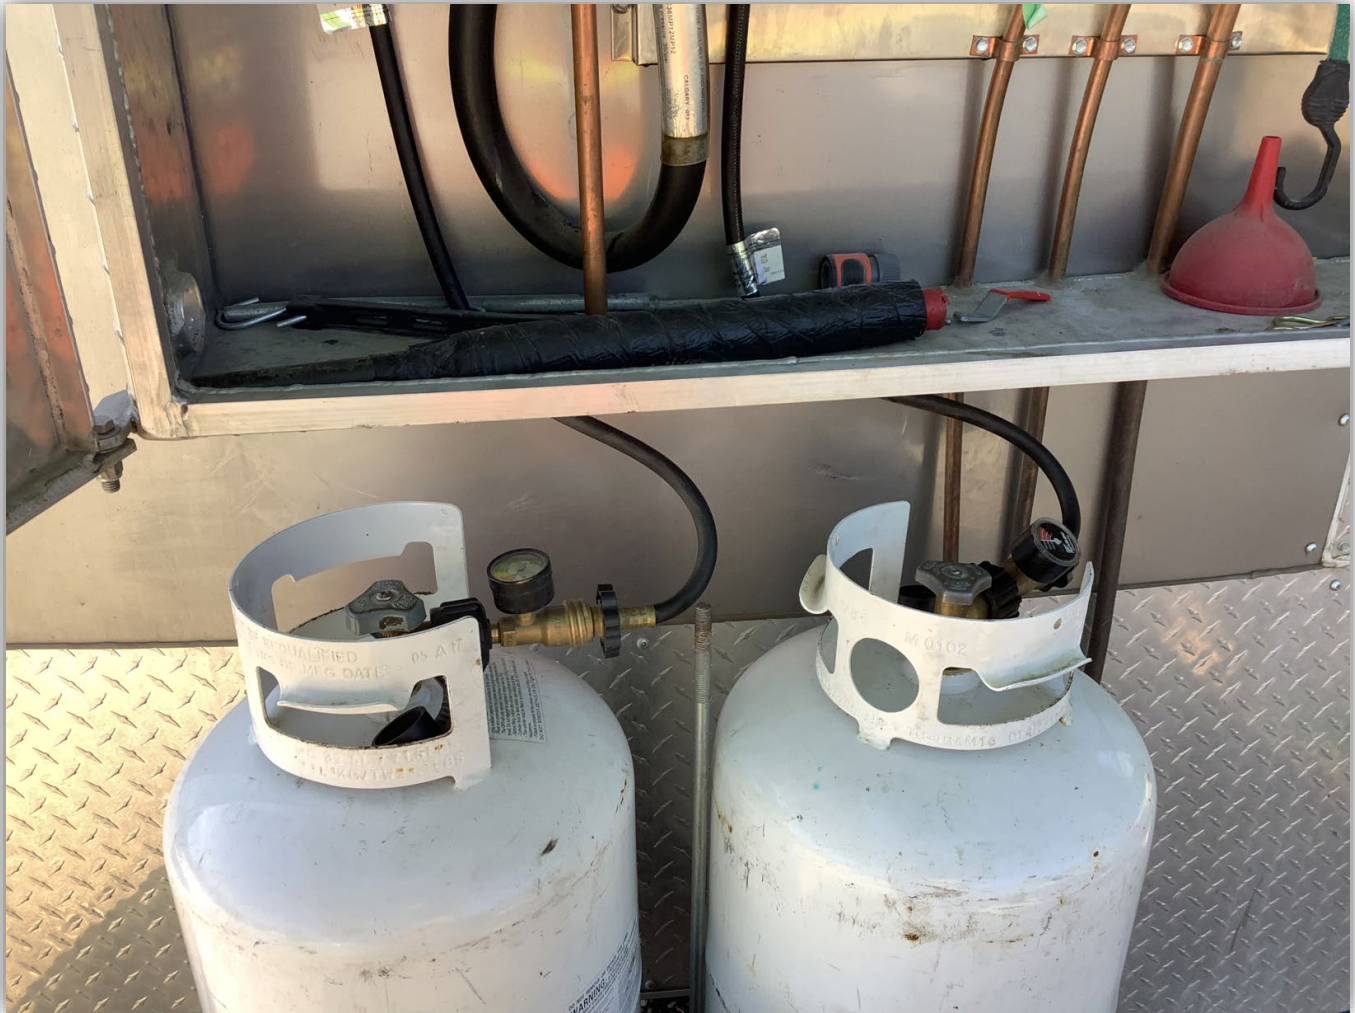
Image 2 – Propane cylinders on front of trailer.

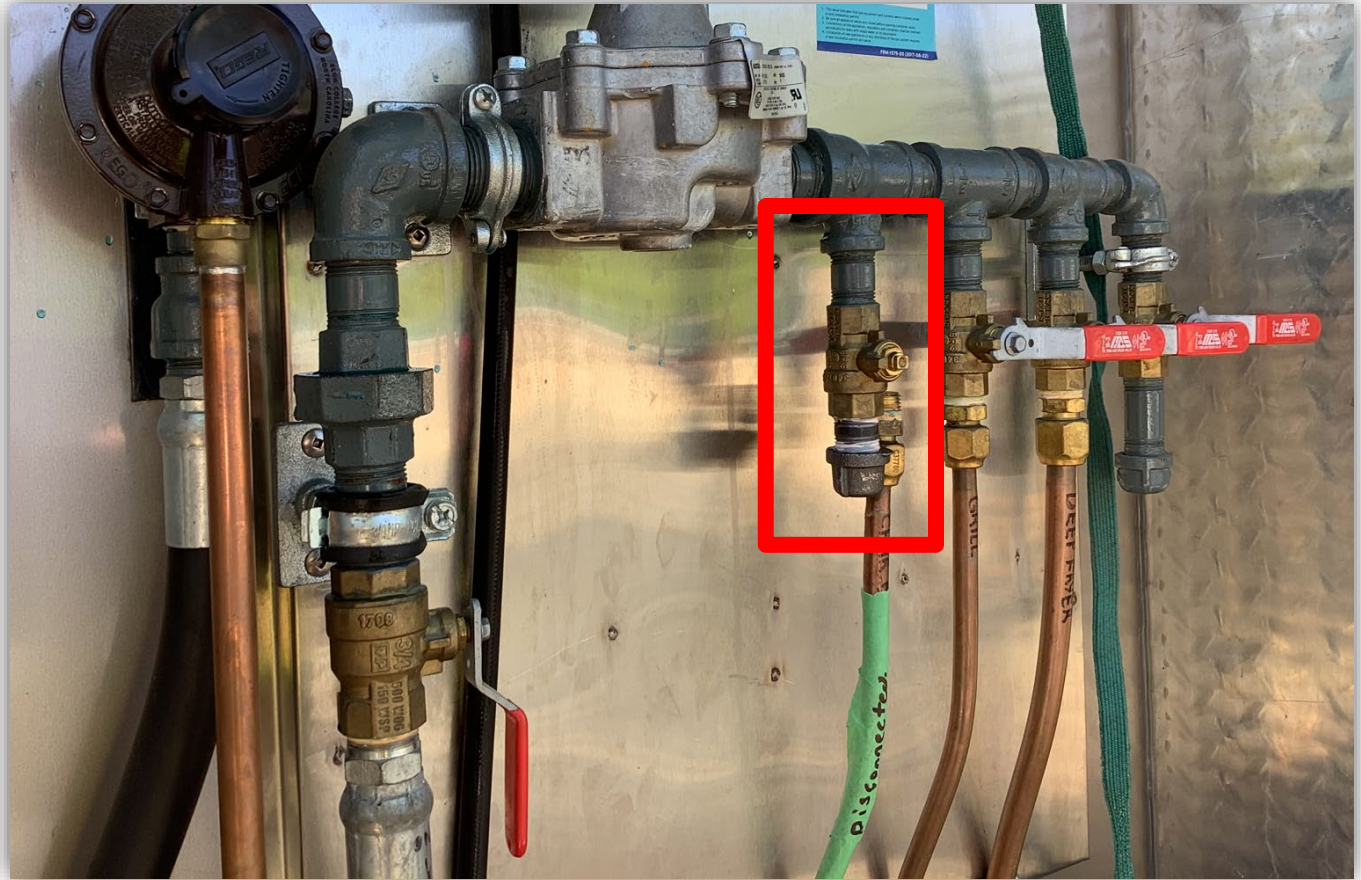
Image 3 – Gas lines from manifold. [RED] Capped gas line to char-broiler after incident with the shut off handle removed. (When the incident occurred, the line was connected, and the handle was on the valve.)

Failure scenario(s)	<p>The owner of the mobile food trailer, who was not a qualified gas fitter, had removed the propane char-broiler from the system but did not cap the copper gas line inside the trailer and relied on the shut off ball valve for the line to stop the flow of gas. The shut off valve was not effectively closed when the propane gas cylinders were turned on and the pilot light for the deep fryer was attempting to be lit with an open flame. Gas escaped from the open gas line for the old char-broiler and mixed with the air to create a combustible fuel air mixture that was ignited and started on fire. The worker inside the trailer received first degree burns and was admitted to hospital for treatment.</p>

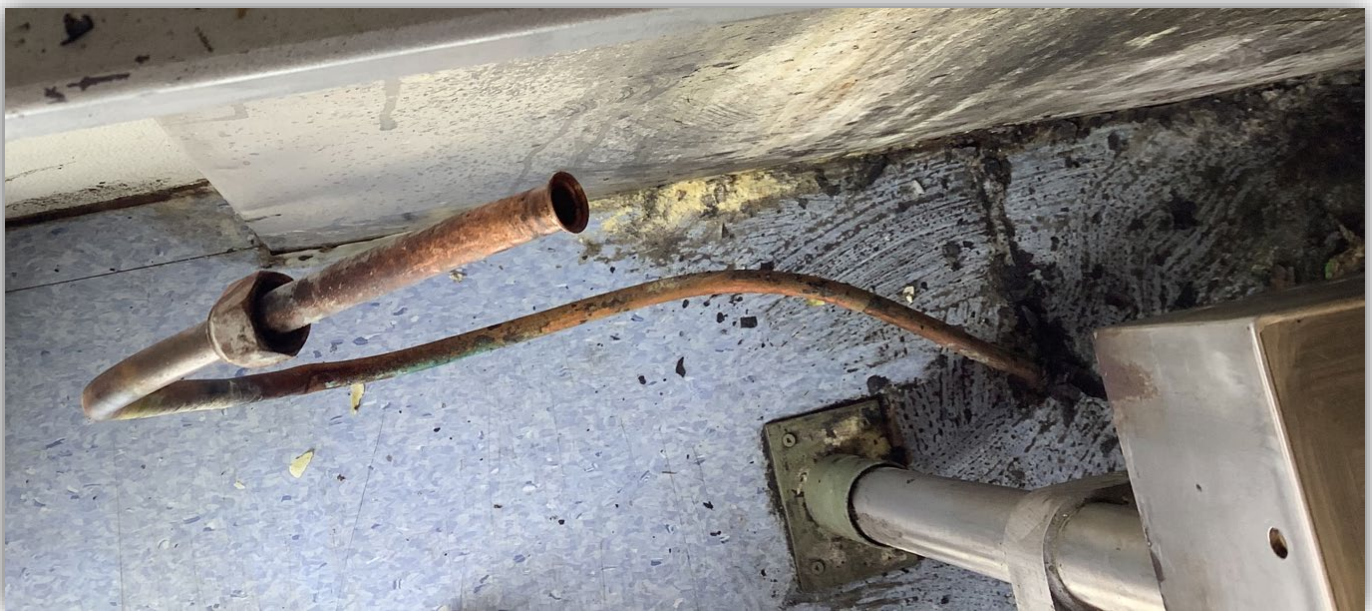
Facts and evidence	<p>Owner statements:</p> <ul style="list-style-type: none"><li>• They had removed the char-broiler and did not cap the copper gas line that went to it.</li><li>• They are not a qualified gas fitter.</li><li>• When the worker was inside attempting to light the pilot light for the deep fryer next to the open gas line, gas escaped from the open line and ignited burning the worker who was hospitalized for their injuries.</li></ul> <p>Site observations:</p> <ul style="list-style-type: none"><li>• The gas system was originally installed and approved in 2018.</li><li>• The gas lines to the appliances were distributed from a manifold and each line has its own shut off ball valve.</li><li>• A deep fryer and grill were installed in the trailer, but the char-broiler had been removed.</li><li>• A ½" copper gas line was observed in the trailer with a flared end and no cap or plug installed.</li></ul>

Causes and contributing factors	<p>The cause of the incident was very likely the release of propane gas from a gas line left uncapped after the alteration of the gas system following the removal of the char-broiler by the uncertified owner.</p>

Image 4 – Uncapped gas line previously connected to the char-broiler.

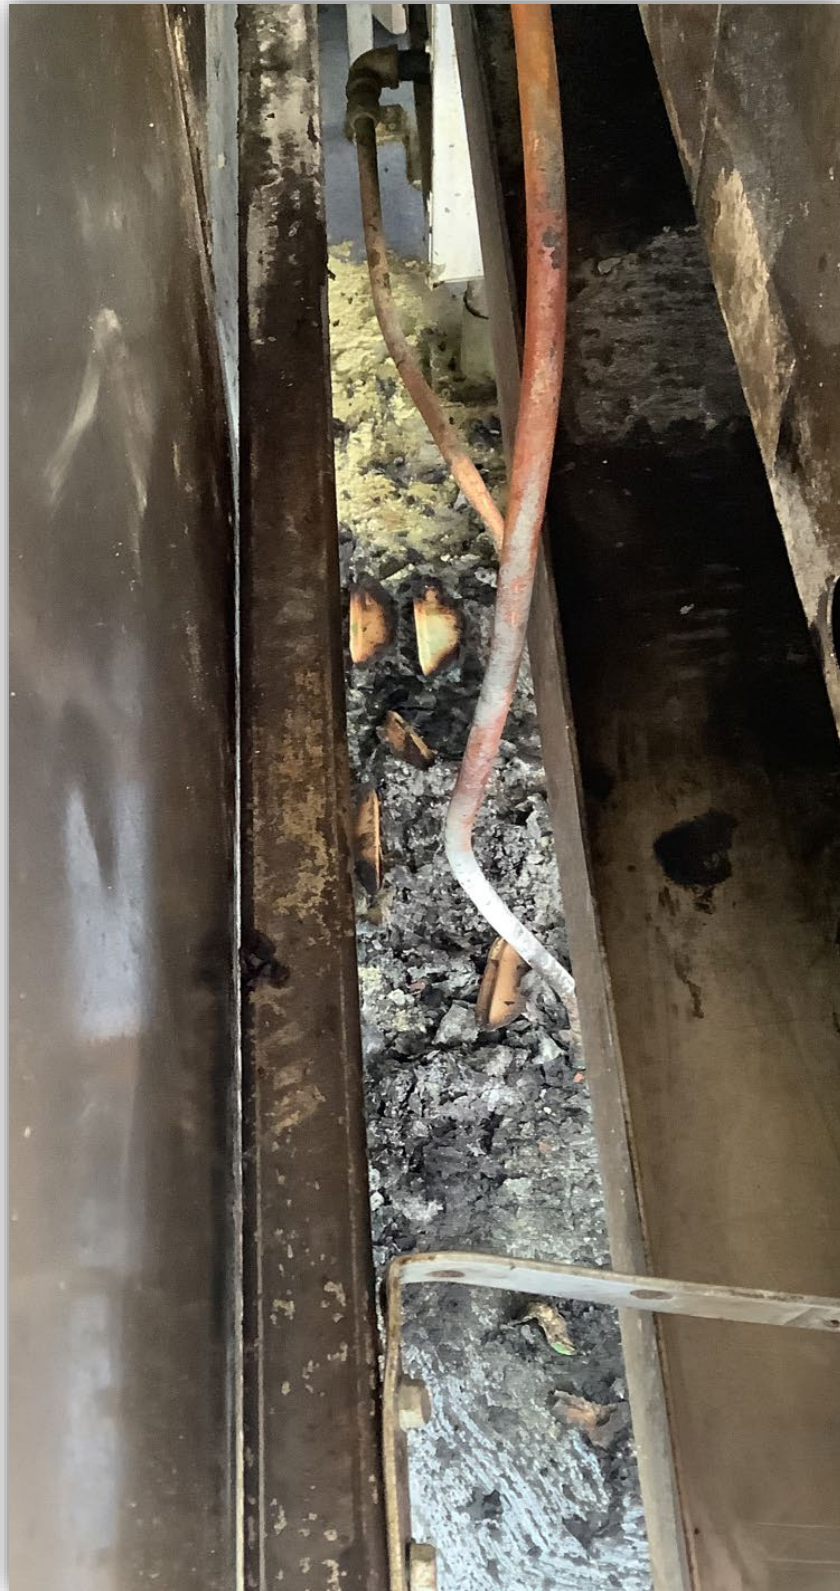
Image 5 – Fire damage behind gas appliances.
