## Incident Summary #II-1674930-2024 (#44402) (FINAL)

SUPPORTING INFORMATION	Incident Date	February 18, 2024	
	Location	Smithers	
	Regulated industry sector	Gas - Natural gas system	
	Impact	Qty injuries	1
		Injury description	An occupant returned home to find their pet deceased near the mechanical room. The occupant had been getting headaches and feeling drowsy over the past few months. A visit to the emergency room confirmed the occupant had been poisoned due to carbon monoxide (CO) exposure inside their home.
		Injury rating	Moderate
	Damage	Damage description	A clogged heat exchanger and vent restricted the flow of the flue gases to outside causing incomplete combustion and high levels of carbon monoxide spilling into occupied space of the home.
		Damage rating	Major
	Incident rating	Major	
	Incident overview	A Superhot atmospheric boiler used to heat a house was venting its products of combustion into the home. The homeowner found his pet deceased on the floor near the mechanical room and called the local authorities to check his gas system. The homeowner had been experiencing symptoms of CO poisoning for some time.

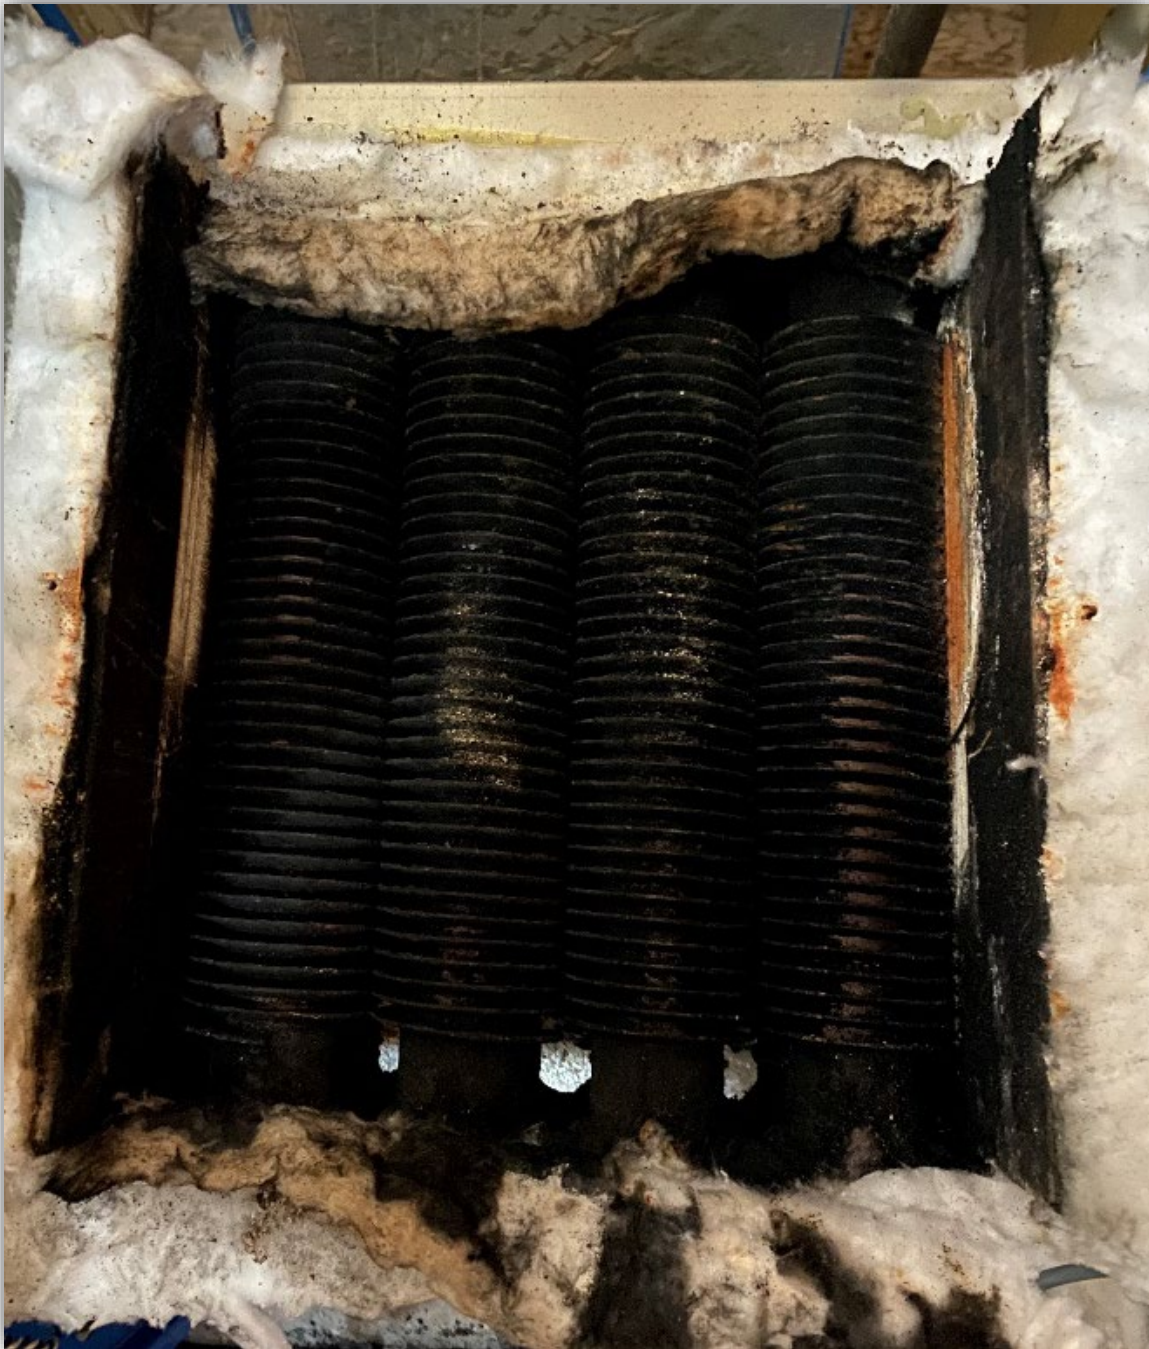
Image 1 - Soot blocking heat exchanger. The fins are covered in soot. This photo was taken after the unit failed. A gas fitter tried to clean after the fact as well.

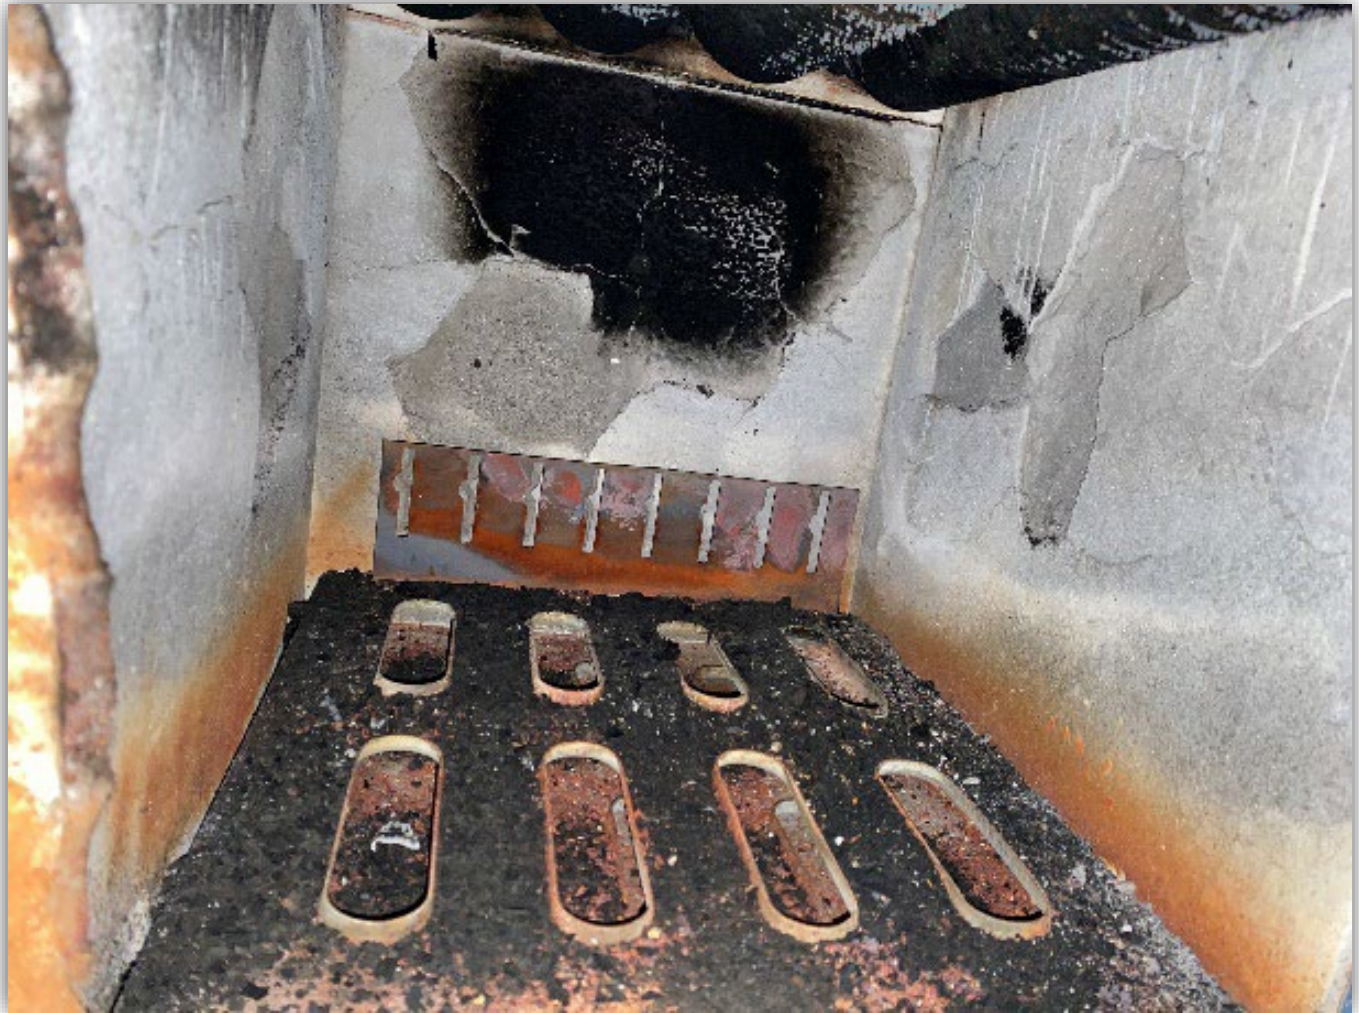
Image 2 - Burner compartment. The atmospheric burners were in this space. The soot at the rear of the burner compartment and cracking of refractory likely caused by flame impingement.

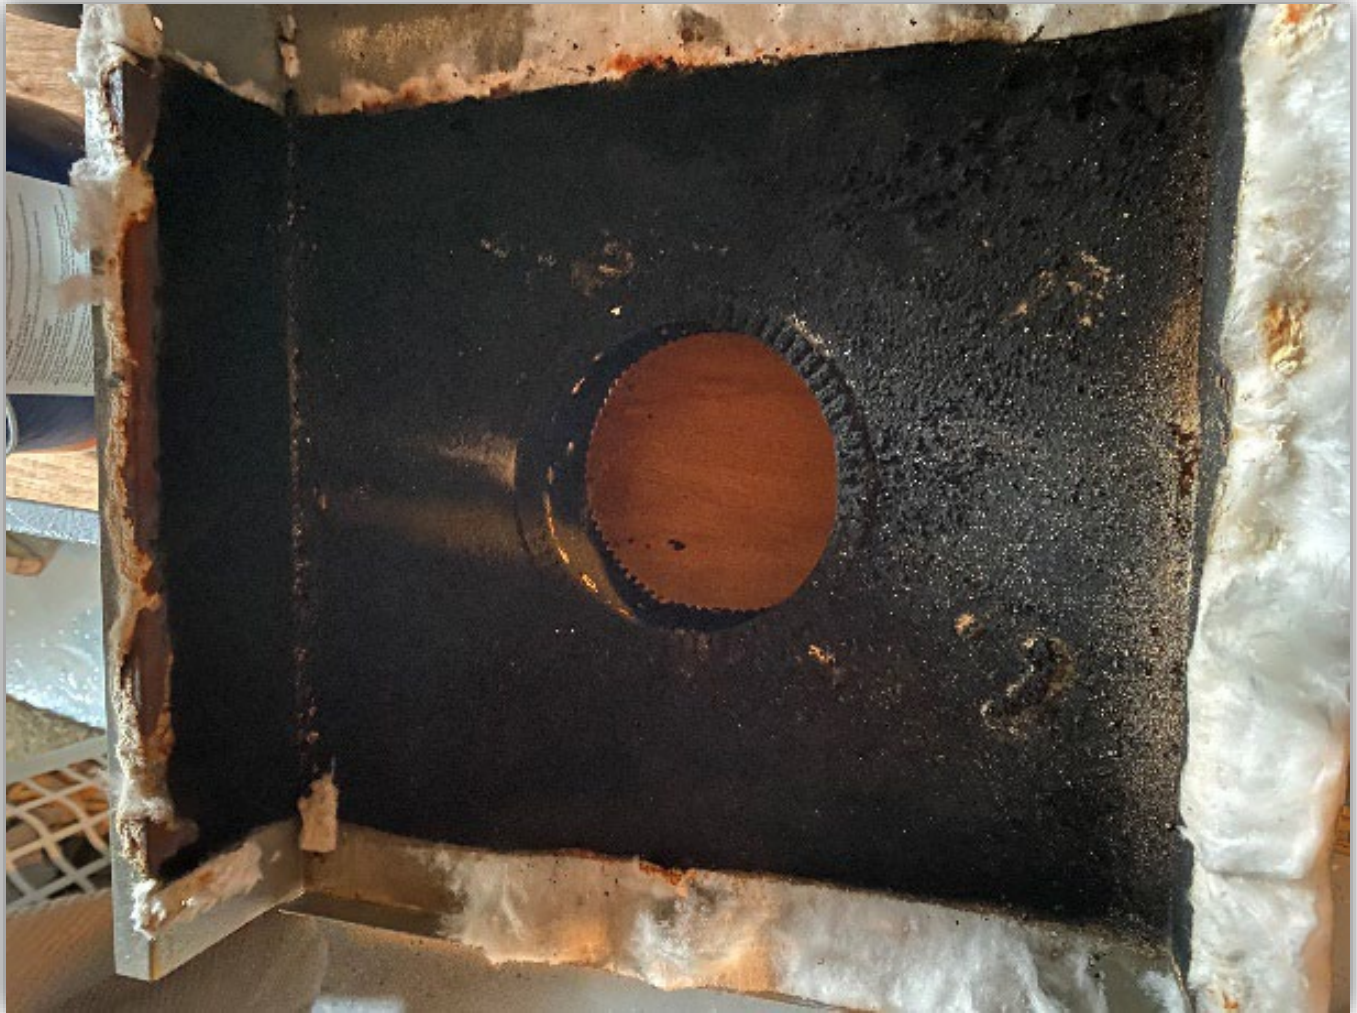
Image 3 - Top cover of the heat exchanger. This will seal in the burner compartment from the outside of the boiler and convey flue gases through the centre hole to flue.

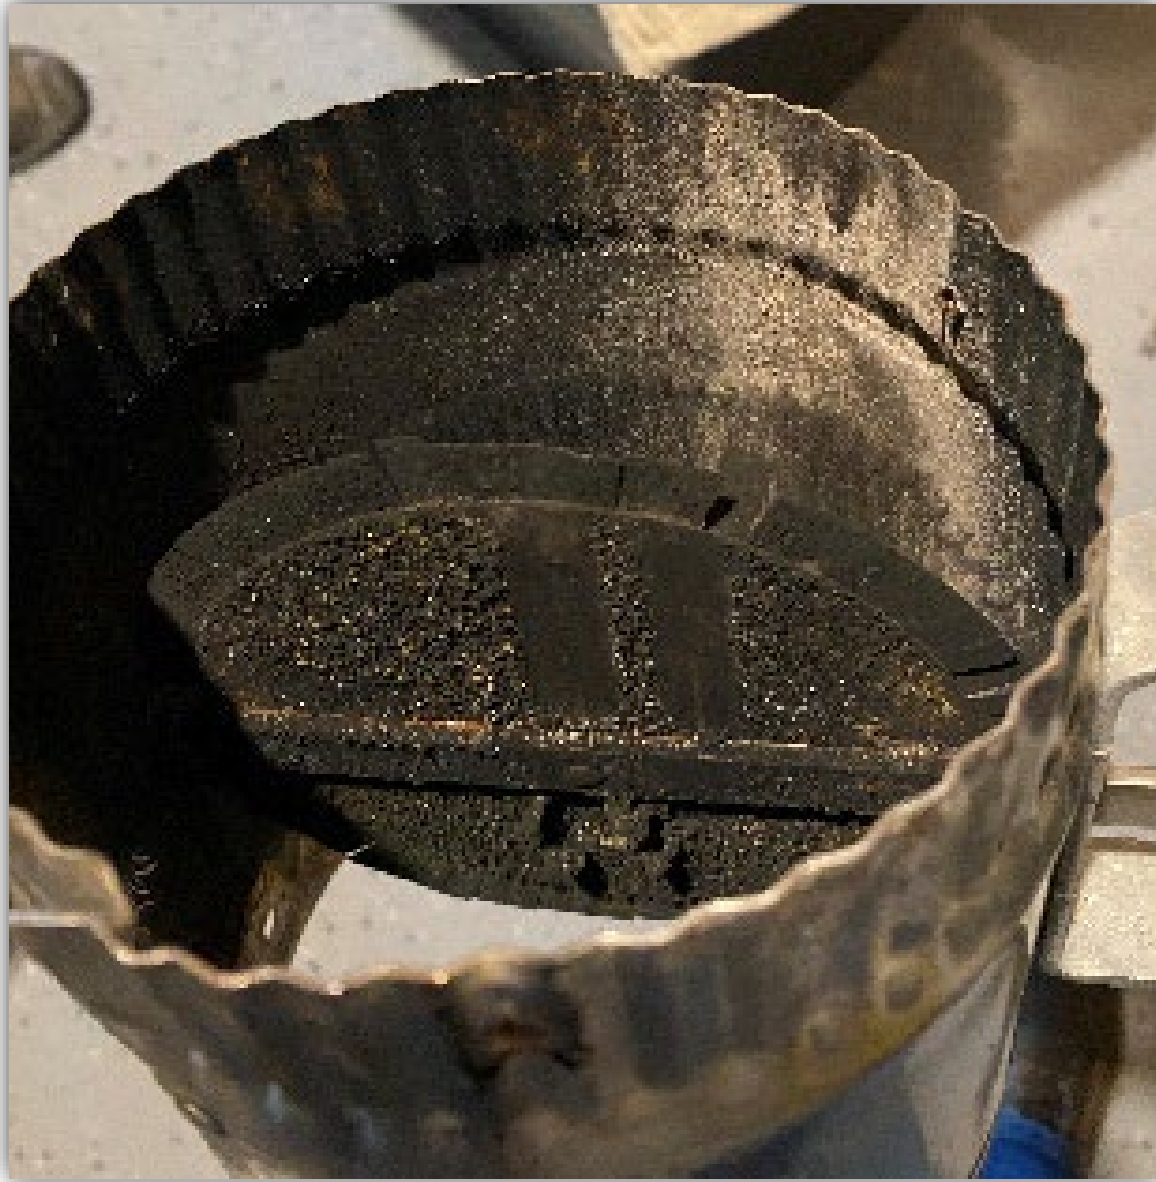
Image 4 - Soot inside flue. Soot is located through the flue to termination, this proves there was incomplete combustion during usage.
