Incident Summary (II-637636-2018)

SUPPORTING INFORMATION	Incident Date		January 11, 2018	
	Location		Mission	
	Regulated industry sector		Low voltage electrical system (30V to 750V)	
	Impact	Injury	Qty injuries	1
			Injury description	One person reported minor smoke inhalation
			Injury rating	Minor
	Damage	Damage	Damage description	2 power bars, a timer, 3 plug in light fixtures, and the basement of a house were fire and smoke damaged.
			Damage rating	Major
	Incident rating		Major	
Incident overview		The occupant of a house awoke to a “pop” sound and the smell of smoke in the early hours of the morning. He made his way from the main floor of the house to a basement room that had electric lighting being used to grow plants. He found the area on fire, observed thick smoke, and attempted to put out the fire but was unable to. He and the other occupants of the house exited the building and called 911.

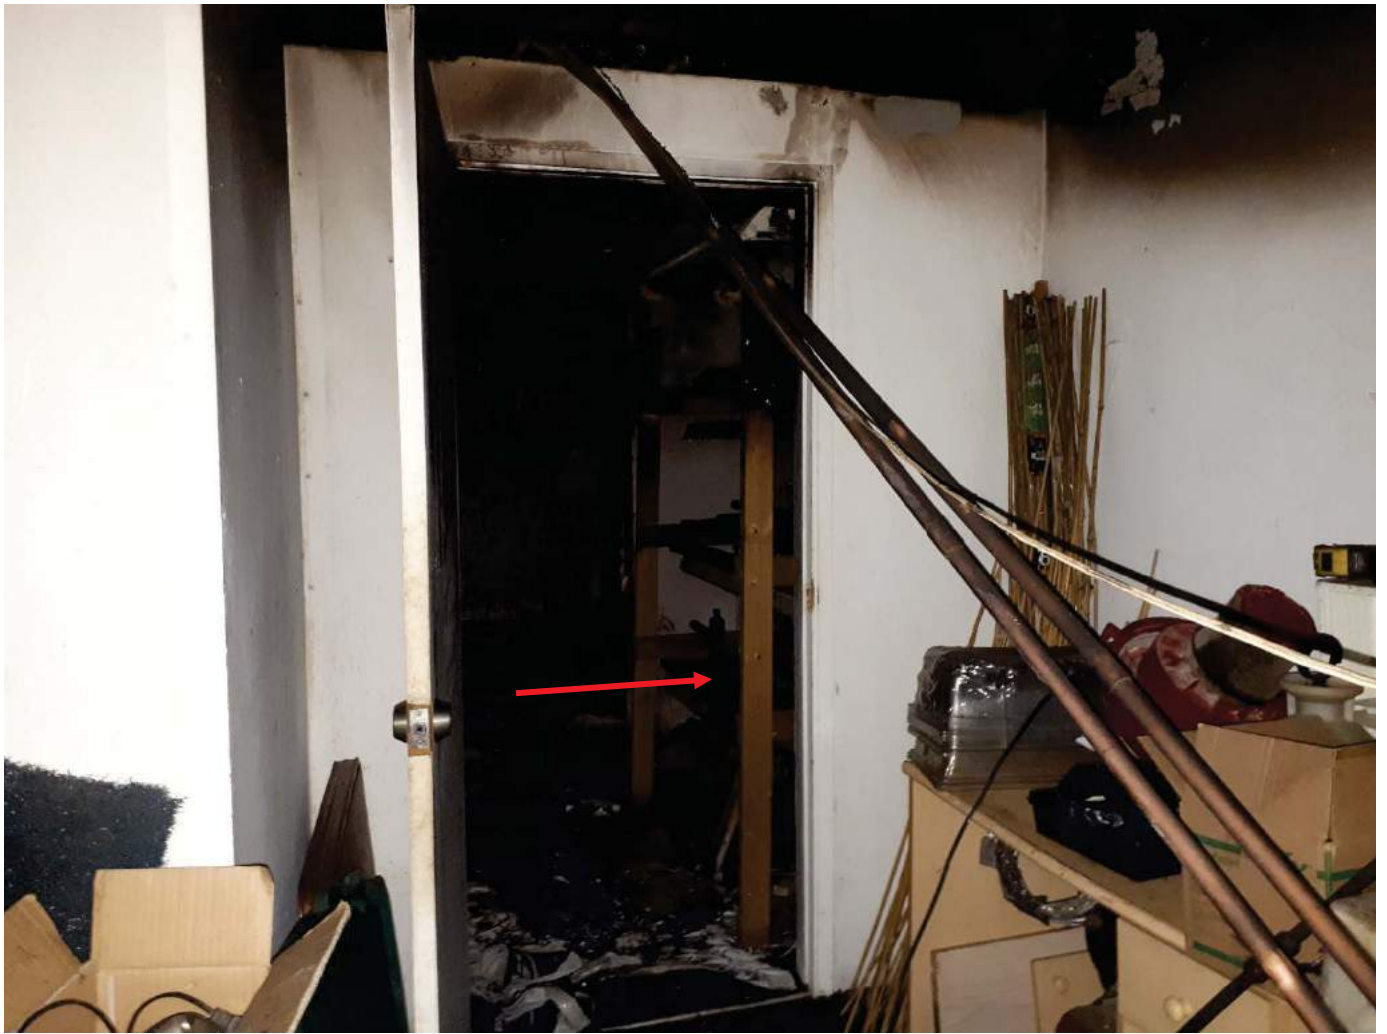
Figure 1 - Photo provided by the fire department showing the room where the fire occurred. The red arrow shows the area of origin.

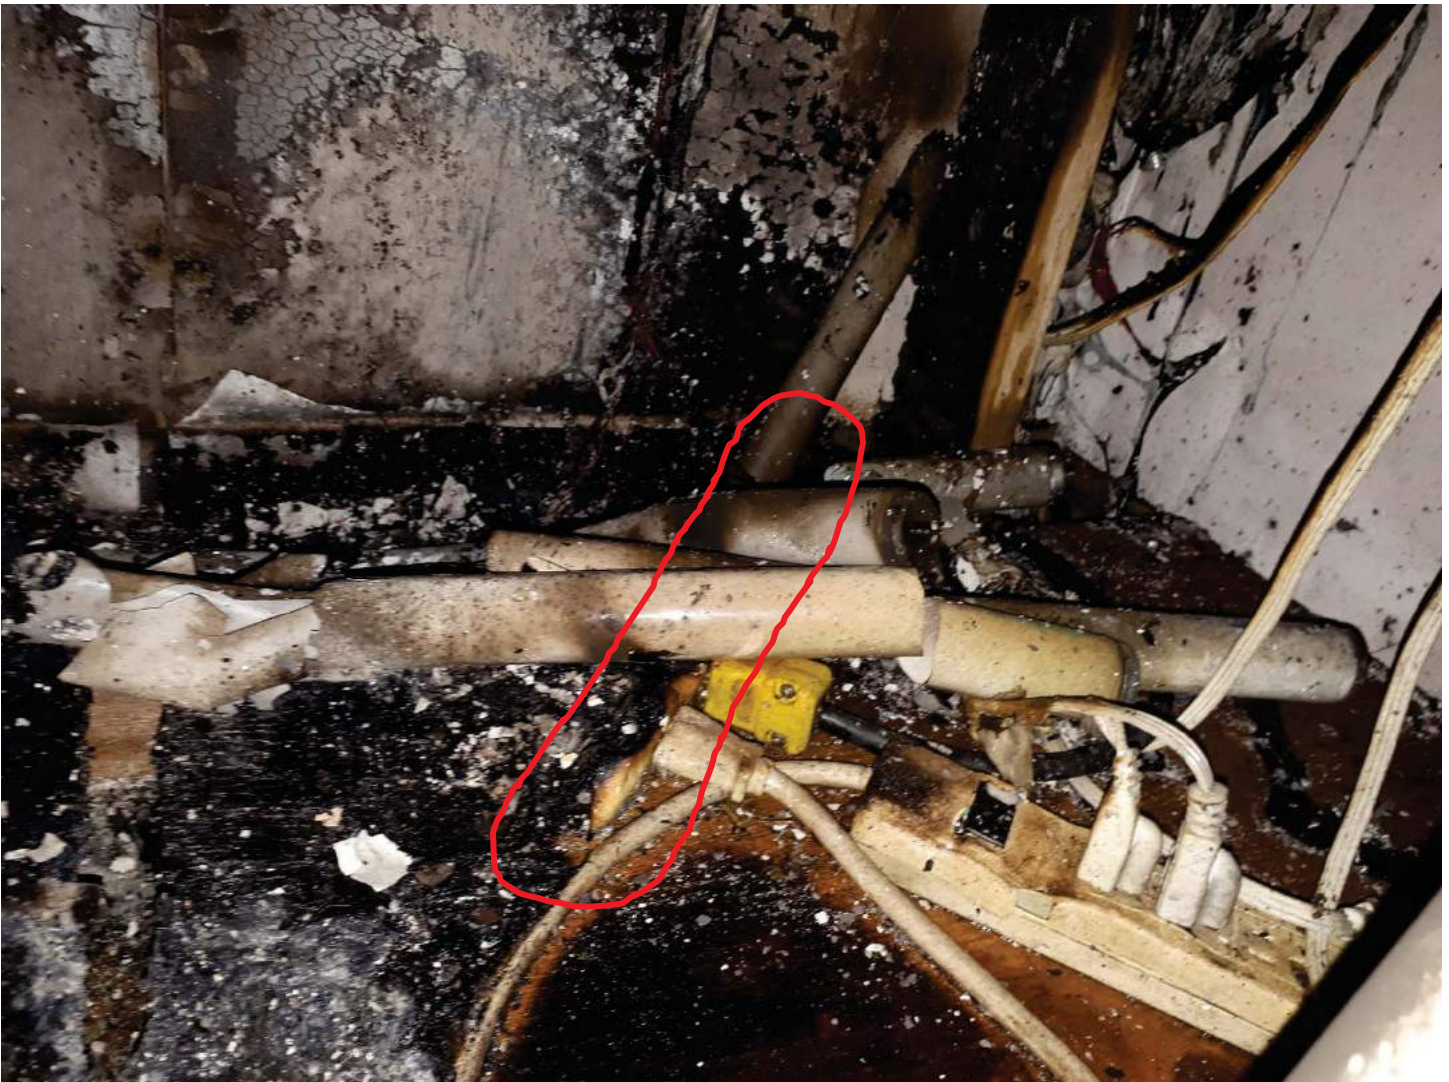
Figure 2 – Photo provided by the fire department. The red outline shows the power bar location on the plywood shelf viewed from the front of the shelf.

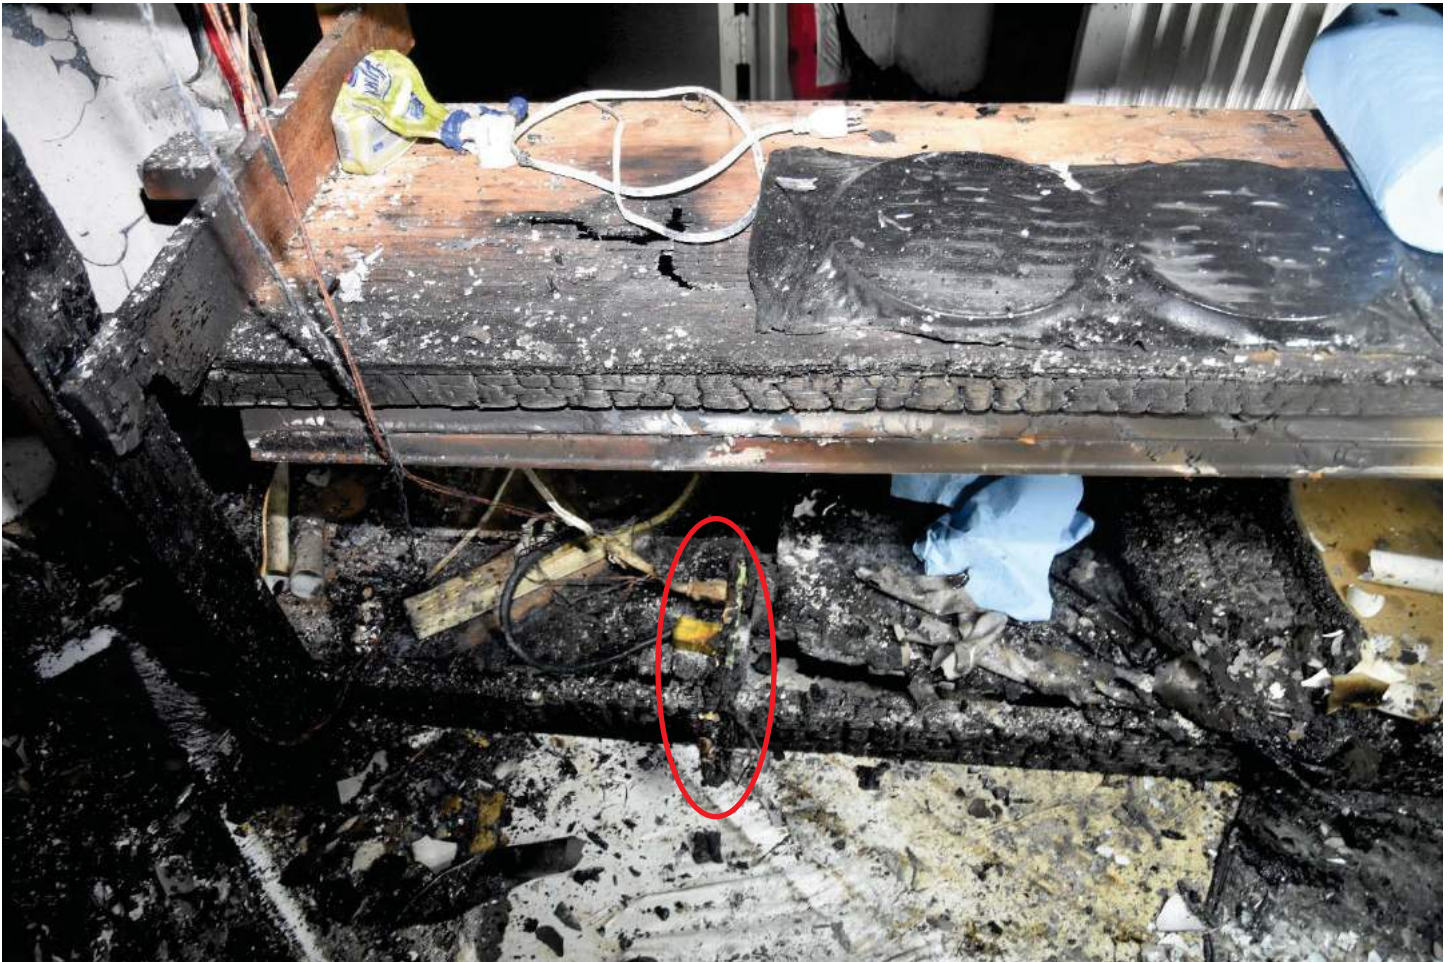
Figure 3 – Photo provided by the private fire investigator. The red outline shows the power bar location viewed from the back of the shelf (shelf pulled away from the wall). This is believed to be the area of origin.

<p>occurred that produced arcing and thermal energy in close proximity to combustible material.</p> <ul style="list-style-type: none"> - The point of origin appeared to be on the power bar and/or flexible cord near the end where the cord entered the device and where the switch was located. - Multiple power bars were in use throughout the house and growing facility. Some being used as a substitute for permanent wiring for oscillating fans, ducted ventilation fans, and other equipment related to the growing of plants. - Most exemplar power bars showed signs of external discoloration from water/moisture, what appeared to be plant resin or organic matter, and likely chemicals from fertilizers or pesticides. - Information observed on the back of an exemplar power bar that was in use at the site indicated "DO NOT PLUG INTO ANOTHER RELOCATABLE POWER TAP – USE IN DRY LOCATIONS ONLY" - The area where the power bar was being used contained plants grown in trays/containers with dirt that required hand watering, suggesting that the power bar may have been exposed to water and operating in a location that was not dry. - The adjacent room/area contained a hydroponic growing system that contained water mixed with nutrients for growing as well as potted plants growing in dirt. <p>Review of the fire scene photos provided by the fire department and private investigators:</p> <ul style="list-style-type: none"> - Fire patterns in the room and on the wooden shelving indicated that the area of origin was the bottom shelf where the power bar was located. - Other investigators did not identify other ignition sources in the area of origin.

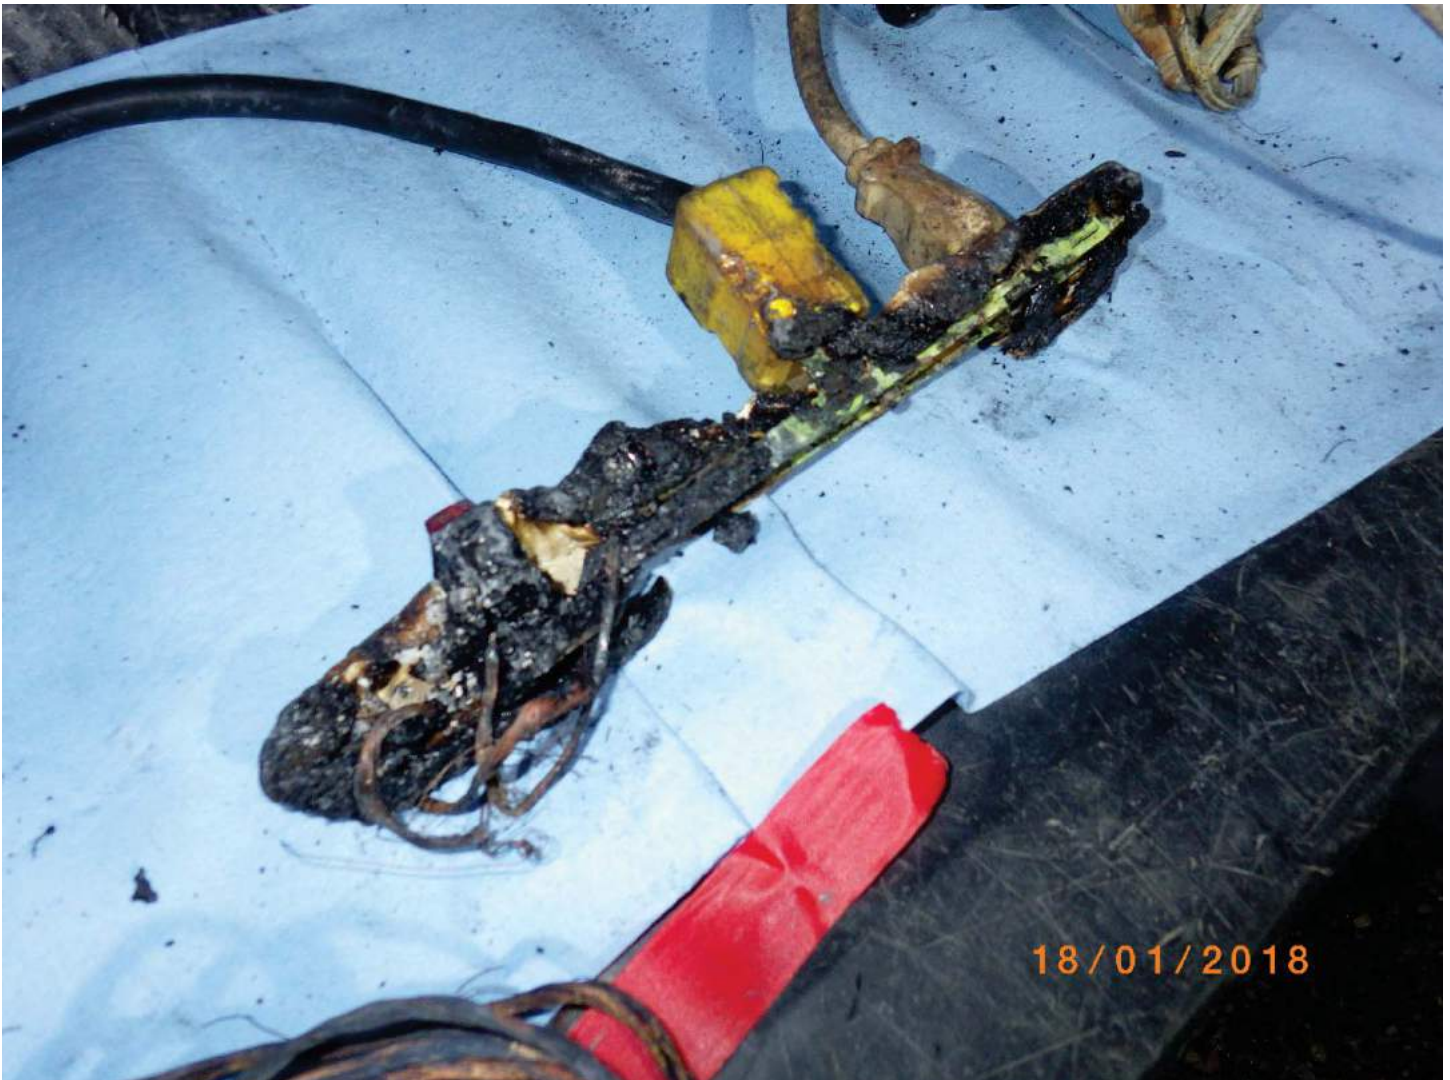
Figure 5 – This photo shows the fire damaged power bar near the end where the flexible cord entered the device and where the switch is located.

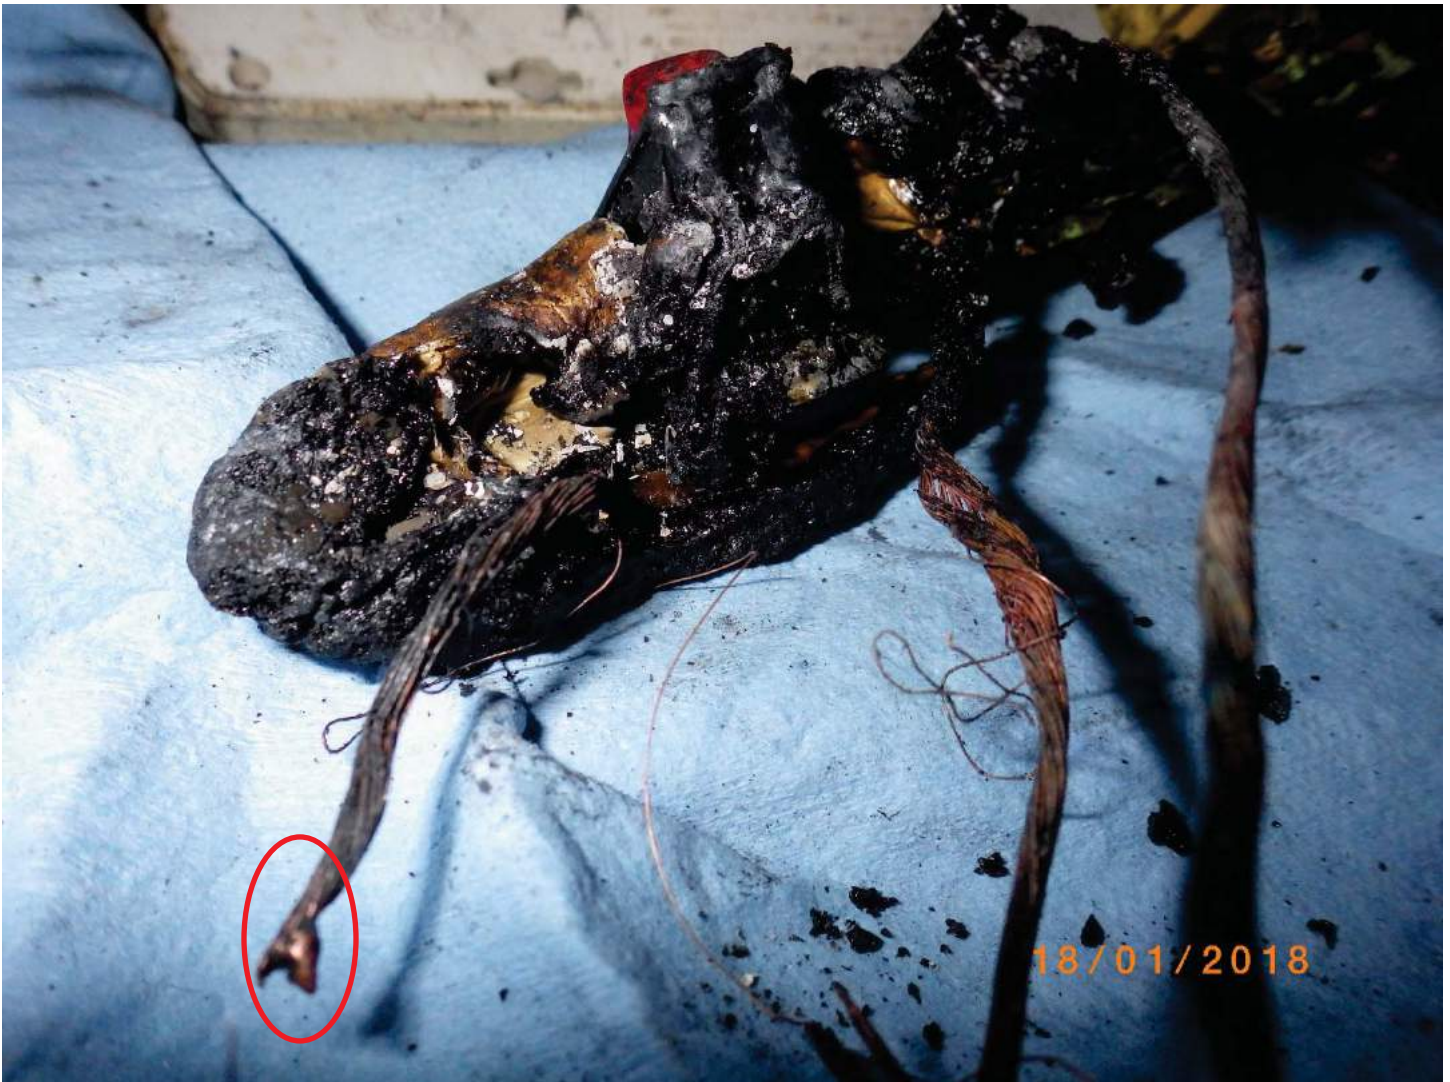
Figure 6 – This photo shows the end of the power bar where the flexible cord enters the device and where the switch is located. It is believed that this area of the power bar is the point of origin based on the damage to the power bar in this location and the corresponding fire damage to the shelving structure. The red oval shows arcing/melting on the flexible cord conductor, indicating that this power bar was energized at the time of the incident.

<p>A 15A 120V timer was plugged into a 15A 120V duplex receptacle located on the wall. A 15A 120V power bar was plugged into the timer, and another 15A 120V power bar was plugged into the first power bar. Three florescent light fixtures were plugged into the power bars.</p> <p>Use of the power bar in this incorrect configuration over an extended period of time combined with use in an environment where it was repeatedly subject to water/moisture, plant resin/organic matter, and chemicals caused the power bar to fail.</p> <p>The occupant of the house heard a “pop” and smelled smoke.</p> <p>A fire originated at one of the power bars damaging the power bars, light fixtures and basement area.</p>
Facts and evidence	<p>Interview with occupant of the house that called 911:</p> <ul style="list-style-type: none"> - He awoke at 04:45 to a loud “Pop” sound and smelled smoke. - He went to the basement to check the source of the sound/smell and discovered the fire on the shelving unit. - He turned the main breaker off, tried to put the fire out, then got the other occupants out and called 911. - He was taken to hospital for smoke inhalation and later released. - An electrical contractor upgraded the service to the house from 100A to 200A in 2014 to facilitate the growing facility. - The equipment involved in the incident had been in use since the upgrade. <p>Interview with the fire department investigator:</p> <ul style="list-style-type: none"> - The house was being used as a growing facility. - The fire originated in a room in the basement being used to grow small plants. - Fire patterns indicated the area of origin appeared to be the bottom shelf of a wooden shelving unit used to support light fixtures and plants. - The point of origin appeared to be a power bar used to plug the lights into. - No other ignition sources were observed in the area of origin. <p>Interview with private investigators:</p> <ul style="list-style-type: none"> - Wooden shelving had growing lights and power bars located on them. - A power bar was plugged into a timer, had another power bar plugged into it (not approved for this use), and light fixtures were plugged into both power bars. - Fire patterns indicated the point of origin was a power bar located on the bottom shelf of a wooden shelving unit used for plugging in lighting fixtures to grow small plants. - The point of origin appeared to be the end of the power bar where the cord entered the device and where the switch was located. - No other ignition sources were observed in the area of origin. <p>On site observation of the timer and power bars:</p> <ul style="list-style-type: none"> - The first power bar was extensively fire damaged on the end where the cord entered the device, where the switch was located, and on the side of the power bar. - The power bar cord was destroyed by the fire and the conductors had evidence of electrical arcing. This indicated the power bar was energized at the time of the incident and also indicates an electrical fault may have

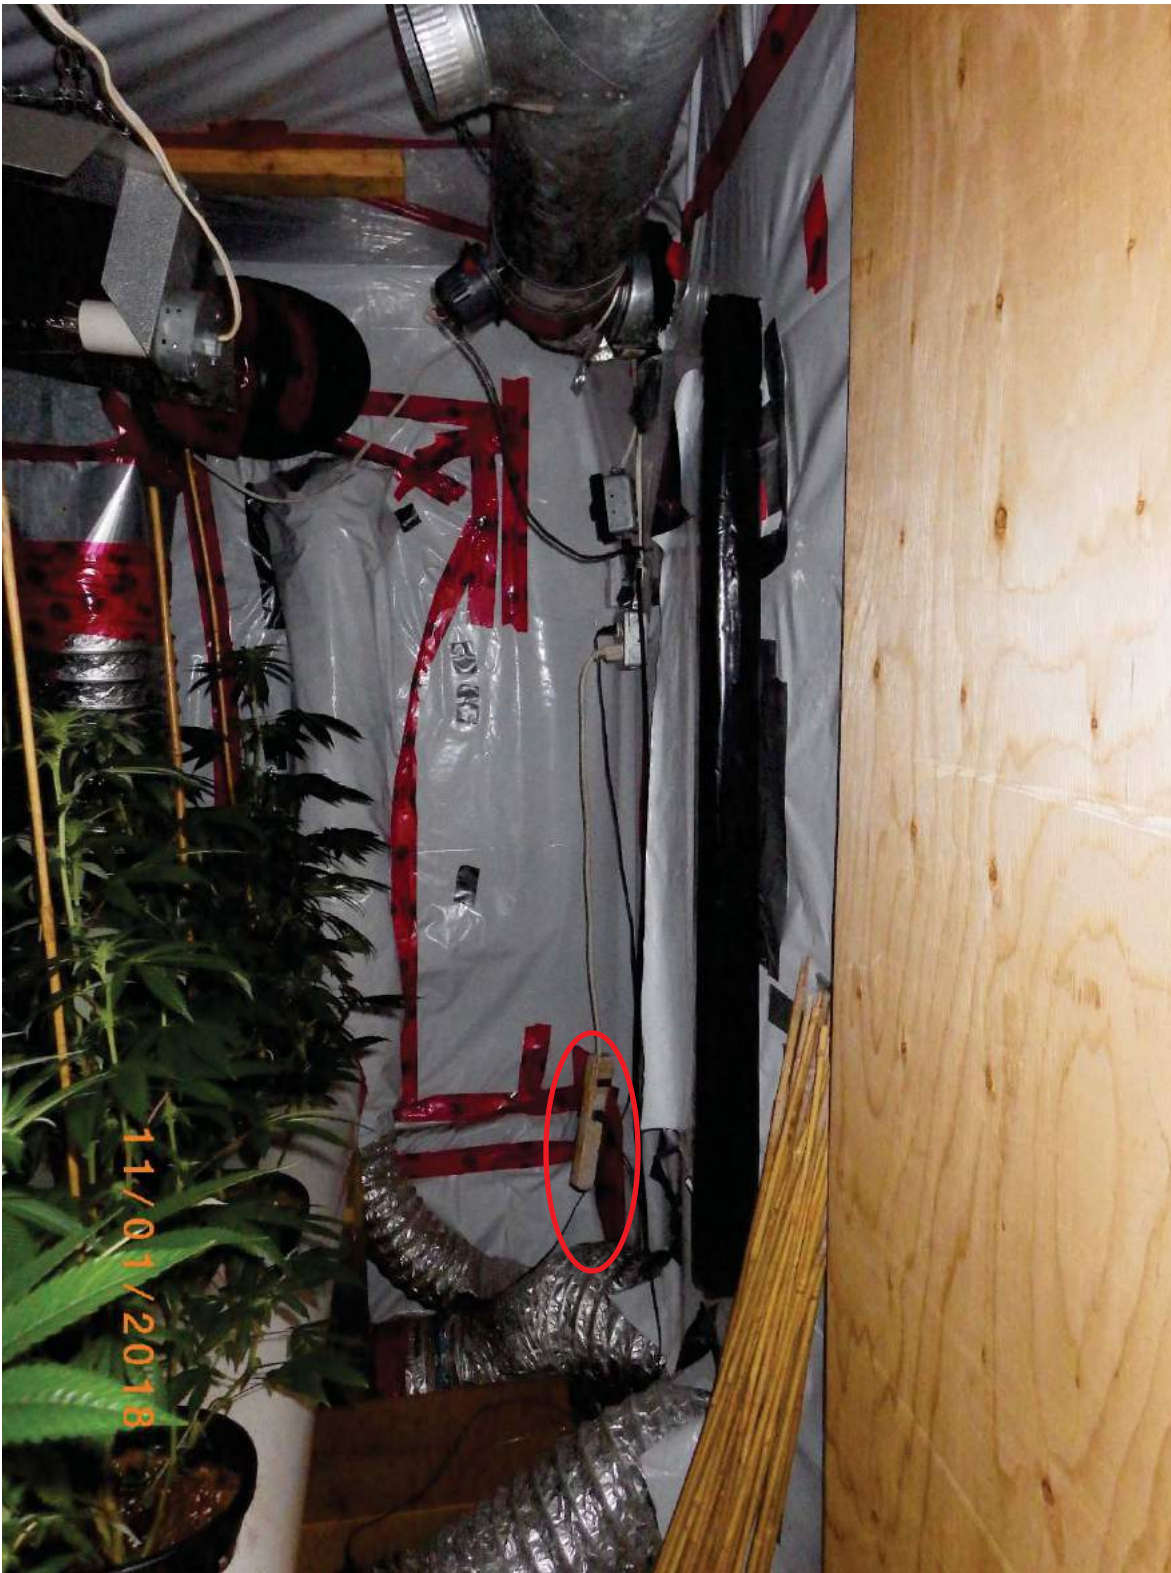
Figure 7 – This photo shows an exemplar power bar used in the basement area. See red oval.

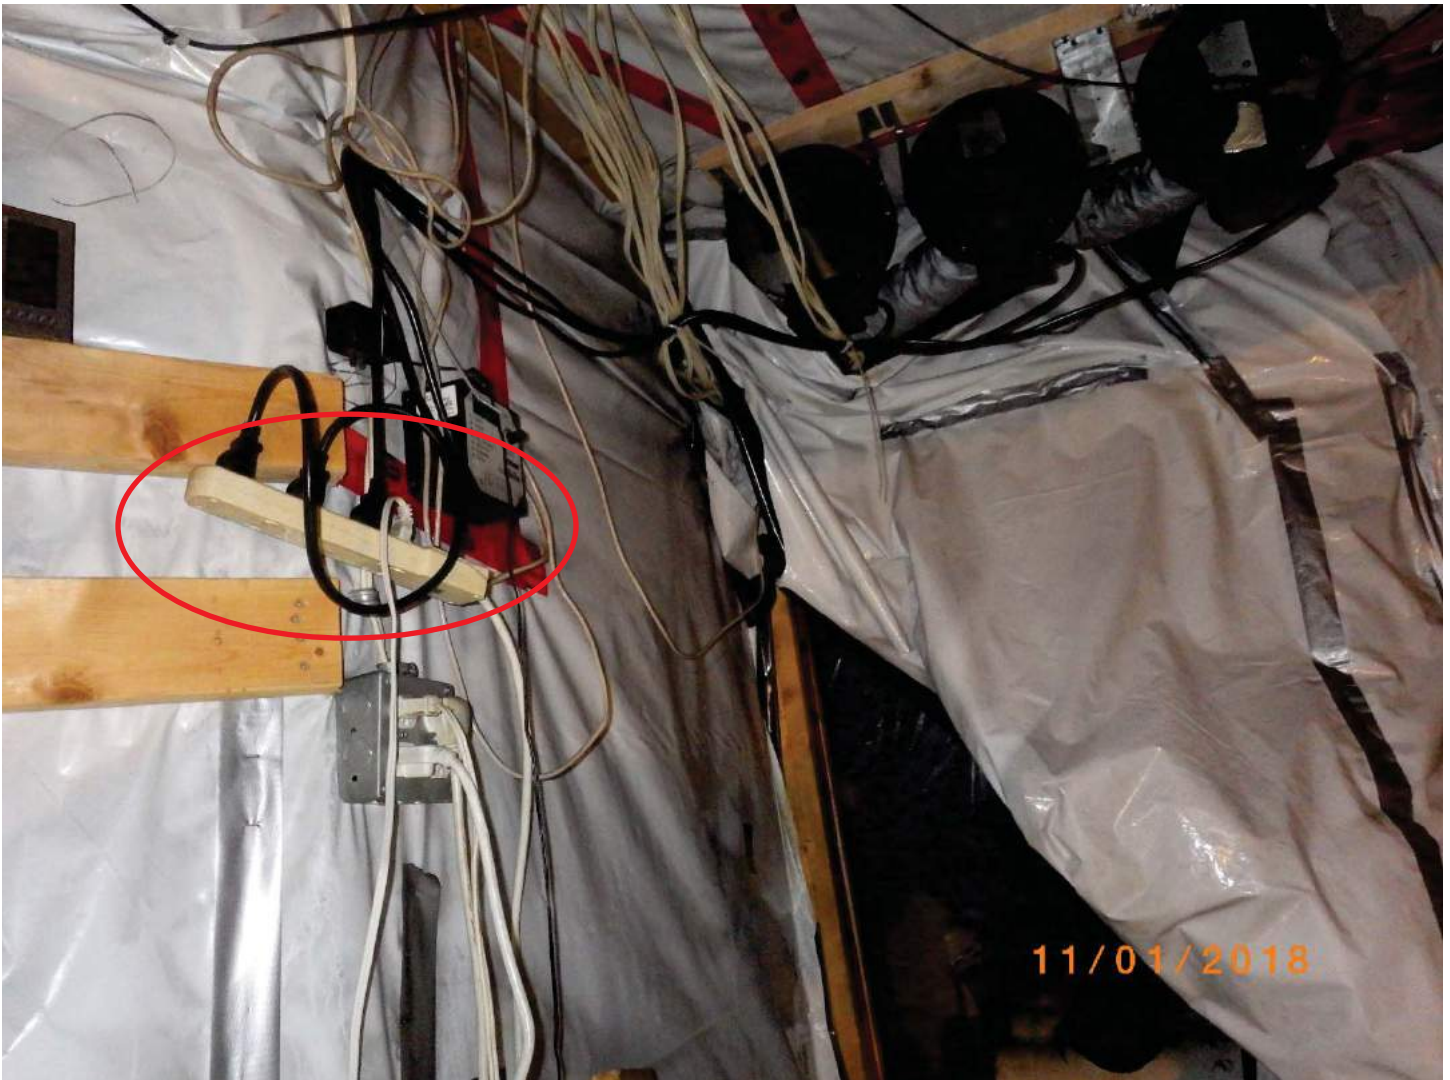
Figure 8 – This photo shows an exemplar power bar (red oval) used in another part of the basement area. Both figures 7 and 8 show that the power bars were similarly used throughout the basement. These configurations and use are similar to the configuration at the point of origin.

<p>Causes and contributing factors</p>	<p>The cause of the fire was likely due to the use of the power bar in an incorrect configuration and in a location subject to water/moisture, plant resin/organic material, and chemicals.</p> <p>The power bars were not approved to be plugged into other power bars or have other power bars plugged into them.</p> <p>The power bars were only approved for use in dry locations.</p> <p>It's probable that internal electrical components of the power bar corroded or faulted resulting in arcing or a high resistance connection and the release of thermal energy which ignited the fire.</p> <p>Using power bars in this type of environment over an extended period of time as a substitute for fixed wiring and receptacles likely contributed to the failure.</p>

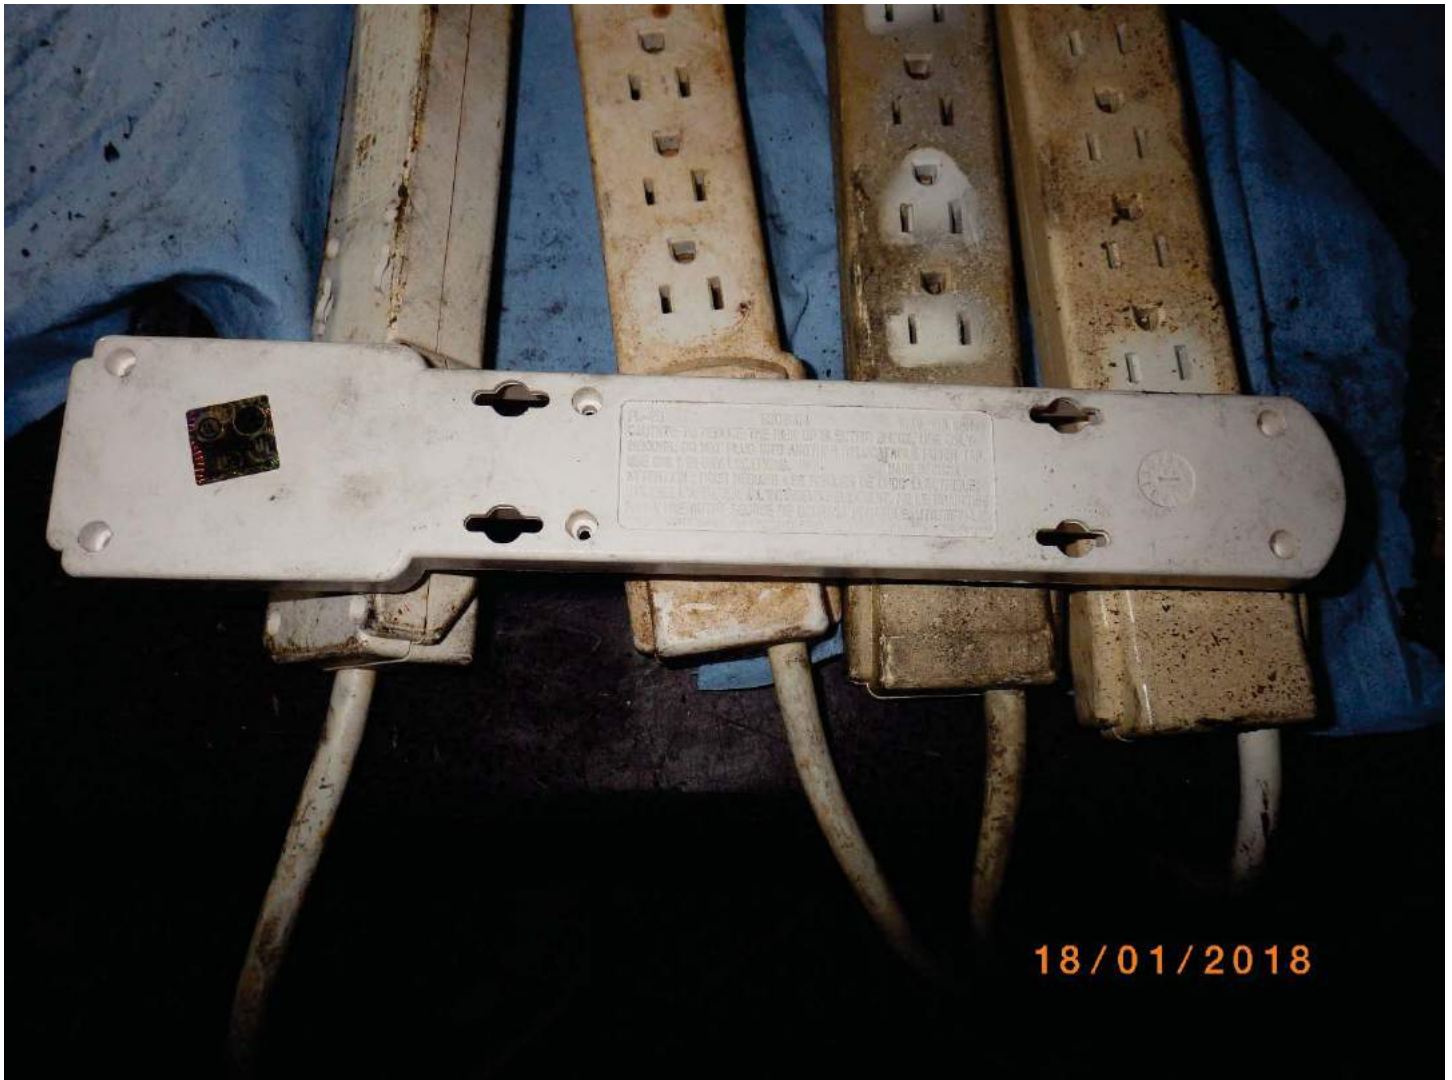
Figure 9 – This photo shows several more exemplar power bars used in the basement growing areas. Note the discolored plastic indicating the wet/humid environment, combined with what appeared to be plant resin or organic matter, and the use of chemical fertilizers and/or pesticides was not ideal for use of this type of equipment that is intended and approved only for use in a dry environment. These conditions will likely cause corrosion and damage to internal electrical components and contacts inside the power bar.

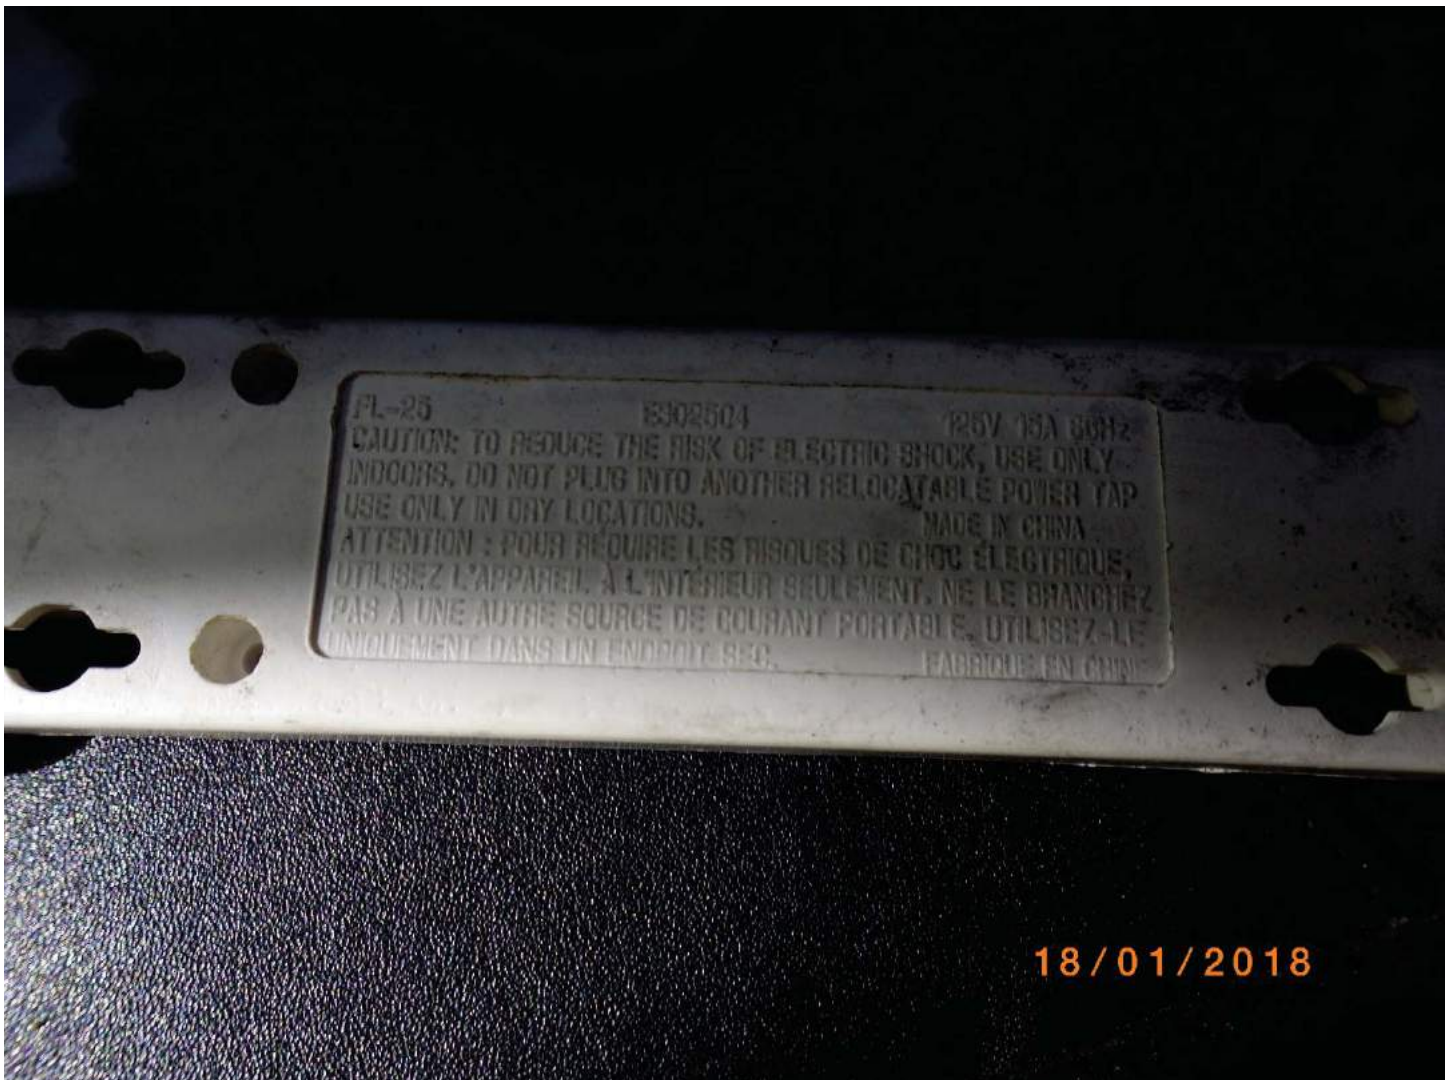
Figure 10 – This photo shows the warning on the back of the power bar indicating “DO NOT PLUG INTO ANOTHER RELOCATABLE POWER TAP. USE ONLY IN DRY LOCATIONS”.
