# Appendix I – Engineering analysis by Laporte Engineering Ltd

**TECHNICAL SAFETY BC**

**ARCTIC GLACIER - KAMLOOPS**

**ENGINEERING ANALYSIS**

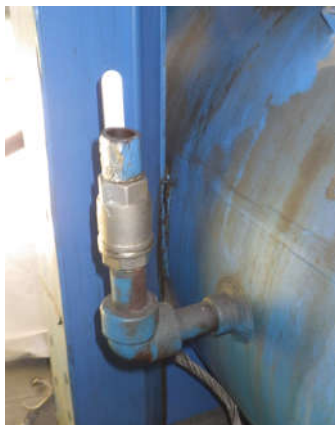
The source of the ammonia release was a 1" valve located on the HPR, shown below in Figure 1. This nozzle connection to the vessel was for the high-pressure liquid supply piping. Prior to being cut, this piping would have been connected, through control valves and a surge drum, to the evaporator.

Figure 1: The 1" valve on the P34 HPR that was the source of the release

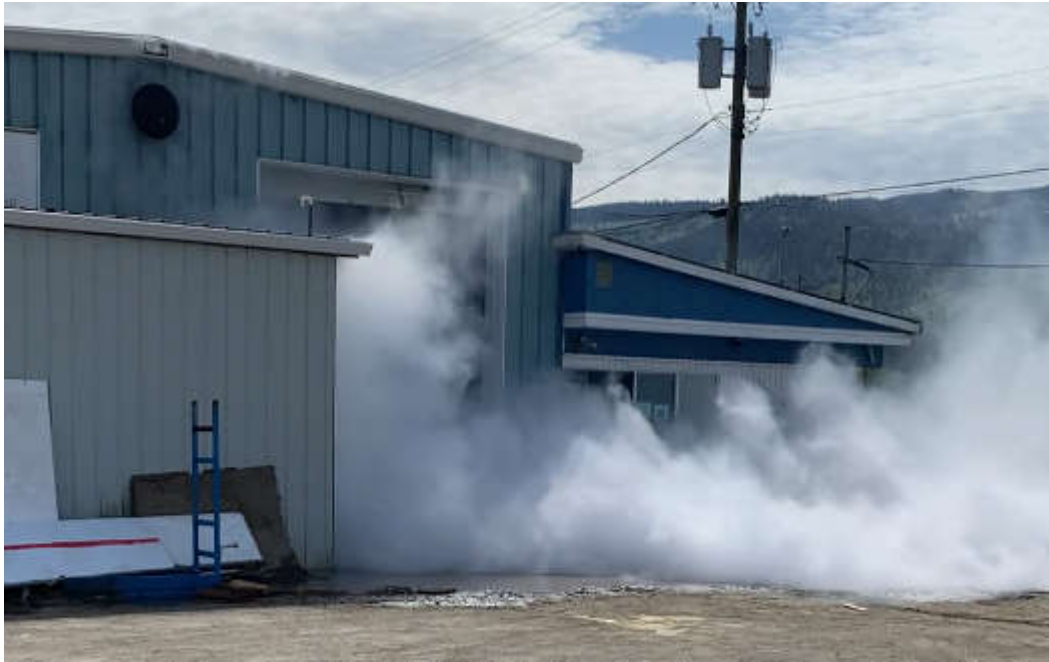
Video surveillance of the ammonia release shows a large volume of ammonia exiting the overhead door in a mist or dense vapour cloud as shown in Figure 5. This type of cloud is indicative of a flashing liquid release where pressurized saturated liquid ammonia is released and the sudden drop in pressure causes a portion of the refrigerant to boil (flash). The boiling refrigerant cools the remaining liquid refrigerant in the air and the cloud persists until the ammonia is warmed and the remaining liquid molecules evaporate.

Figure 5: Ammonia cloud indicating a flashing liquid release.

While the video footage does not show the leak directly, it is possible to estimate the amount of time liquid was released by observing the change in the ammonia cloud that is visible moving through an overhead door in the video footage. Approximately 9-10 minutes after the workers evacuated the area, the ammonia stops “pouring” out of the door; while the ammonia continues to visibly move through the door, the density and quantity appear lower.

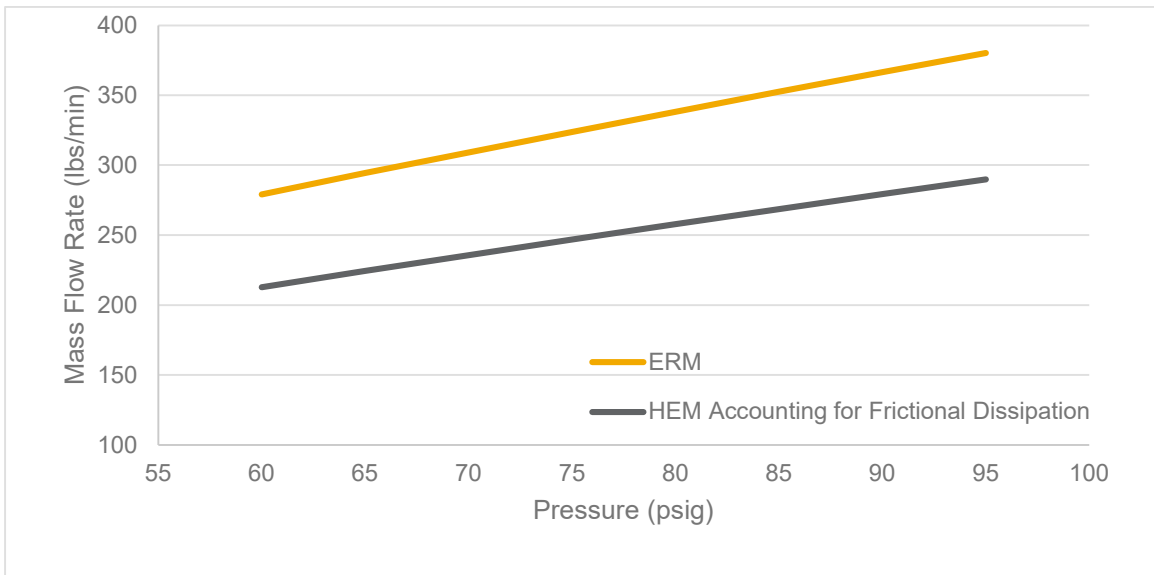
The overnight low ambient temperature in Kamloops on the day of the incident was approximately 9°C and the temperature at the time of the incident was approximately 16°C. Since the room was likely close to ambient temperature, the pressure in the HPR would have likely been between 71 psig and 95 psig when the release occurred. The estimated initial mass flow rate was calculated under these conditions and is shown graphically in Figure 7 below for both the ERM method and the HEM method accounting for frictional dissipation. The pressure in the vessel would decrease as the release occurred by a factor that corresponds to a balance between the change in mass, the change in internal energy of the refrigerant in the vessel, and the enthalpy of the leaving refrigerant. This calculation was performed assuming that there was no heat transfer between the vessel and the ambient air, the results in Table 3 take into account the resulting pressure decrease averaged over the leak event.

Figure 7: The results of the ammonia leak rate through the open valve using the ERM method with a correction for outlet piping pressure drop.

Using the maximum safe refrigerant inventory in the vessel of 1,645 lbs and the minimum duration of the release of 9 minutes, the maximum estimated release rate is 182 lbs/min. Considering the minimum refrigerant inventory and maximum release duration of 10 minutes, the minimum estimated release rate is 130 lbs/min. A comparison of the mass flow rate ranges modeled using the video footage and ammonia inventory compared to the release rate based on the Fauske model is shown in Table 3 below.

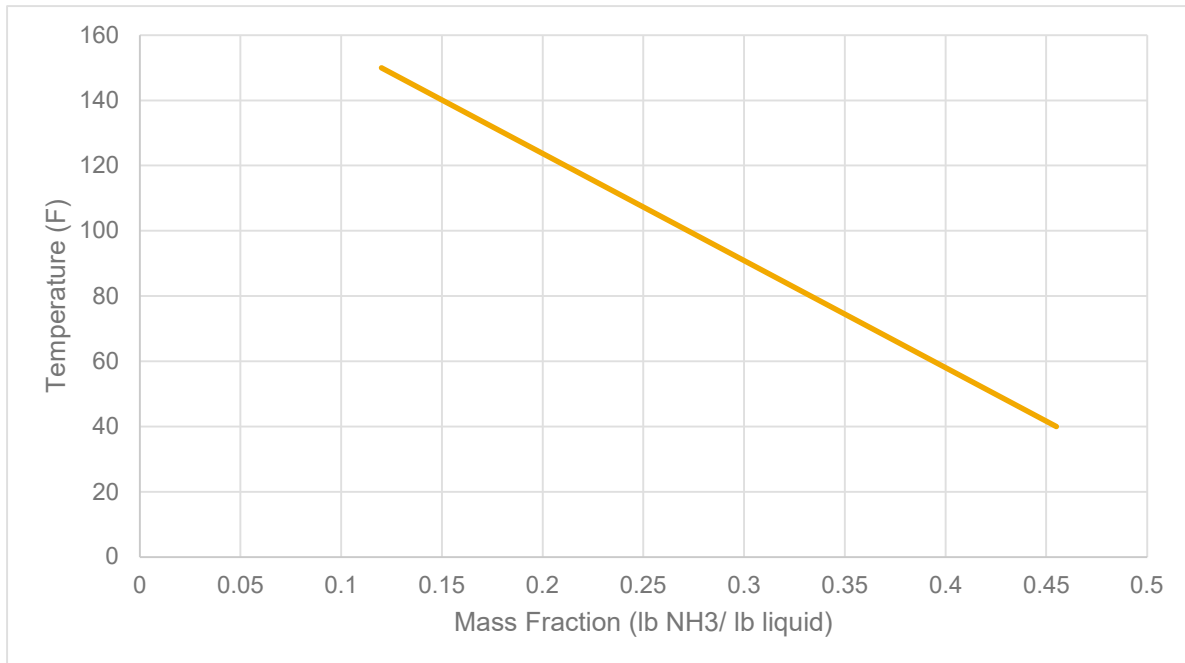
Ammonia vapour is soluble in water and when ammonia vapour is released into water, the ammonia molecules bond with the water molecules using a hydrogen bond. The amount of ammonia that can be absorbed into the water is strongly dependent on the temperature of the water. Figure 9 shows the mass fraction of ammonia that can dissolve in an aqueous ammonia solution at different temperatures.

Figure 8: The mass fraction of ammonia in fully saturated water solution at different temperatures and atmospheric pressure (Kim & Herold, 2001).

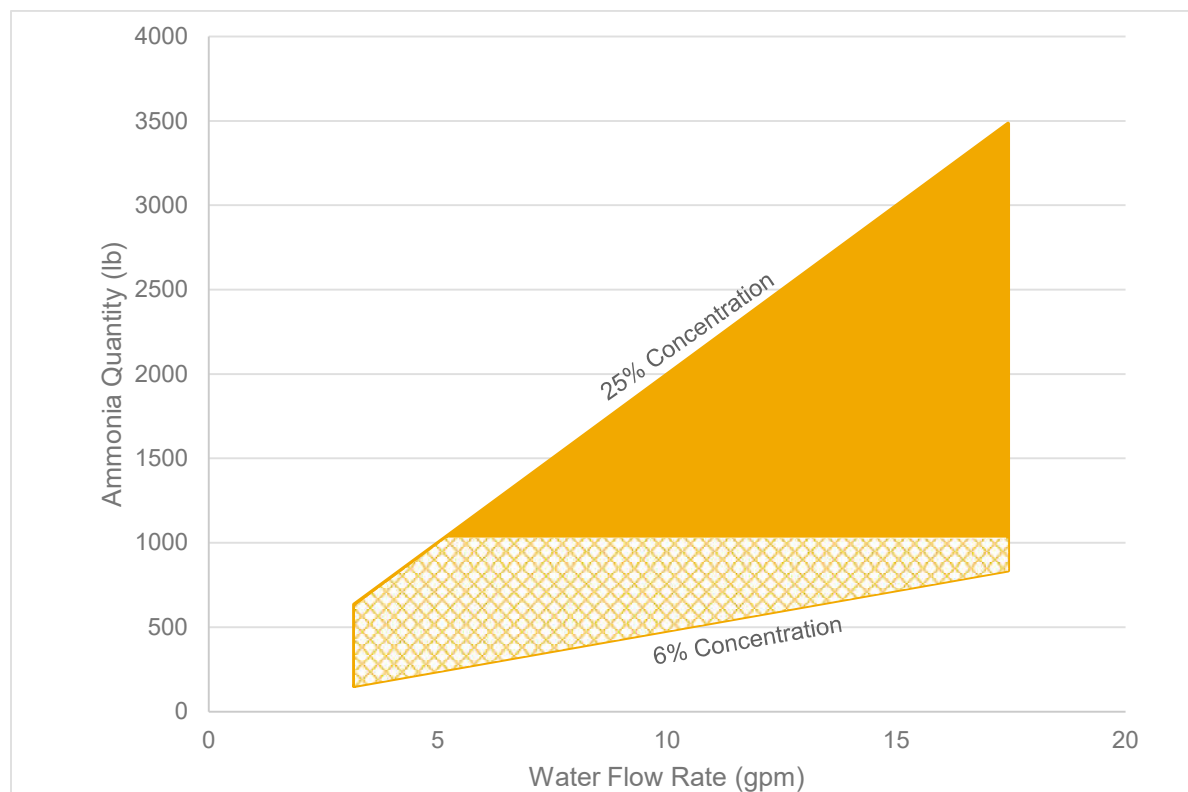
Based on the range of possible water flow rate, ammonia concentration, and the assumptions above, the quantity of ammonia that was vented may have ranged from 150 lbs to 3,492 lbs. However, at 90% full, the receiver could have only contained 1,044 lbs which limits the maximum quantity of ammonia that was vented. Figure 10 shows a graphical representation of these results.

Figure 10: The possible amount of ammonia vented from P24 during the demolition. The hatched area indicates the range of possibilities, and the solid area indicated those possible based on the model but not possible based on the physical size of the receiver.

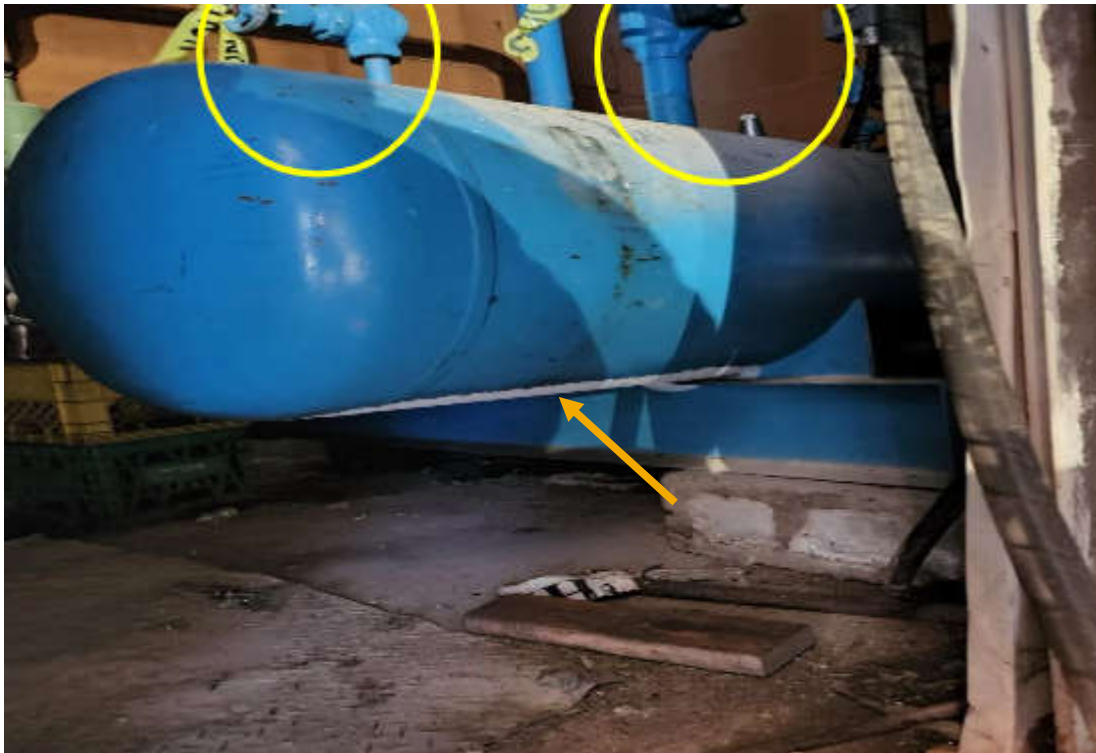
Following the liquid ammonia venting into the tote, the residual vapour ammonia was vented. When vapour is vented, the remaining refrigerant in the system is cooled and it is typical for frost to form where any remaining liquid is present in the system. In this case, a frost line formed on the bottom of the receiver, as shown in Figure 13, indicating that there was still a small amount of ammonia remaining. Based on rough measurements from the photos, there was approximately 25 lb of ammonia remaining in the bottom of the P24 receiver after the liquid was vented.

Figure 12: P24 receiver frost line after purging

A pressure gauge connected to the receiver prior to removing ammonia post-incident indicated that the pressure was 50 psig (Nicol, 2022). Because of the ambient air temperature, this pressure is not possible if the contents of the vessel were entirely anhydrous ammonia; the presence of water or oil in the ammonia tank would cause the overall pressure to be lower. Assuming the temperature of the ammonia was between 50°F to 60°F, this pressure corresponds to an ammonia mass fraction of 60-65% remaining in the vessel post-incident.

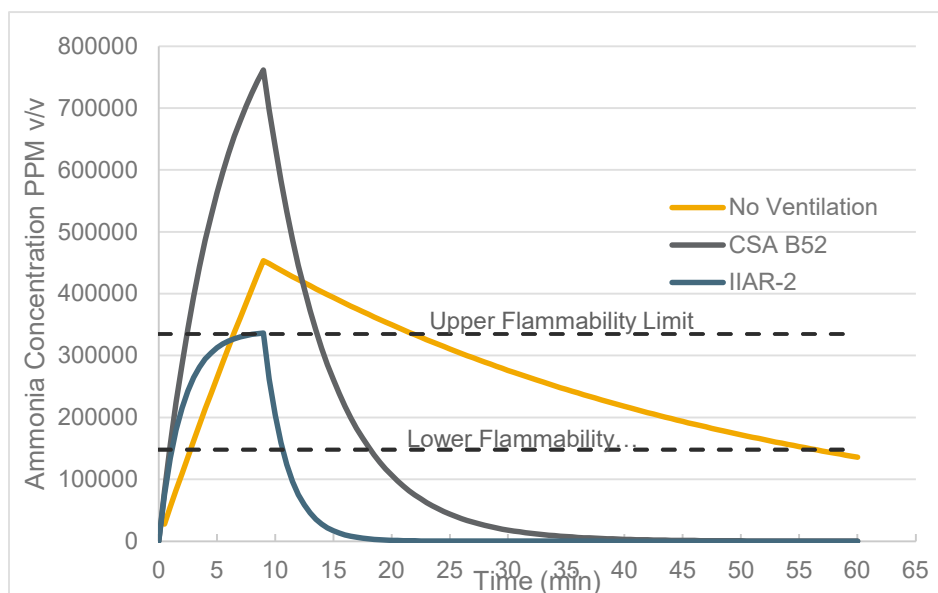
exhaust fan, an accurate model of the ammonia concentration in the room is complicated significantly by the fact that the overhead door was open, and a large quantity of ammonia released directly to the outdoors. Given the nature of the assumptions, a reliable model is not possible. However, it remains interesting to compare the time the facility would have been at risk of deflagration during the release if the facility had functioning emergency exhaust equipment. Figure 14 shows the approximate ammonia concentration for three scenarios,

**Figure 14: Ammonia concentration in the mechanical room in three different ventilation scenarios. The “No Ventilation” scenario is a simplification of the situation that occurred during this incident with a large amount of ammonia leaving the room through an open door.**

There are too many assumptions in the comparison of ventilation rates to draw specific conclusions related to this event. Most importantly, it was not possible to accurately quantify the amount of ammonia that moved outside through the open door. However, it is apparent that increasing the ventilation rate decreases the amount of time the concentration in the room is within the flammability range. It is important to note that concentrations are an average and that during any leak event there will be pockets of ammonia that are within the flammability range.
