Incident Summary #II-996167-2020 (#16909) (FINAL)

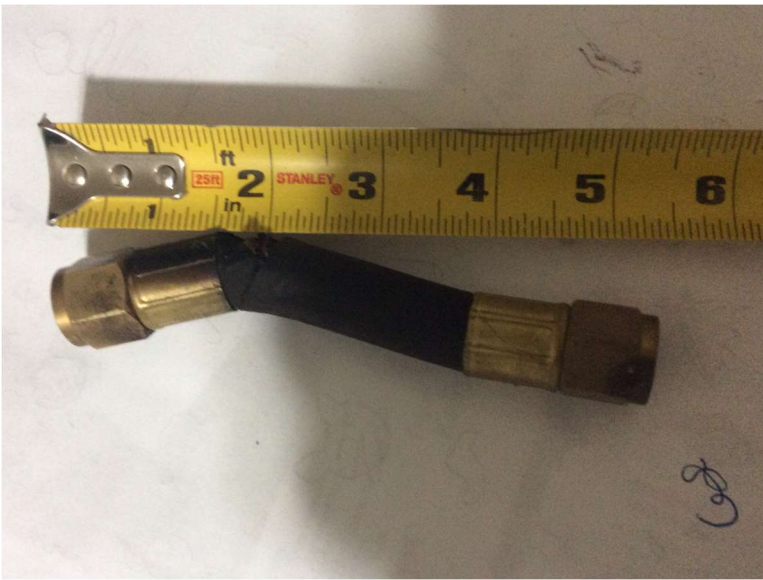
SUPPORTING INFORMATION	Incident Date	March 19, 2020	
	Location	Summerland	
	Regulated industry sector	Gas - Natural gas system	
	Impact	Qty injuries	0
		Injury description	NA
		Injury rating	None
	Damage	Damage description	Gas hose between gas valve and burner cracked causing a gas leak which ignited and burnt the control wiring and ignition module for a radiant heater.
		Damage rating	Minor
Incident rating	Minor		
Incident overview	Radiant heater caught fire due to a gas leak. A gas hose between the gas valve and burner was installed with a sharp 90 degree bend at the gas valve end. The strain on the hose cracked the hose causing a gas leak which ignited and burnt the control wiring and ignition module.		
INVESTIGATION CONCLUSIONS	Site, system and components	The gas hose is designed to supply gas from the gas control valve to the burner of the radiant heater.	
	Failure scenario(s)	The strain on the backside of the gas hose where the sharp bend was located caused the hose to perforate and leak gas which was ignited by the burner. The burning gas caused a hole to form in the gas hose which increased the amount of gas that was burning.

Damaged gas hose

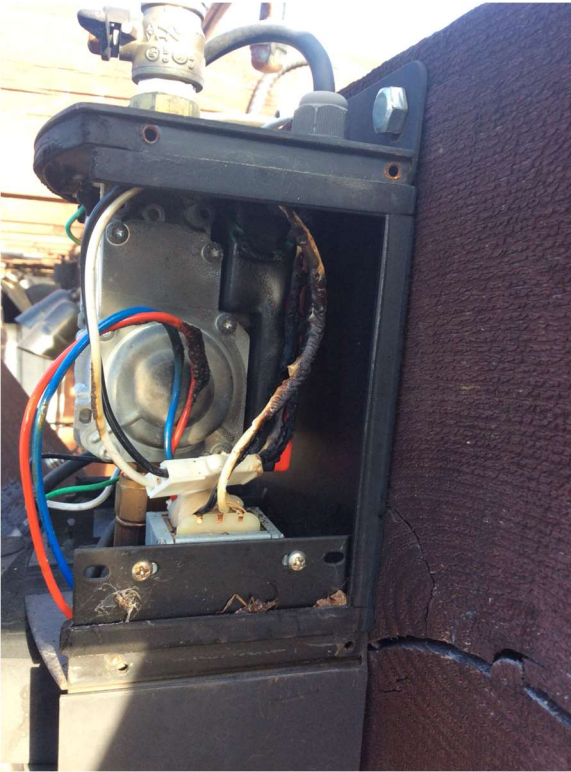
Burnt wiring by gas valve

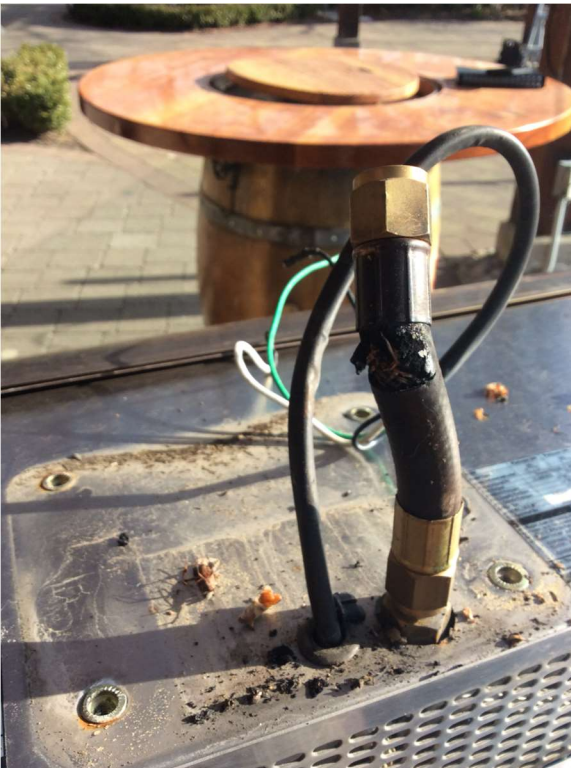
Gas hose connected to burner

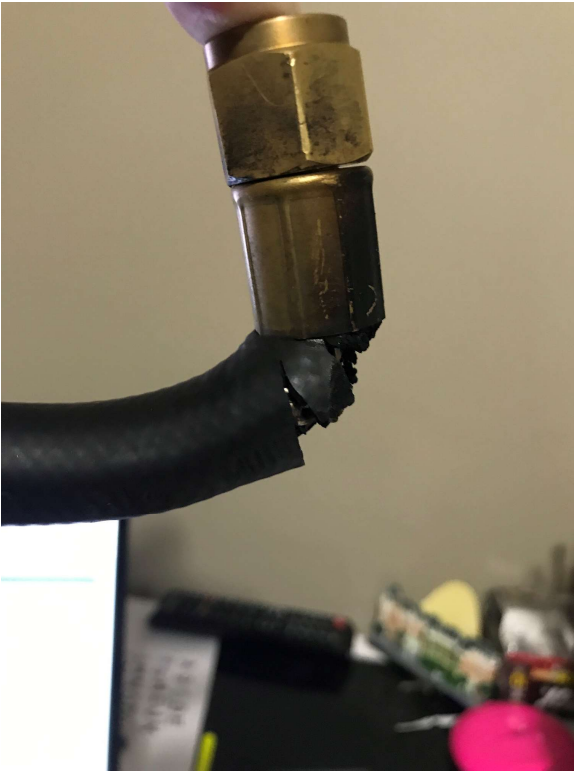
Facts and evidence	The type 1 gas hose which connects the gas valve to the burner was installed at the factory with a sharp bend in it. The stress on the hose over time caused it to perforate and leak gas which ignited and started a small fire.	
	Causes and contributing factors	The incident was very likely caused by the manufacturer installing the gas supply hose in a manner that formed a sharp 90-degree bend. The stress on the hose because of the sharp bend caused the hose to crack allowing gas to leak which ignited, burning the hose and control wiring near the gas valve.

Factory installed hose with sharp bend that caused the damage to the gas hose.
