Incident Summary #II-1135989-2021 (#20547) (FINAL)

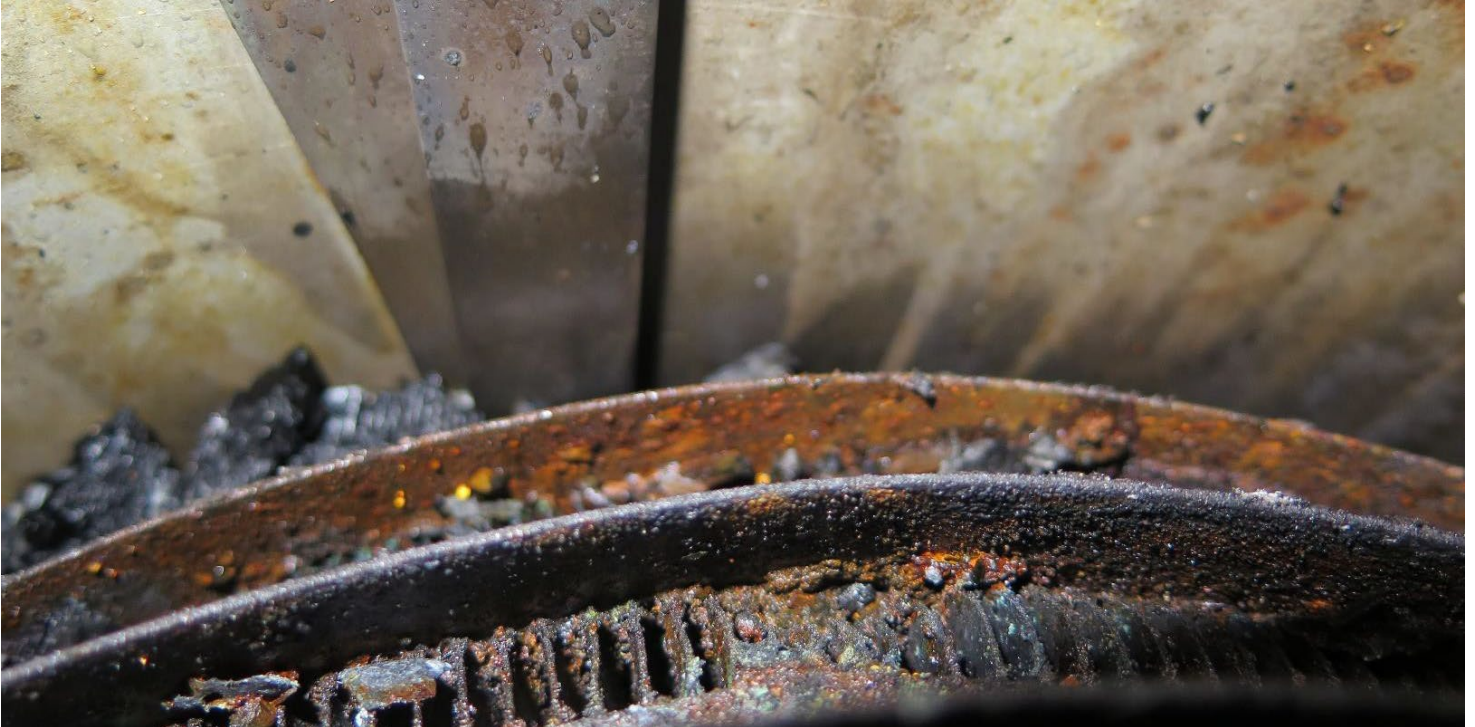
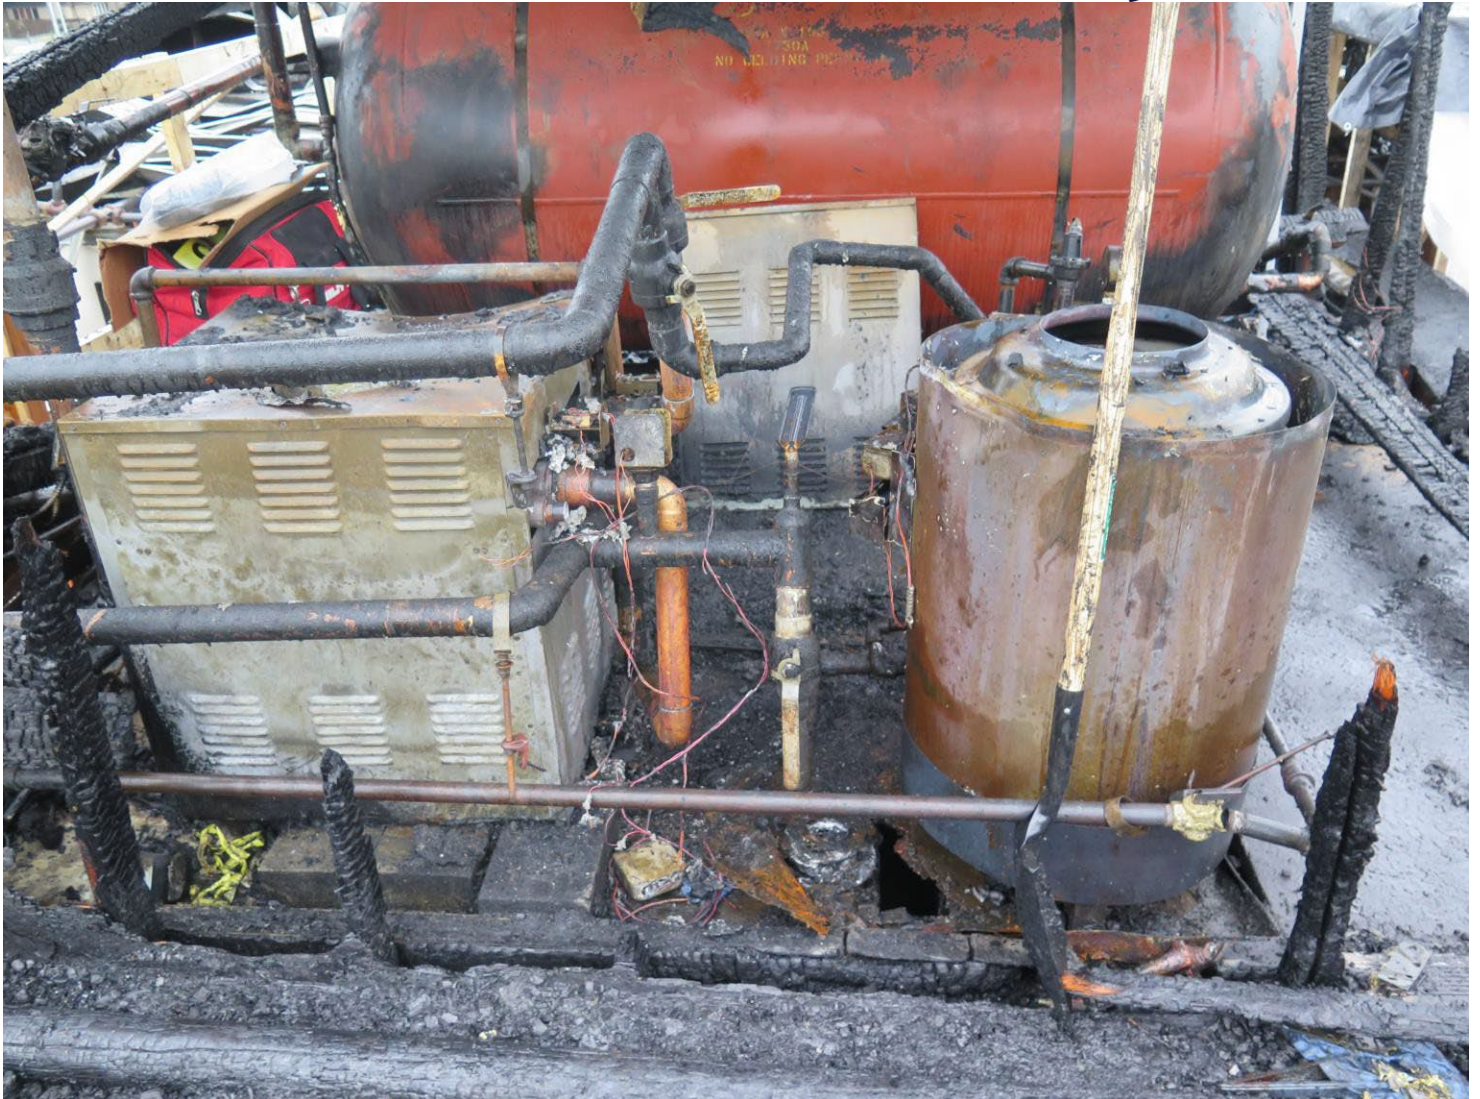
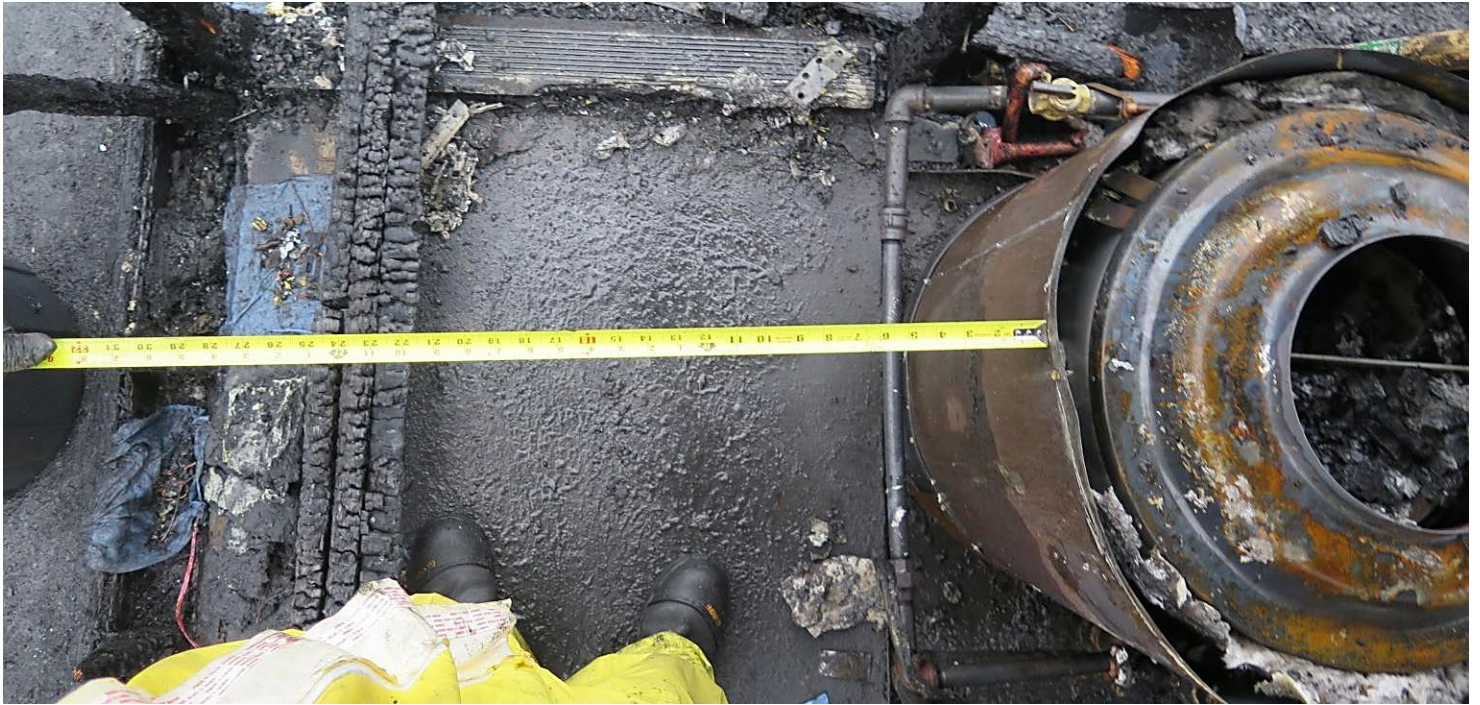
Failure scenario(s)	The boiler at the hotel had been operating without any recent inspection or maintenance which caused a build-up of soot on the heat exchanger of the boiler, This build-up eventually caused a block in the boiler system causing a condition called “flame rollout”, where the fire inside the combustion chamber burns out of the front of the boiler and into the mechanical room instead of upwards and through the venting system. A flame rollout safety switch failed to shut off gas during the unsafe condition. The boiler placement was installed too close to the wall as per code requirements and the wall next to the boiler caught fire.	
	Facts and evidence	During investigation of the boiler, the finned heat exchanger was observed to be plugged with soot and carbon. The original location of the installation of boiler and proximity to the wall was observed and found to be too close to a combustible wall. Burn mark patterns were observed starting from installed boiler location and spreading outward.

It is highly probable that lack of proper maintenance on the boiler allowed the boiler heat exchanger to become plugged up as well as a lack of identification of a possible safety control failure. This combined condition most likely created a flame rollout condition which then caught the adjacent wall on fire.
