Incident Summary #II-1310863-2022 (#25692) (FINAL)

SUPPORTING INFORMATION	Incident Date	January 6, 2022	
	Location	Charlie Lake	
	Regulated industry sector	Gas - Propane system	
	Impact	Qty injuries	1
		Injury description	Second degree burns to arms, hands, upper torso, and face.
	Damage	Injury rating	Major
		Damage description	A residence was destroyed by an explosion and fire. Vehicles and additional propane tanks and cylinders were damaged by flying debris and heat damage from the fire.
		Damage rating	Major
Incident rating	Major		
Incident overview	During an unseasonable stretch of extreme cold weather, two 100-pound propane cylinders were brought inside a residence and used for heating. A leak from one of the propane cylinders inside of the residence caused an explosion and fire.		
INVESTIGATION CONCLUSIONS	Site, system and components	<p>The occupant was residing in a small building on the property that was serviced by RV style appliances connected to multiple propane tanks and cylinders outside. Several other propane tanks and cylinders were also stored around the outside of the building.</p> <p>Propane is a fuel commonly stored and transported as a liquid and used as a vapo

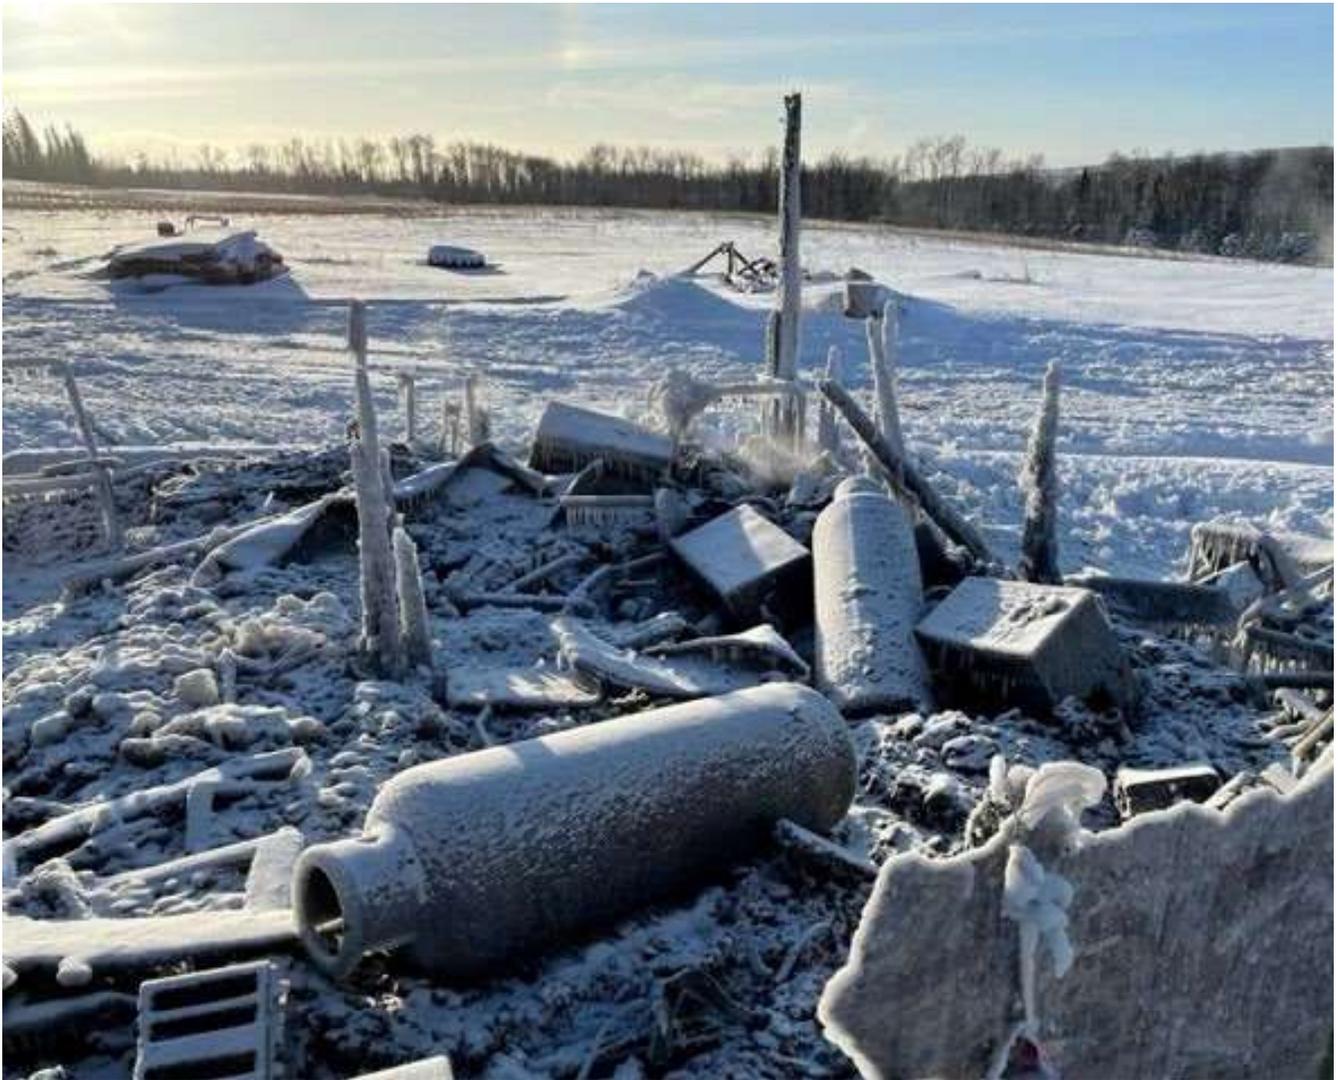
<p>Facts and evidence</p>	<p>Site observations</p> <ul style="list-style-type: none"> • Two 100-pound cylinders were found inside the residence at the time of initial investigation (Photo 1). • Several propane tanks, cylinders and auto propane tanks were found surrounding the building some with regulators and gas lines attached to RV style propane appliances (Photo 2 and 6). • Almost the entire building structure was destroyed, and fire damage was observed on vehicles parked next to the building (Photo 4 and 7). <p>Interview statement</p> <ul style="list-style-type: none"> • The occupant stated he had brought the cylinders inside to use with a cylinder mounted heater. • The occupant stated the cylinder began leaking after changing the heater from an empty cylinder to a full cylinder. • The explosion had blown him out of the building, and he gained consciousness on the ground outside. • Additional explosions were heard from other propane containers during the fire. <p>Historical weather data</p> <p>The area was experiencing extreme cold temperatures. The two days leading up to and the day of the incident the temperatures were highs of -32 and lows of -37 degrees Celsius. The historical average temperature for that month is -12 degrees Celsius.</p>

Photo 1 – Two 100-pound propane cylinders inside the remnants of the residence.

<p>Causes and contributing factors</p>	<p>It is most likely that full propane cylinders being used indoors with an infrared heater to supply heat allowed escaping gas from a leaking cylinder to accumulate within the structure causing the explosion incident and subsequent fire.</p> <p>The extreme cold weather may be a contributing factor to the incident.</p>

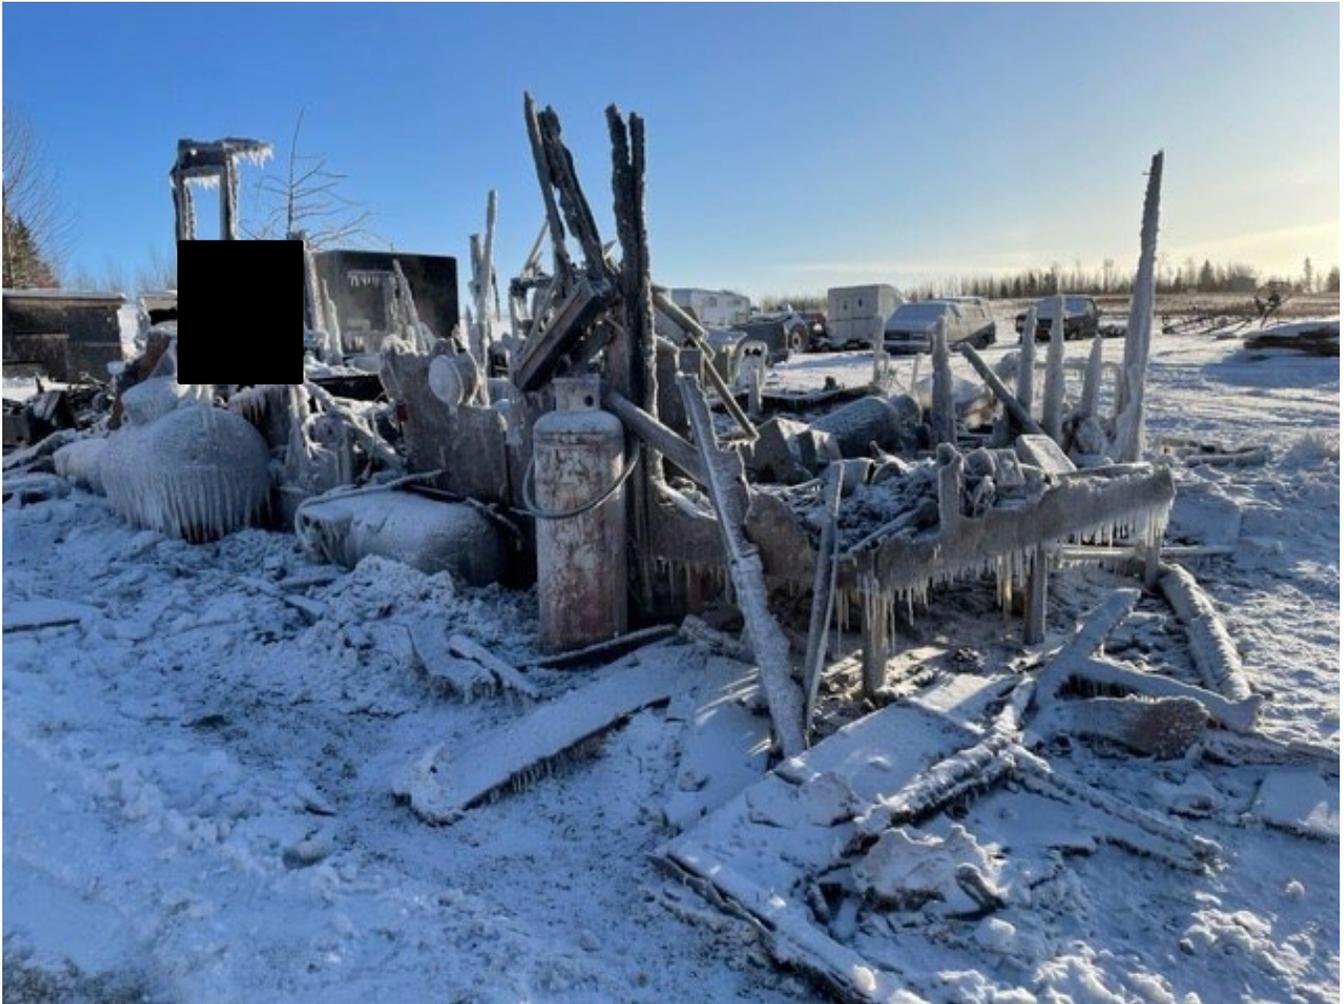
Photo 2 – The remaining structure of the residence showing multiple propane containers along the outside wall.

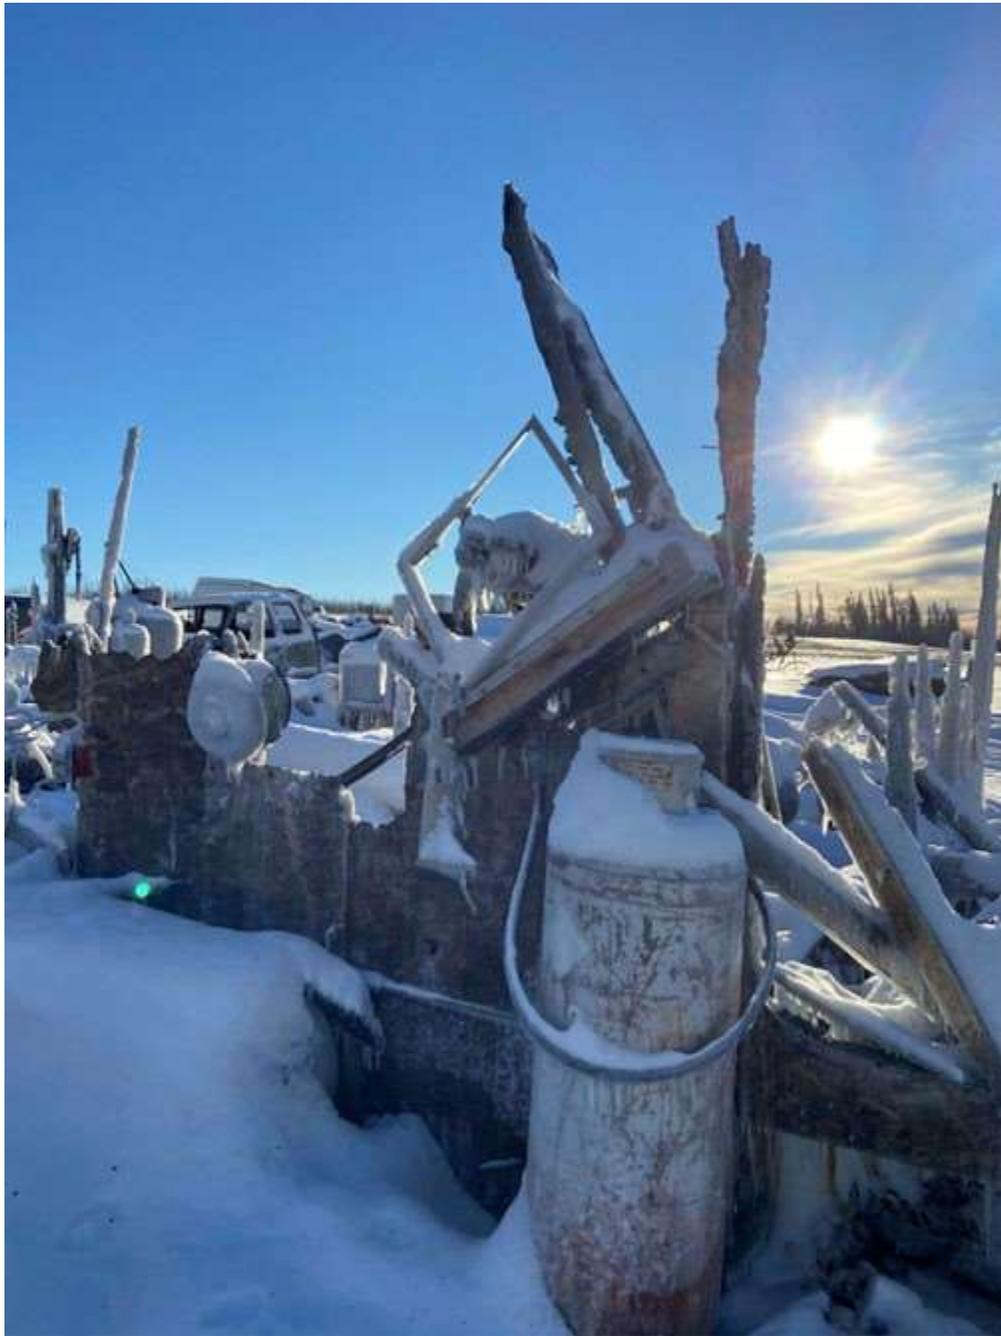
Photo 3 – 100-pound propane cylinder outside the residence connected to an RV style appliance.

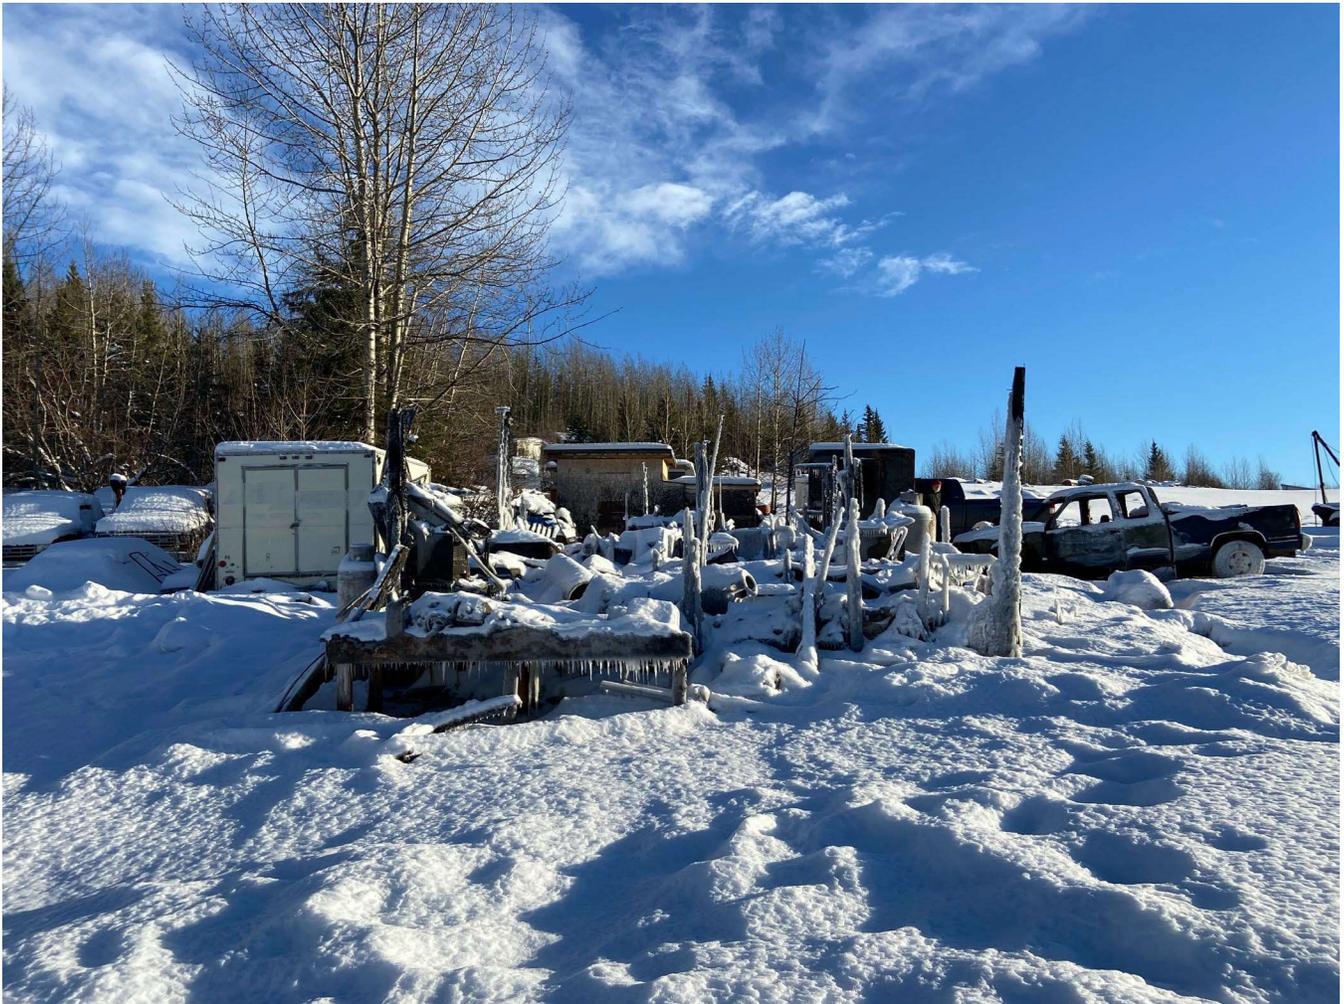
Photo 4 – The residence damaged by explosion and fire.

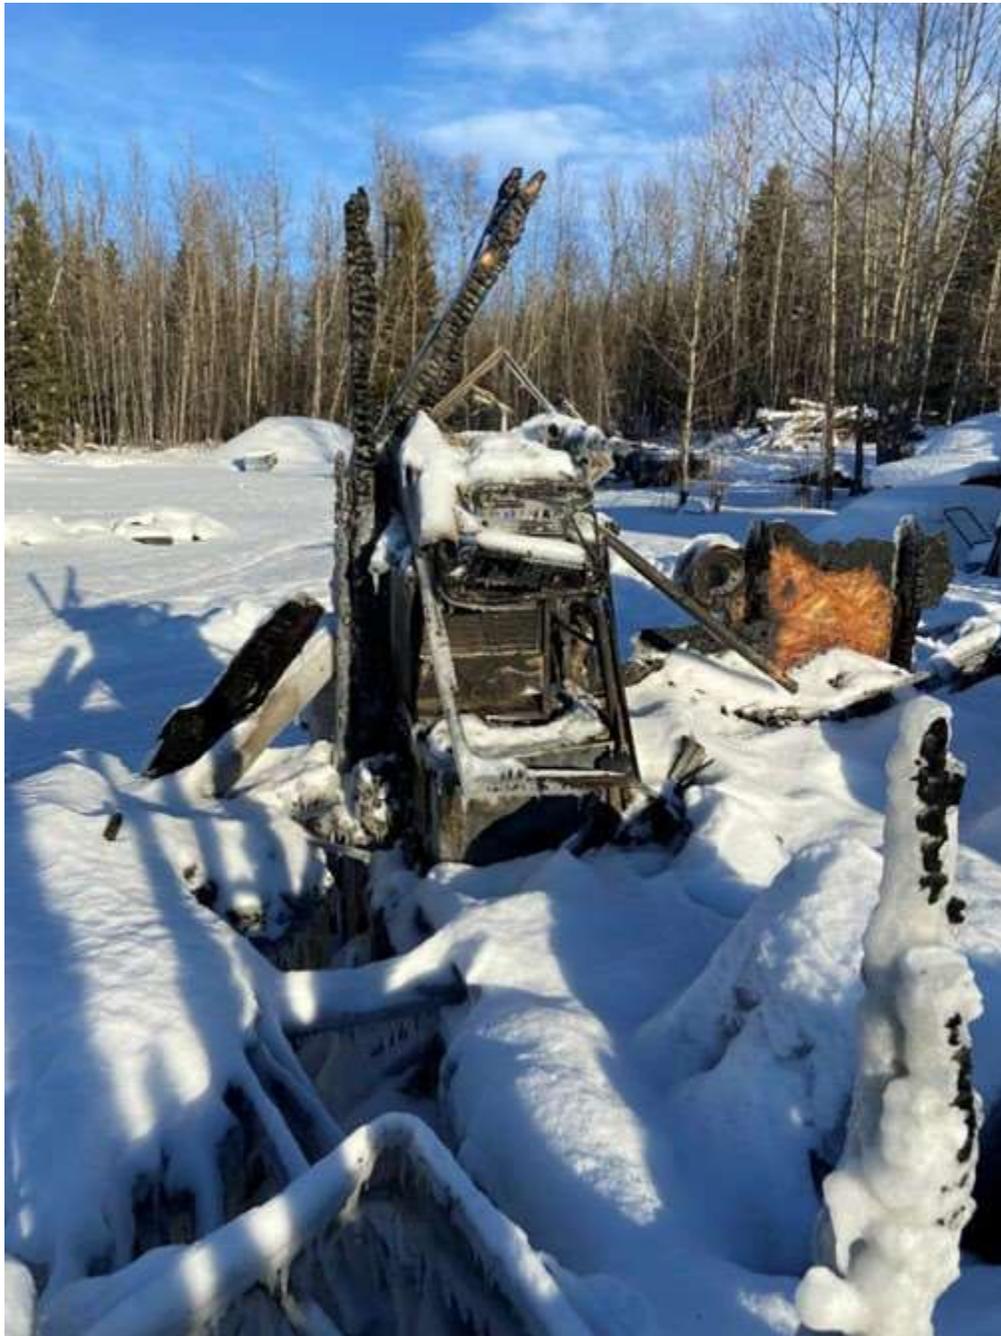
Photo 5 – RV style furnace and refrigerator

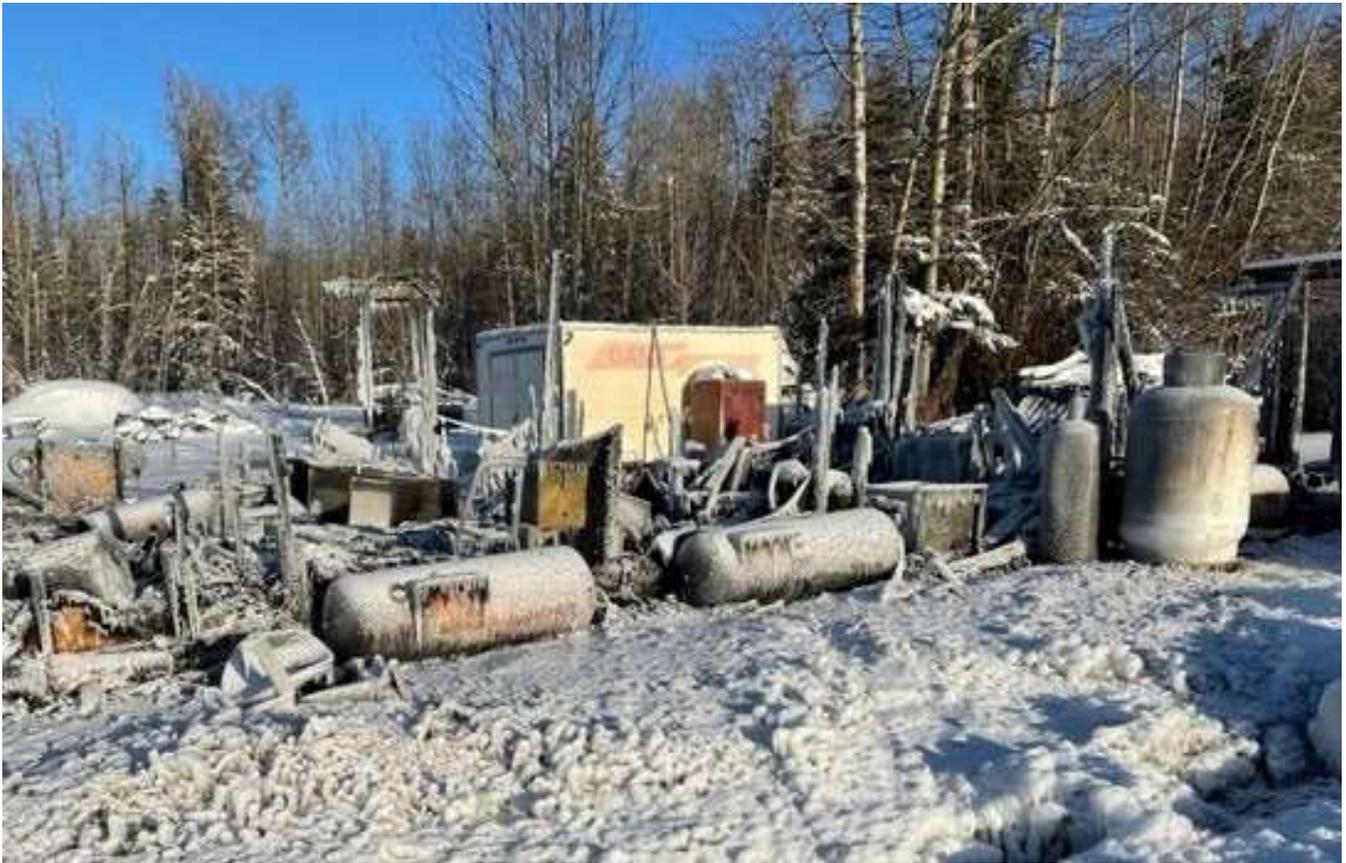
Photo 6 – Multiple propane cylinders and tanks on the outside of the residence.

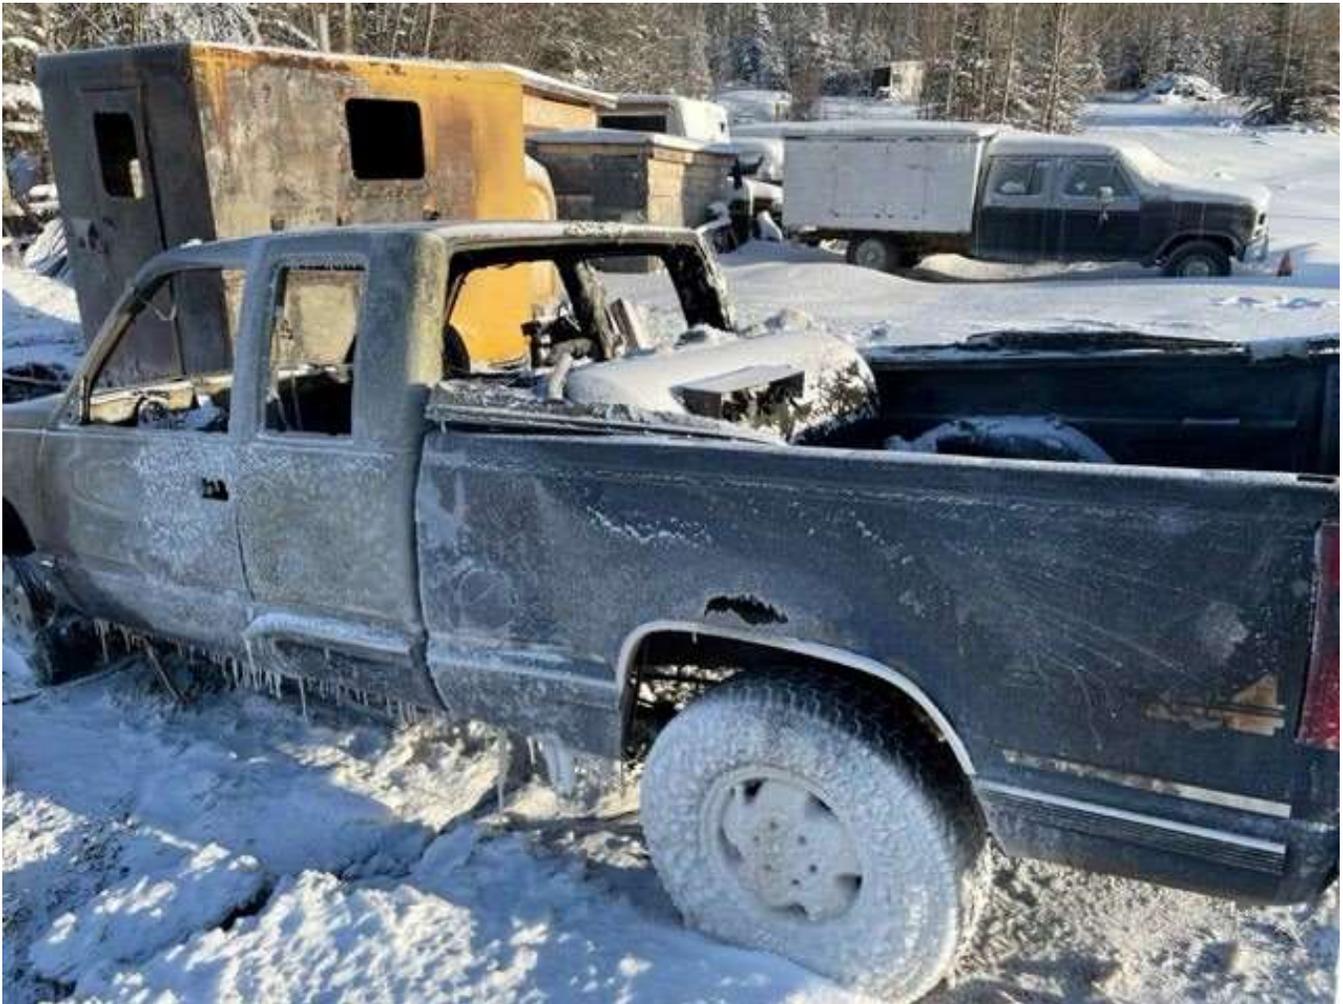
Photo 7 – Propane fueled vehicle damaged by explosion and fire.
