Incident Summary #II-1304266-2021 (#25455) (FINAL)

Failure scenario(s)

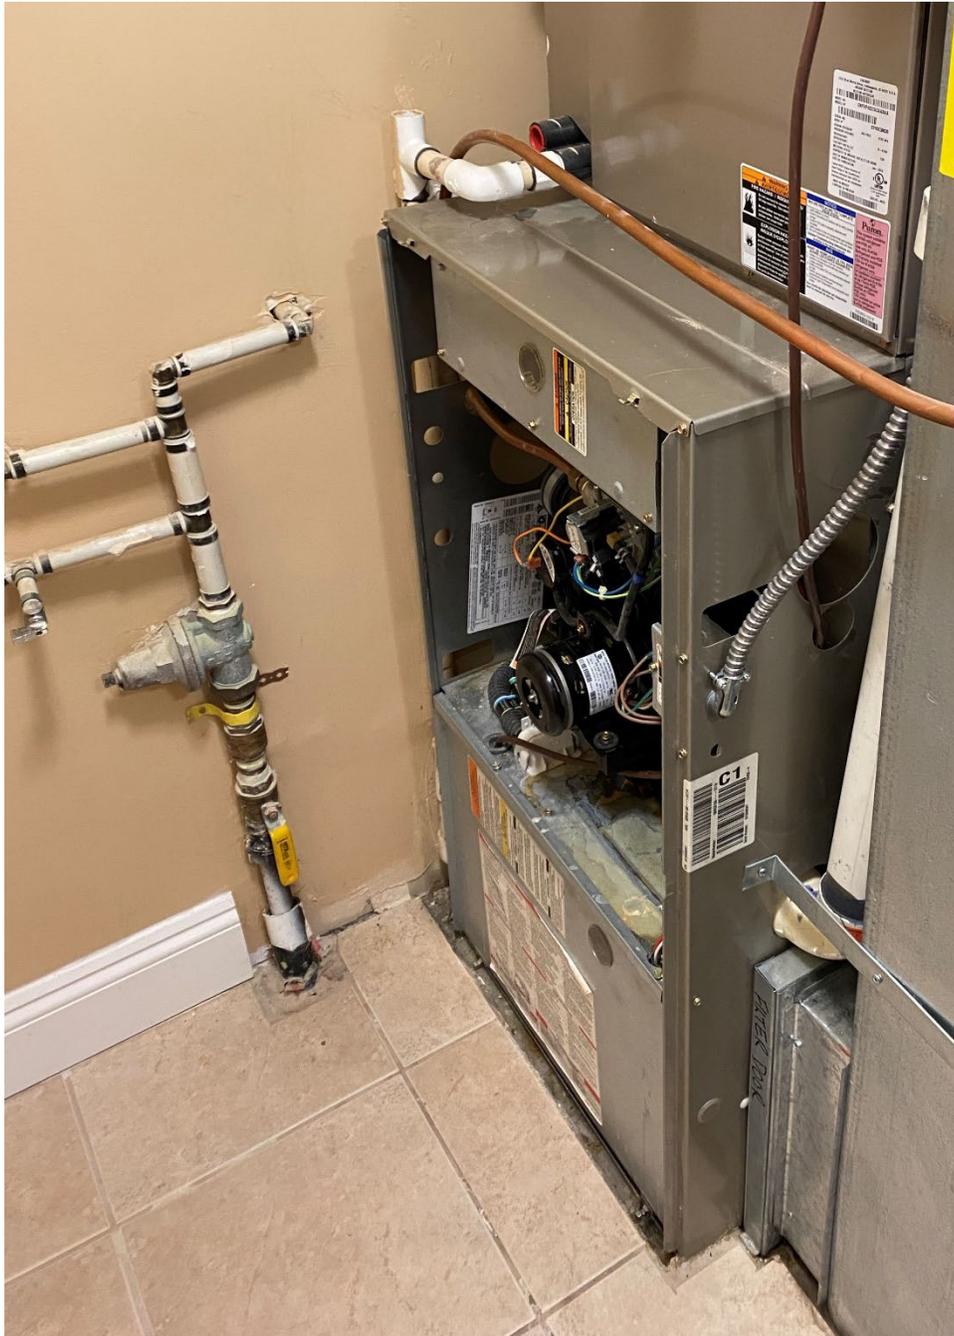
Photo 1 – Furnace installed in basement of home in the up-flow position

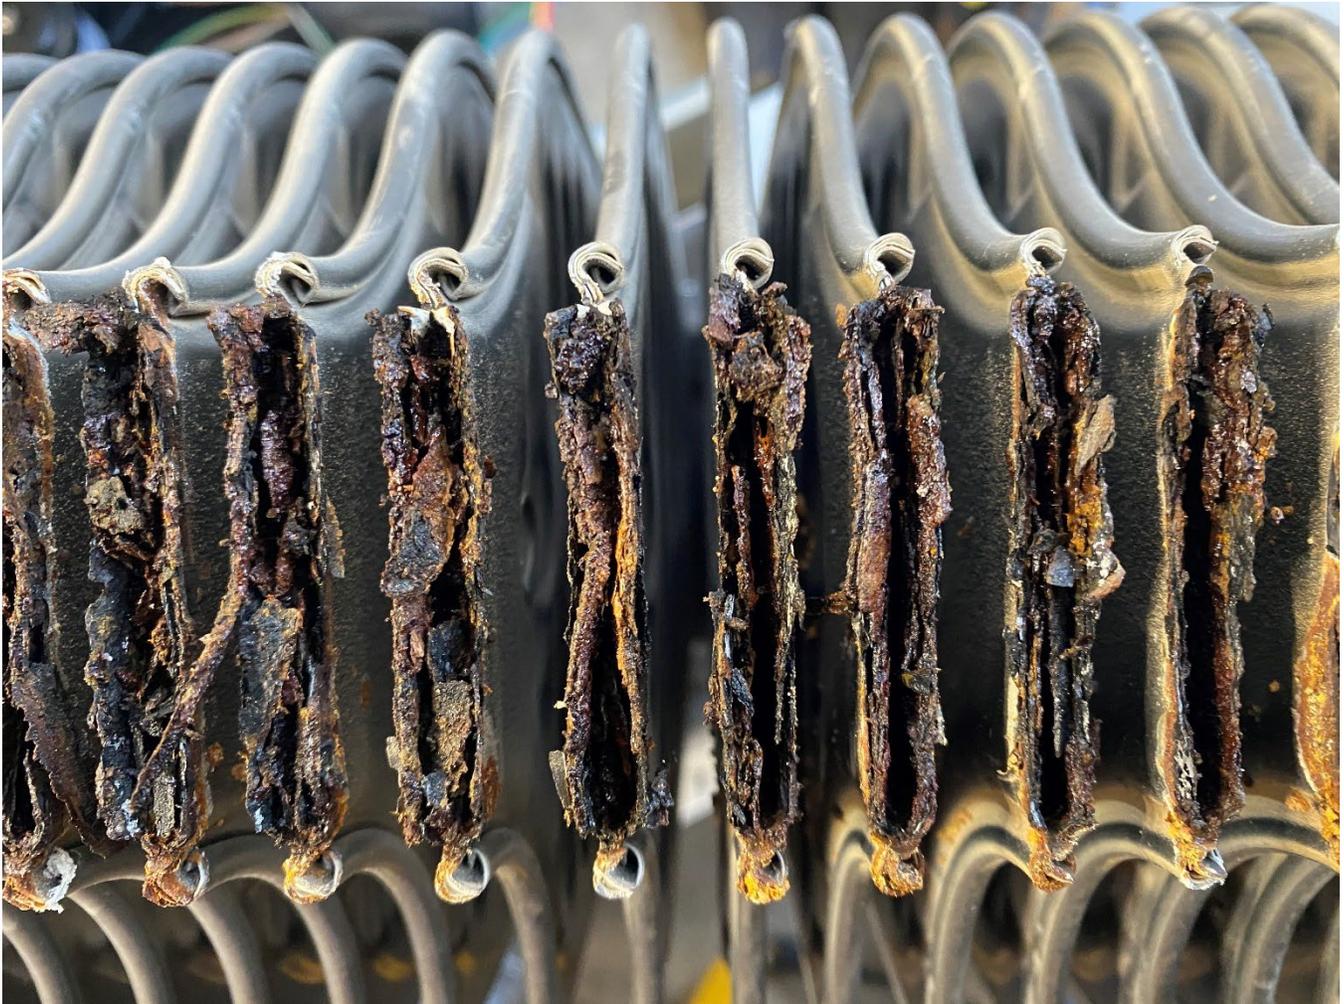
<p>Evidence Examination</p> <p>The inlets to the furnace's secondary heat exchanger tubes had corroded and the interior polypropylene lining had delaminated which restricted the airflow through them. The restricted airflow reduced the amount of air at the point of combustion in the burner box. The unbalanced air/fuel ratio caused incomplete combustion that produced elevated levels of carbon monoxide in the flue products.</p> <p>During operation of the furnace, the burner characteristics were observed, and the restricted flue passages in the secondary heat exchanger were seen causing the flames to slightly roll out of the burner tubes inside of the burner box. The flame rollout switch was not triggered by the amount of flame rollout and allowed the furnace to continue to operate in an unsafe condition.</p> <p>The furnace venting terminated horizontally on the side of the home (Photo 9). The vent termination had a 90-degree elbow on it that pointed down towards a window well. The owner stated that the window had been closed all winter and was never open when the CO alarms in the home activated. The termination was 24" away from the ventilation air grill for the gas fireplace cavity and 32" away from the top of the window opening which met the minimum requirements of 12" dictated by the gas code and the manufacturer. The side of the home where the vent terminated was separated from the neighboring property by a 5' high solid wooden fence. The vent pointing down and the fenced area beside the home allowed the flue gas containing very high levels of CO to gather and accumulate instead of dissipating and allowed hazardous levels of CO to migrate back into the home through the building openings. Dilution of the flue gas as it mixed with the outside air was not enough to eliminate the hazard of exposure due to the excessive concentration of CO in the flue gas of the operating furnace.</p>

Photo 7 – Close up photo shows corrosion and delaminated polypropylene liners at the heat exchanger inlet tubes.

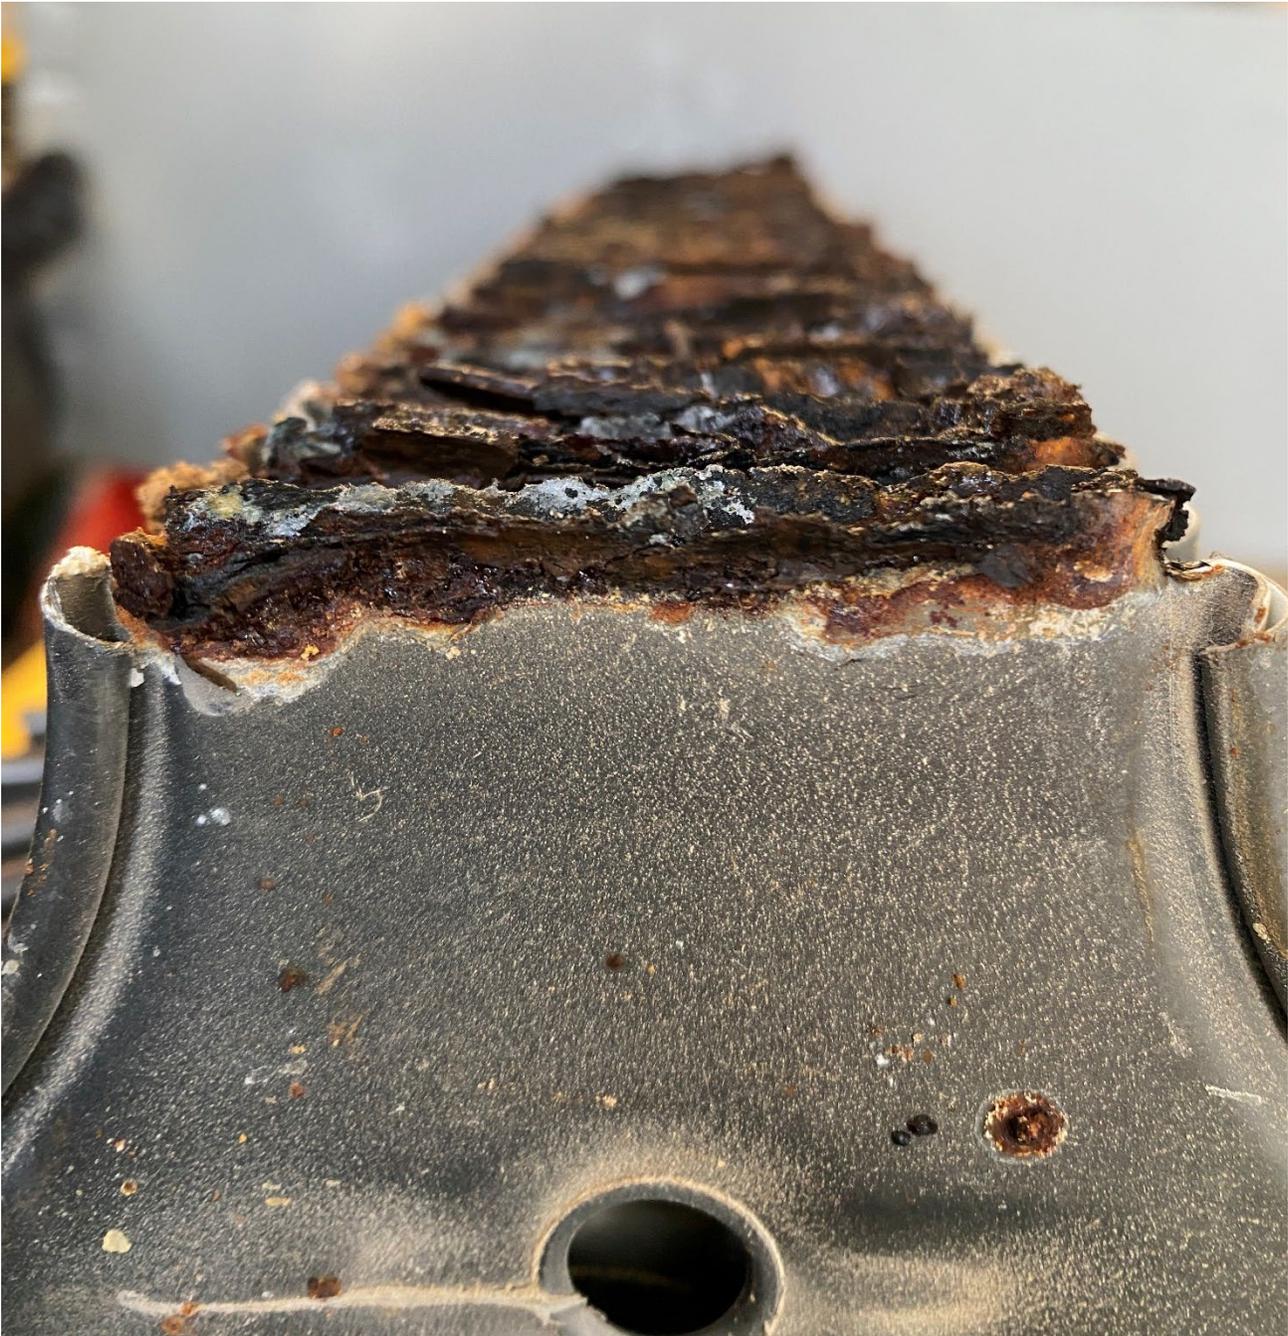
Photo 8 – Profile showing the corrosion of the heat exchanger inlet tubes.

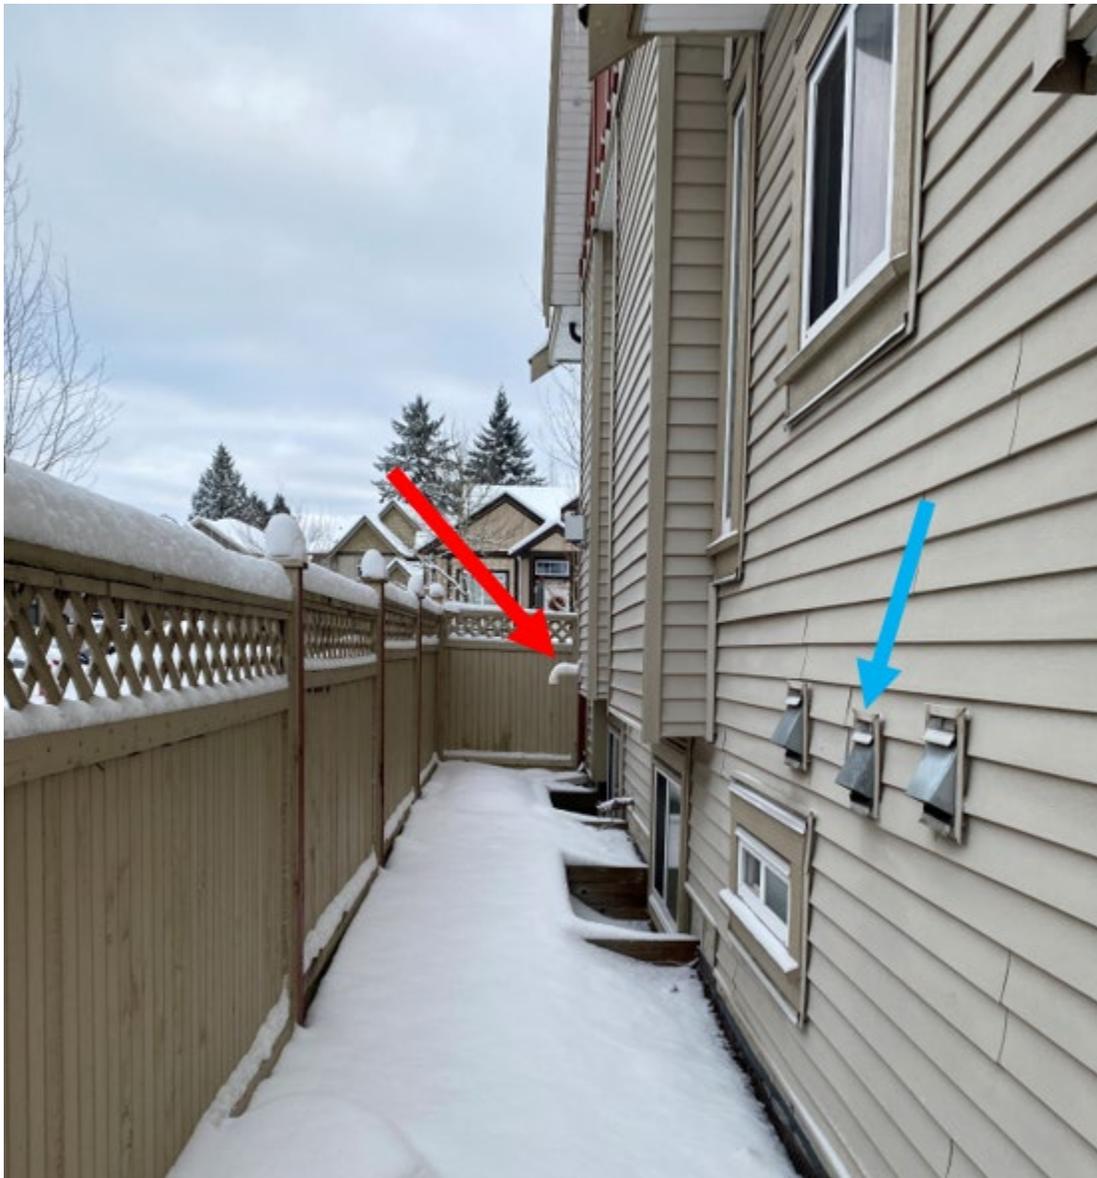
Photo 9 – **Red** shows furnace vent termination at side of house. **Blue** shows air intake grills to the house 24 feet away where flue gas containing 90ppm CO was measured migrating into the home.

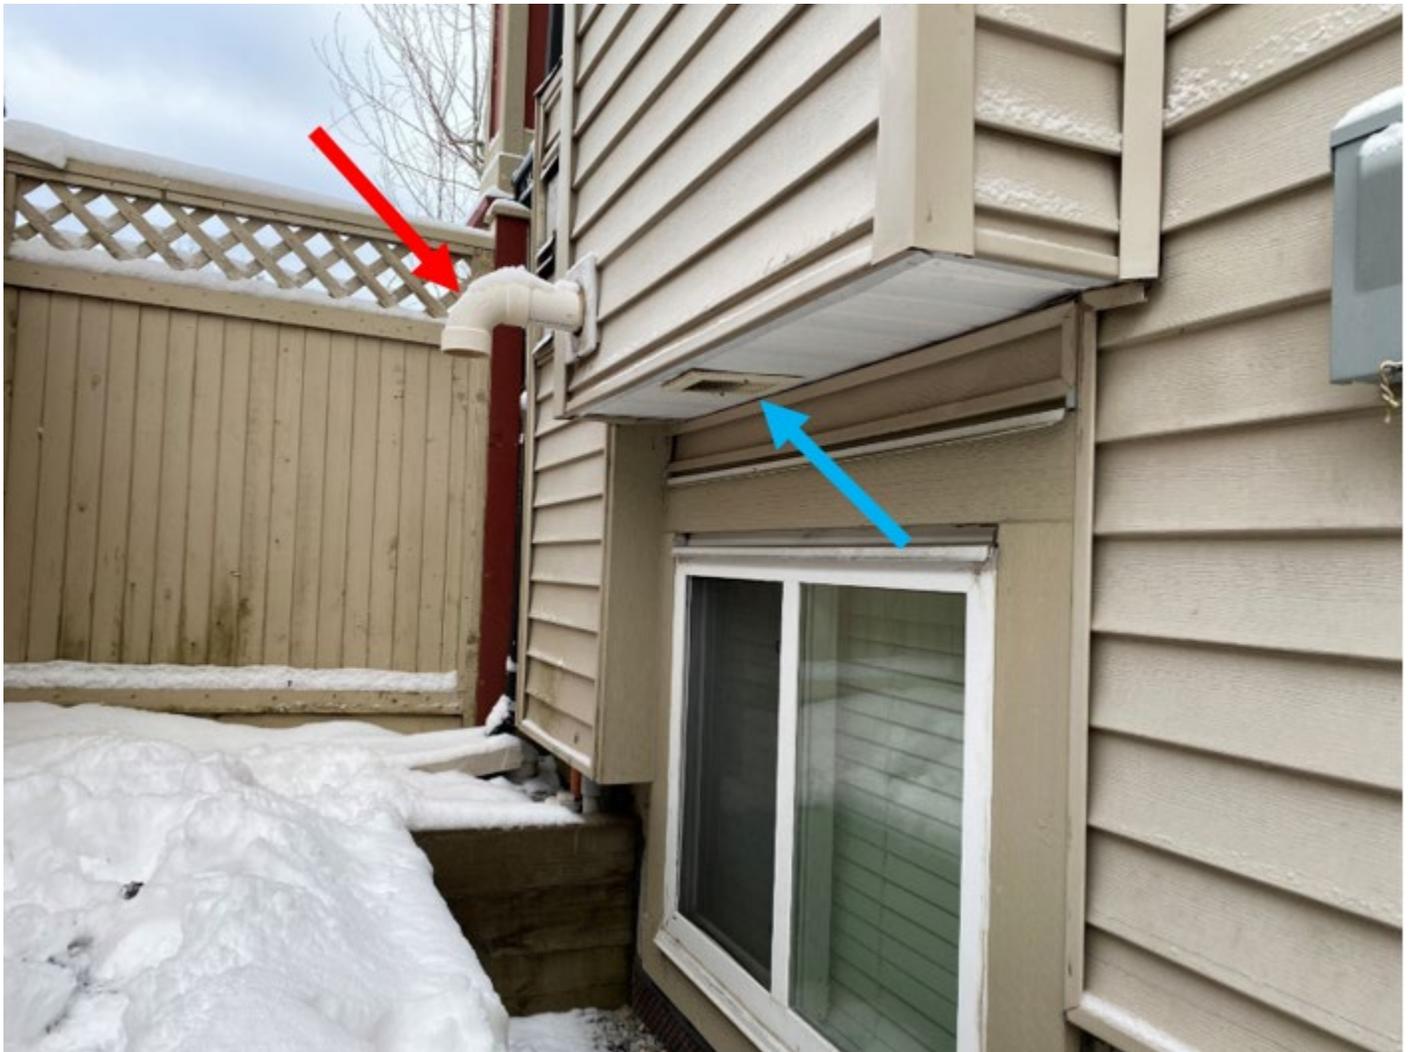
The Natural Gas code and the furnace manufacturer's published instructions require the termination of the furnace to vent horizontally out the side of a building and maintain 12" of clearance to building openings such as opening doors, windows and non-mechanical air-supply inlets when the appliance input is rated from 10,000 btu/h to up to and including 100,000 btu/h.

The furnace vent materials manufacturer states in their installation manual that horizontal wall penetrations should be straight out, and the exhaust should not be directed into window wells.

Photo 10 – **Red** shows furnace vent termination with a 90-degree elbow pointing down. **Blue** shows ventilation air opening for gas fireplace cavity.

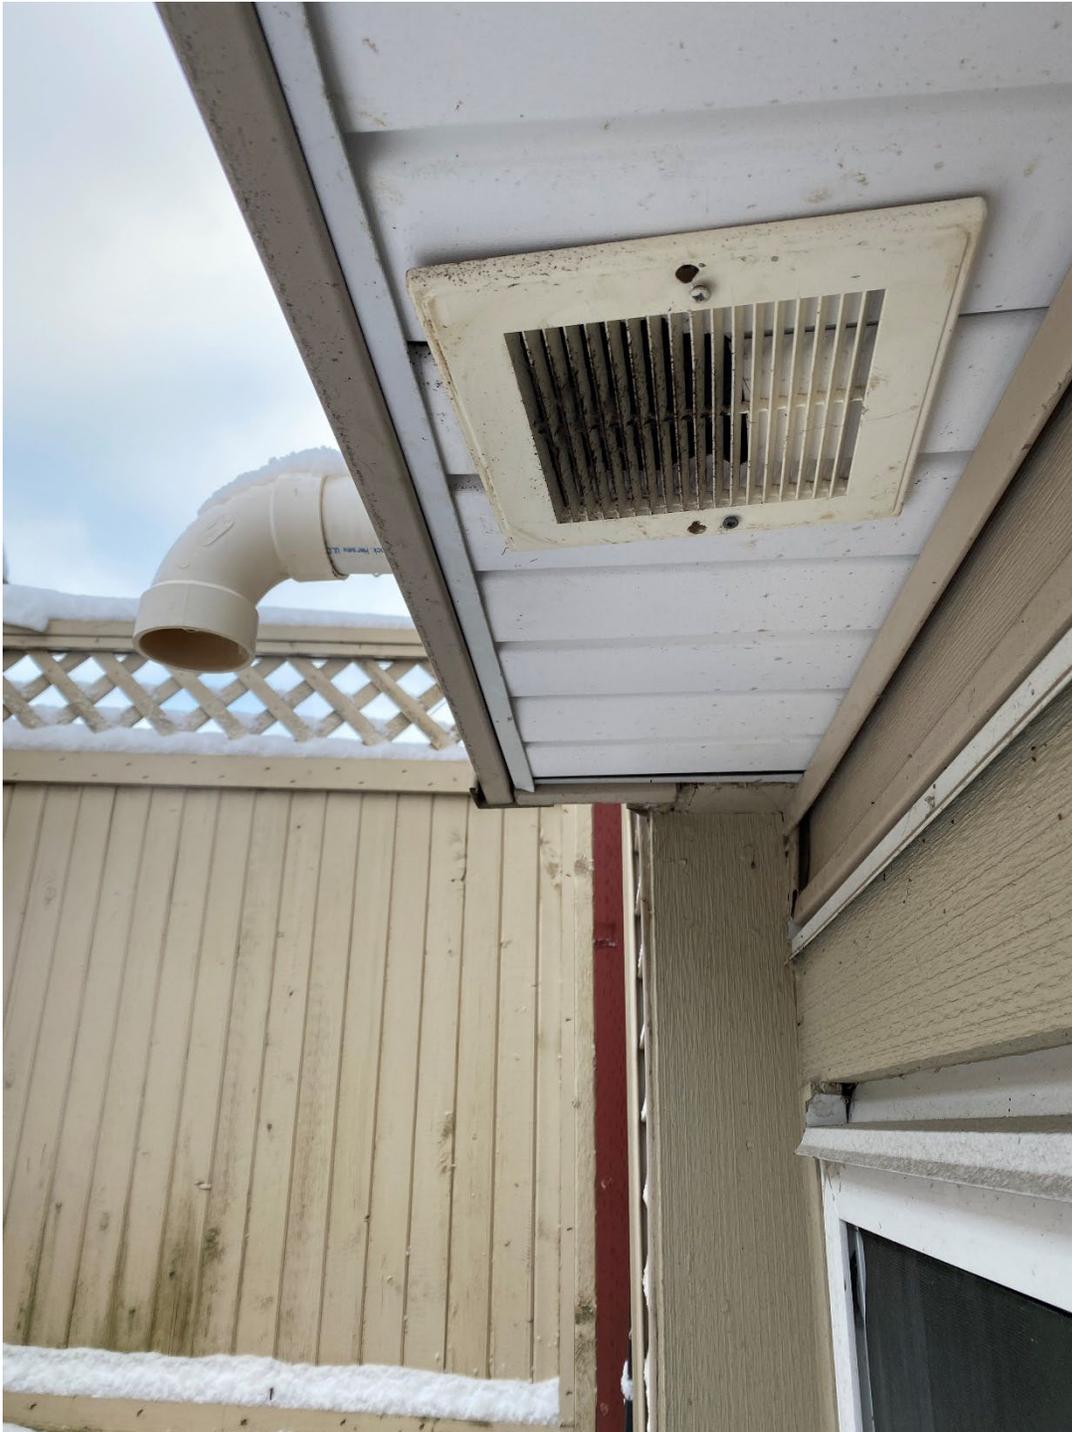
Photo 11 - The ventilation opening for the gas fireplace cavity that flue gas containing 168ppm of CO was measured migrating into the home.
