Incident Summary #II-982535-2020 (#16663) (FINAL)

SUPPORTING INFORMATION	Incident Date	February 18, 2020	
	Location	Langley	
	Regulated industry sector	Gas - Natural gas system	
	Injury	Qty injuries	0
		Injury description	None
		Injury rating	None
	Impact Damage	Damage description	A residential furnace heat exchanger failed, and produced of high levels of carbon monoxide (CO), while a redundant safety feature (flame rollout switch) controlled the hazard by shutting off the furnace.
			High level of carbon monoxide produced at furnace vent termination at side of home.
		Damage rating	Moderate
	Incident rating	Moderate	
Incident overview	A natural gas furnace in a residential home produced elevated levels of carbon monoxide. Carbon monoxide was released from the furnace vent termination at the side of the home and directed toward the neighbour's house.		
INVESTIGATION CONCLUSIONS	Site, system and components	<p>Residential gas furnaces use the heat produced from the combustion of a gas/air mixture to heat the home. The combustion occurs at the entrance to a heat exchanger. The flue gases produced by combustion pass through the inside passages of the heat exchanger and are carried saf

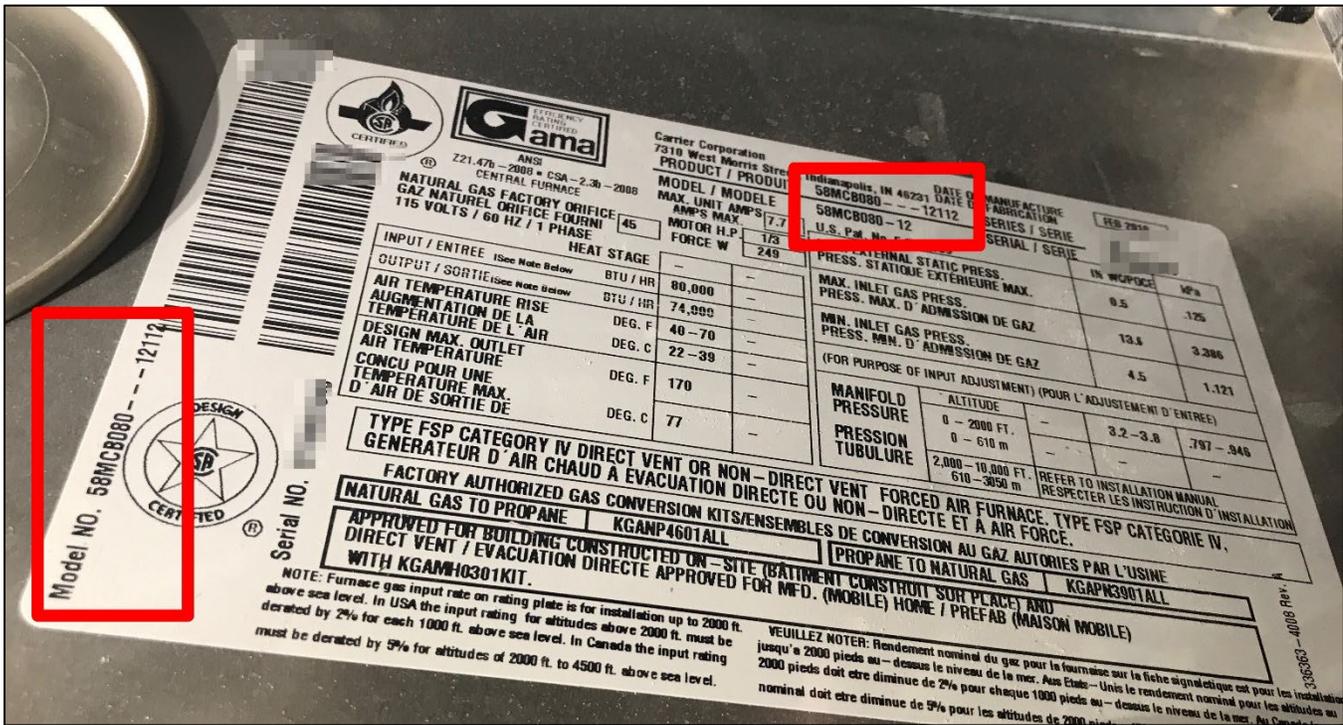
Image 2 – Furnace data tag identifying it as a Carrier model # 58MCB080.

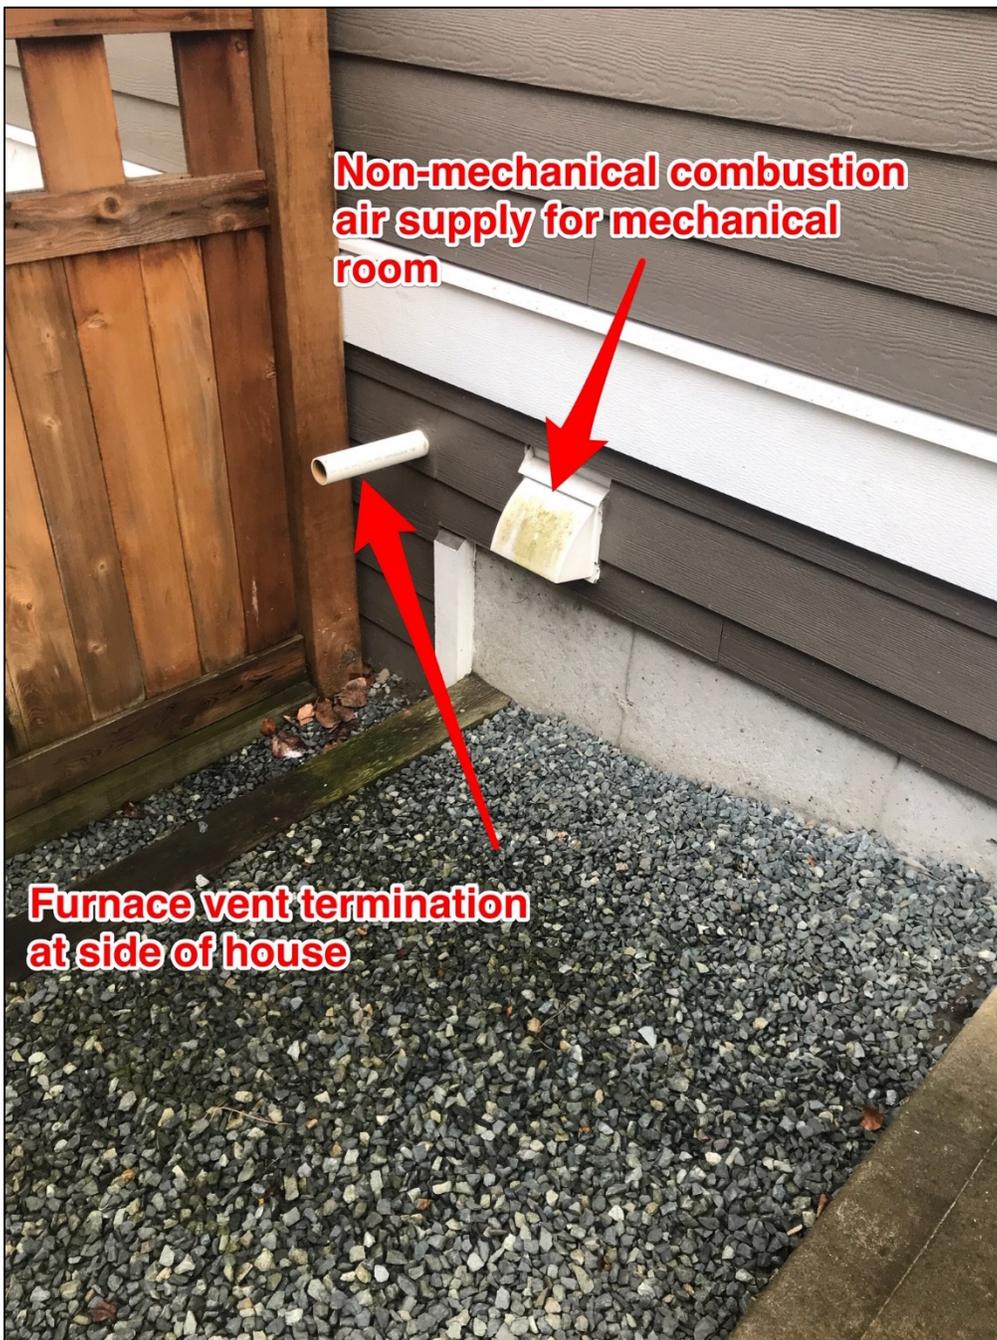
Image 3 - Furnace vent termination extending 9" out from wall and 12" away from "non-mechanical" combustion air supply inlet (A non-mechanical inlet does not have a fan attached, whereas a mechanical combustion air inlet would incorporate a fan, which in turn would need to be a minimum of ten feet away from the furnace vent termination). The fence location restricts natural air flow that would have otherwise helped carry furnace exhaust gas away from home.

The furnace vent was terminated horizontally at the side of the house. The termination was installed correctly and met the minimum requirements of the B149.1-15 Natural gas installation code along with the requirements of the manufacturers installation instructions. The vent pipe is required to extend between 6-10" beyond the exterior wall a minimum of 12" above exterior grade, and must maintain a minimum clearance of 12 " to the passive combustion air supply to the building (Image 3). The fence added to one side of the vent and the proximity to the combustion air inlet would reduce natural air flow in that area. Under some environmental conditions it is plausible that the very high levels of carbon monoxide present in the flue gas would allow carbon monoxide to migrate into the home through the combustion air supply duct.

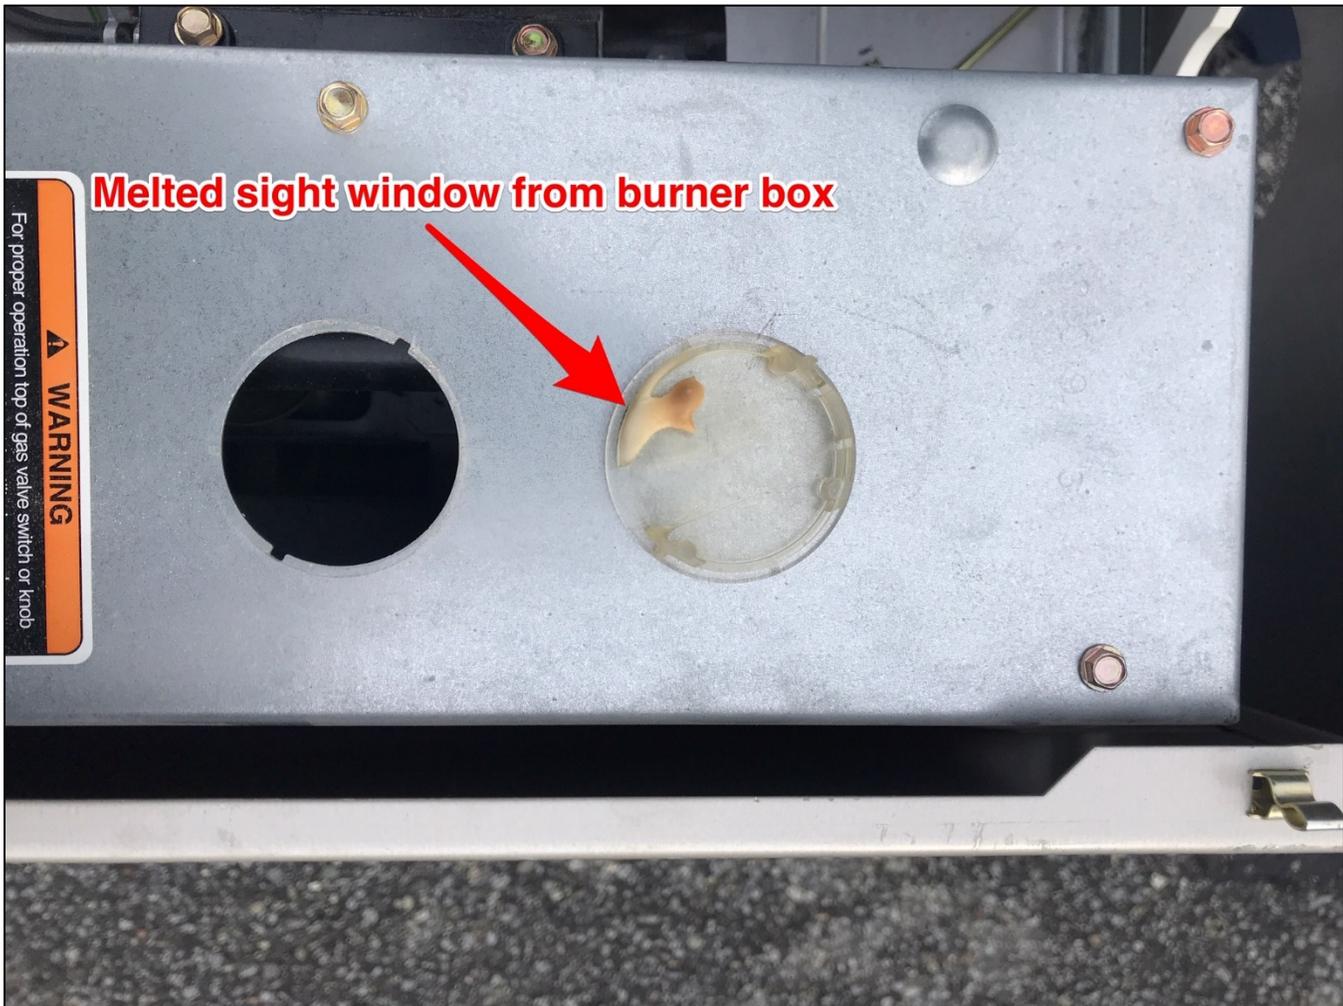
During a physical investigation it was observed that the furnace was installed at the correct level of slightly pitched forward as specified in the manufactures installation instructions. Burn marks observed on the outside of the burner box and the plastic sight window showed signs of melting and overheating (Image 4). The PVC venting system was intact but found to be dark and discoloured on the inside. When the furnace was started the burner flames were weak and yellow tipped but not rolling out severely. After a couple of minutes of burner operation carbon monoxide measurements were taken around the main floor of the house and the heating registers in the kitchen and front foyer. No carbon monoxide was detected at these locations of the house. Carbon monoxide was measured at the furnace vent termination at the side of the home and levels in excess of 1000 parts per million (ppm) were recorded. The upper measurable limit of the measuring device was 1000 ppm so the actual maximum concentration of carbon monoxide was undetermined. Physical examination of the burner flames failed to identify any evidence of high carbon monoxide production in the flue gas.

Image 4 - Plastic sight window removed from burner box showing signs of melting from insufficient air flow and flame rollout.

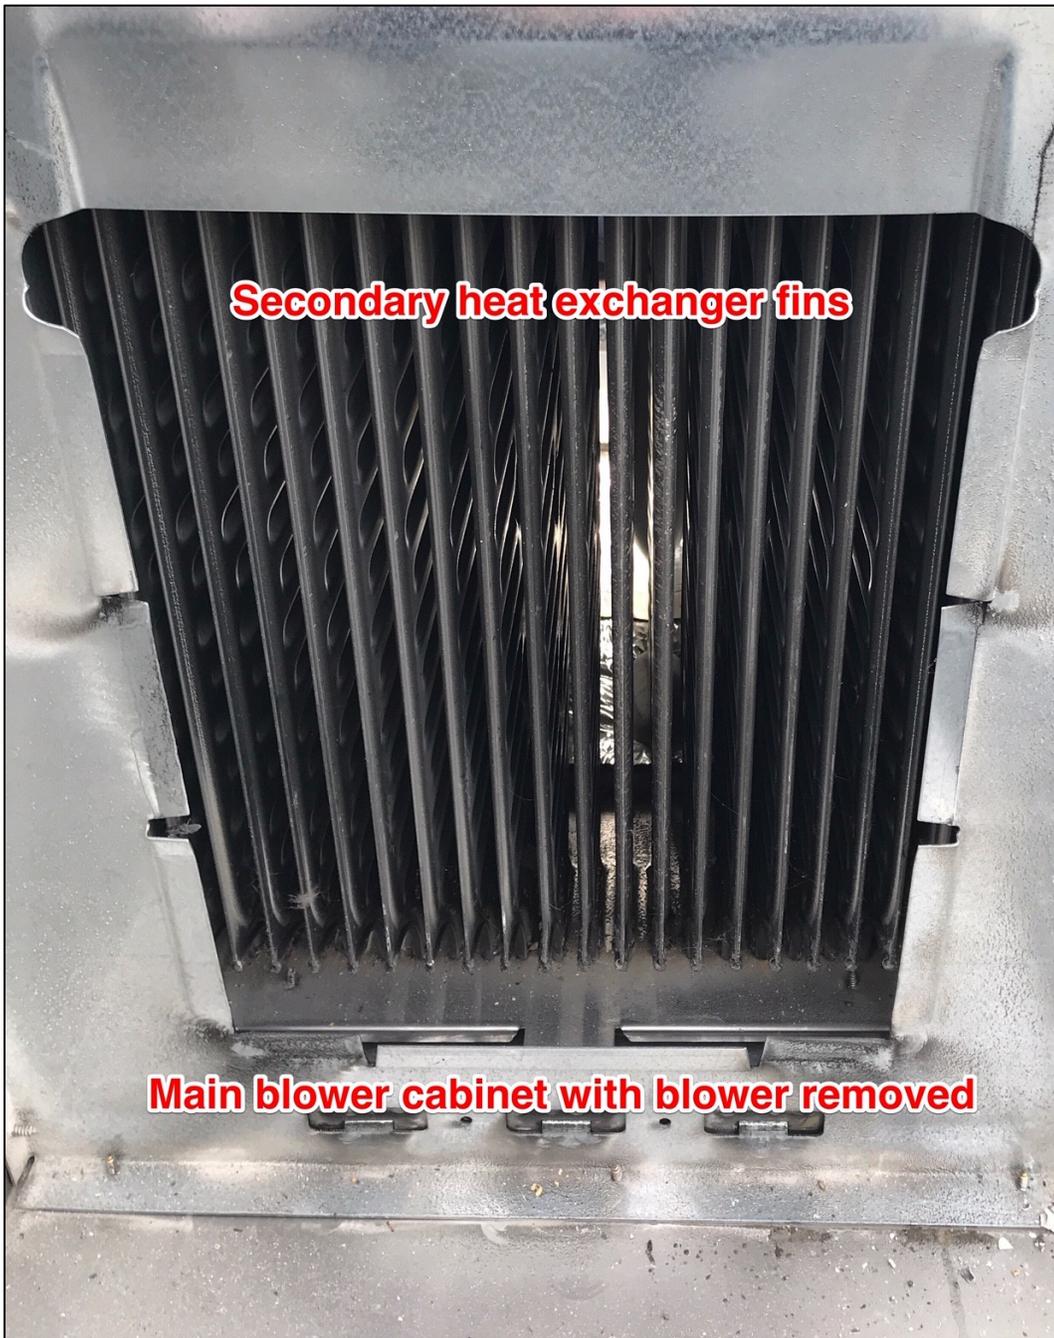
Image 7 - The main blower blows air up through the secondary heat exchanger then through the primary heat exchanger above it.

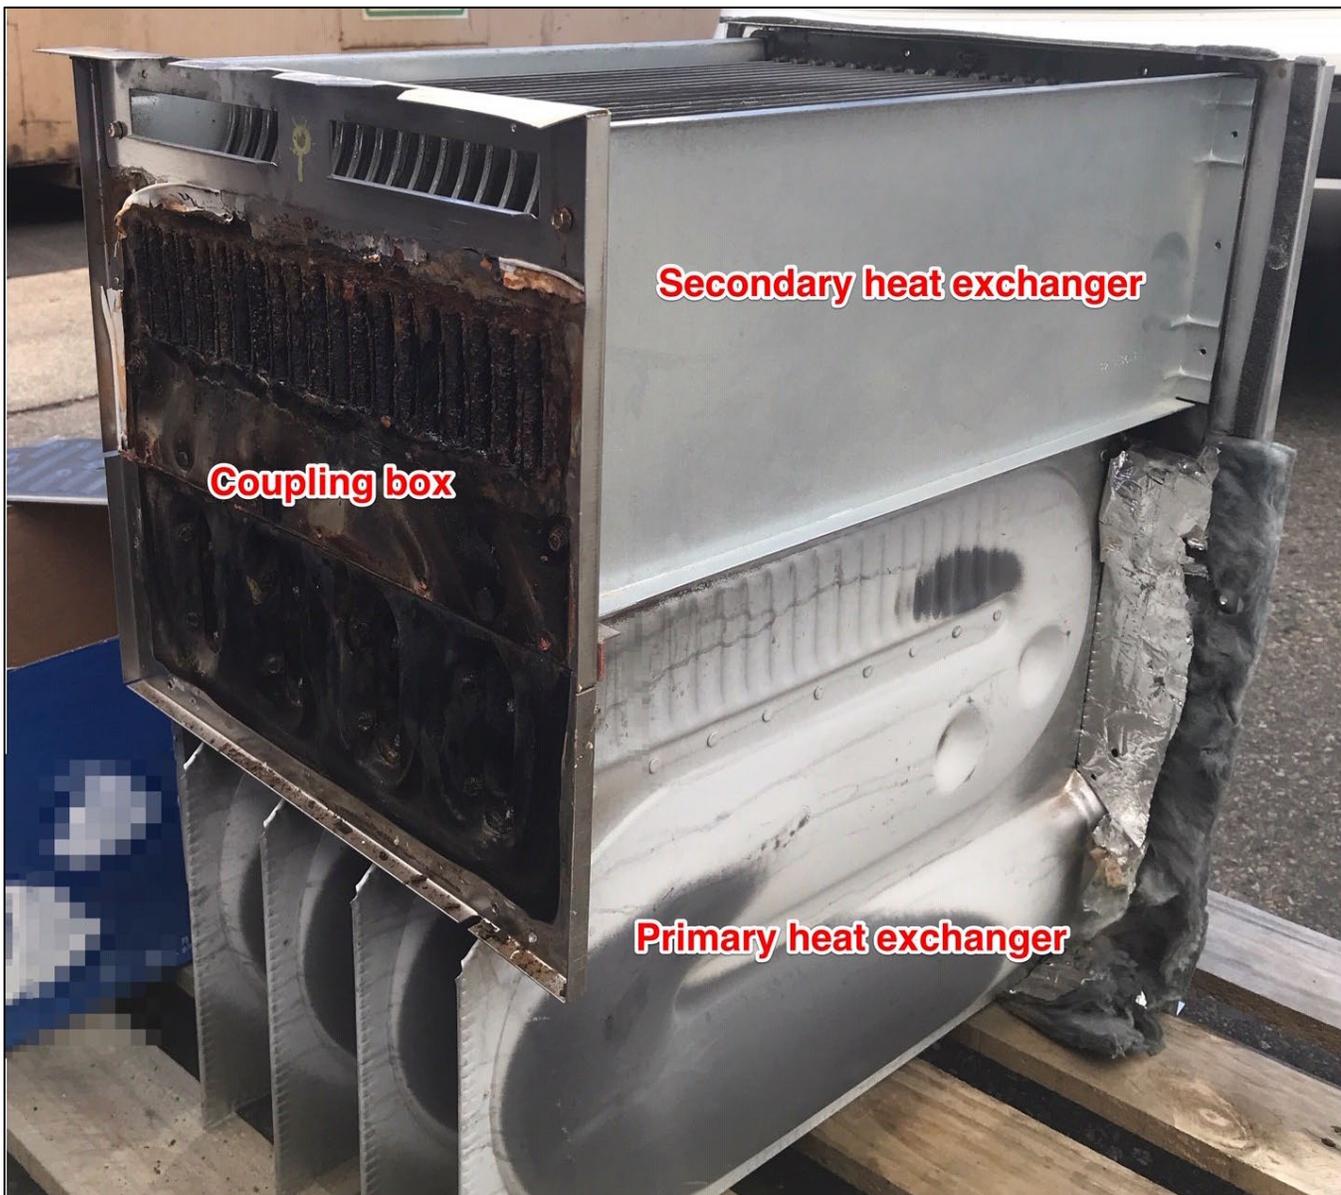
Image 8 – Complete heat exchanger assembly removed from furnace for examination (coupling box cover and baffle removed in this image). The heat exchanger is sitting upside down from its up flow operational position. Combustion products from the gas burners travel through the S-shaped primary heat exchanger to the coupling box and then pass through the secondary heat exchanger tubes before being expelled to the outdoors by the draft inducer fan through the vent piping.

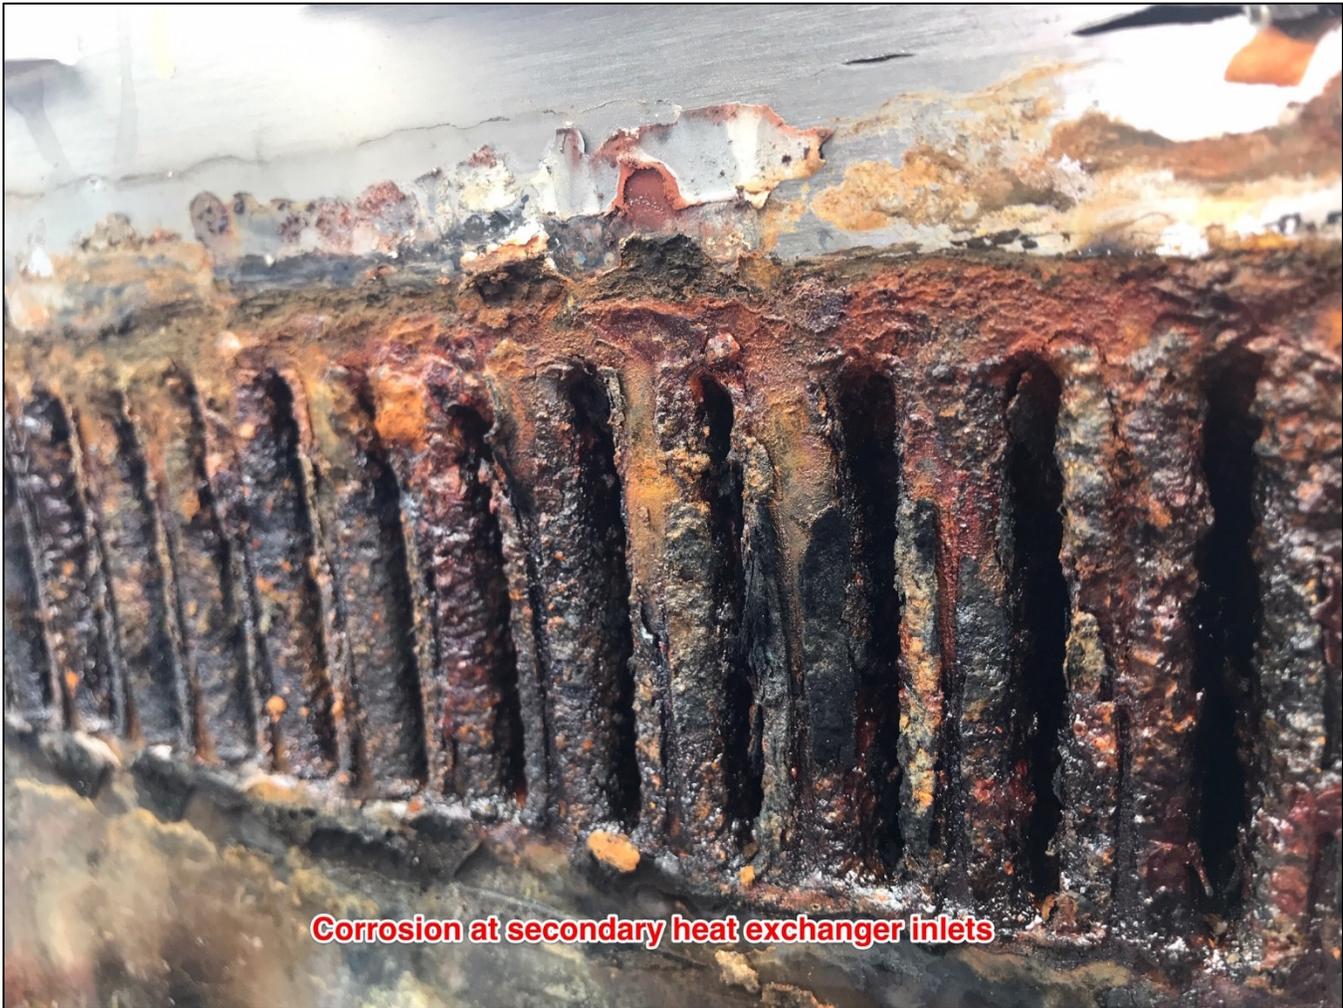
The furnace was shut off and removed for replacement. No incorrect installation characteristics were observed prior to the removal of the furnace that may have contributed to a premature failure. The furnace was examined by engineers at a laboratory to determine the cause of failure. The inlets to the furnace's secondary heat exchanger tubes had corroded and the interior polypropylene lining had delaminated which restricted the airflow through them. The restricted airflow reduced the amount of air at the point of combustion in the burner box (Images 9-11). The unbalanced air/fuel ratio produced elevated levels of carbon monoxide in the flue products.

Image 9 – Close up of secondary heat exchanger tube inlets in coupling box showing severe corrosion.

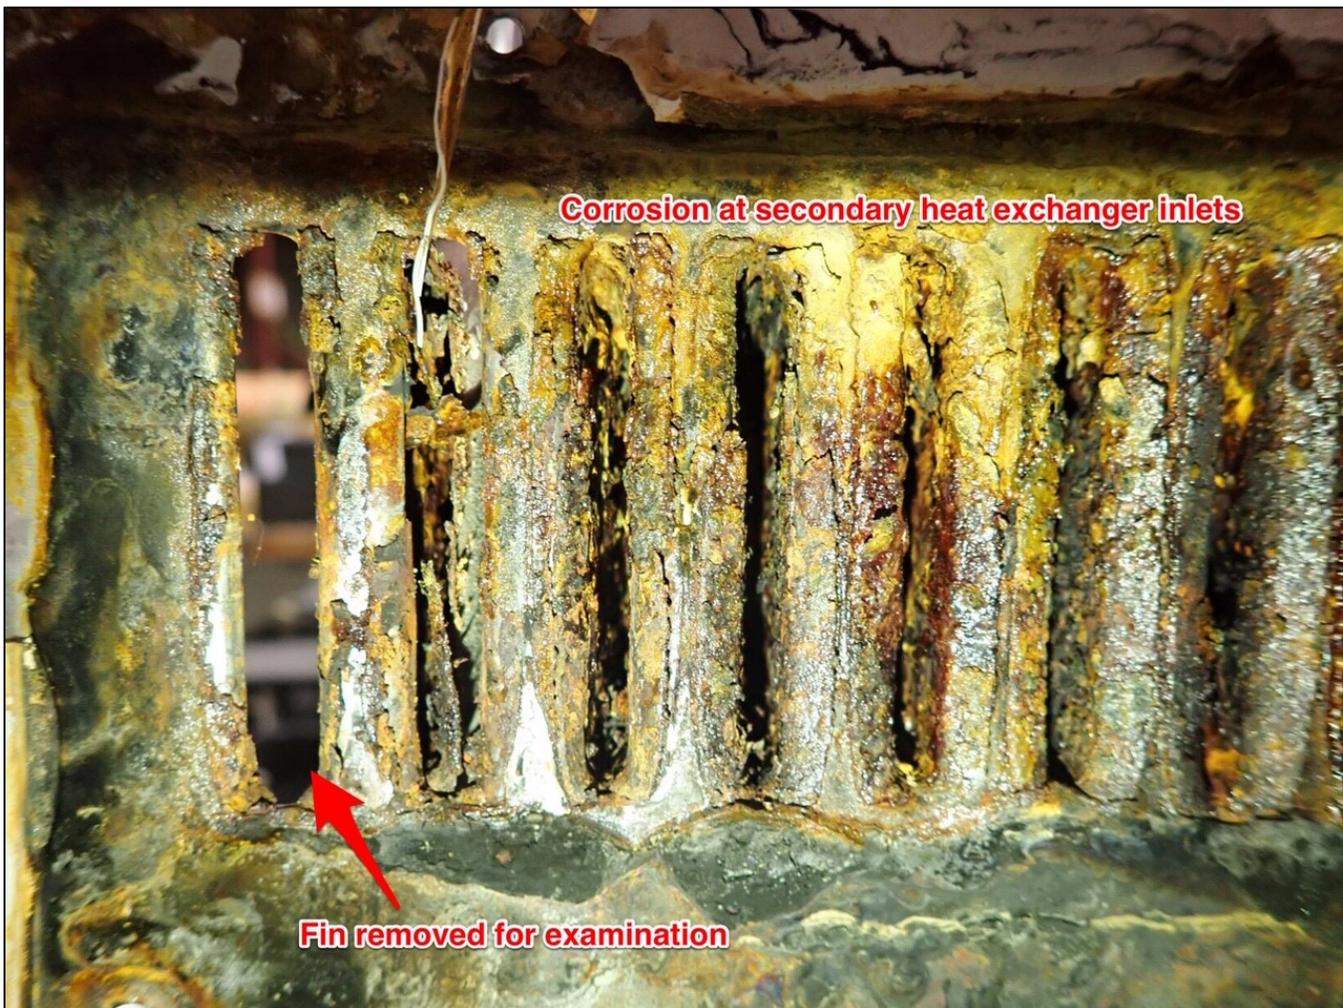
Image 11 – Secondary heat exchanger tube inlets with one tube completely removed for examination. Image shows corrosion, delamination of polypropylene liner and restricted passages.
