Incident Summary #II-1136528-2021 (#20560) (FINAL)

SUPPORTING INFORMATION	Incident Date	January 26, 2021	
	Location	Surrey	
	Regulated industry sector	Gas - Natural gas system	
	Impact	Qty injuries	3
		Injury description	Three individuals were found in medical distress due to exposure to carbon monoxide (CO) in a residential home. The occupants were reported to have lost consciousness or were unresponsive. The three individuals were taken to hospital and were treated for CO poisoning.
		Injury rating	Major
	Damage	Damage description	NA
		Damage rating	None
Incident rating	Major		
Incident overview	A natural gas fired boiler used for hydronic heating in a residential home produced high levels of CO. The CO was able to infiltrate into the occupied space causing hazardous exposure to occupants of the home.		
INVESTIGATION CONCLUSIONS	Site, system and components	<p>The home utilizes a natural gas fired boiler as the main source of heat. The boiler uses the combustion of natural gas to heat water which is circulated to radiators within the home providing heat for the spaces.</p> <p>The flue gas from combustion is drawn through natural convection up a venting system designed to safely e

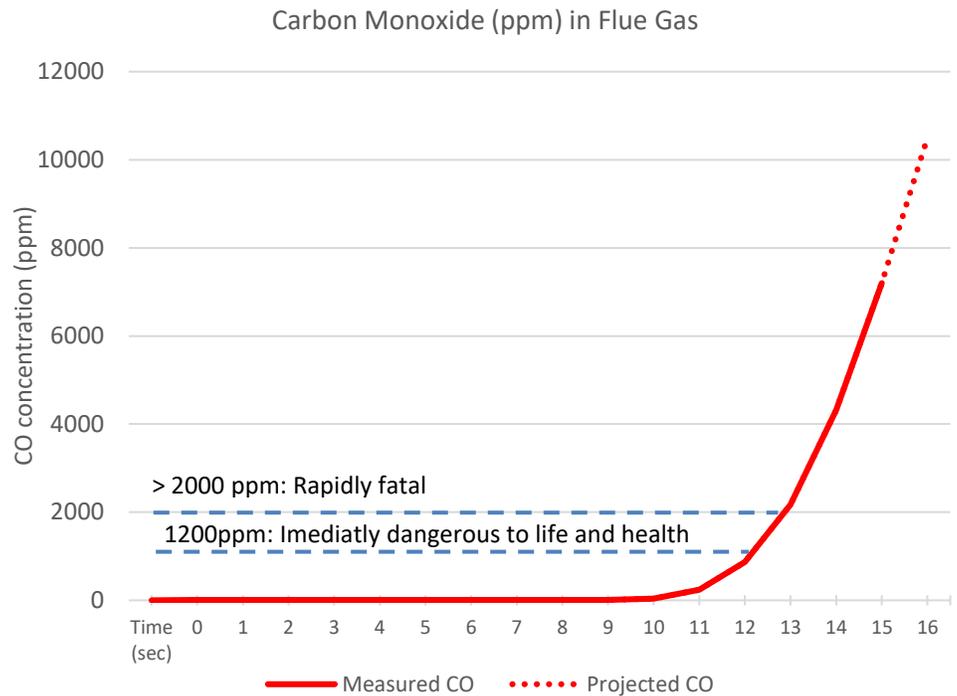
A combustion analysis test of the boiler flue gas was conducted. With only the pilot burner in operation, the CO in the flue gas measured a steady 8 ppm. When the main burners were lit the CO level stayed steady for the first 8 seconds then rapidly rose to beyond the 7200 ppm maximum reading of the instrument in an additional 7 seconds (Figure 1).

Figure 1 – CO concentrations in the flue gas of the boiler with the main burners on. Rapidly fatal and immediately dangerous to life and health (IDLH) CO concentrations ref. Chart 2

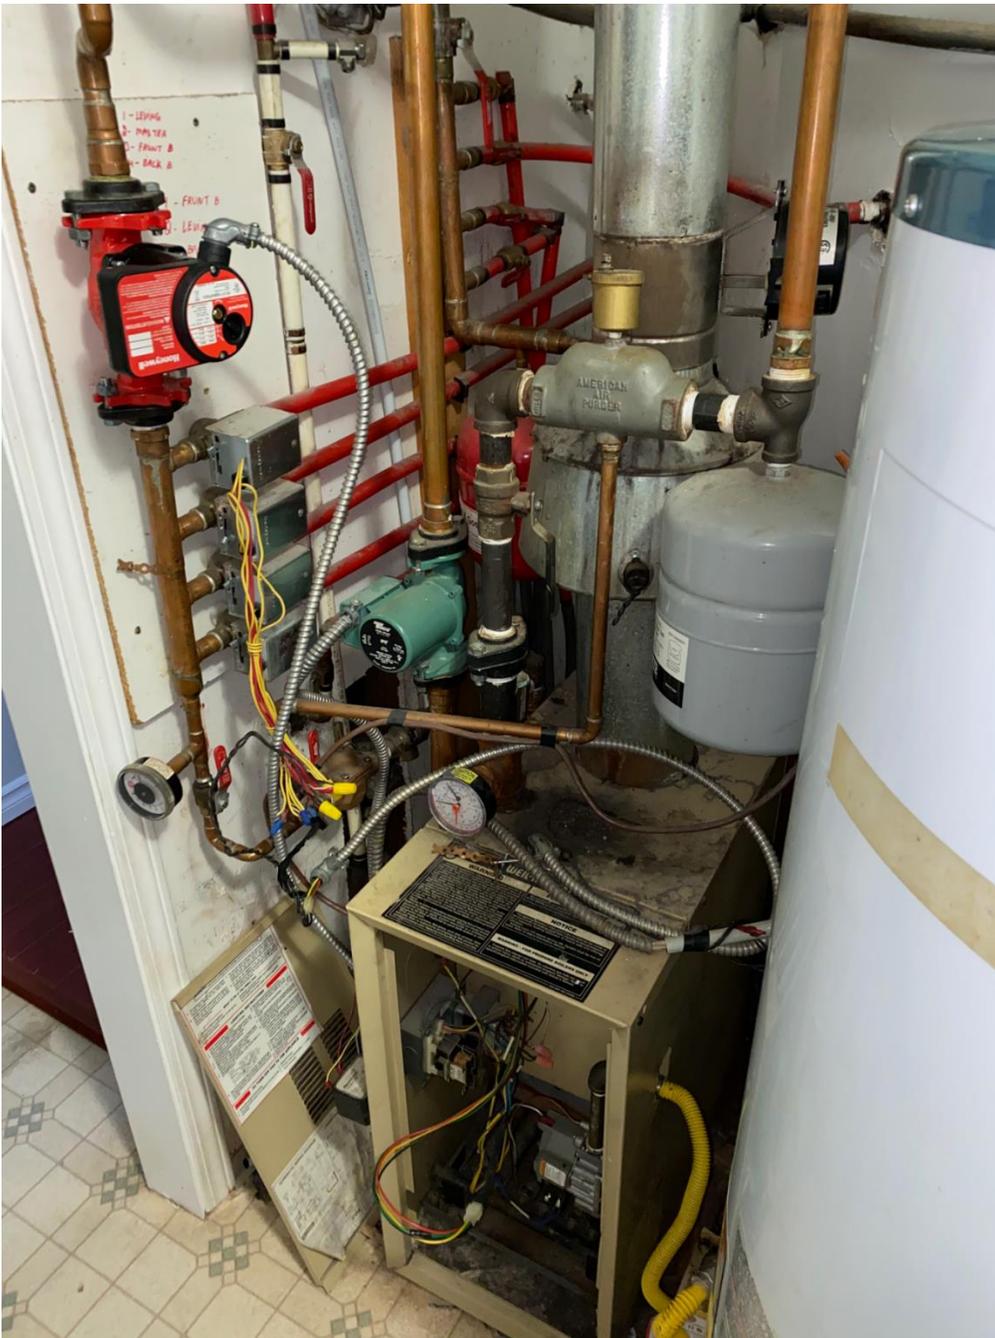
Image 1 – Natural gas fired boiler installed on main floor of home

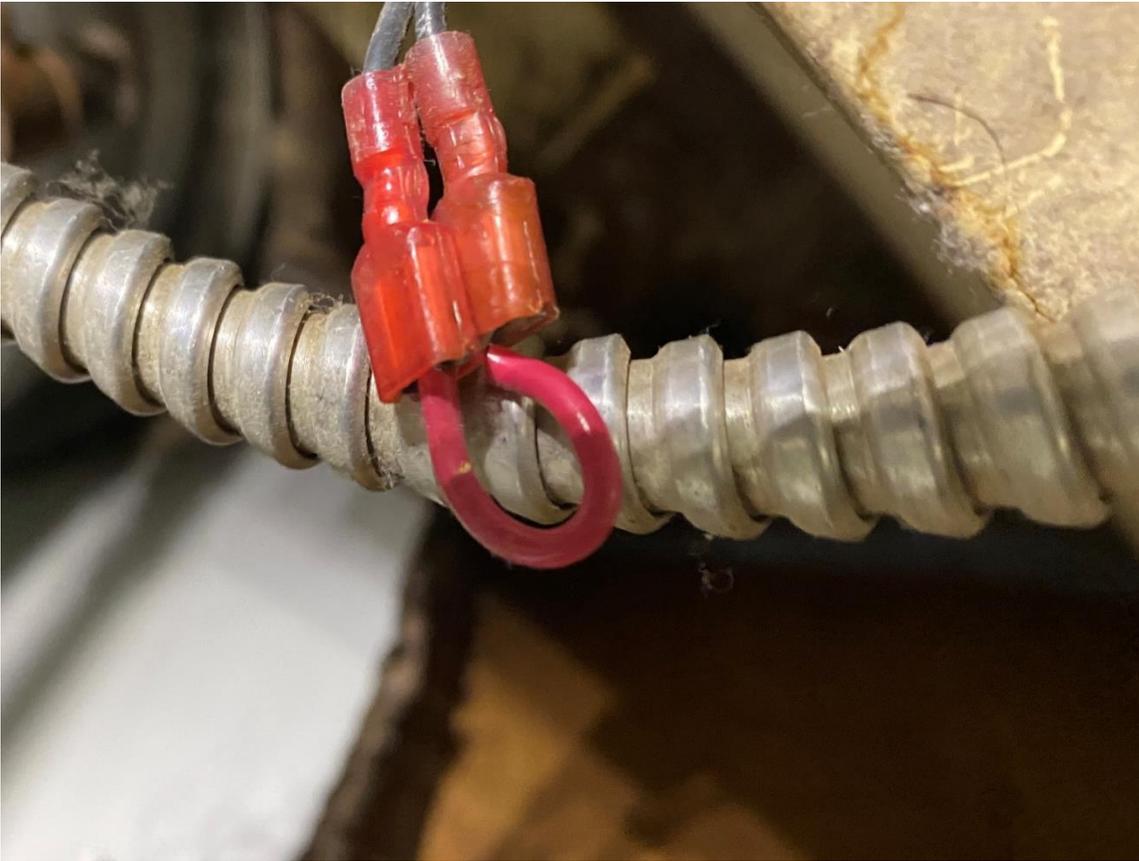
<p>Facts and evidence</p>	<p>Site examination</p> <p>Site visits were conducted by investigators after the incident. The following was observed during examination of the gas equipment:</p> <ul style="list-style-type: none"> • The home was heated by a natural gas fired boiler • The boiler had electrical wires known in industry as “jumpers” bypassing the venting spill switch and the damper motor end switch (Images 2-3)

Image 2 – Jumper #1 electrical wire bypassing the draft hood spill switch

- They were unaware of wire jumpers that were installed bypassing the damper motor and spill switch
- They were unaware of the oversized pilot burner orifice or soot and carbon buildup in the venting and heat exchanger

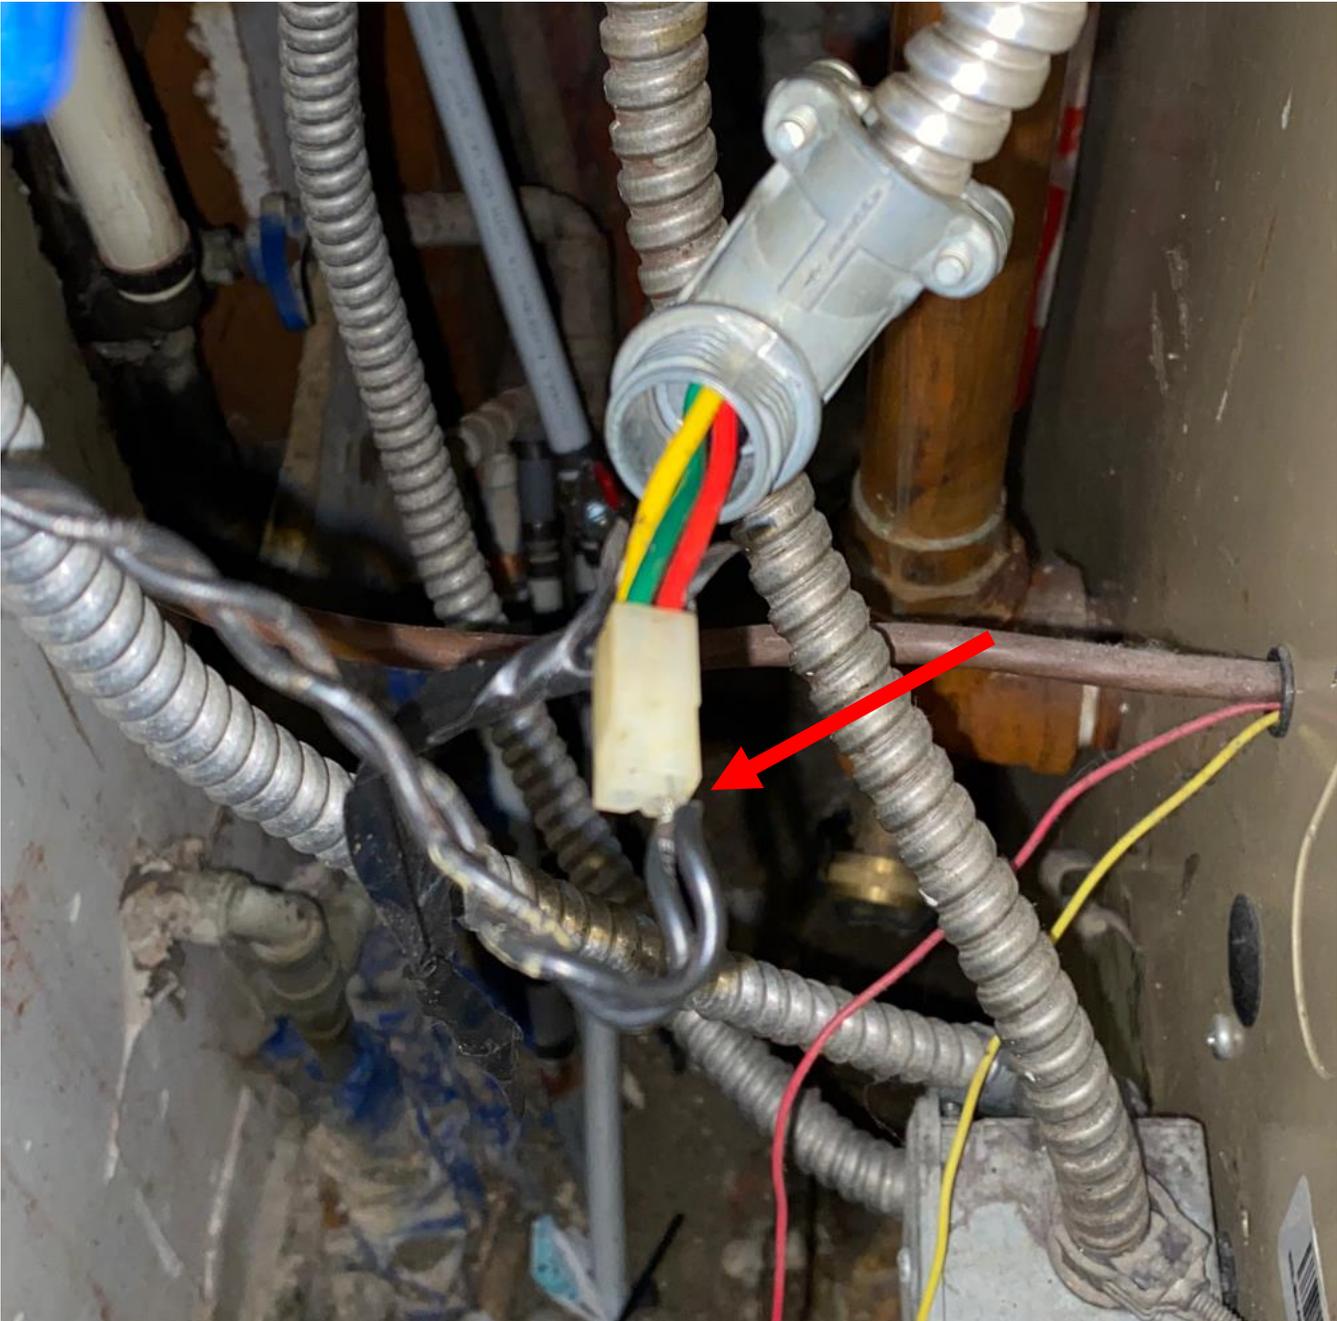
Image 3 – Jumper #2 electrical wire bypassing the damper motor end switch

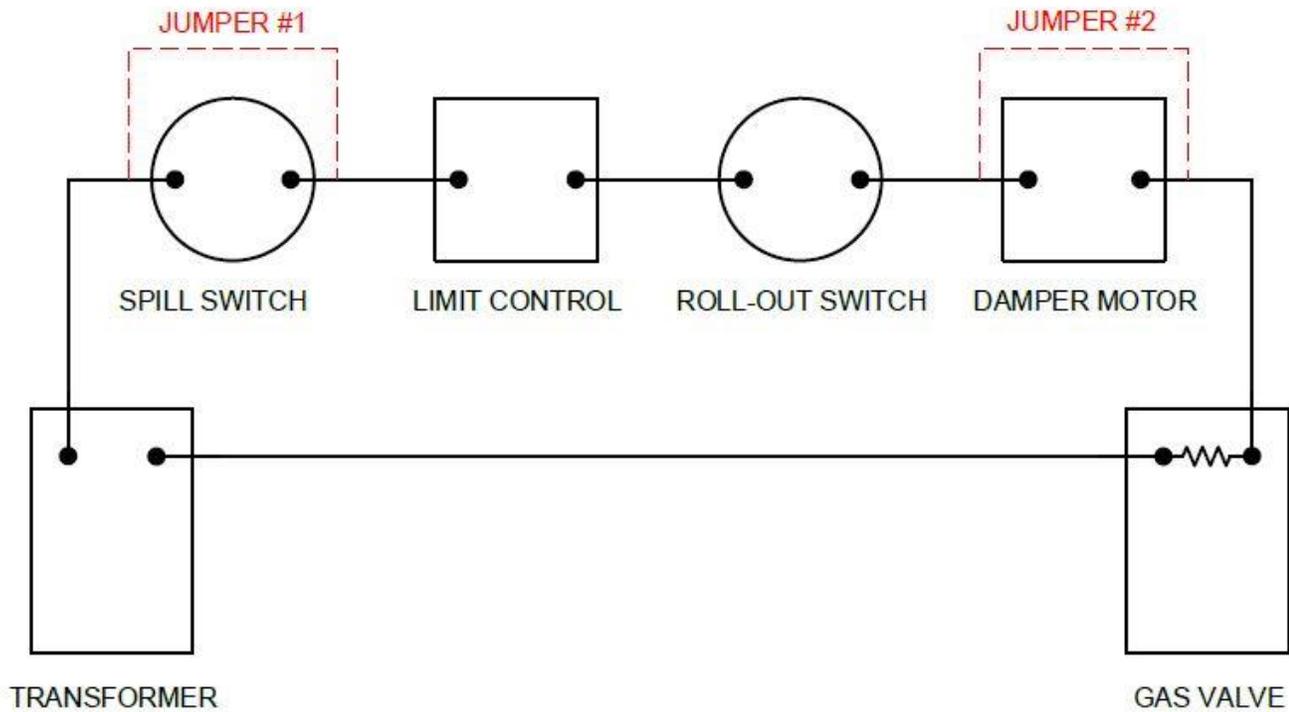
Image 4 – Wiring diagram identifying how the vent spill switch and damper motor position end switch were bypassed with “jumpers” allowing the gas valve to operate

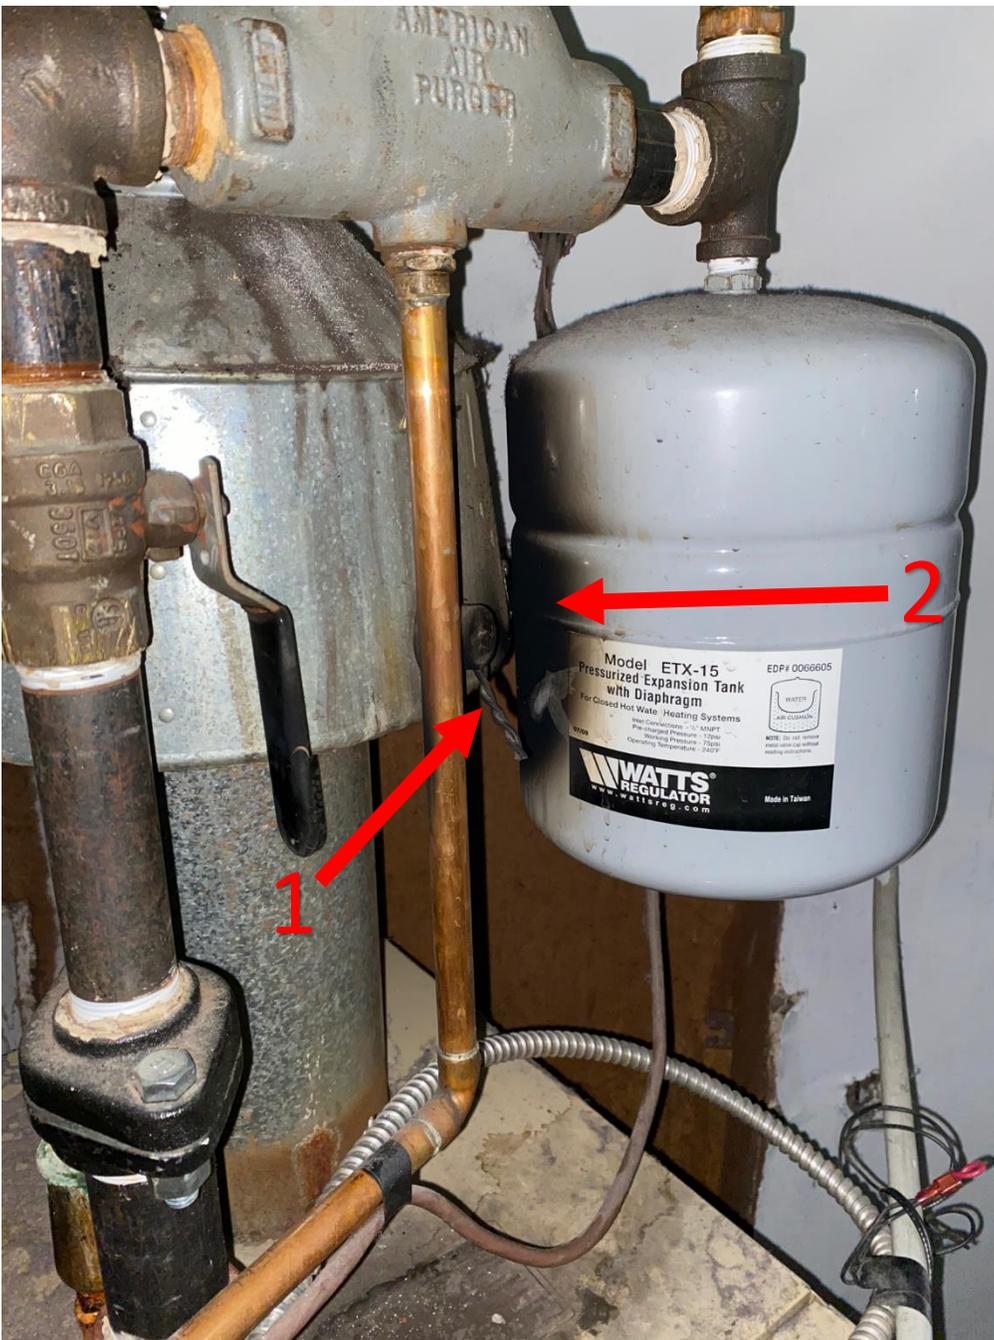
- Soot and carbon were observed on the pressure tank next to the draft hood, inside the venting system, the damper and behind the burner cover plate (Image 5)
- Heavy sooting and carbon deposits were observed above the main burners restricting the flue passages through the heat exchanger (Image 6)

Image 5- Wires to the venting spill switch had been cut (1) and soot visible on expansion tank (2)

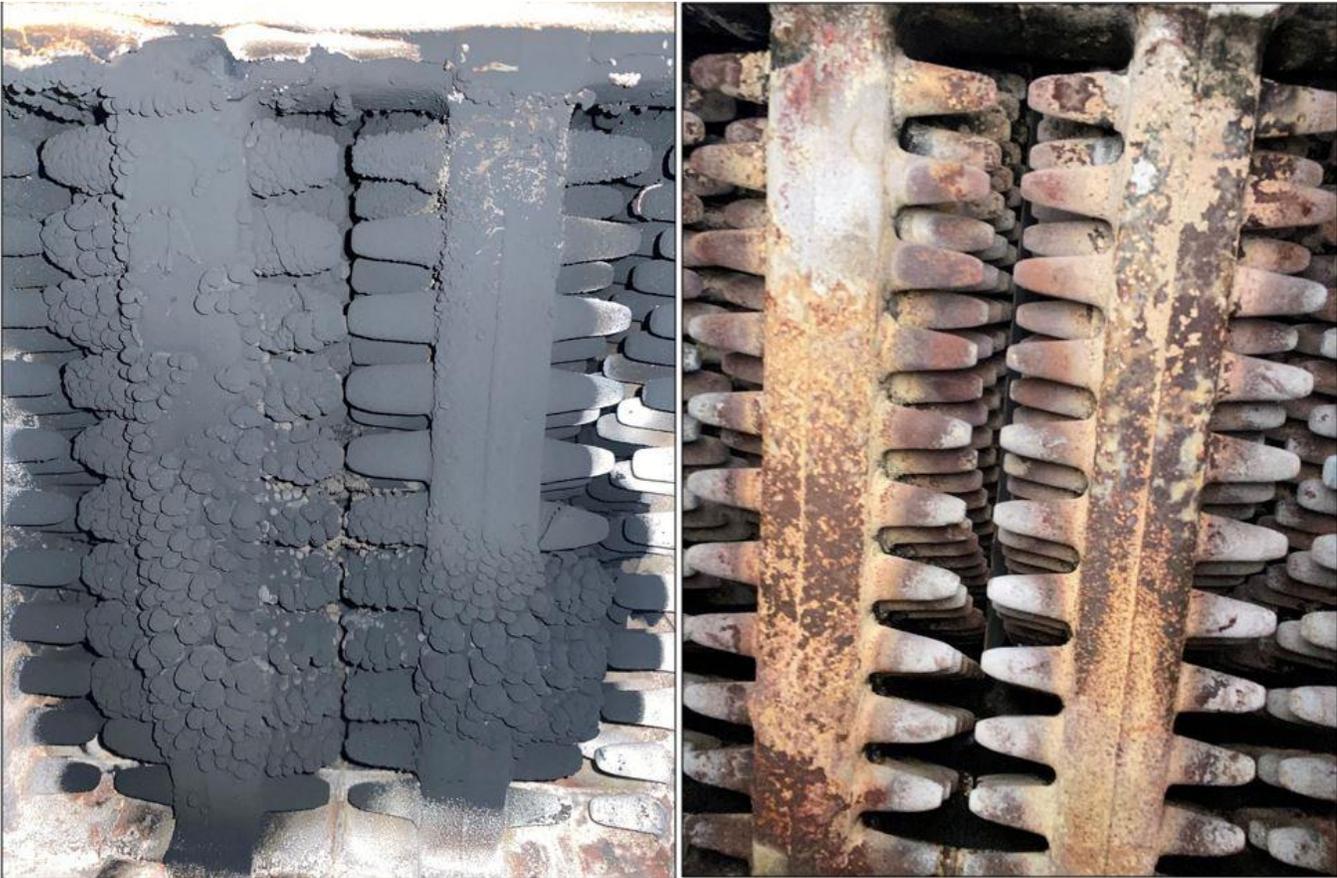
Image 6 – Soot and carbon deposits found on the boiler heat exchanger following the incident (left) and after cleaning (right). The soot and carbon deposits restricted the flue gas passage through the heat exchanger.

The pilot orifice for the boiler had been enlarged, possibly to address the issue of delayed ignition of the main burners that were causing a “booming” noise. This resulted in a very large and lazy pilot flame. The flame generated soot and carbon which collected on the interior of the boiler and venting system. This restricted the flue passages above the main burners through the heat exchanger. The restriction caused an insufficient amount of combustion air to be drawn into the main burners and combustion chamber resulting in the production of extremely high levels of CO and the spilling of flue gas containing CO into the occupied space of the home.

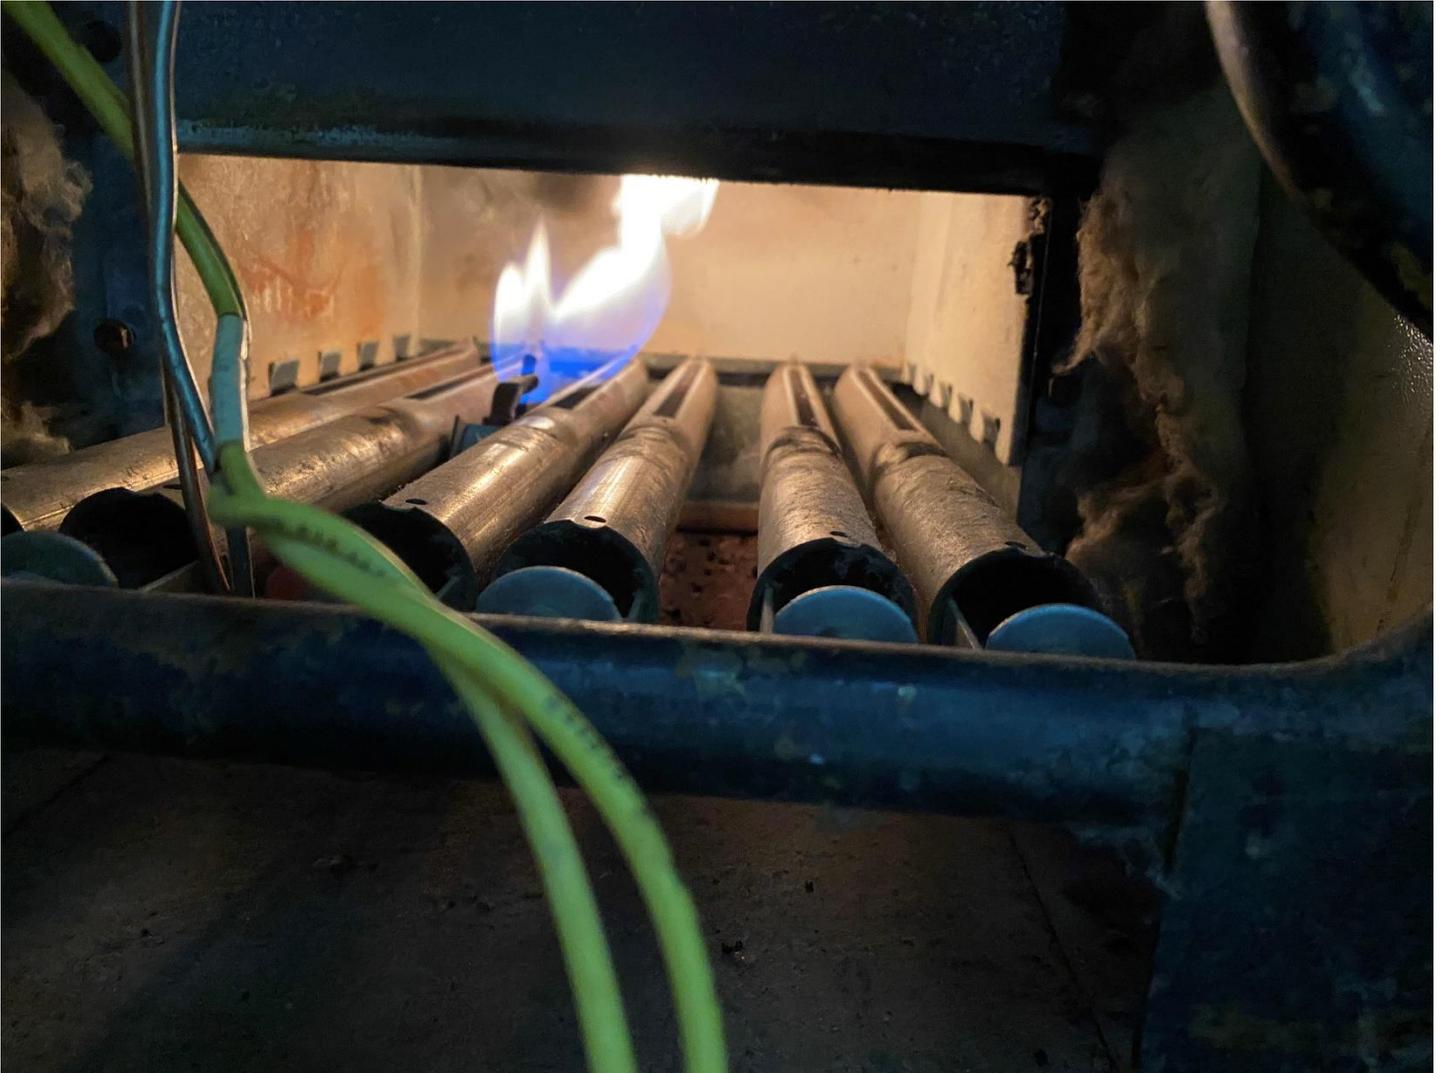
- Two gas fireplaces upstairs had been shut off and not used in 20+ years
- The natural gas hot water heater was operating correctly and was not a source of CO in the home
- No other potential sources of CO were identified other than the boiler
- The pilot burner flame for the boiler was extremely large and produced a lazy yellow flame (Image 7)
- The orifice for the gas pilot burner had been enlarged from an original factory size of 0.018" to 0.0465" (#56 drill size)
- The enlarged pilot orifice size increased the pilot burner input from the original factory rating of 823 btu/hr to 5490 btu/hr
- Their expert opinion was that the enlarged pilot flame would be the source of the soot and carbon deposits found inside the boiler and venting system

Image 7 – Boiler pilot flame in operation. The boiler operating manual states that a proper pilot flame is blue with the inner cone engulfing the thermocouple and an overfired pilot flame with lack of primary air will have a large lifting flame with a yellow flame tip as seen in the image and here: [Pilot flame video](#).

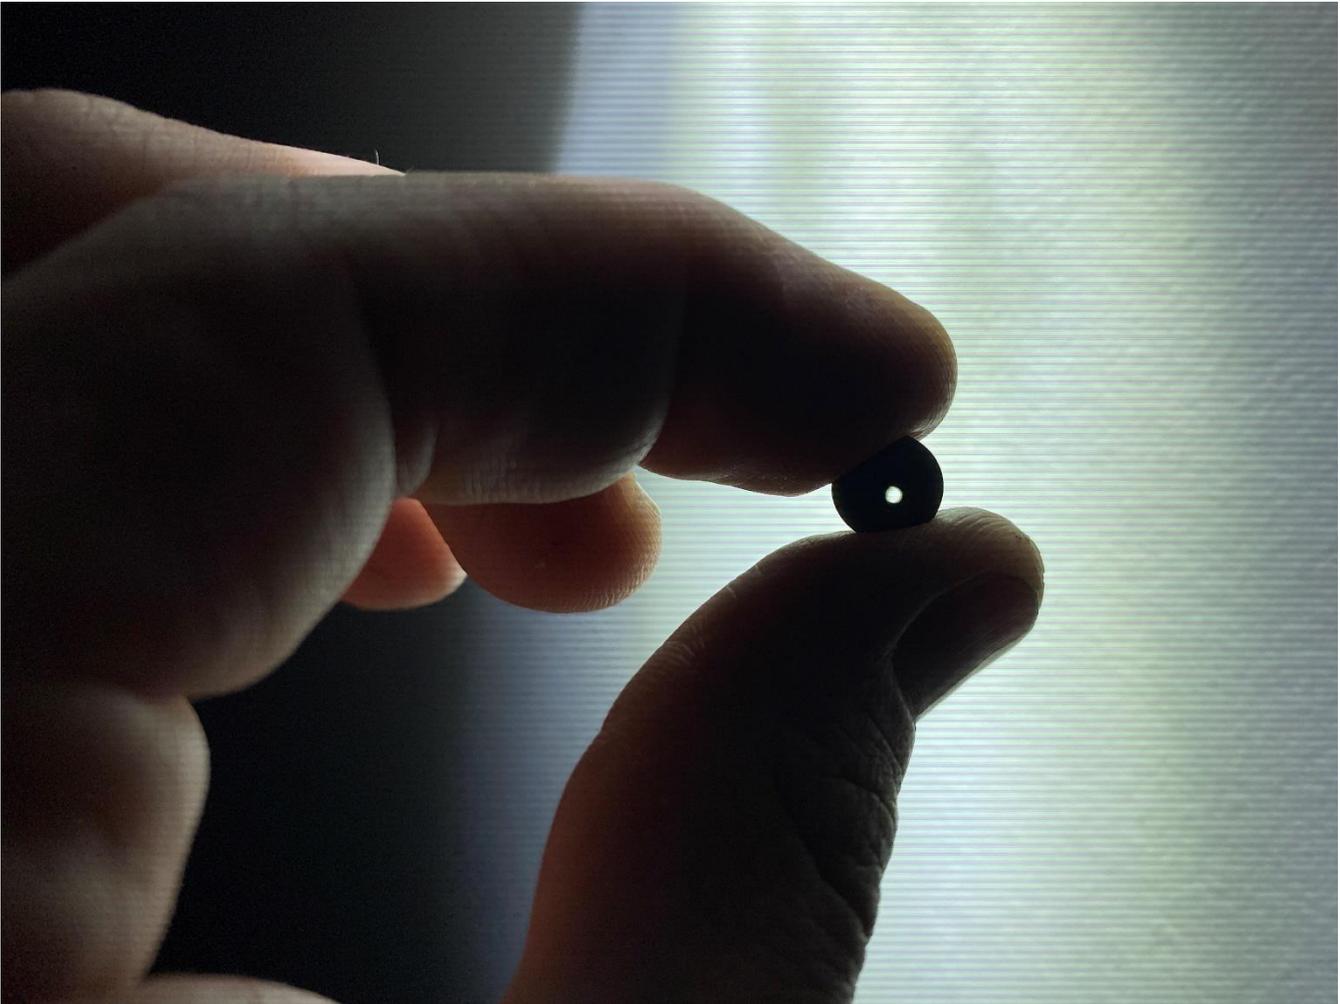
It is highly likely that the oversizing of the pilot orifice led to a pilot flame that deposited soot and carbon on the inside of the boiler which caused the incident.

Image 8 – Pilot orifice showing the enlarged size of the gas flow opening

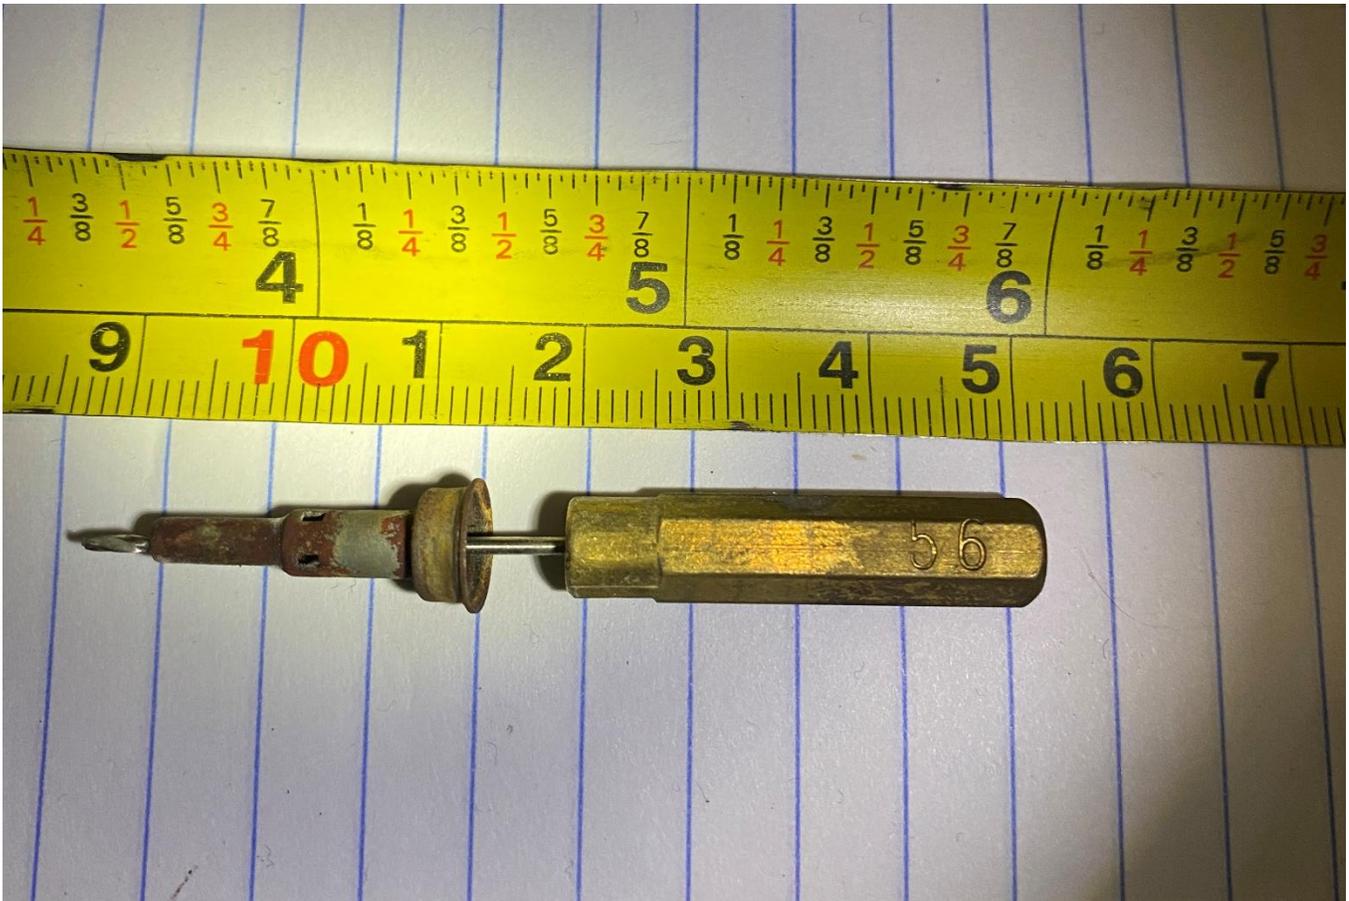
Image 9 – Pilot orifice with a #56 orifice drill (0.0465”) inserted to measure the size of the enlarged gas flow opening
