Appendix B - Site and equipment

Technical Safety BC investigated an incident that occurred on May 26, 2022, involving refrigeration equipment at an ice making facility in Kamloops. The site consisted of two ammonia refrigeration systems:

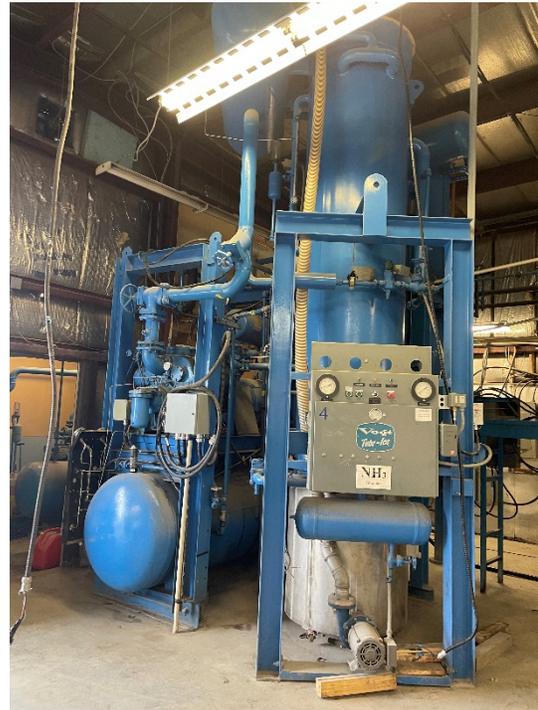
Figure 4: P34 Skids Pre-Incident; high-pressure receiver and compressor on left; freezer and hand expansion valve on right

The rest of the P34 was assembled on two separate skids. One skid containing the high-pressure receiver, compressor, and associated equipment. The other skid containing the freezer, hand expansion valve, and associated equipment. (Figure 4). Both skids were installed side by side in the NW corner of the ice making room near the main bay door.

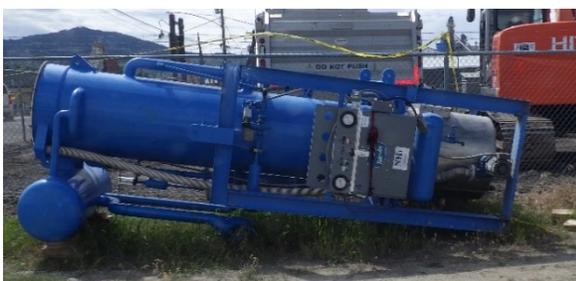
Figure 7: P34 Freezer as Found (Left) and Piping Configuration (Right) Post Incident

Every valve on the freezer skid was found to be closed and many pipes were cut as depicted in Figure 7. The freezer had a control panel with 2 pressure gauges. These gauges both read 0 PSI.

The two pressure gauges on a control panel were installed to measure pressure at the suction accumulator and at a strainer along the system thaw gas line. Neither of the gauges were installed to provide information regarding the pressure within the P34 high-pressure receiver.

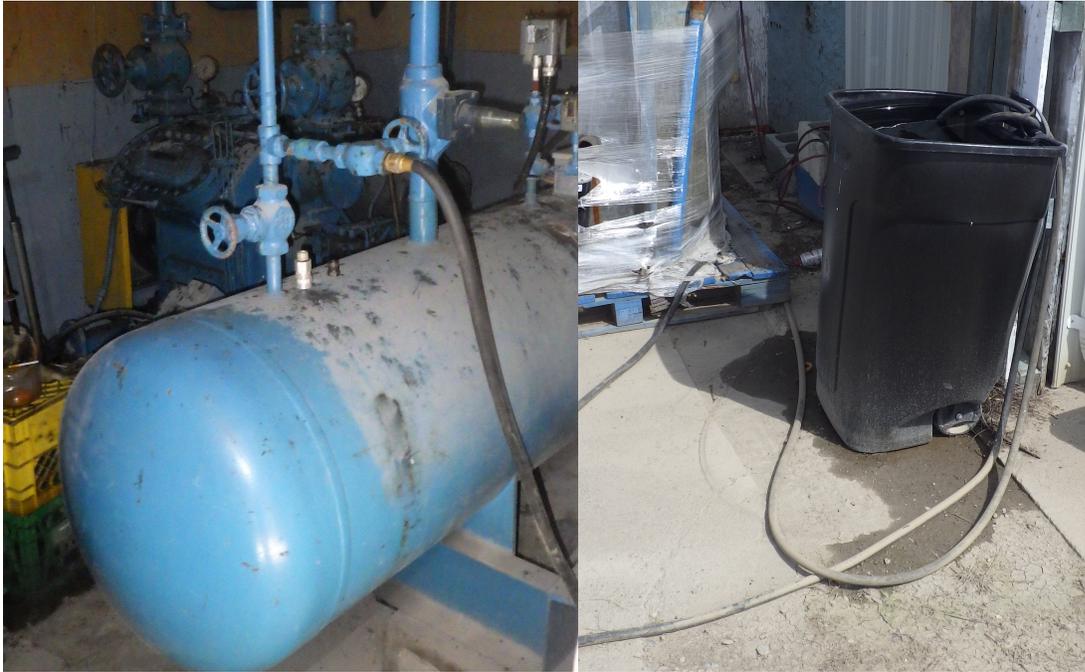
Figure 13: Hose connected to the P24 high-pressure receiver (left) and piped into a garbage bin outside (right)

There was a garden hose attached to the outlet of valve #3 on the P24 high-pressure receiver. This garden hose was piped outside and into a black garbage bin at the NW end of the building addition (Figure 13). There was another hose in the garbage bin that was connected to the building water supply.
