## Incident Summary (5611963) Final

SUPPORTING INFORMATION	Incident Date		February 15 2017	
	Location		Langley BC	
	Regulated industry sector		Electrical •Low voltage electrical system (30V to 750V)	
	Impact	Injury	Qty injuries	1
			Injury description	Electrical shock sustained to lower right leg(calf area). Visible swelling to described area
			Injury rating	Minor
	Damage		Damage description	Electrical shock occurred, receptacle to device box attachment failure. Exposed energized conductors and receptacle terminals
			Damage rating	Moderate
Incident rating		Moderate		
Incident overview		A device box housing a wall receptacle has malfunctioned, the receptacle is no longer attached to the device box and the energized receptacle terminals and branch circuitry wiring are exposed. Energized equipment has caused a shock to a person.		
INVESTIGATION CONCLUSIONS	Site, system and components		<ul style="list-style-type: none"> <li>•Receptacle: 15 amp, 120 volt duplex receptacle with metal mounting screws located at top and bottom of the receptacle frame</li> <li>•Device Box: Single device, yellow plastic box with threaded holes at top and bottom to accept receptacle mounting screws</li> <l

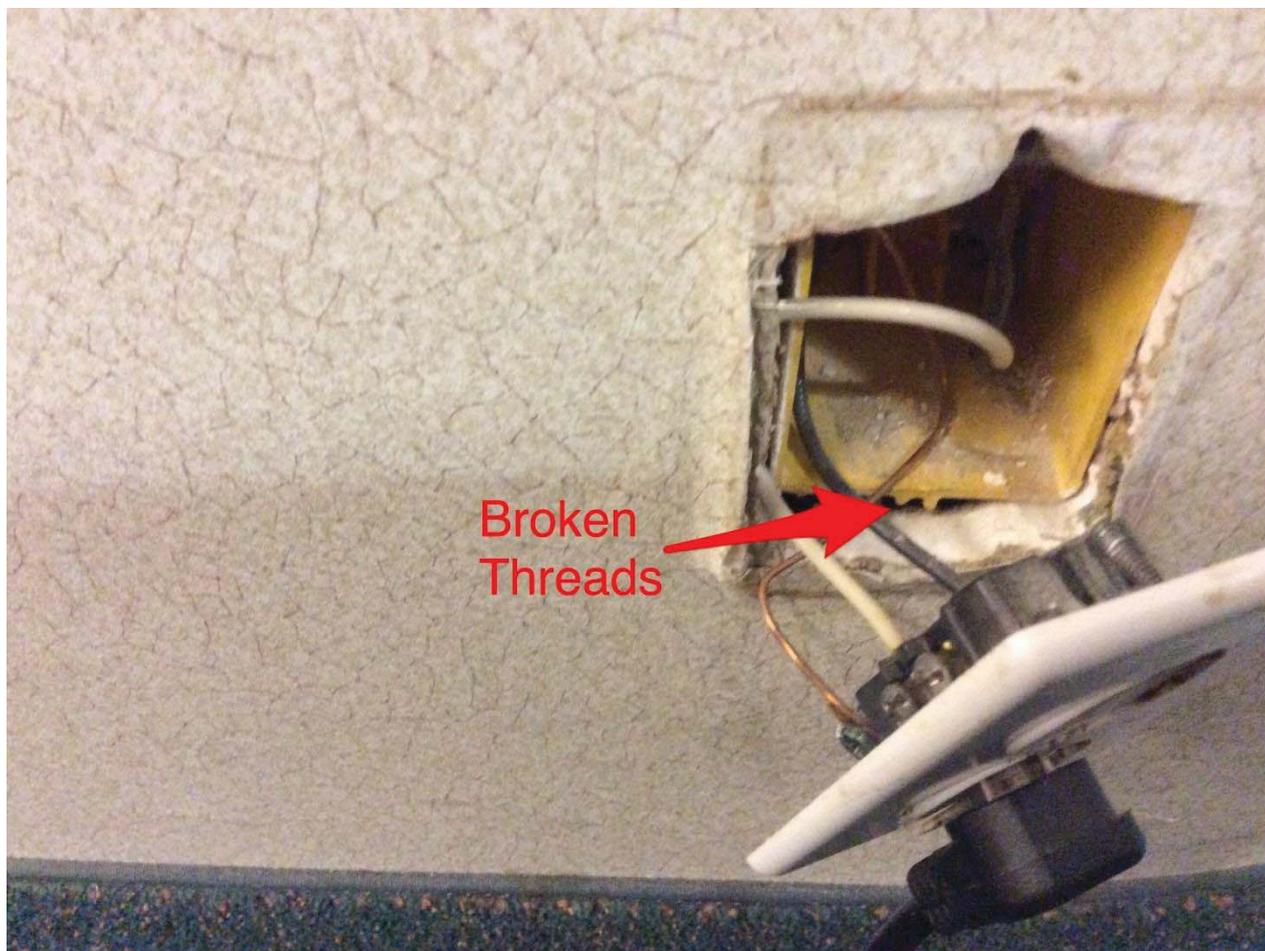
Receptacle at room entry,  
fridge plugged in and cover  
plate on.

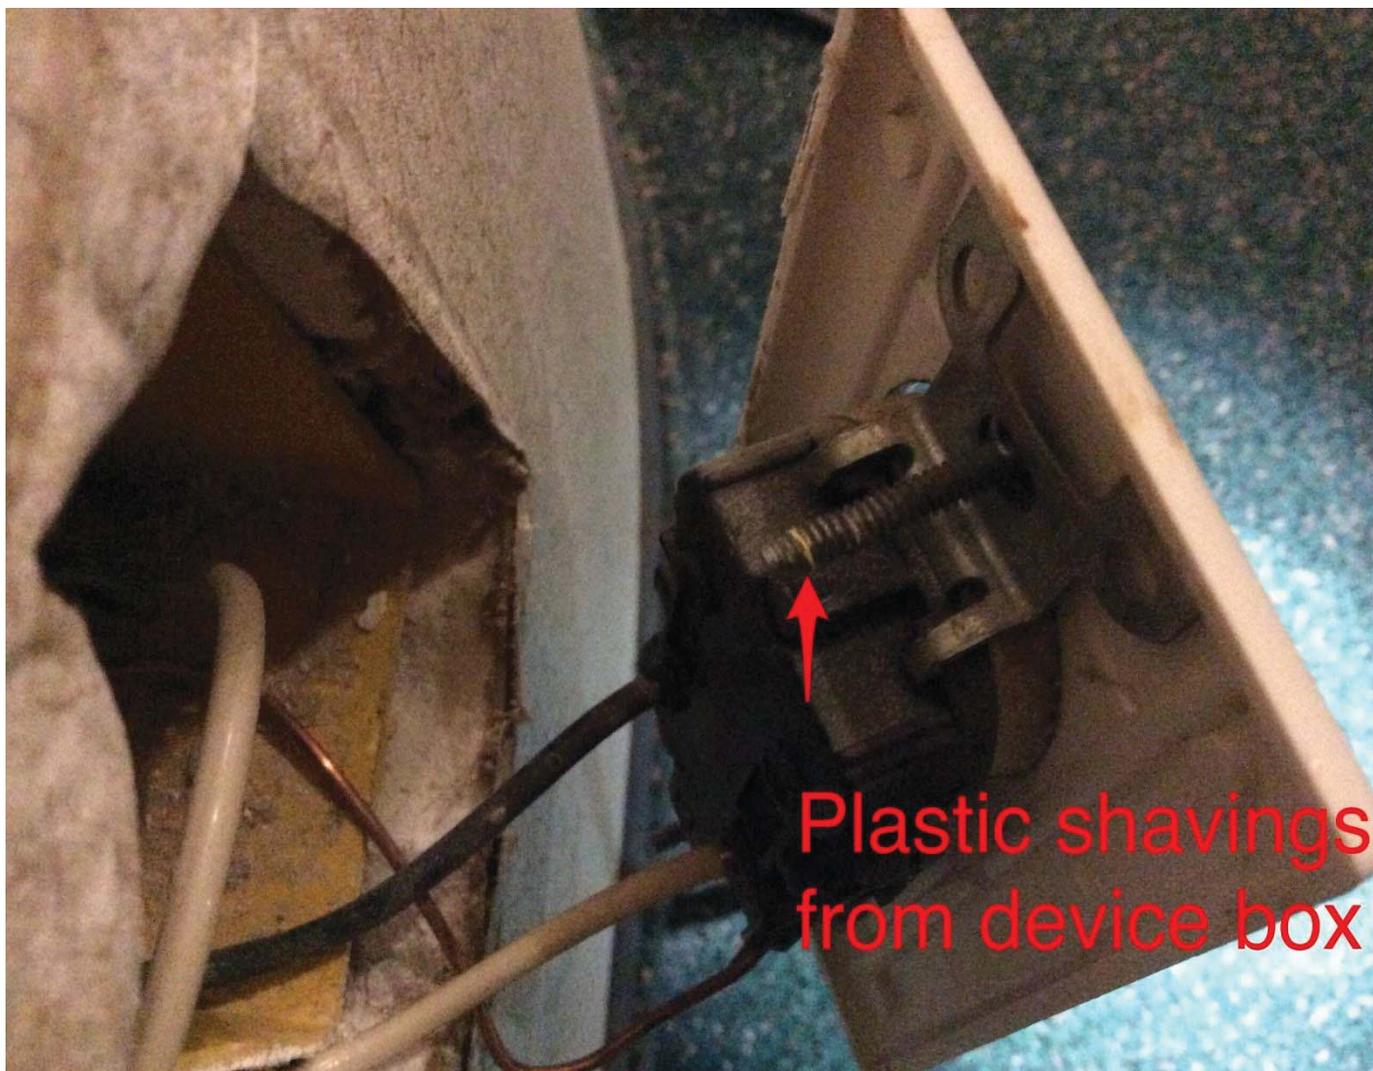
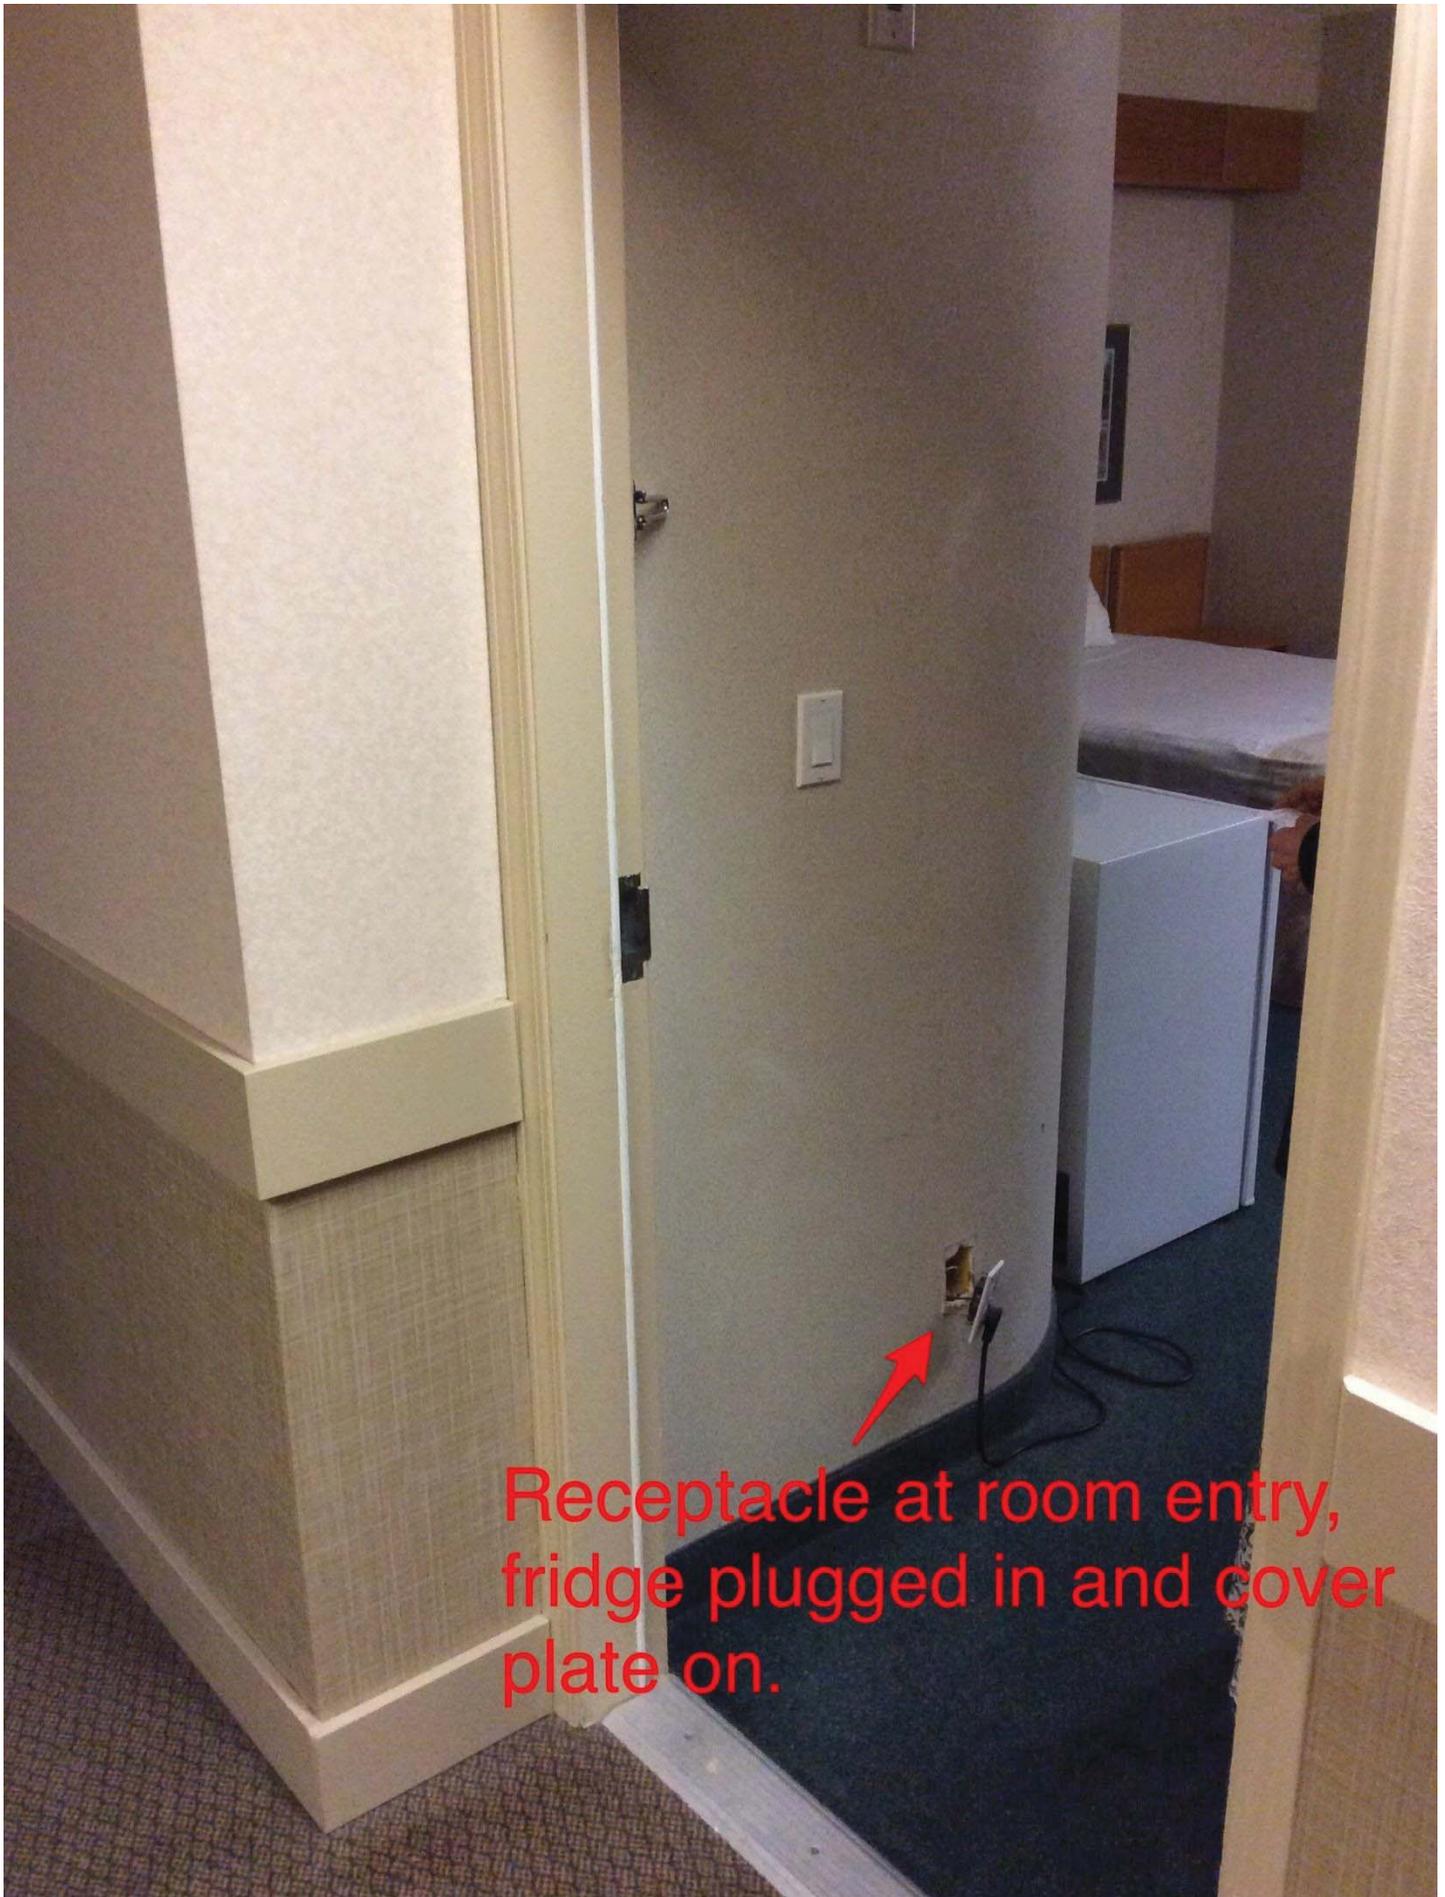
Failure scenario(s)		Repeated plugging and unplugging of electrical equipment into this receptacle causes a pushing and pulling force on the plastic and metal threads of the device box and receptacle mounting screws respectively. With time and repeated use of the receptacle the threaded metal screws may have worked to deteriorate the plastic threads of the device box. This would provide a scenario where the receptacle is no longer attached to the device box.	
	Facts and evidence		<p>Receptacle:• 15 amp, 120 volt duplex receptacle.</p> <ul style="list-style-type: none"> <li>• Cover plate attached to receptacle</li> <li>• Receptacle is not attached to device box at time of assessment</li> <li>•Fridge is plugged into this receptacle at time of assessment</li> <li>•Yellow plastic shavings found on receptacle mounting screw threads</li> <li>•Visual inspection of receptacle, terminals and cover – all components described are intact and not damaged.</li> </ul> <p>Device Box:•Single gang yellow plastic device box approved for non-metallic sheathed cable</p> <ul style="list-style-type: none"> <li>•Threaded hole located at top of box for receptacle mounting is intact.</li> <li>•Threaded hole located at bottom of box for receptacle mounting is broken through its entire length and no longer provides a threading/attachment means for a receptacle mounting screw.</li> </ul> <p>Branch Circuitry, Wiring inside device box:</p>

<ul style="list-style-type: none"> <li>•#12 gauge 2 conductor non-metallic sheathed cable, with integral #14 gauge bond conductor.</li> <li>• Wiring is plugged into back of receptacle in order to terminate, side wire binding screws are not in use.</li> <li>•Visual inspection of conductors in device box confirms wiring is in good order and not damaged or compromised.</li> </ul> <p>Relevant Information gathered during interviews:</p> <ul style="list-style-type: none"> <li>•Receptacle in question was confirmed to be the receptacle that is used during daily vacuuming and cleaning duties for the hotel room.</li> <li>•Repeated daily plugging and unplugging of electrical equipment by cleaning staff ,and general use by rental patrons would cause excessive wear and force on this receptacles mounting screws, potentially causing equipment failure.</li> </ul>
	<p>Causes and contributing factors</p>	<p>It is likely that repeated use of this receptacle, both general duty and daily cleaning equipment use, would have contributed to excessive wear and stress on the electrical equipment and threads. Metal screw threads on the receptacle are harder than the plastic threads of the device box, this would be a likely cause of the visible thread failure of the device box and minimal damage to the threads of the receptacle screws. Compressed branch circuitry inside the device box is likely a factor in pushing the receptacle out of the device box, thus exposing energized conductors and screw terminals providing an area for accidental contact.</p>
