## Incident Summary (II-637757-2018) (Incident ID #4284) (Final)

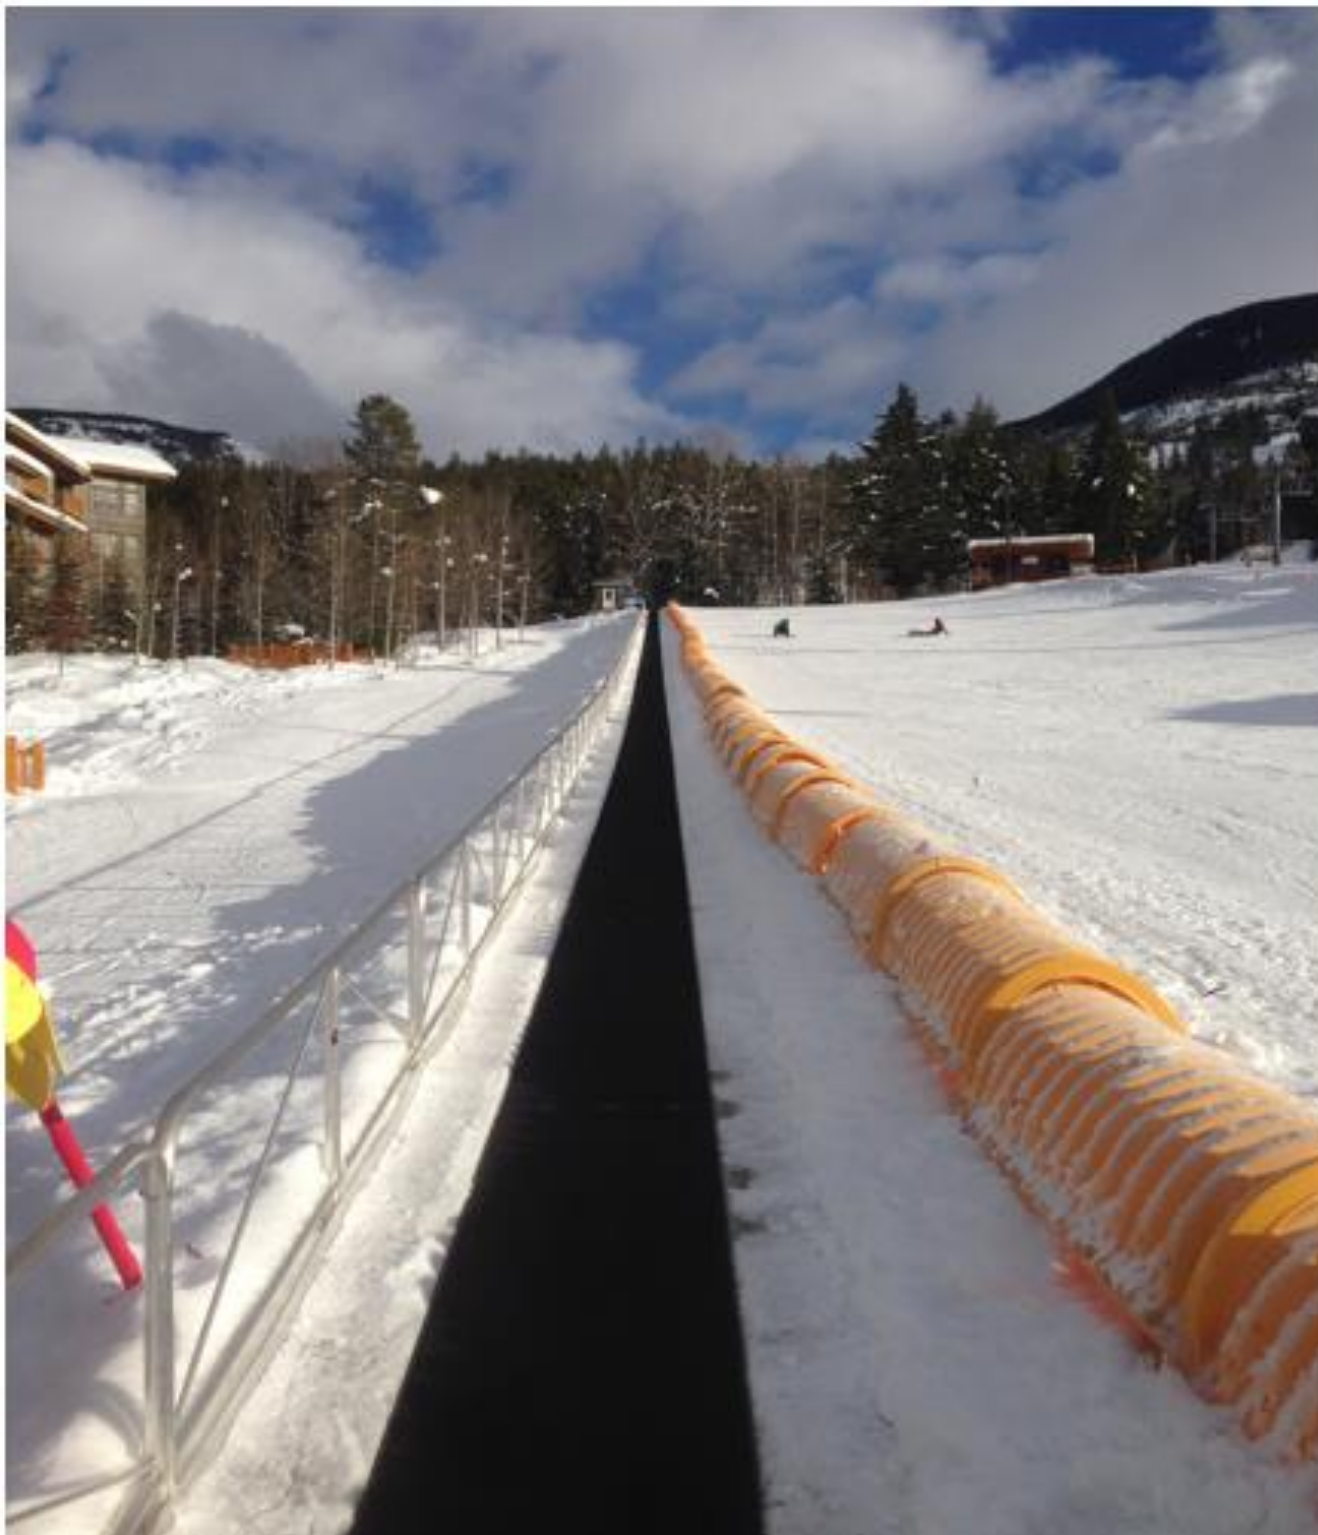
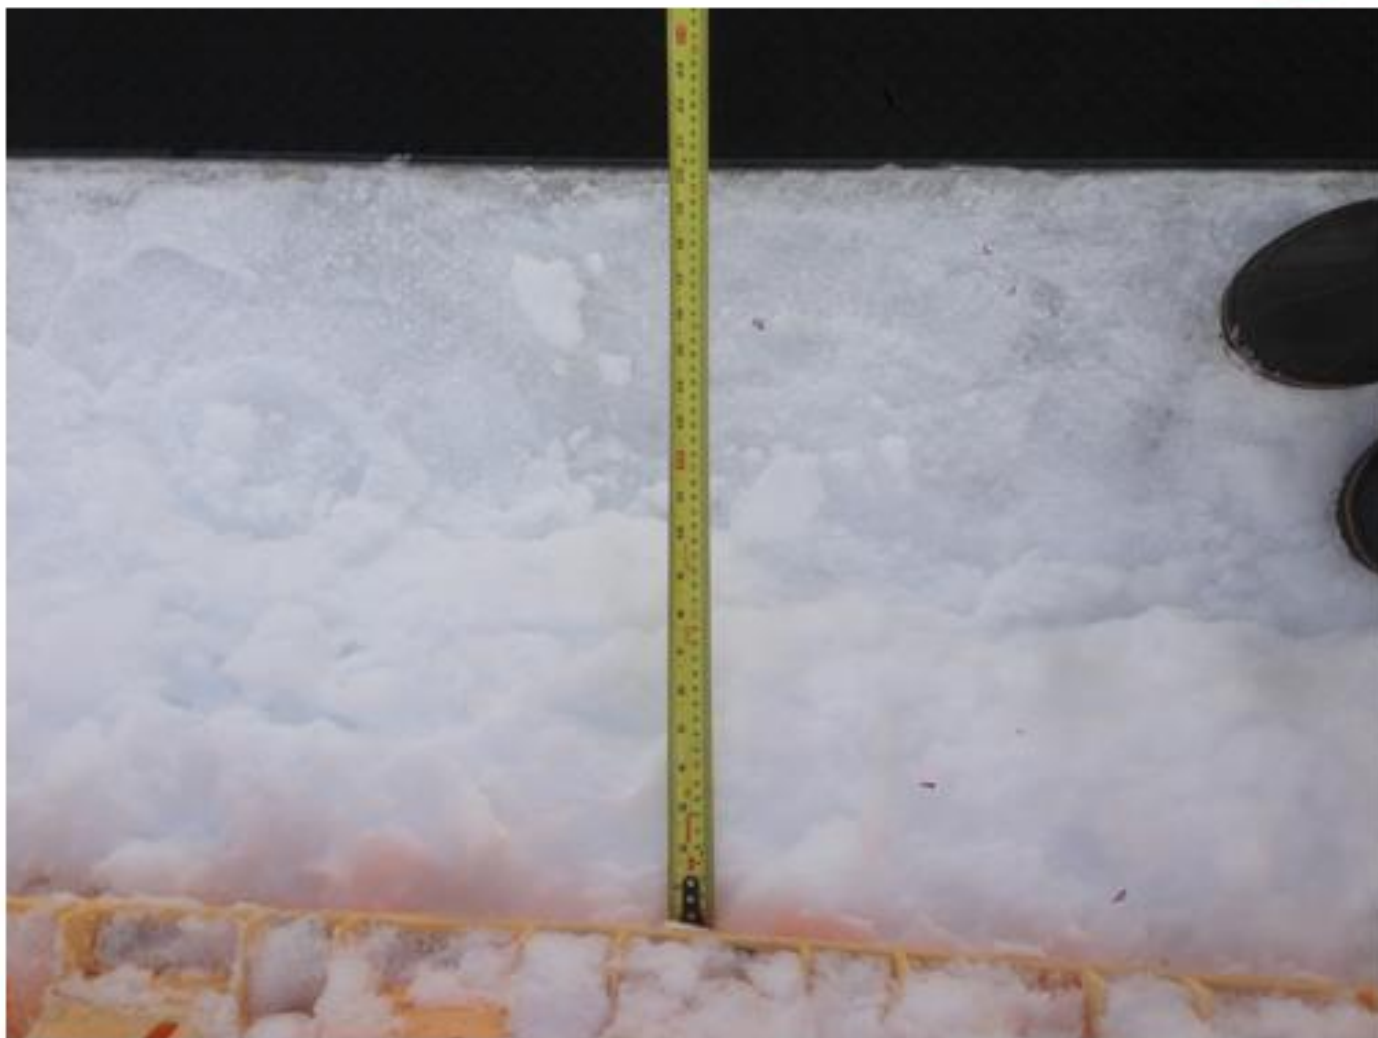
Photos:

Failure scenario(s)		The passenger attempted to grab one of the covers adjacent to the conveyor, and lost his balance causing them to fall over, resulting in the reported injury.	
	Facts and evidence		<p>As reported by the duty holder:</p> <ul style="list-style-type: none"> <li>• A Snowboard Instructor standing 10m behind witnessed the snowboard passenger holding onto conveyor cover.</li> <li>• Covers were placed adjacent to the conveyor (see attached photos).</li> <li>• Lift fully loaded with passengers at time of incident.</li> <li>• Incident occurred mid-way up conveyor.</li> <li>• Lift attendant stopped lift once passenger fell.</li> </ul>	
	Causes and contributing factors		It is very likely that the passenger attempting to hold onto a conveyor cover caused the passenger to fall and sustain the reported injury.
