Incident Summary #II-733176-2018 (#8294) (FINAL)

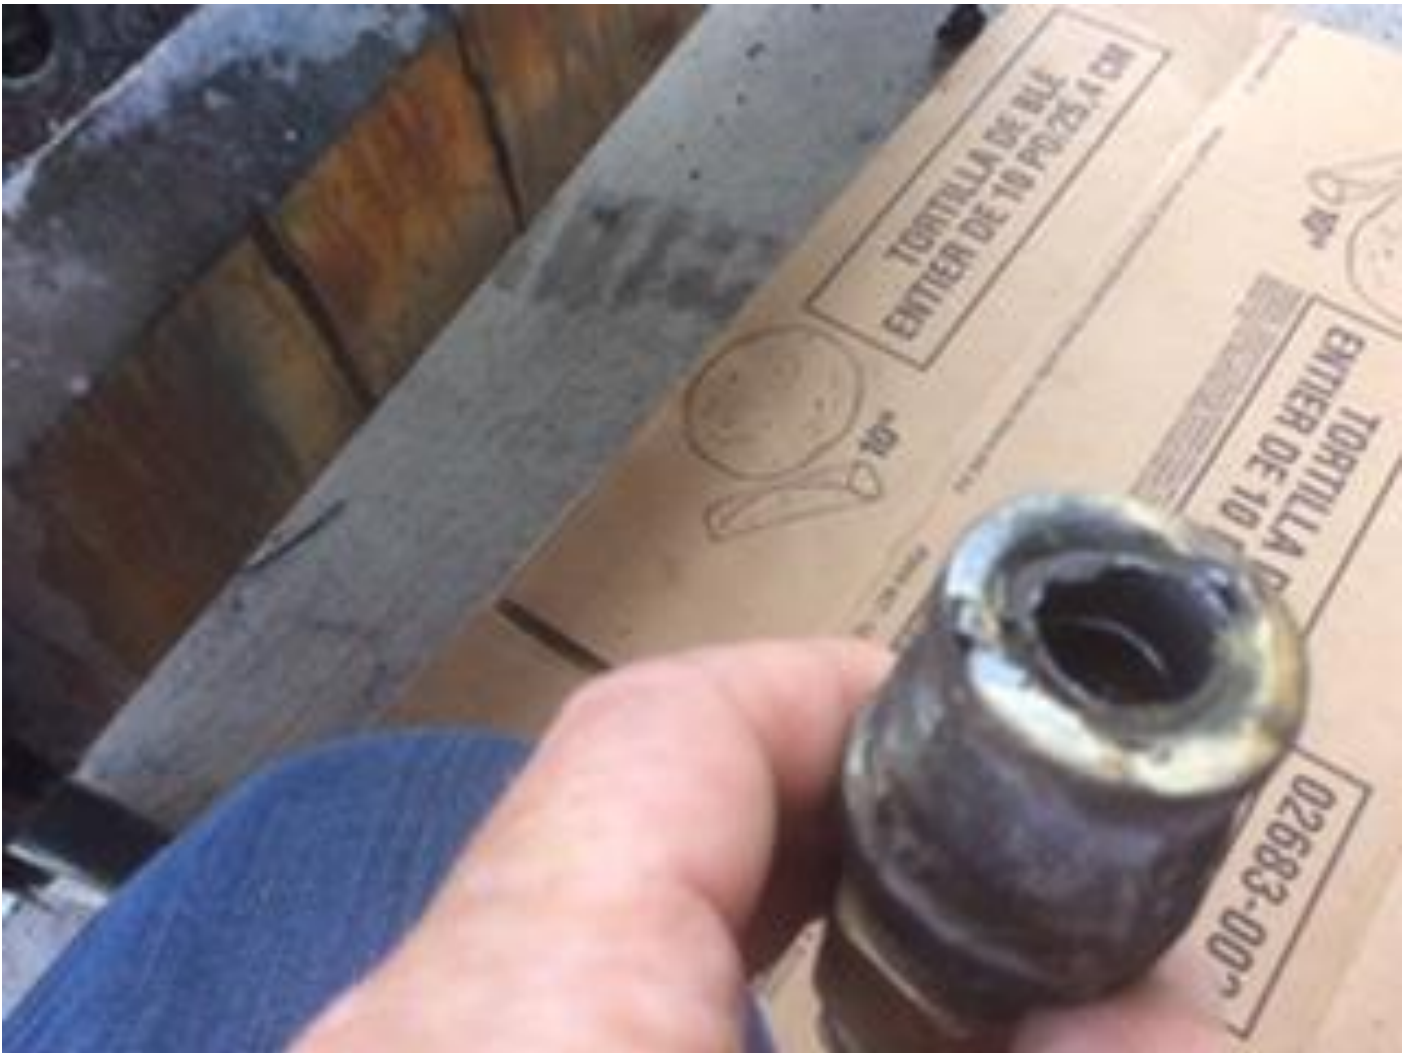
Facts and evidence	Upon investigation the broken fitting showed signs of being overtightened by the lack of visible threads on the appliance connection.	
	Causes and contributing factors	The possibility of the overstressed connection s likely to have been compromised over routine cleanings and movements of the equipment. When this appliance was moved during regular cleaning the connection was stressed to the point of breaking, causing the gas leak.

Broken Connection Point

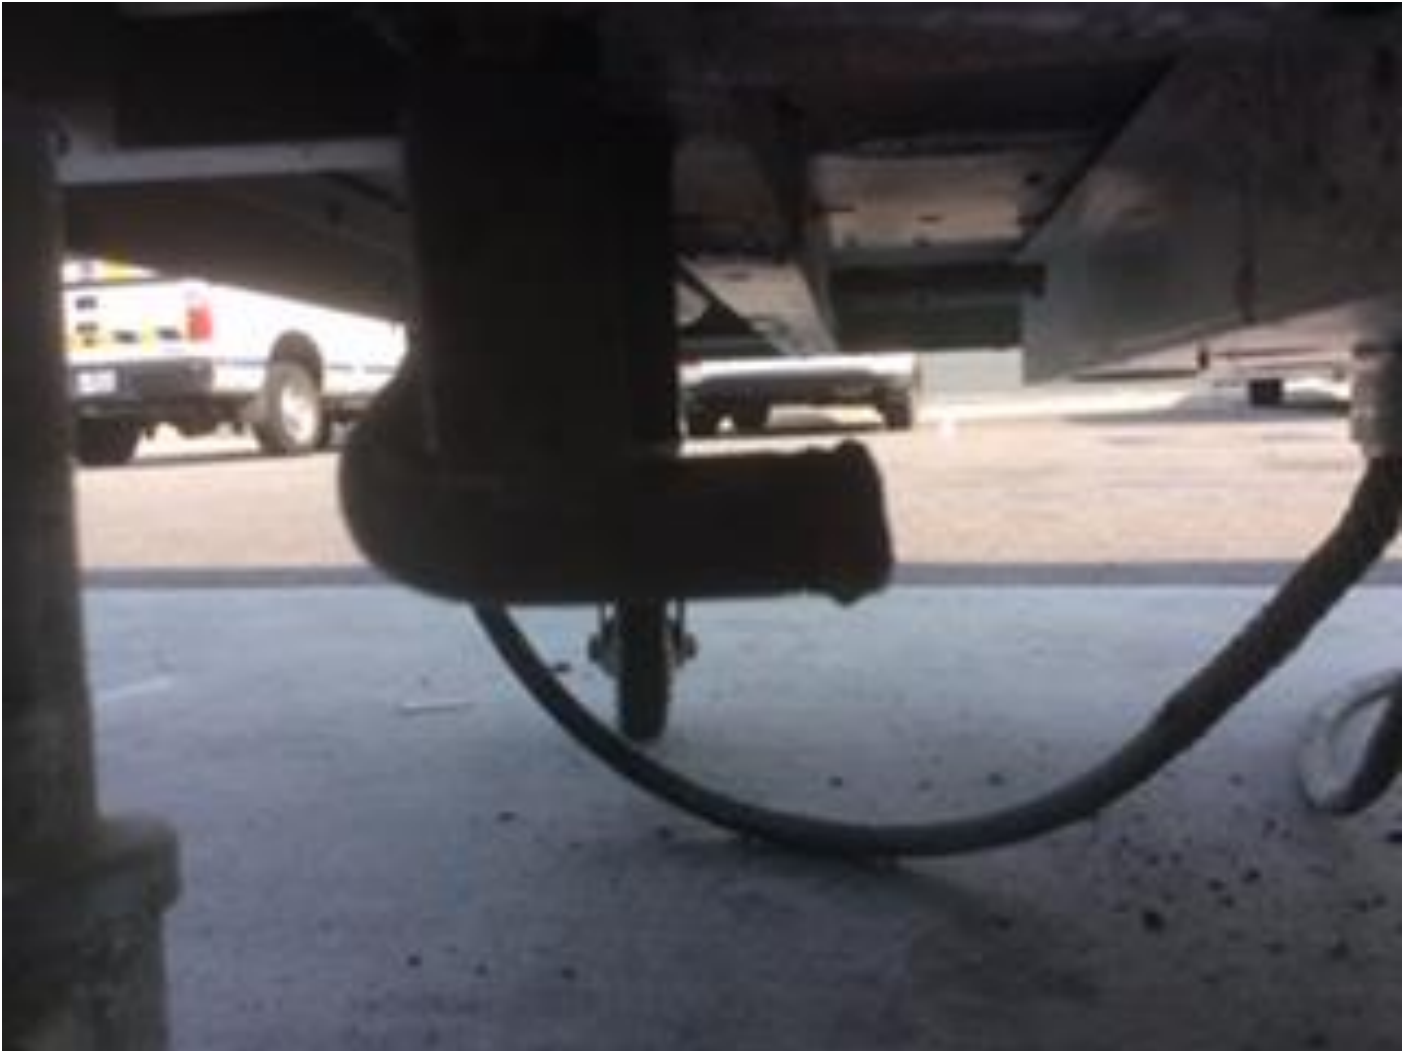
Equipment Side Connection Point
