## Incident Summary (Posse # 5623015)

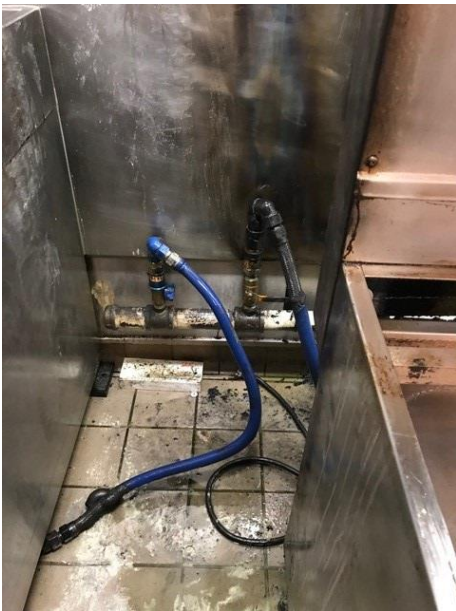
Fire damaged area with gas connectors to appliances.

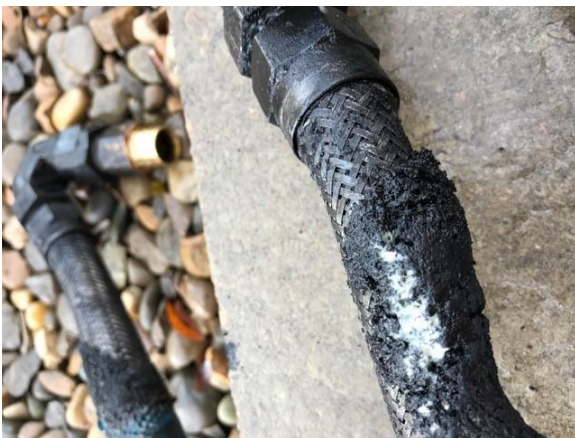
Failure scenario(s)	The issue started with the gas appliance being pulled out too far and aggressively during cleaning operations, without proper restraints installed. This caused a gas leak on the connector hose, which was ignited from pilot flame positioned in close proximity to the leak.	
	Facts and evidence	<p>Found all appliances without proper restraints installed.</p> <p>Statements from manager and line cook, backed up by observed video at time of investigation.</p> <p>-Clearly show at cleaning time, the appliances were moved aggressively to the furthest extent of the gas connectors.</p> <p>-The gas leak on the connector ignited directly after cleaning crew pushed unit back in place, and went un-noticed till the cook arrived.</p>

Close up of gas connector, source of fire.
