Incident Summary Report II-640991-2018 (#5063)

SUPPORTING INFORMATION	Incident Date	December 19, 2017	
	Location	Victoria, BC	
	Regulated industry sector	Elevating devices - Elevator	
	Impact	Qty injuries	0
		Injury description	n/a
		Injury rating	None
	Damage	Damage description	Broken And Bent Bolts
		Damage rating	Minor
Incident rating	Minor		
Incident overview	The elevator suspension means attachment bracket (hitch plate) on the elevator car sling became loose because of some broken (sheared) bolts and the resulting misalignment that tripped the safety switch and the elevator car stopped.		
INVESTIGATION CONCLUSIONS	Site, system and components	A hydraulic pump applies pressure to two hydraulic cylinders with sheaves (grooved wheels) on their tops, wire ropes ride in the sheaves and pull the elevator up via the hitch plate which is bolted to the bottom of the car sling. The hitch is engineered to hold the load plus a safety factor. The elevator is equipped with safety devices called safety plank switches. These switches detect misalignment of the elevator hitch plate safety plank.

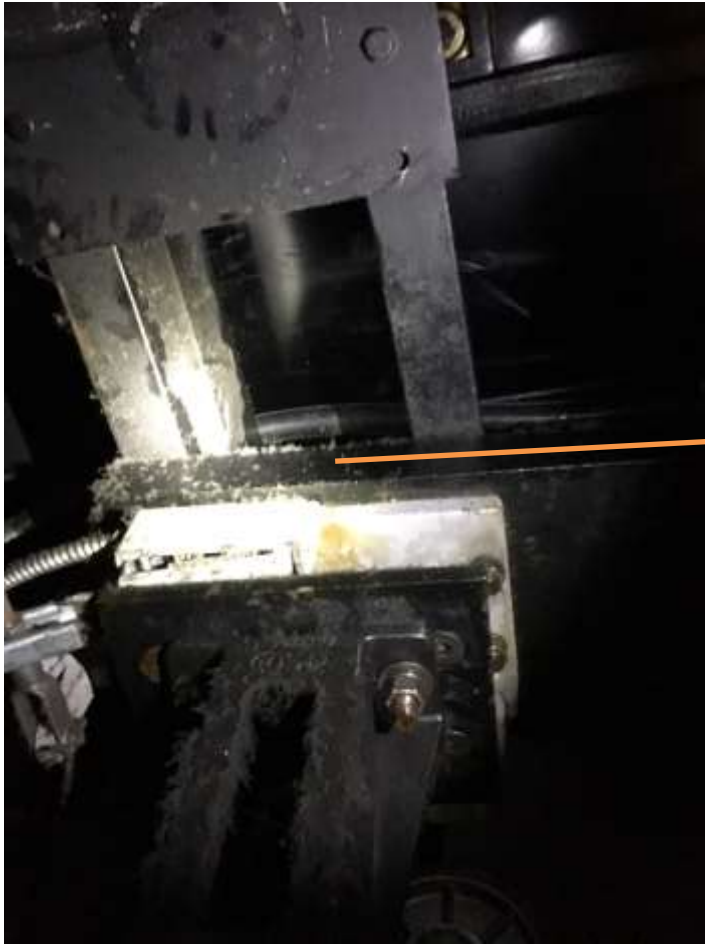
Misaligned Hitch Plate

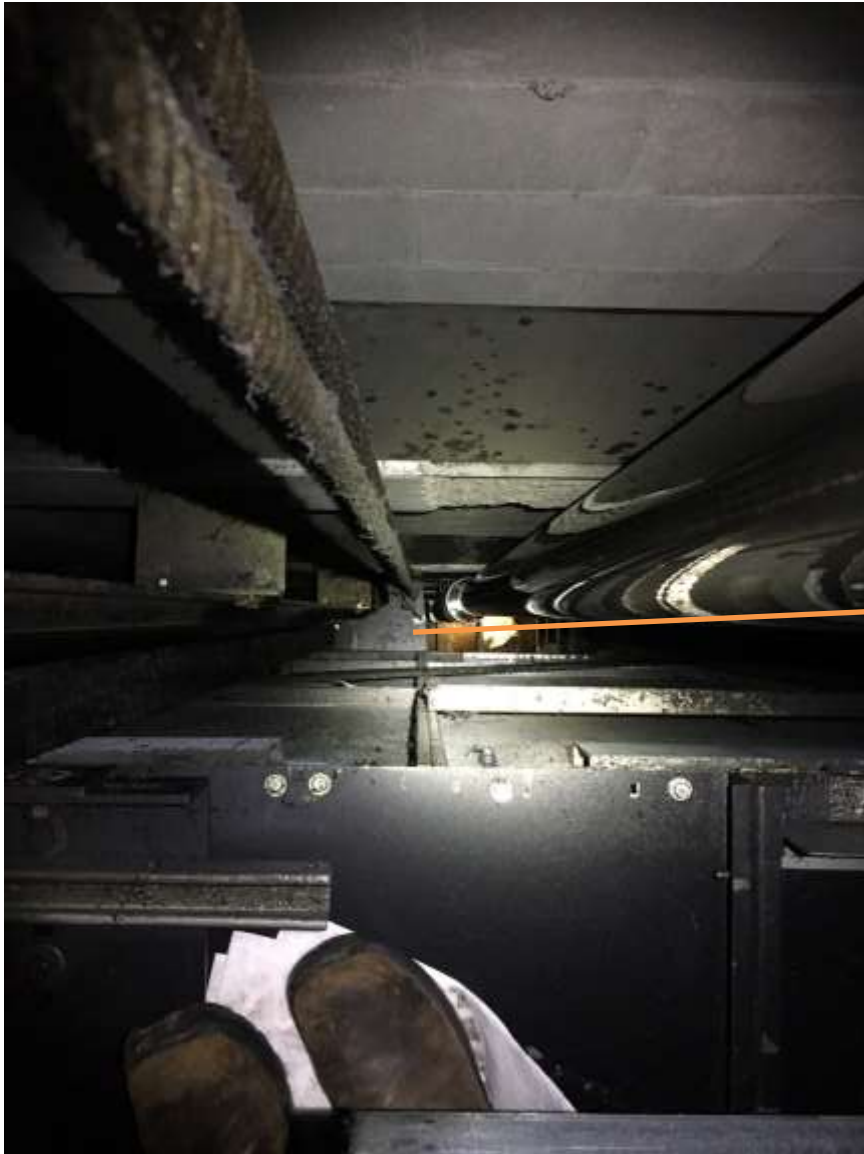
Misaligned Hitch Plate

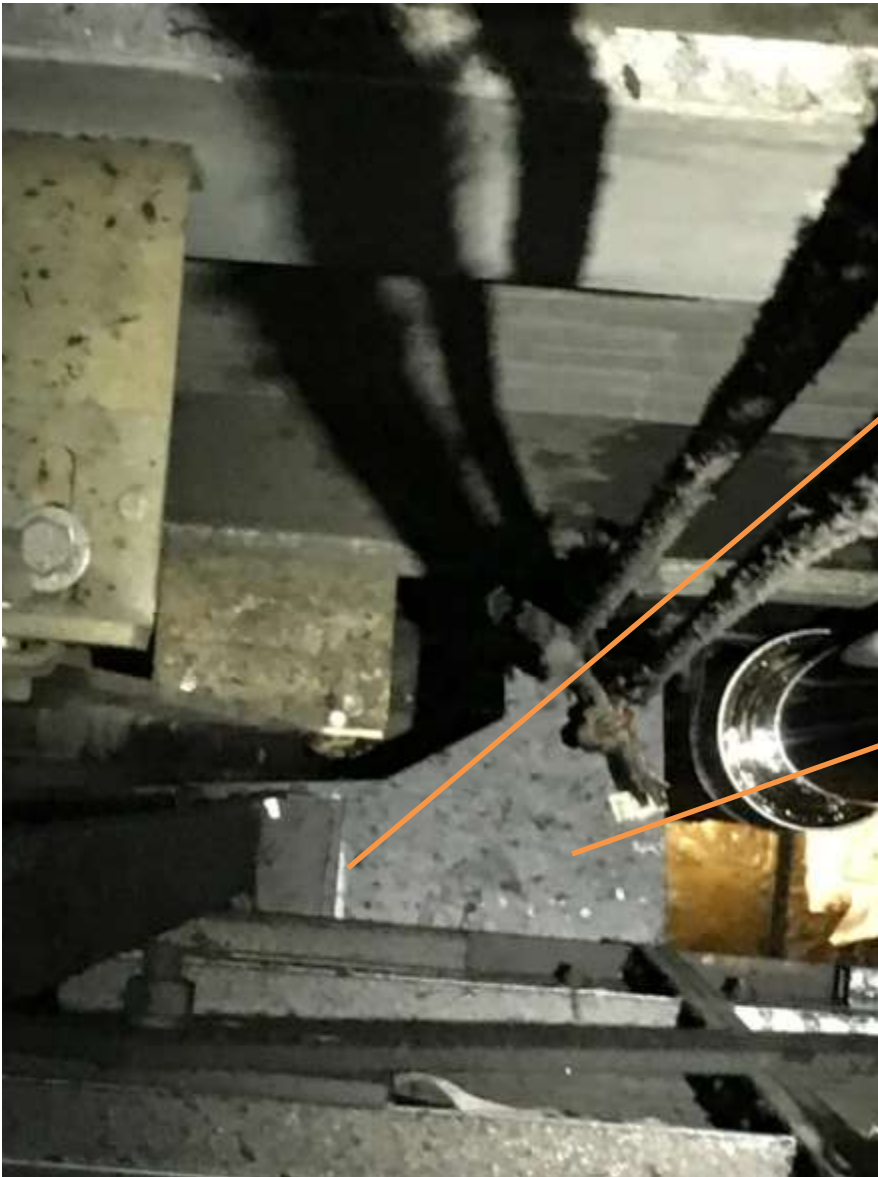
Hitch Plate misalignment.

Hitch Plate

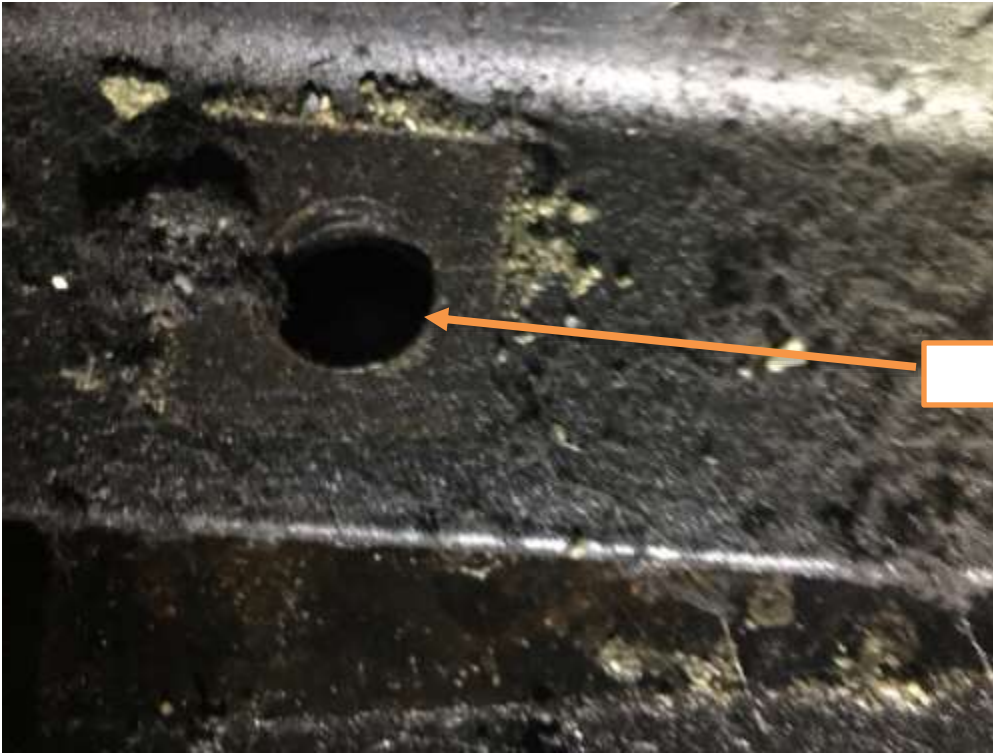
Missing bolt
