## Incident Summary #II-1507023-2023 (#31672) (FINAL)

SUPPORTING INFORMATION	Incident Date	February 8, 2023	
	Location	Abbotsford	
	Regulated industry sector	Gas - Natural gas system	
	Impact	Qty injuries	2
		Injury description	Two occupants of a home were exposed to dangerous levels of carbon monoxide. One of the occupants was incapacitated and lost consciousness and both were taken by ambulance to the hospital for treatment.
		Injury rating	Major
	Damage	Damage description	N/A
		Damage rating	None
	Incident rating	Major	
Incident overview	A natural gas furnace in a residential home, produced high concentrations of toxic carbon monoxide. The carbon monoxide migrated into the home and rapidly reached dangerous levels in the living space. Two occupants of the home were exposed to the carbon monoxide resulting in exposure symptoms and loss of consciousness of one of the occupants.		
INVESTIGATION CONCLUSIONS	Site, system and components	<p>Residential gas furnaces use the heat produced from the combustion of a gas/air mixture to heat the home. A natural draft furnace uses air from its surrounding area for combustion of the gas. The combustion occurs at the entrance to a metal heat ex

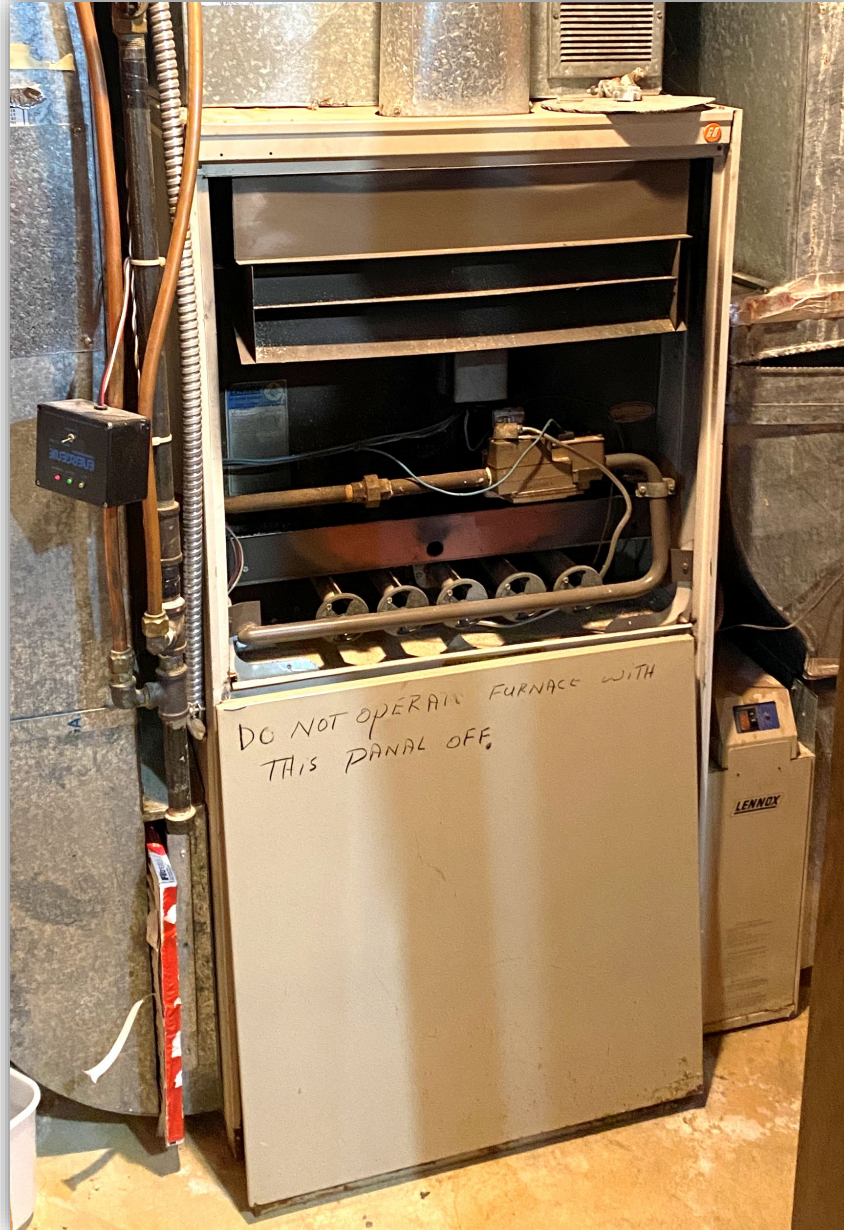
Photo 1 – The gas furnace in the mechanical room with the front cover removed.

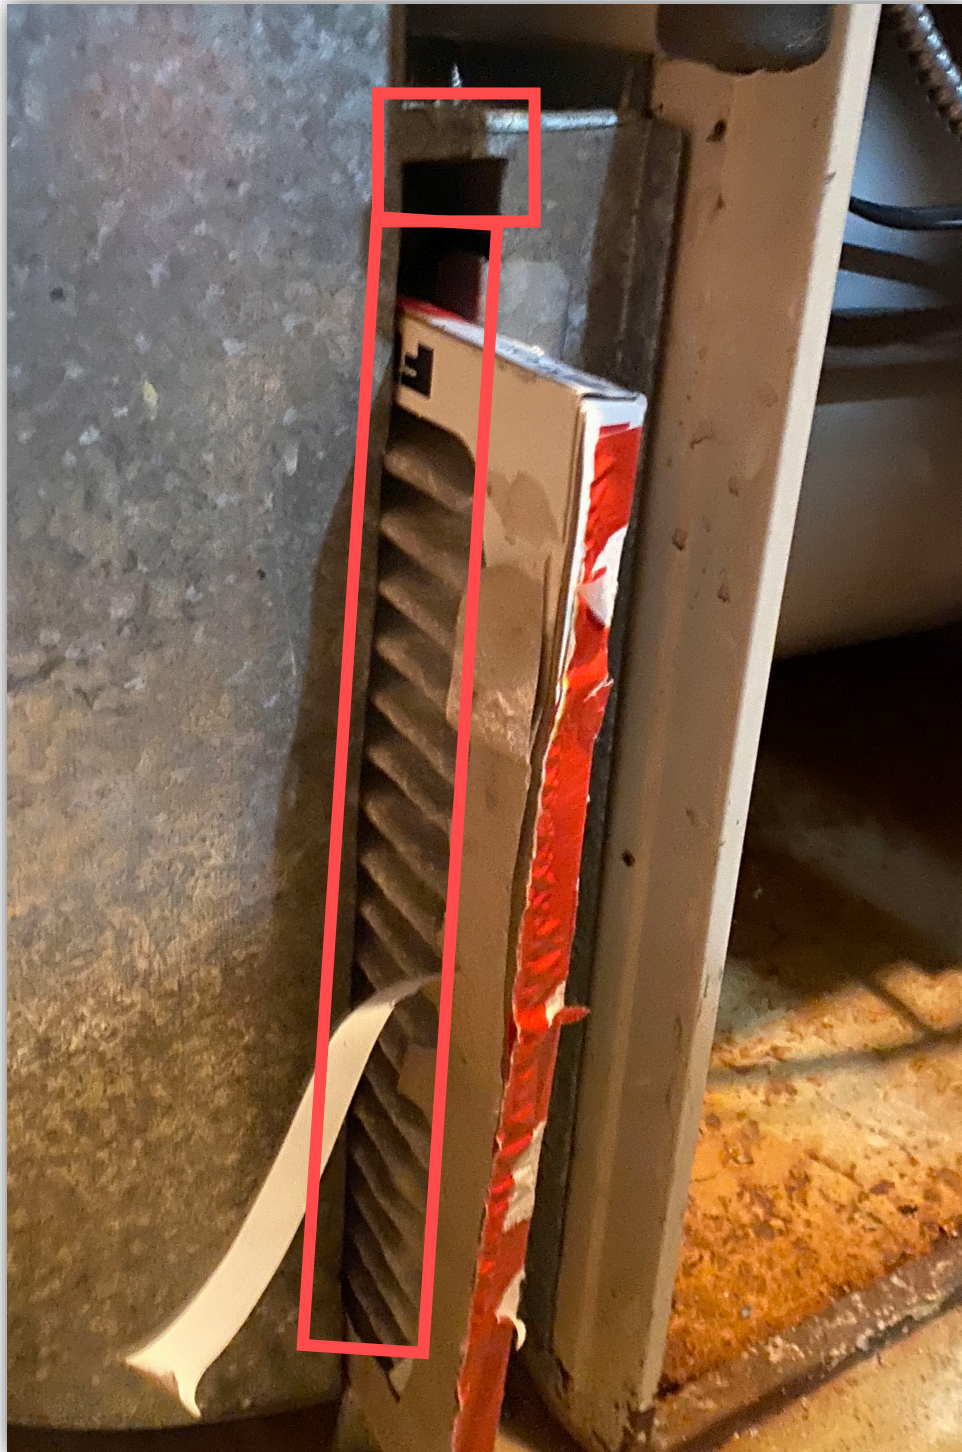
Photo 6 – Incorrect furnace filter installed. (RED) Opening gaps allowing air to be drawn into the blower from the mechanical room.

<p><u>Site observations:</u></p> <ul style="list-style-type: none"> <li>• There were two other additional air filters observed in the mechanical room that were the same size as the incorrect one installed in the furnace.</li> <li>• The furnace was partially disassembled and examined. The orifice size appeared correct, and the heat exchanger did not show any evidence of blockages, corrosion, cracks, or holes that would allow flue gas to pass into the heating air during typical operation.</li> <li>• Somebody has previously written in marker “Do not operate furnace with this panel off” on the blower cabinet front panel. This may have been done to avoid recirculating of flue gasses into the home.</li> <li>• All other potential sources of CO were identified and ruled out as a cause of the CO in the home.</li> <li>• The venting system was examined and found to be free of blockages and no evidence of openings were found that would have spilled flue gas into the home.</li> </ul> <p><u>Documents:</u></p> <ul style="list-style-type: none"> <li>• The fire rescue service’s communications and report confirmed that CO readings were taken by crews walking through the home in full SCBA gear with their gas monitors and high readings were measured in every room of the home with the maximum reading being 1395 ppm of CO in the ambient air.</li> <li>• Fire rescue services arrived on the scene within 6 minutes after being dispatched.</li> </ul>

<p>Causes and contributing factors</p>	<p>The incident was caused by the openings in the return air ducting which allowed the spilling and recirculation of the furnace flue gasses, containing high levels of carbon monoxide, throughout the home.</p> <p><u>Contributing factors to the incident include:</u></p> <ul style="list-style-type: none"> <li>• Incorrect gas manifold pressure setting created high levels of carbon monoxide in the flue gas.</li> <li>• Incorrect sized air filter did not allow for the sealing of the return air duct from the mechanical room.</li> <li>• The small mechanical room with solid doors and limited fresh air supply contributed to the creation of a negative pressure in the room and the spilling and recirculation of the carbon monoxide.</li> <li>• There were not any carbon monoxide detectors installed to alert the occupants of the presence of CO in the home.</li> </ul>
