Incident Summary #II-1020945-2020 (#18073) (FINAL)

SUPPORTING INFORMATION	Incident Date	May 29, 2020	
	Location	Surrey	
	Regulated industry sector	Gas - Natural gas system	
	Impact	Qty injuries	0
		Injury description	NA
		Injury rating	None
	Damage	Damage description	A residential furnace heat exchanger failed, and produced of high levels of carbon monoxide (CO). Redundant safety features (flame rollout switch, air proving switch) failed to control the hazard. This resulted in carbon monoxide exposure inside the home.
		Damage rating	Moderate
	Incident rating	Moderate	
Incident overview	A natural gas furnace in a residential home produced elevated levels of carbon monoxide. Measurable amounts of carbon monoxide were detected inside the home.		
INVESTIGATION CONCLUSIONS	Site, system and components	<p>Residential gas furnaces use the heat produced from the combustion of a gas/air mixture to heat the home. The combustion occurs at the entrance to a heat exchanger. The flue gases produced by combustion pass through the inside passages of the heat exchanger and are carried safely to the outdoors through a venting system connected to the furnace. A blower draws air from inside the home

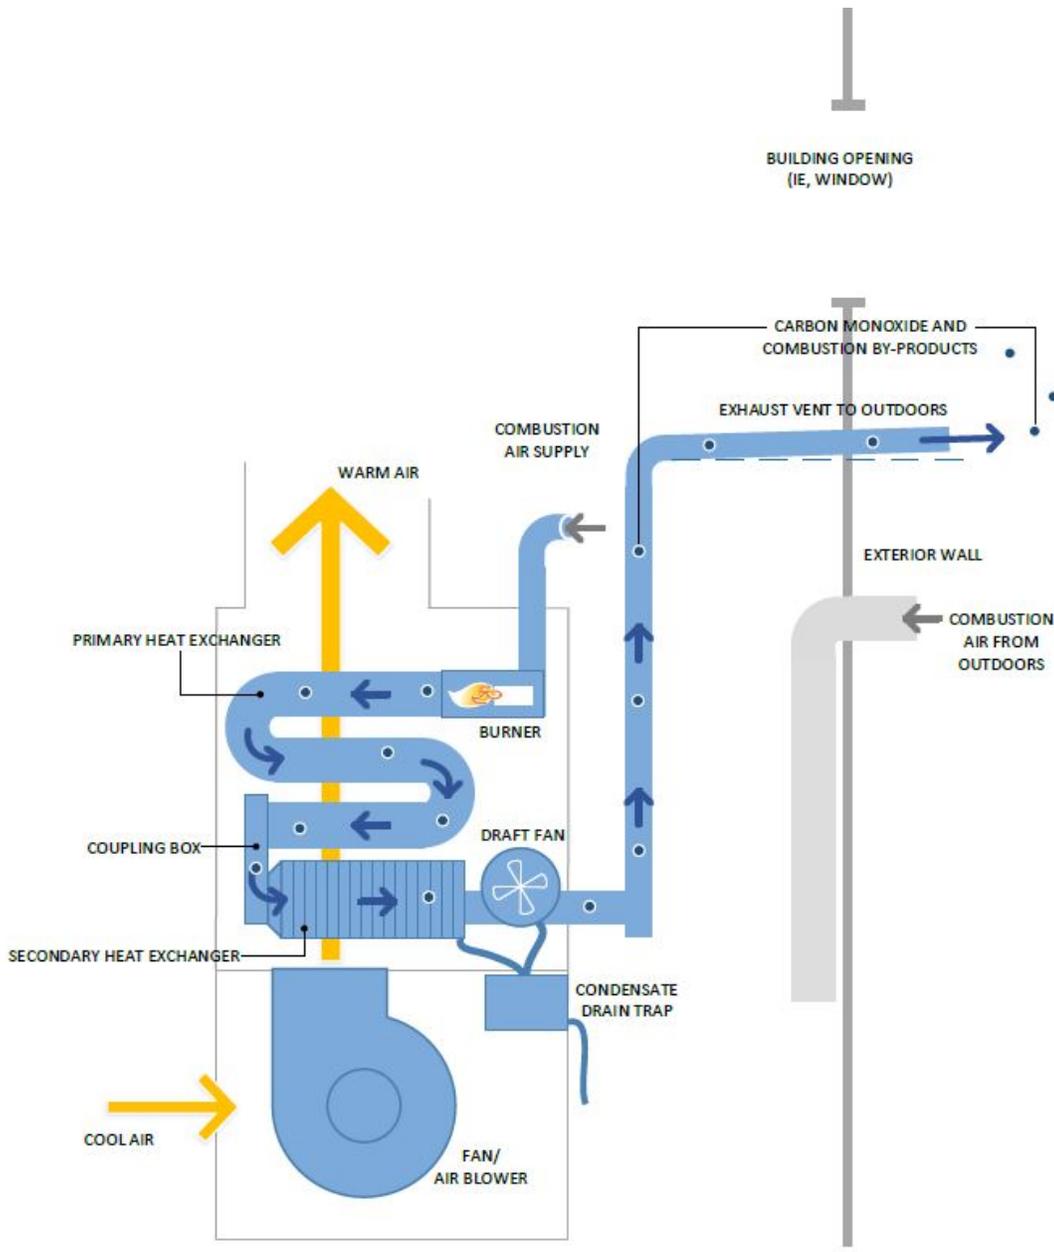
HIGH EFFICIENCY FURNACE INSTALLED IN AN "UP FLOW" ORIENTATION

Diagram 1 – Showing typical furnace operation. Arrows show direction of flue gas flow and dots represent CO.

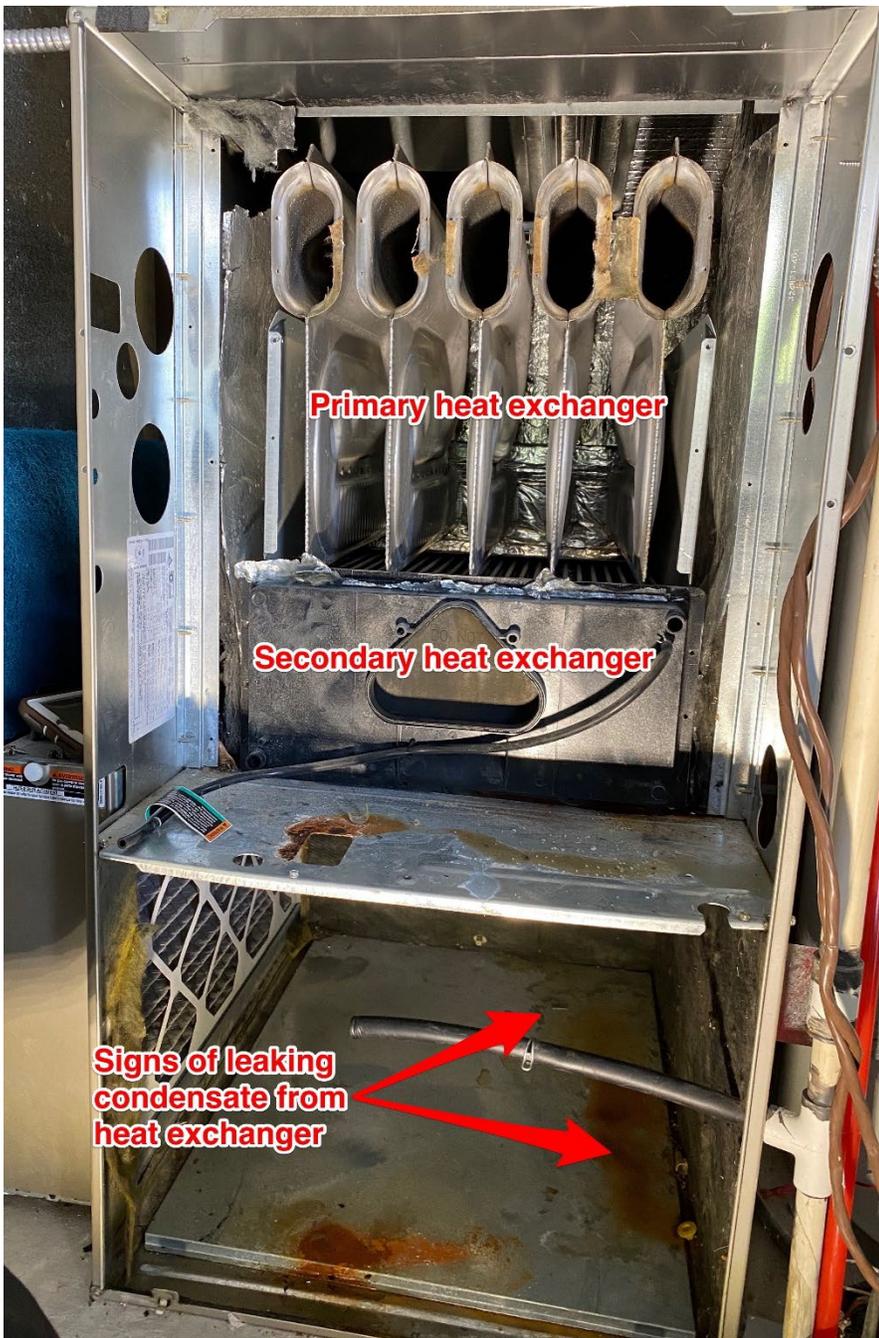
Image 1 – Furnace after blower and burner components removed to access heat exchanger for warranty replacement.

The technician returned to replace both the primary and secondary heat exchangers under the manufacturers enhanced heat exchanger warranty. The replacement components were of the same design and materials as the originals they were replacing.

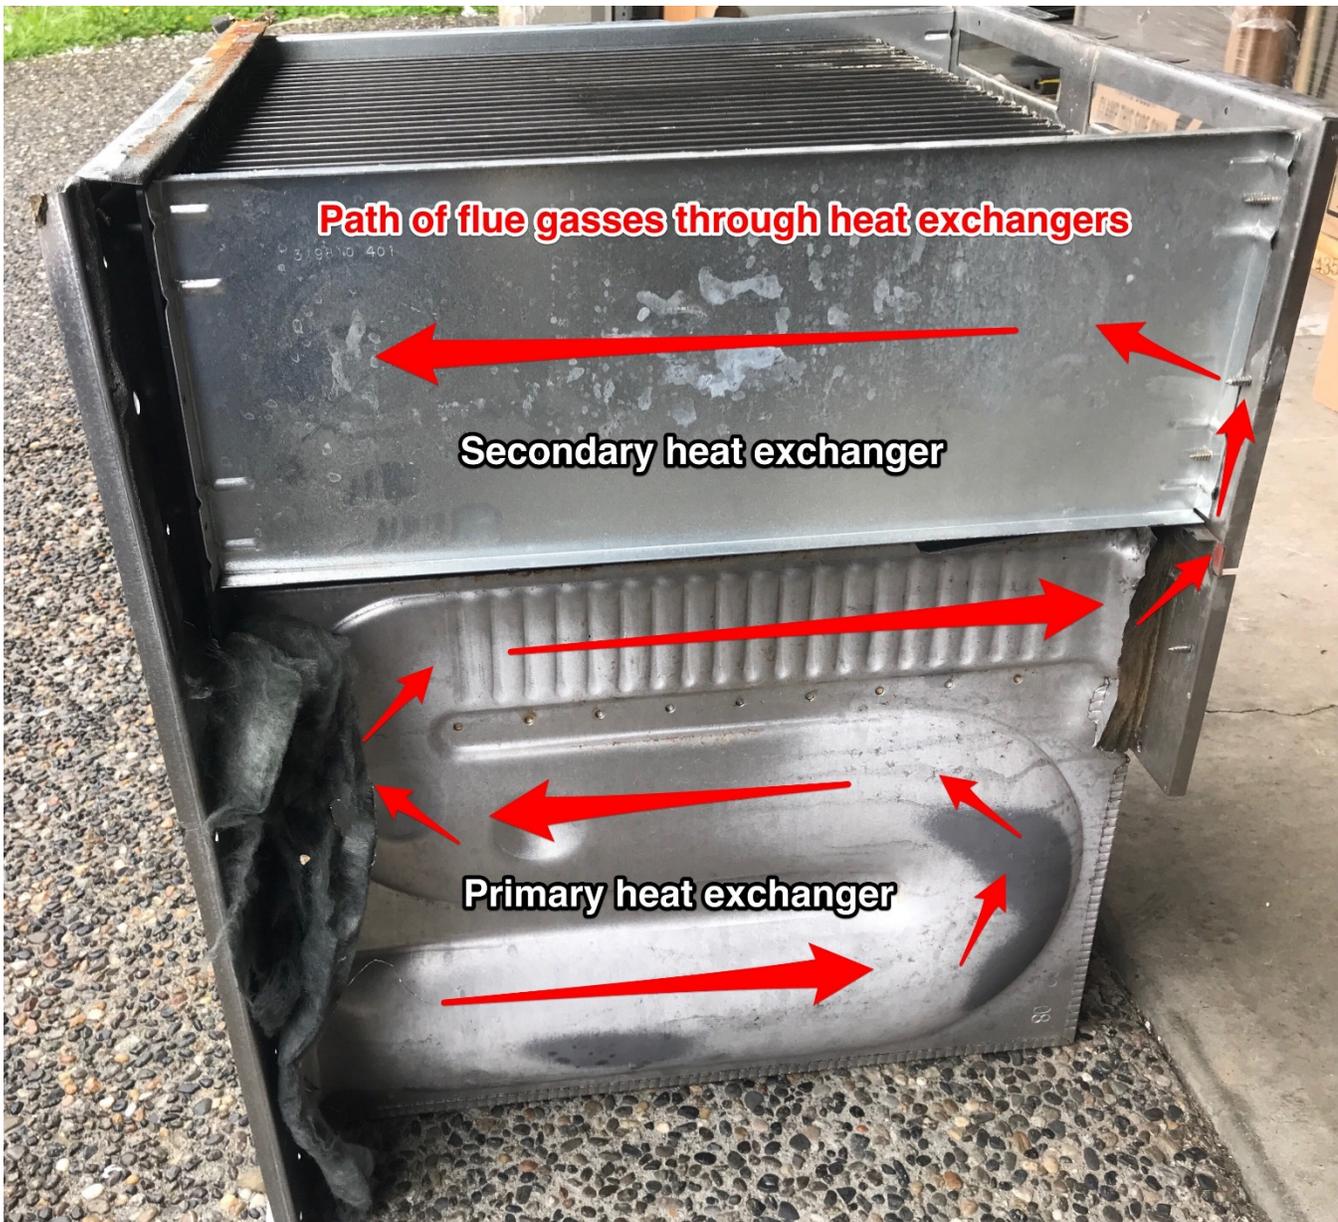
Image 3 – Removed heat exchanger assembly (upside down from installed orientation) showing the path the flue gasses travel through the heat exchangers.

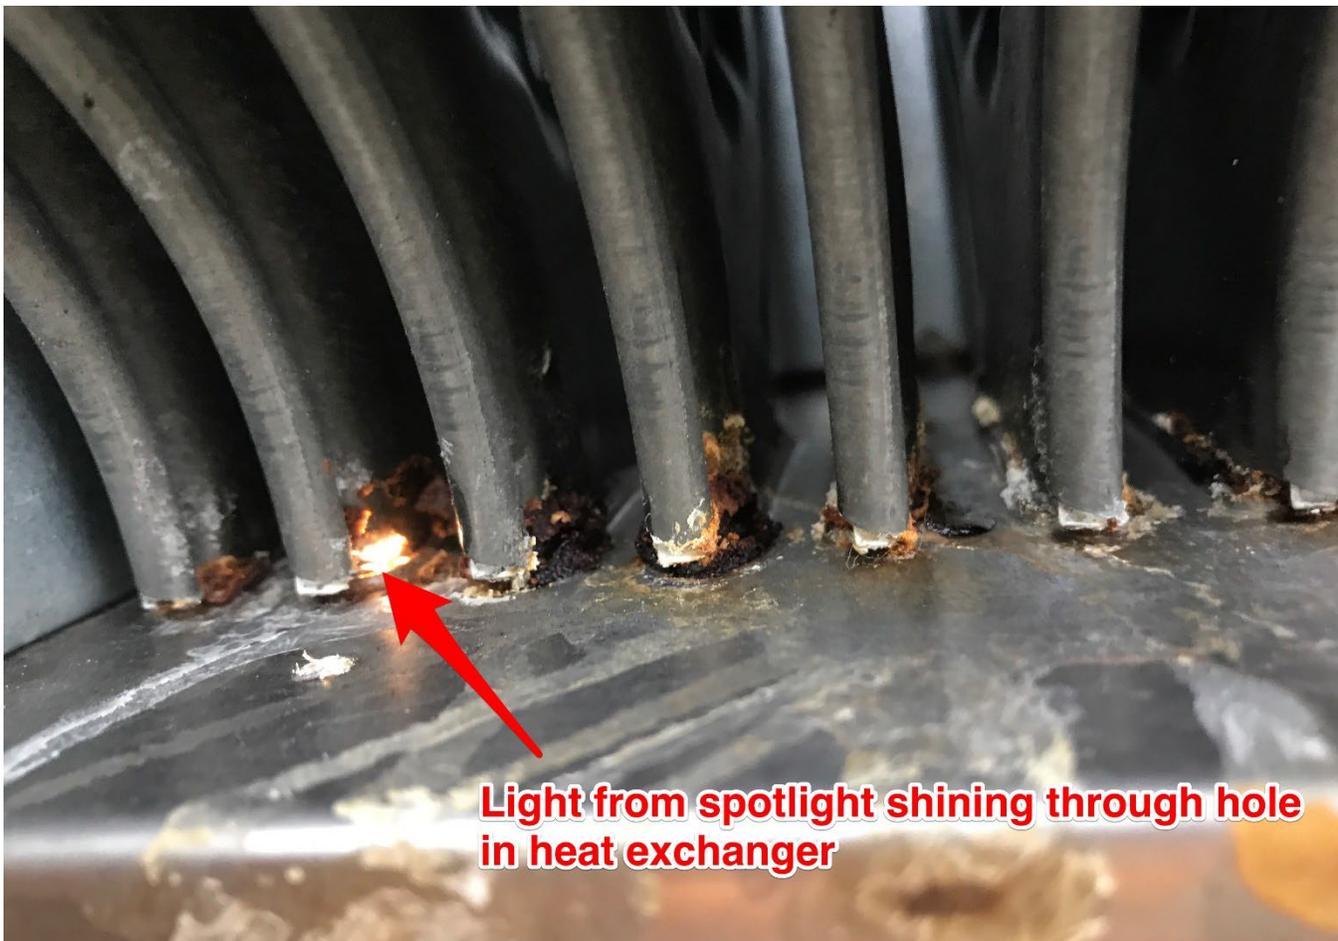
Investigation of the removed furnace heat exchanger assembly showed the primary heat exchanger did not have any holes, cracks or signs of corrosion. While removing the secondary heat exchanger, corrosion and holes were observed on the inlet side to the heat exchanger tubes. Photos show light shining through the holes in the heat exchanger (Image 4).

The corrosion on the secondary heat exchanger created holes which allowed some of the flue products containing carbon monoxide to pass into the heating air for the home instead of being safely removed to the outdoors through the furnace's venting system.

Image 4 – Image taken with a bright spotlight shining in the corroded and blocked secondary heat exchanger inlets. The light is passing through a hole from corrosion where the tube connects to the coupling box.

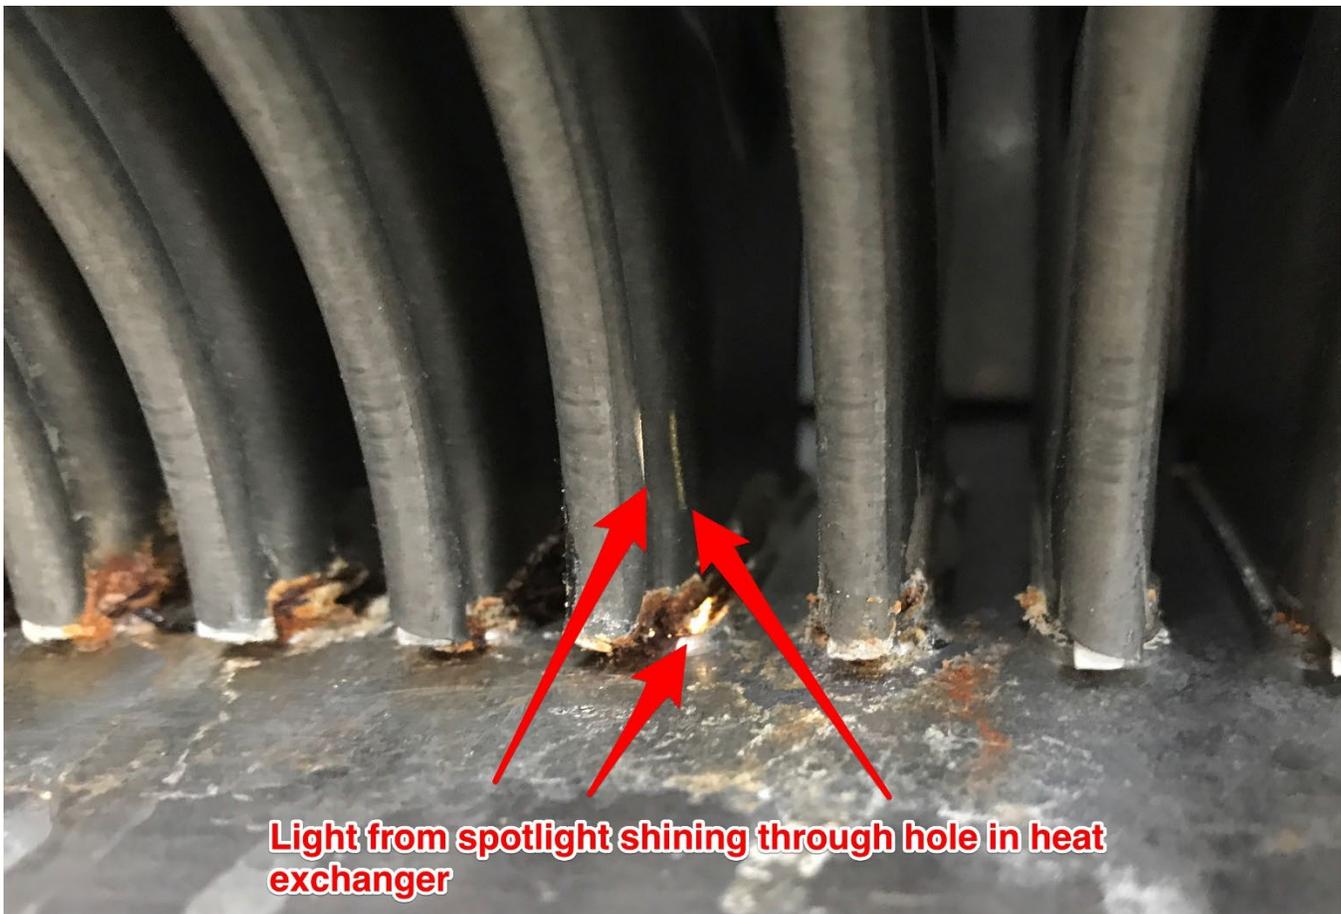
Image 5 -. The light is passing through another hole from corrosion where the tube connects to the coupling box.

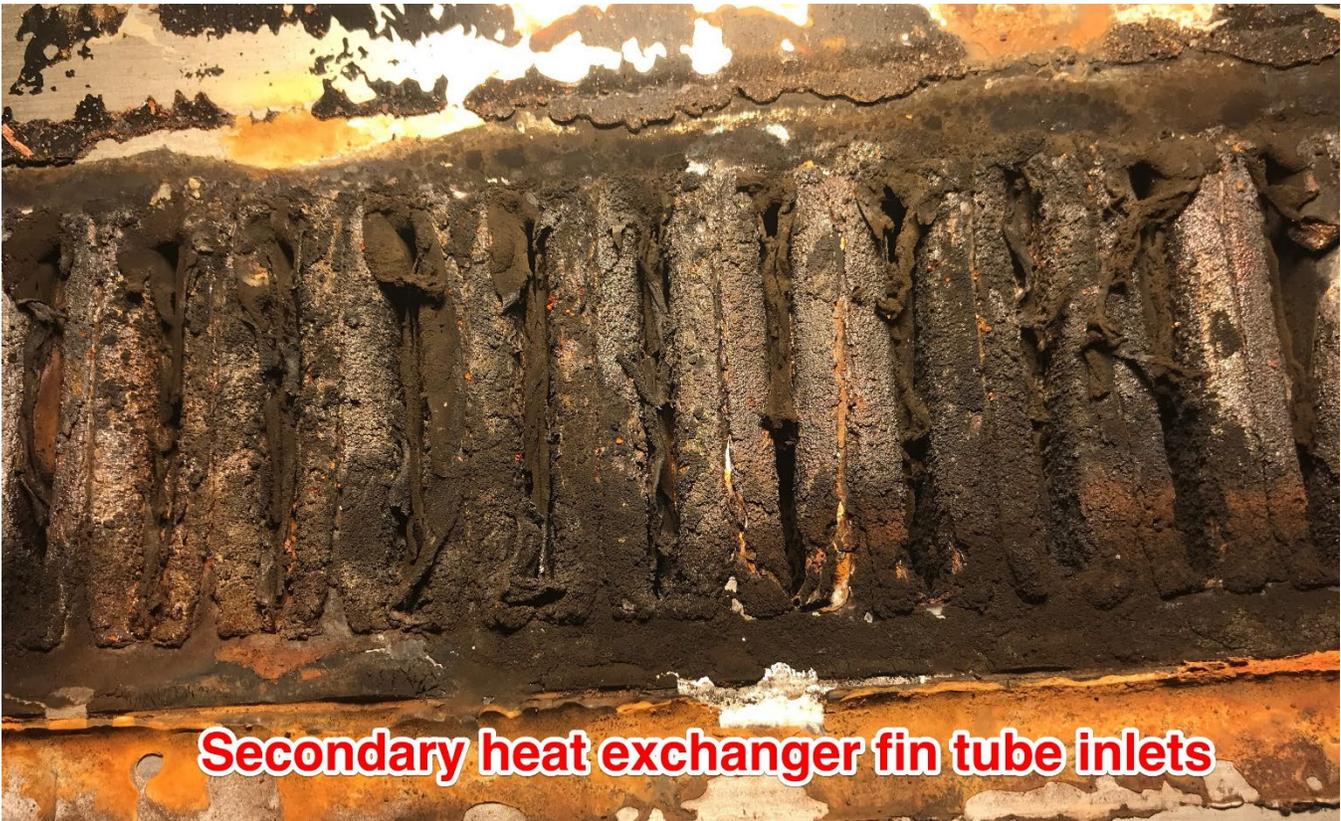
The inlets to the furnace's secondary heat exchanger tubes had corroded and the interior polypropylene lining had delaminated which restricted the airflow through them. The restricted airflow reduced the amount of air at the point of combustion in the burner box. The unbalanced air/fuel ratio produced elevated levels of carbon monoxide in the flue products.

Image 6 – Plugged and blocked tube inlets from corrosion and delaminated polypropylene liners.

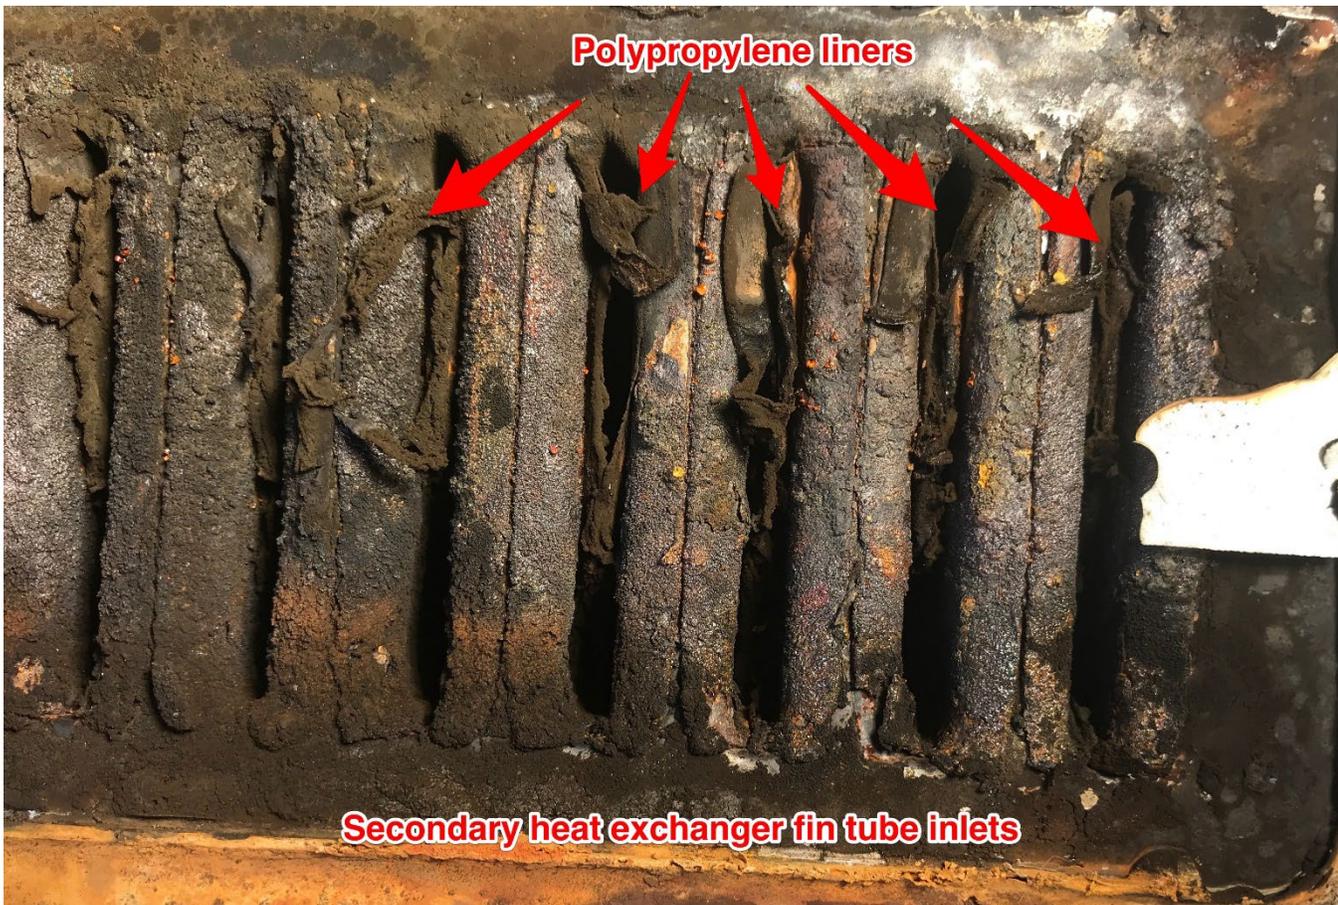
Image 7 – Close up photo shows delaminated polypropylene liners.

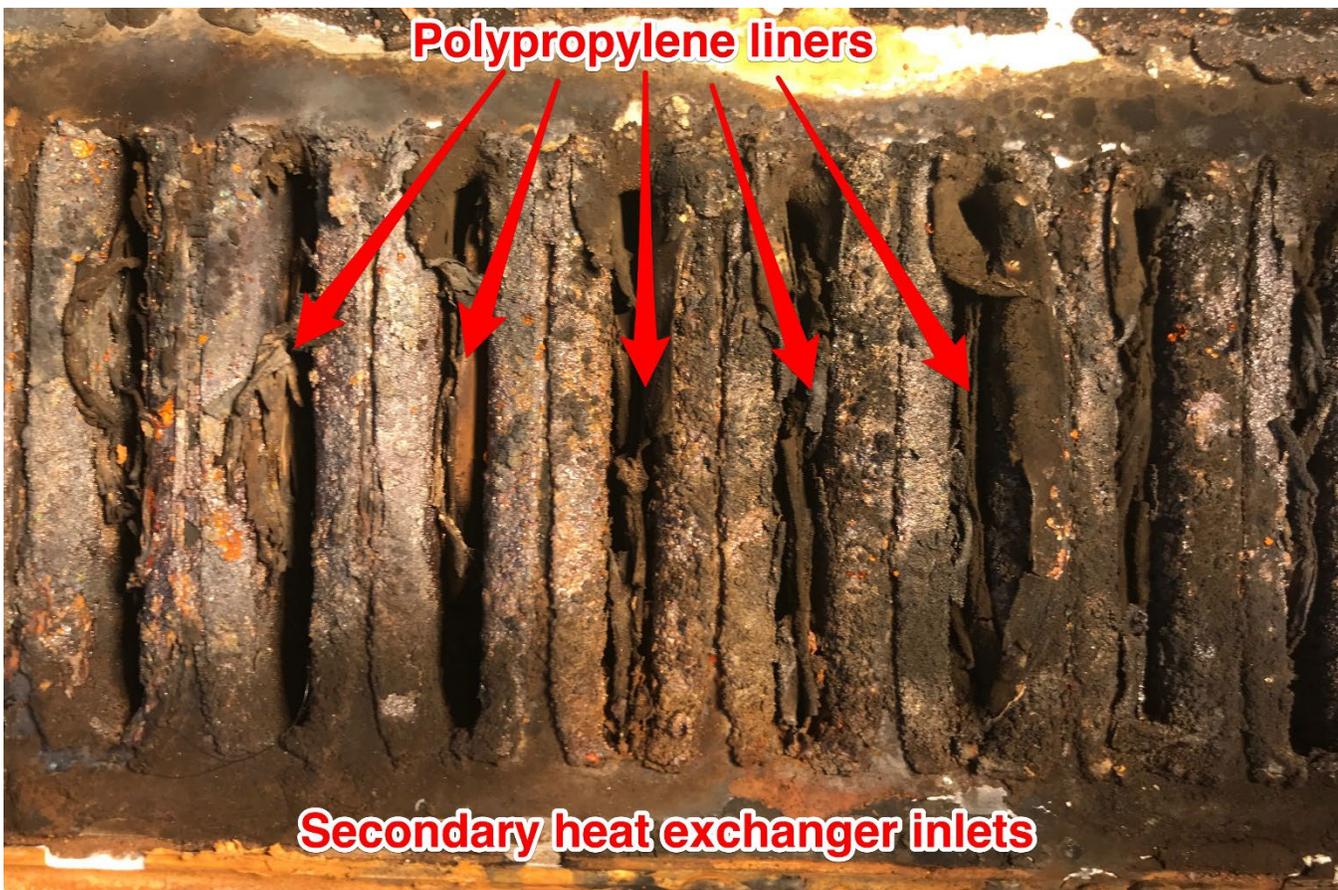
The cause of the incident was the furnace secondary heat exchanger design and use of polypropylene laminated steel materials. Rapid and excessive corrosion of these materials restricted airflow through the furnace resulting in production of carbon monoxide due to incomplete combustion.

Image 8 – Another photo showing excessive restriction to gas flow from plugged and blocked tube inlets due to corrosion and delaminated polypropylene liners
