Incident Summary #II-1556102-2023 (#35674) (FINAL)

SUPPORTING INFORMATION	Incident Date	May 29, 2023	
	Location	Interior Region	
	Regulated industry sector	Gas - Propane system	
	Impact	Qty injuries	1
		Injury description	Second degree burns to the face, hands, arms, and torso.
		Injury rating	Major
	Damage	Damage description	A propane explosion inside a cabin caused windows, doors, and walls to blow out as well as burns to electrical components in the crawl space and interior surfaces in the cabin.
		Damage rating	Major
Incident rating	Major		
Incident overview	A propane fueled on-demand water heater and the supply gas line were installed in the crawl space of a cabin by a person without qualifications. After bleeding gas into the crawl space, the appliance was started, and an explosion occurred (Photo 1).		
INVESTIGATION CONCLUSIONS	Site, system and components	<p>The site consists of two adjacent properties including the main lot with a house and the secondary lot with a cabin and small carriage house. The cabin on the secondary lot had a propane gas fired on-demand water heater (Photo 7) supplied from a 118 US water gallon (USWG) propane storage tank on the main lot. A primary

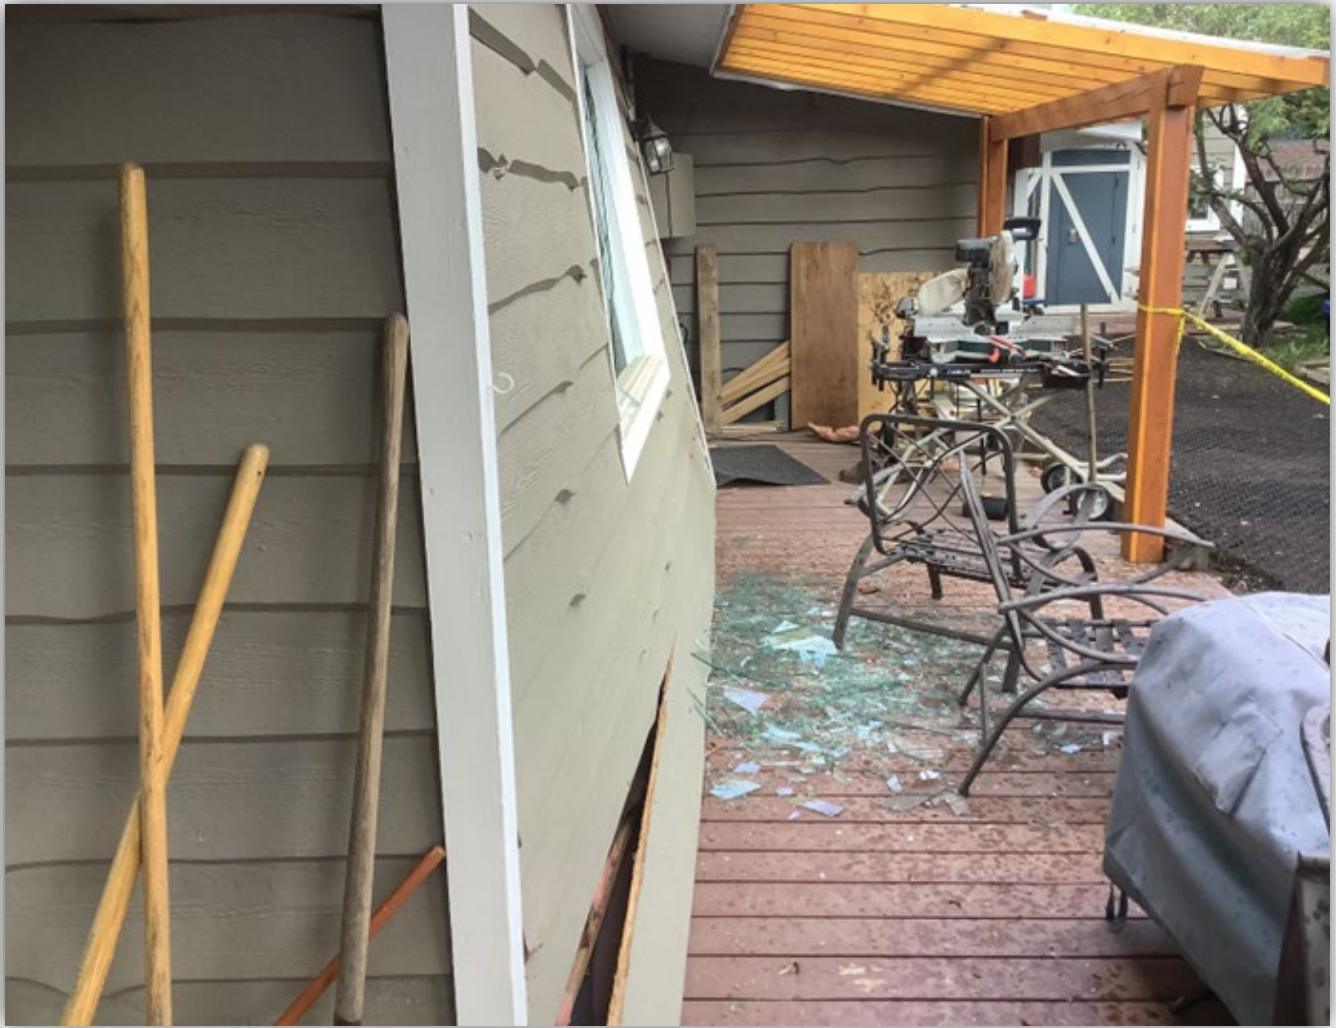
Photo 1 – Exterior wall of cabin blown out.

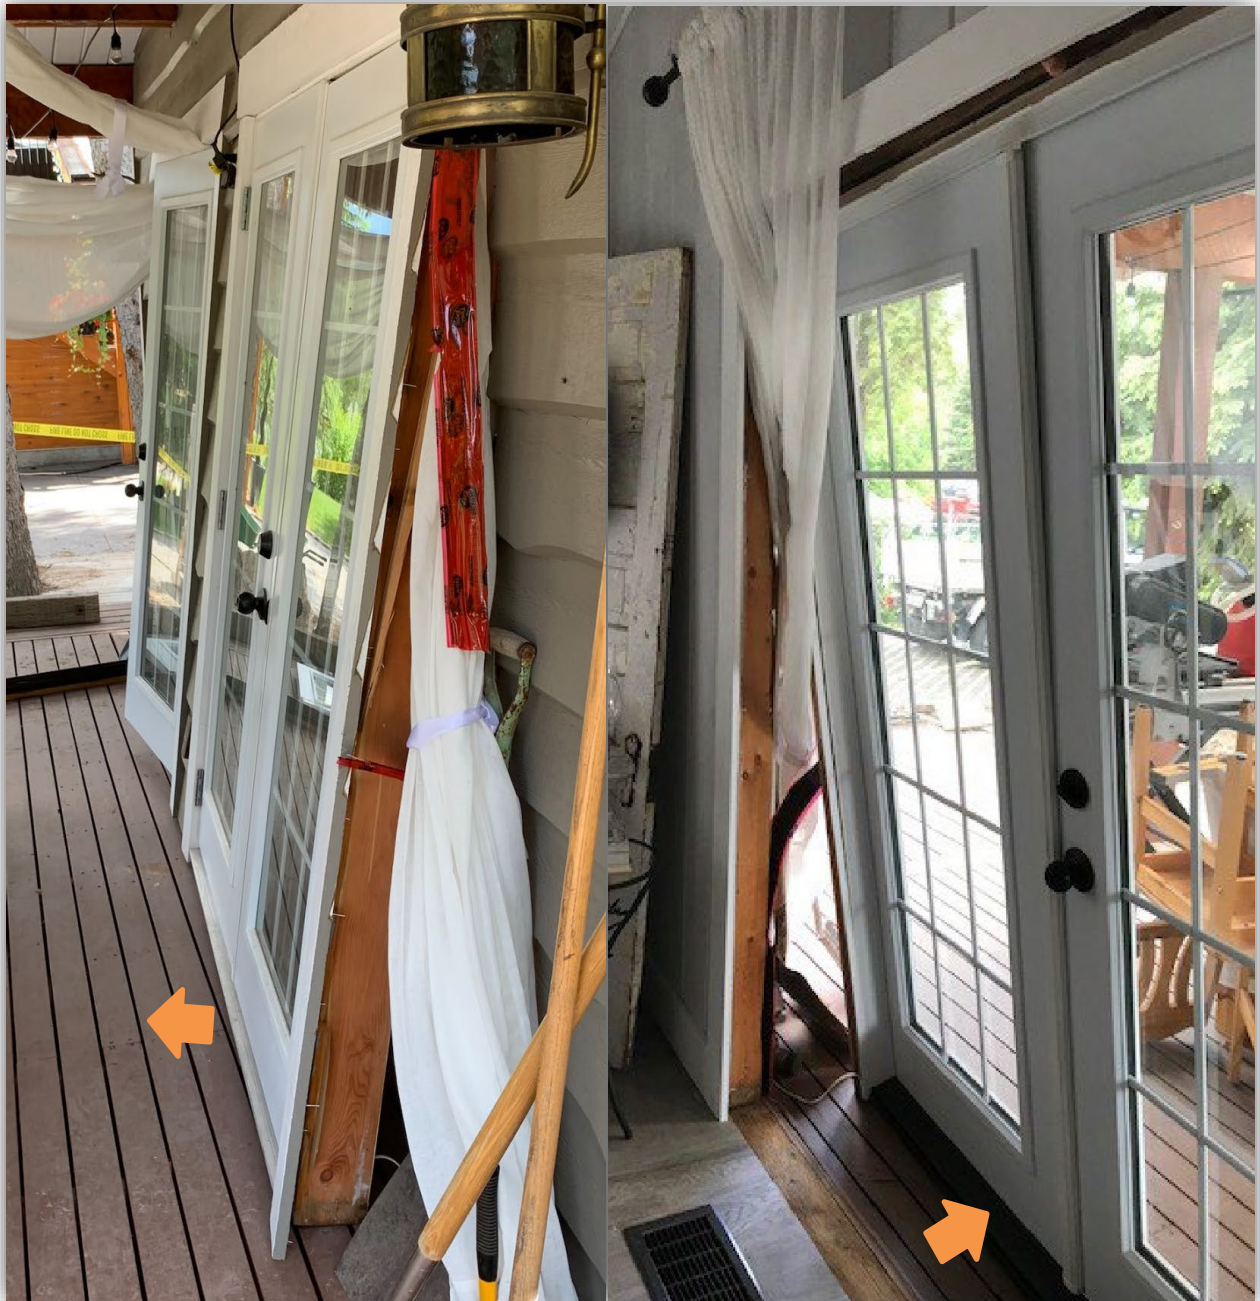
Photo 2 - Exterior doors blown out.

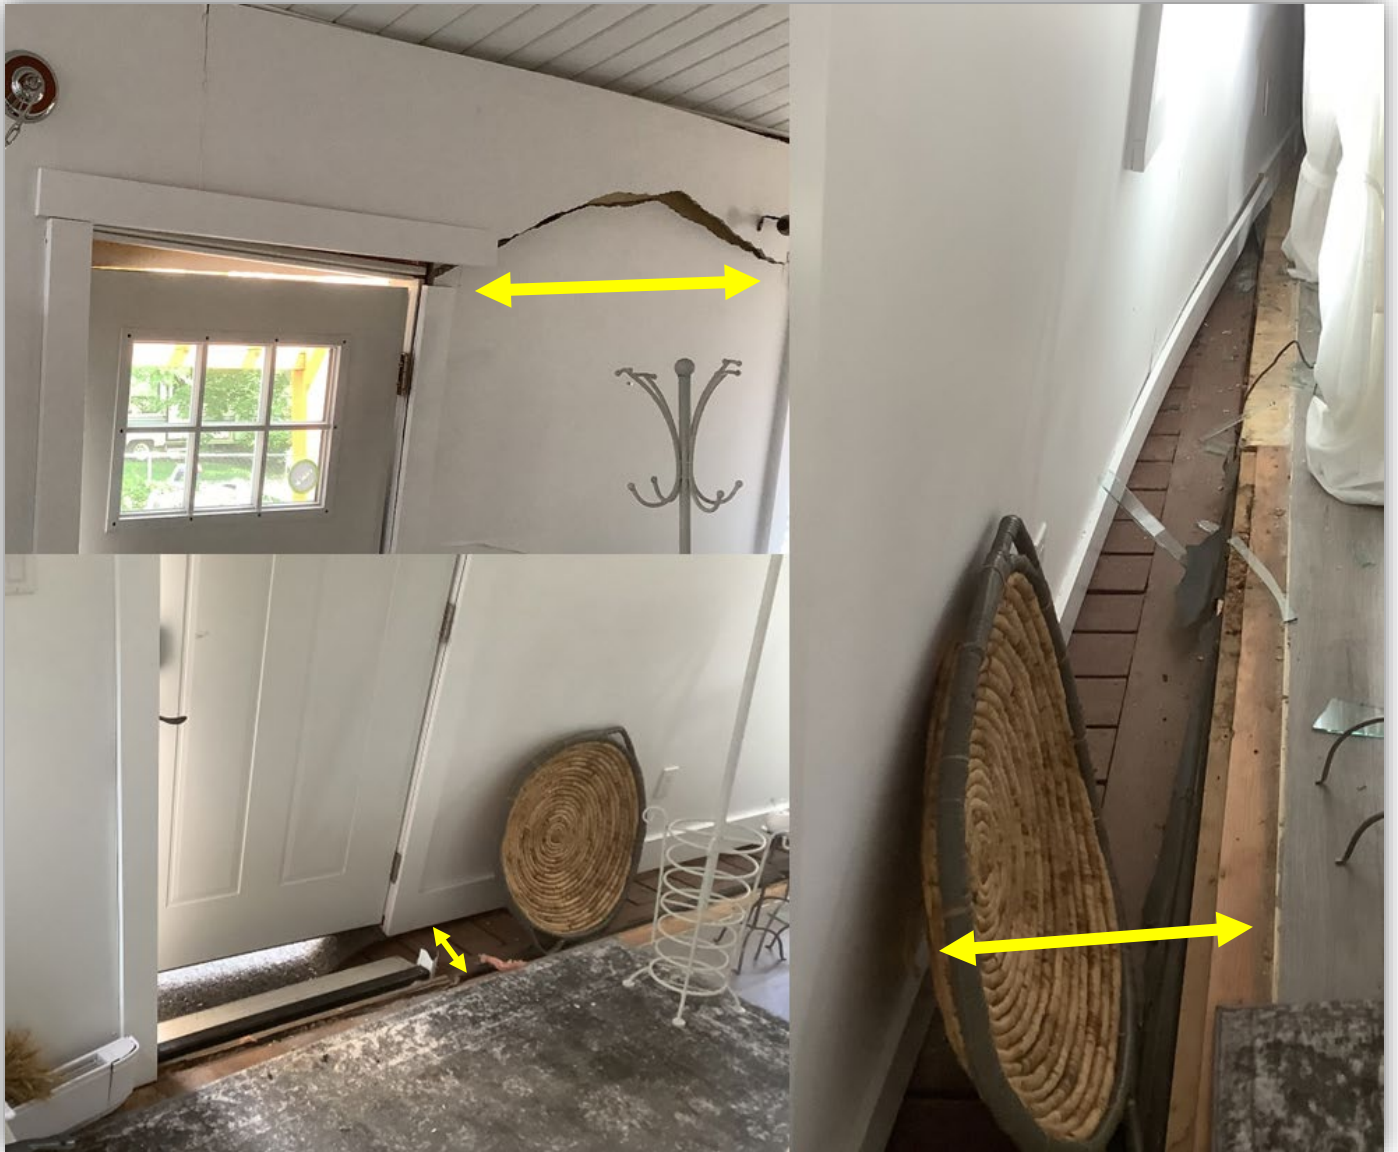
Photo 3 – Damage to wall.

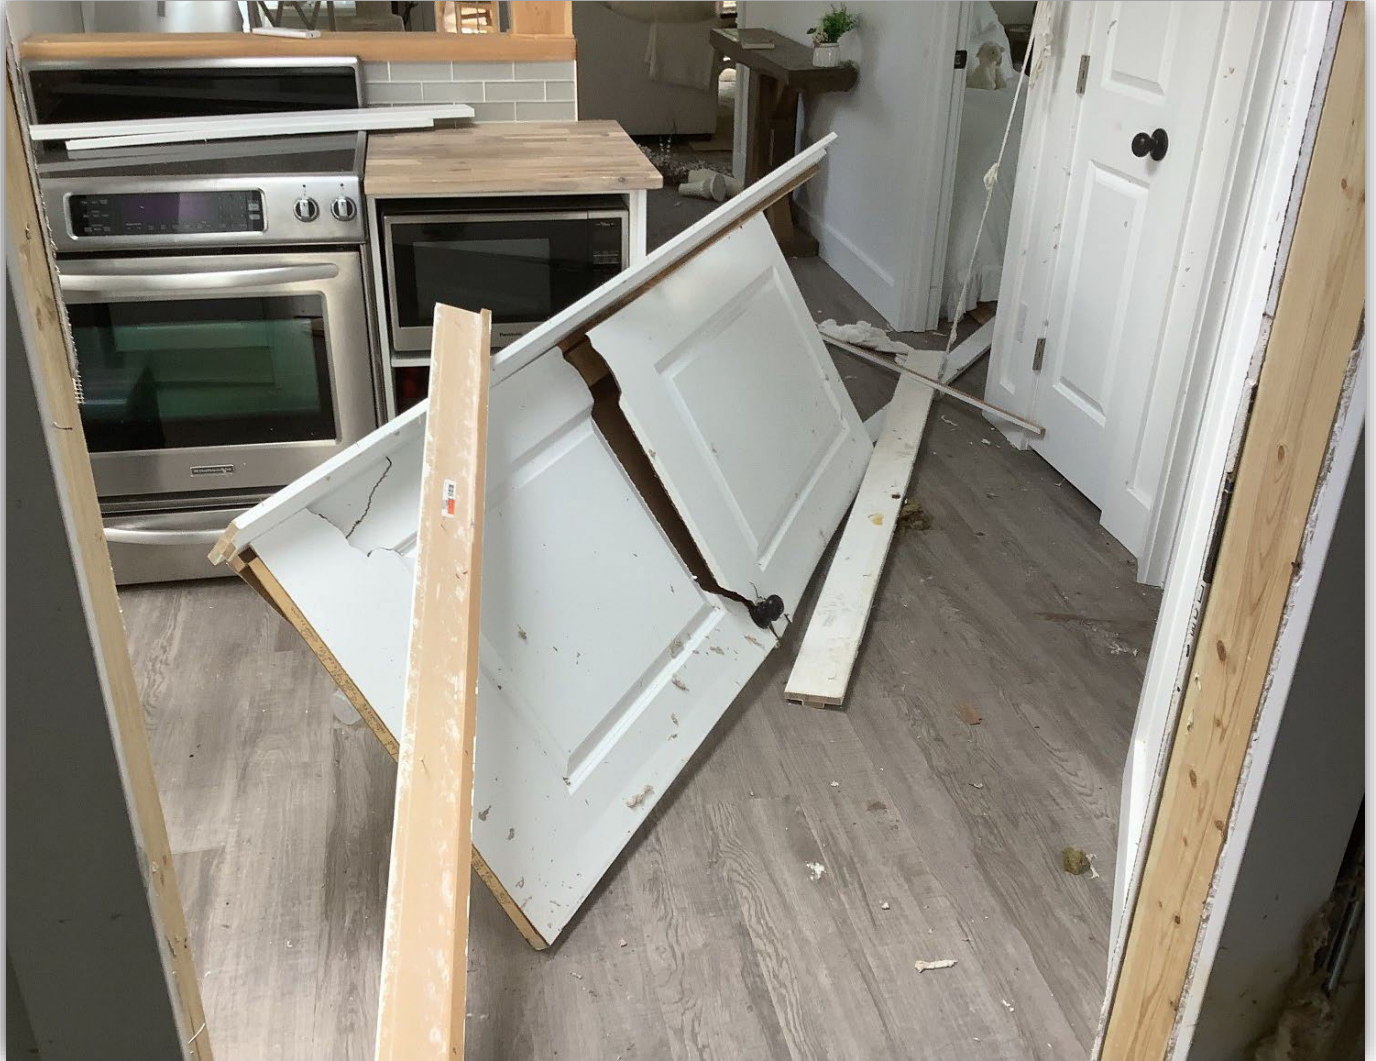
Photo 4 – Interior door blown out.

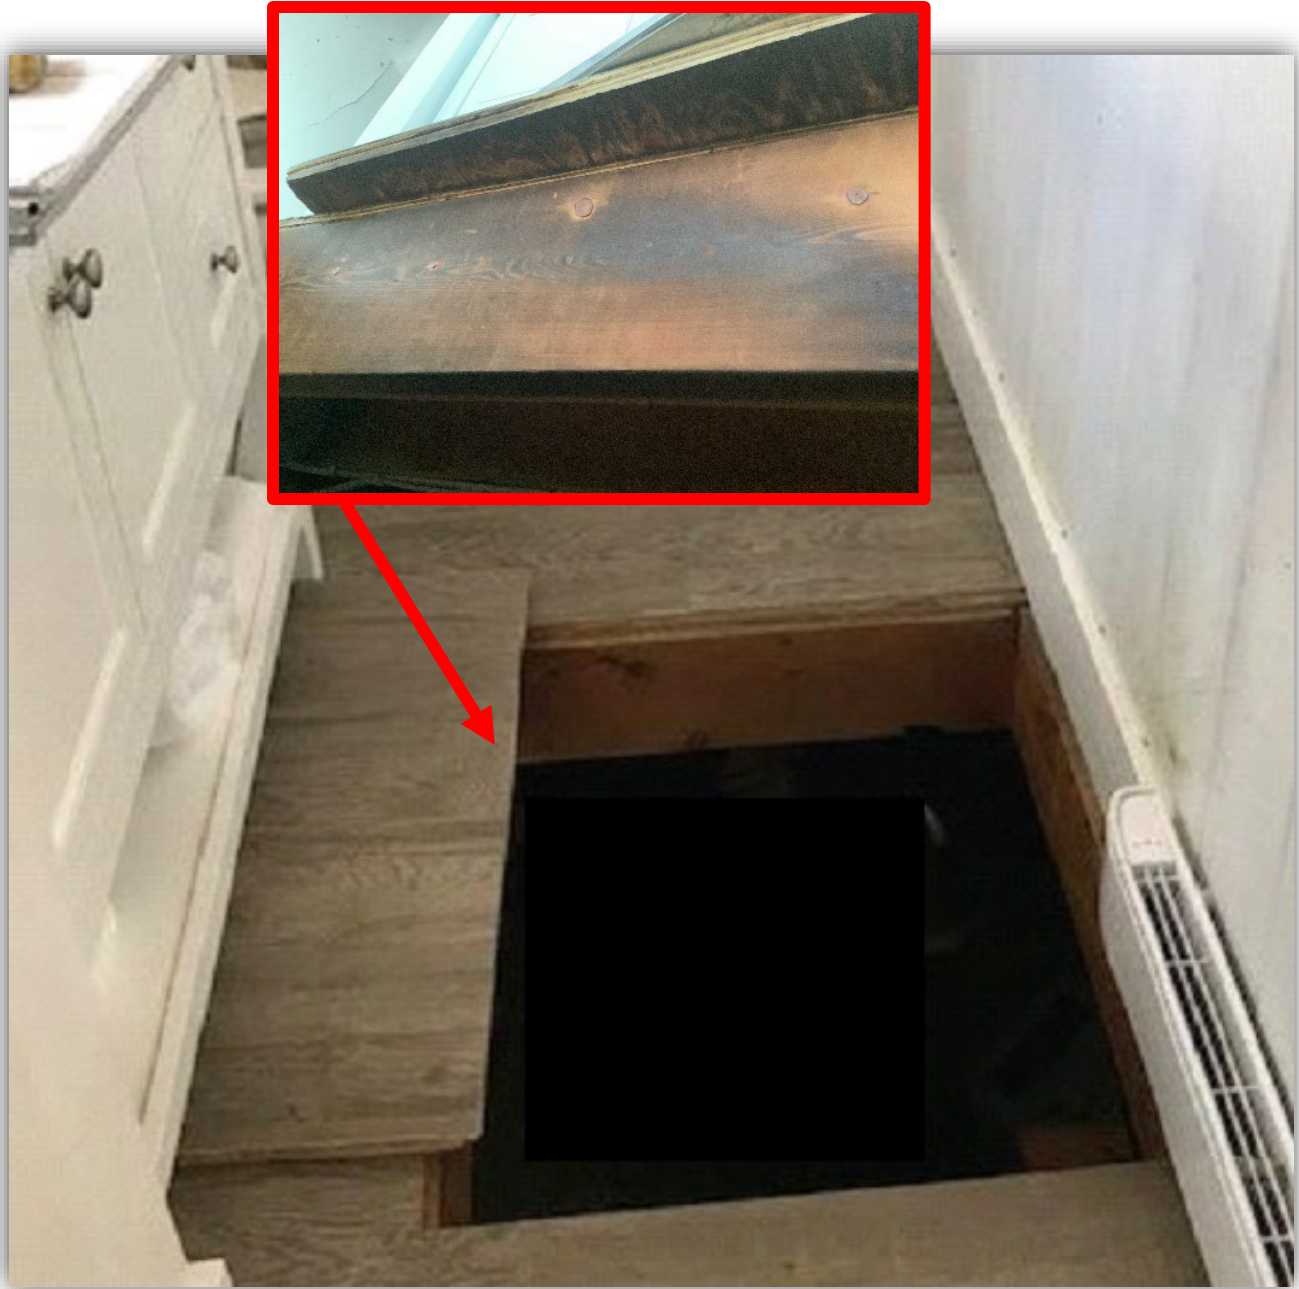
Photo 5 – Burn damage to crawl space entrance.

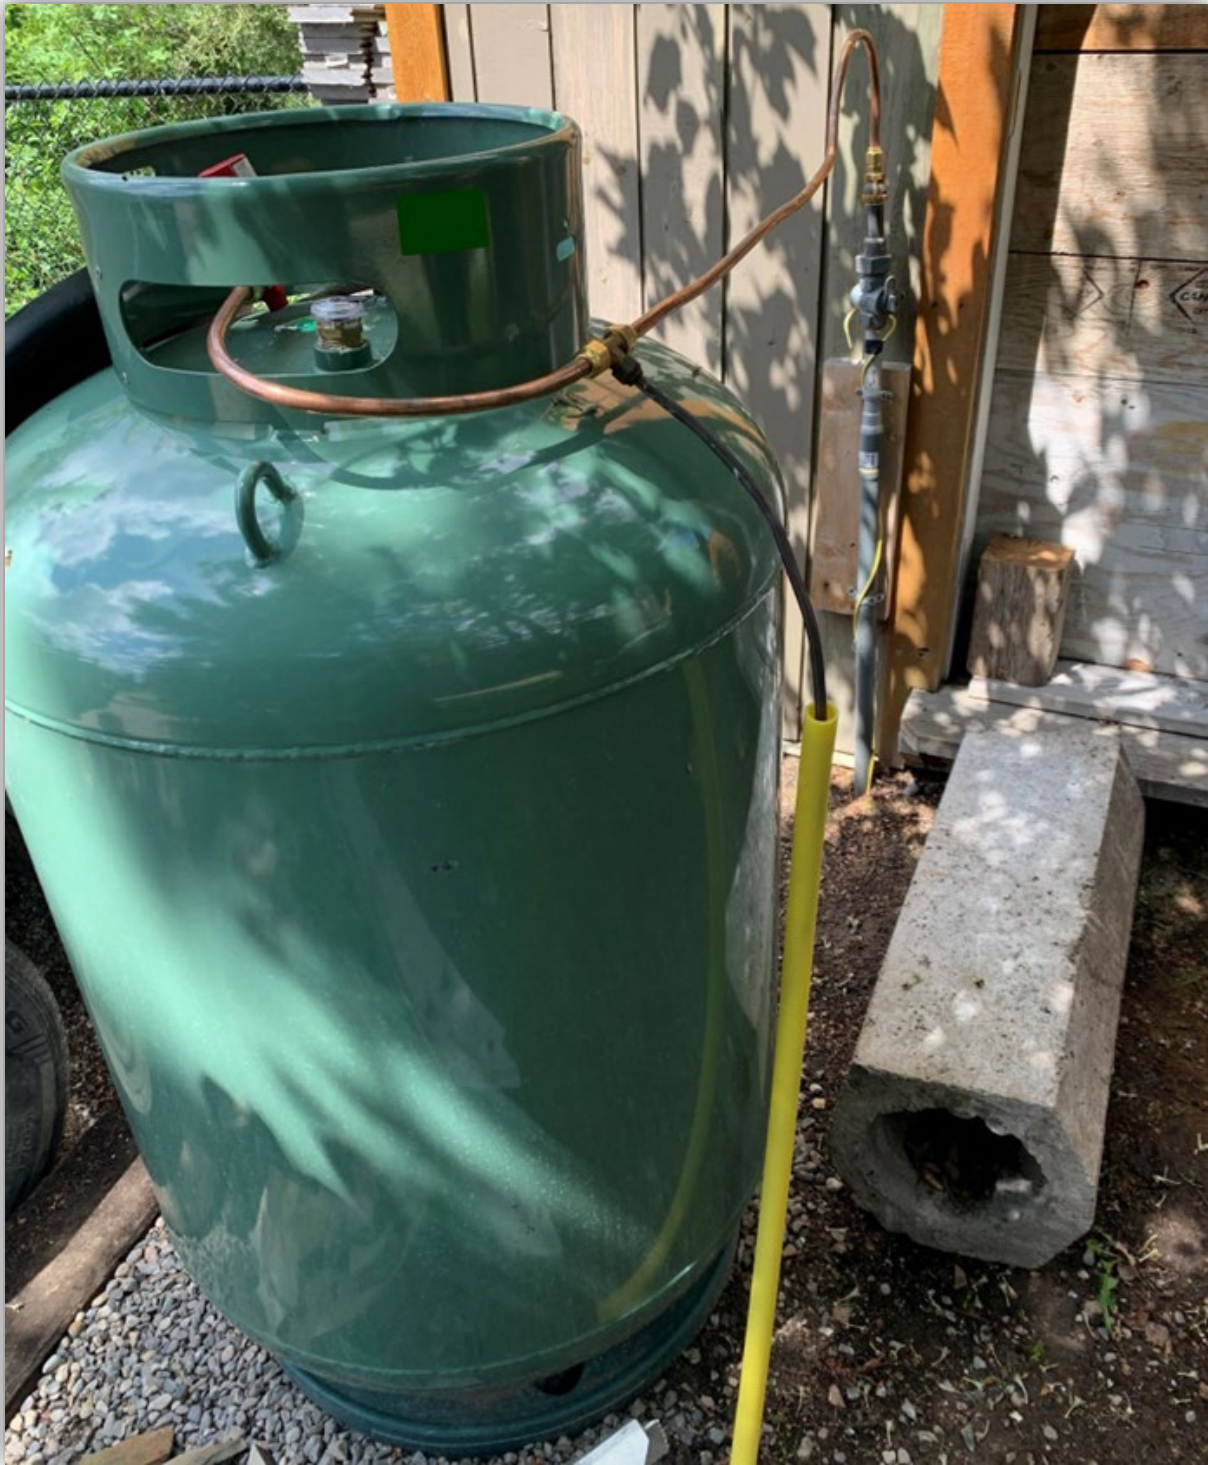
- May 18th, 2023 – Replaced the previous 500-gallon tank with a new full 118-gallon tank with the help of an additional first year apprentice.
- Tied the new tank into the existing line to the main house and replaced the second stage regulator on the main house.
- Was told by the owner that as far as gas appliances, the house only had a stove.
- There was a riser that went to the second house (cabin involved with the incident). The cabin had a yellow prefabricated 3/4 inch poly gas line with the end exposed near the cabin. The line was taped, so they installed a cap on the end.
- Turned the tank on, leak tested the outdoor connected gas lines with liquid solution.

Photo 6 - 118-gallon propane tank.

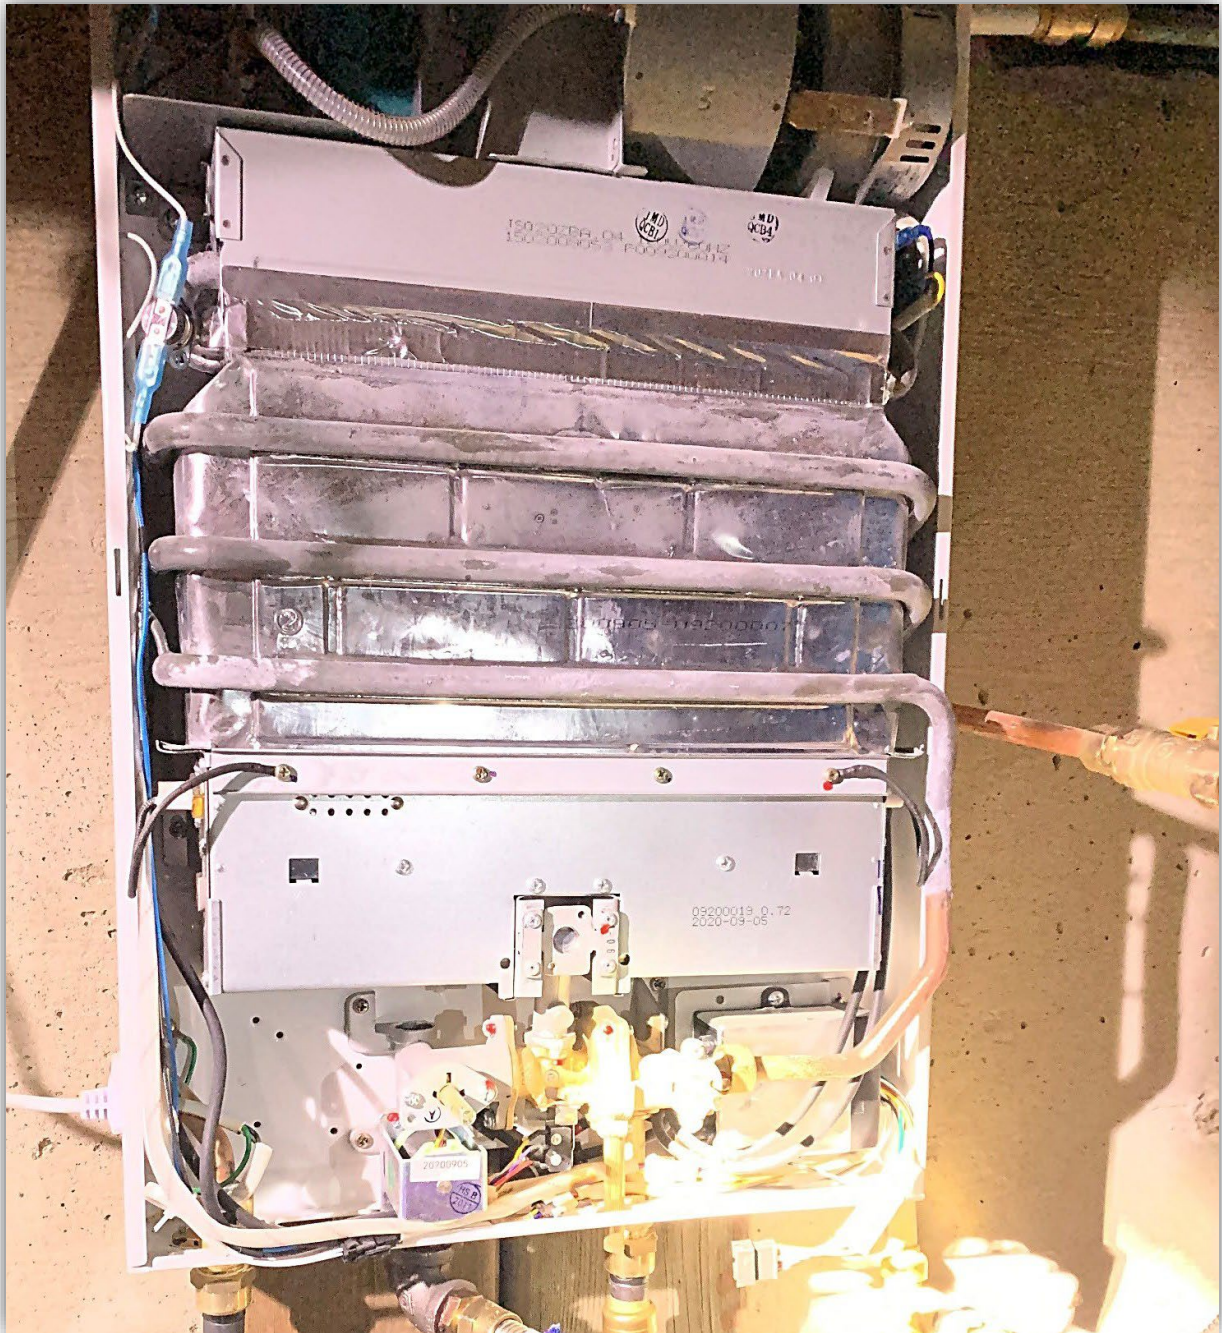
Photo 7 – On-demand water heater.
