Incident Summary #II-798918-2019 (#10565) (FINAL)

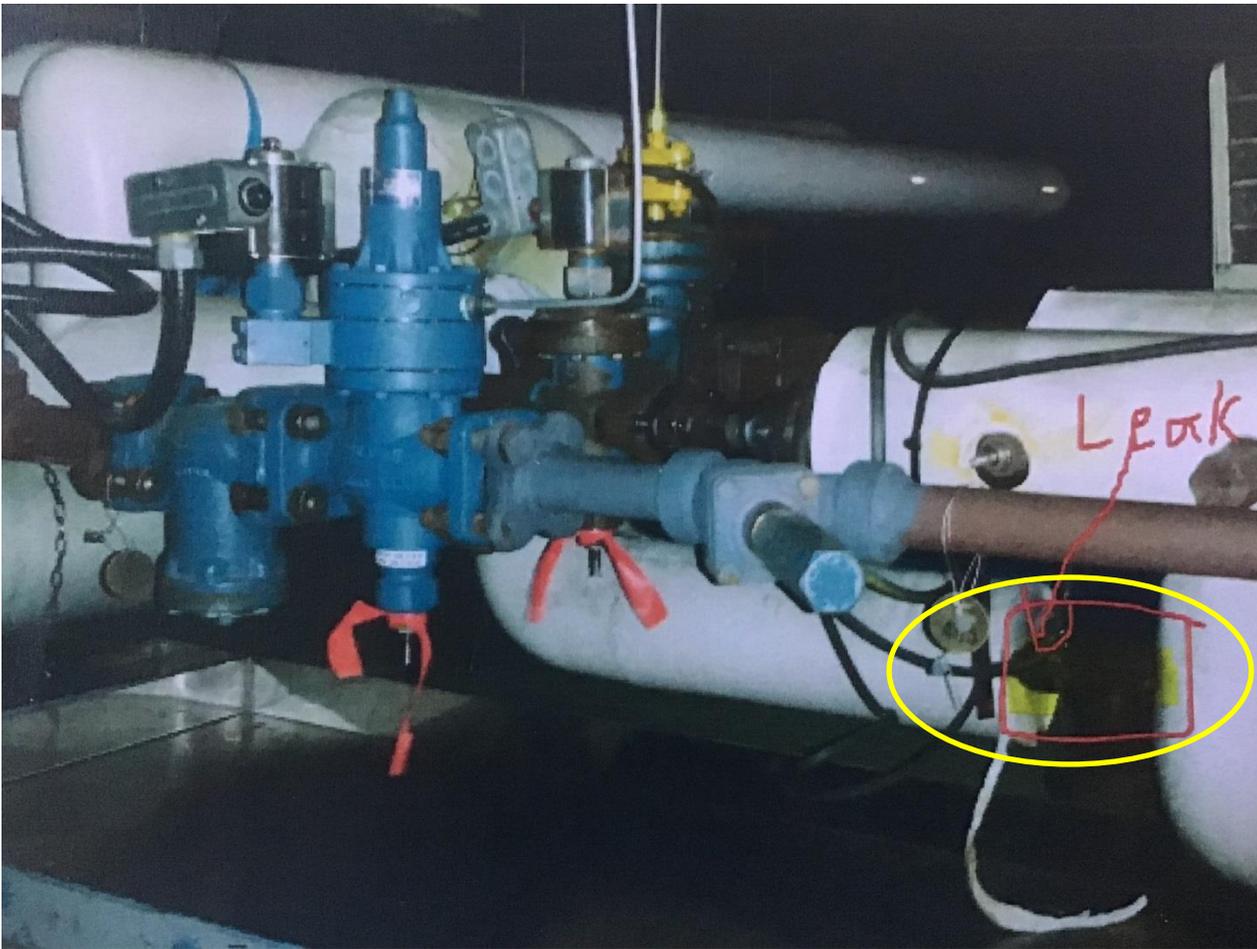
Photo 1 (Submitted by client) shows the location of the ammonia strainer where the leak occurred in the crawlspace area of the facility that the ammonia refrigeration line ran through (yellow oval).

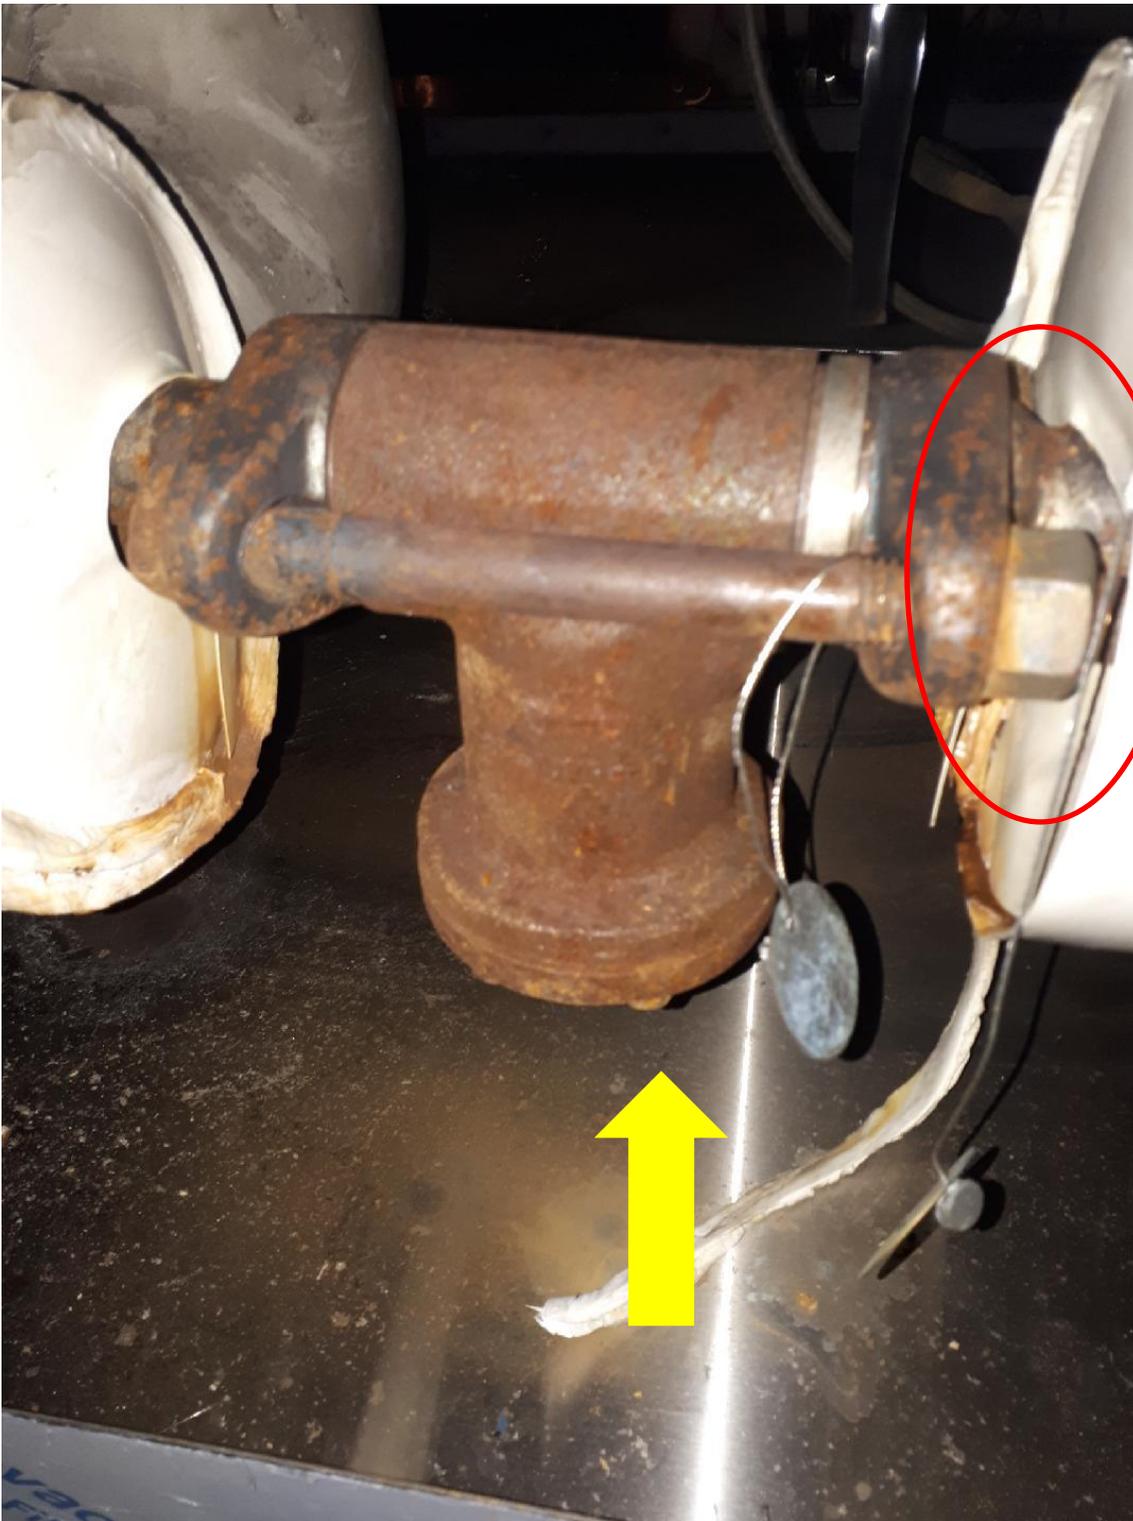
Photo 2 (Submitted by client) Shows the ammonia strainer (yellow arrow) and the flange where the gasket was located (red oval)

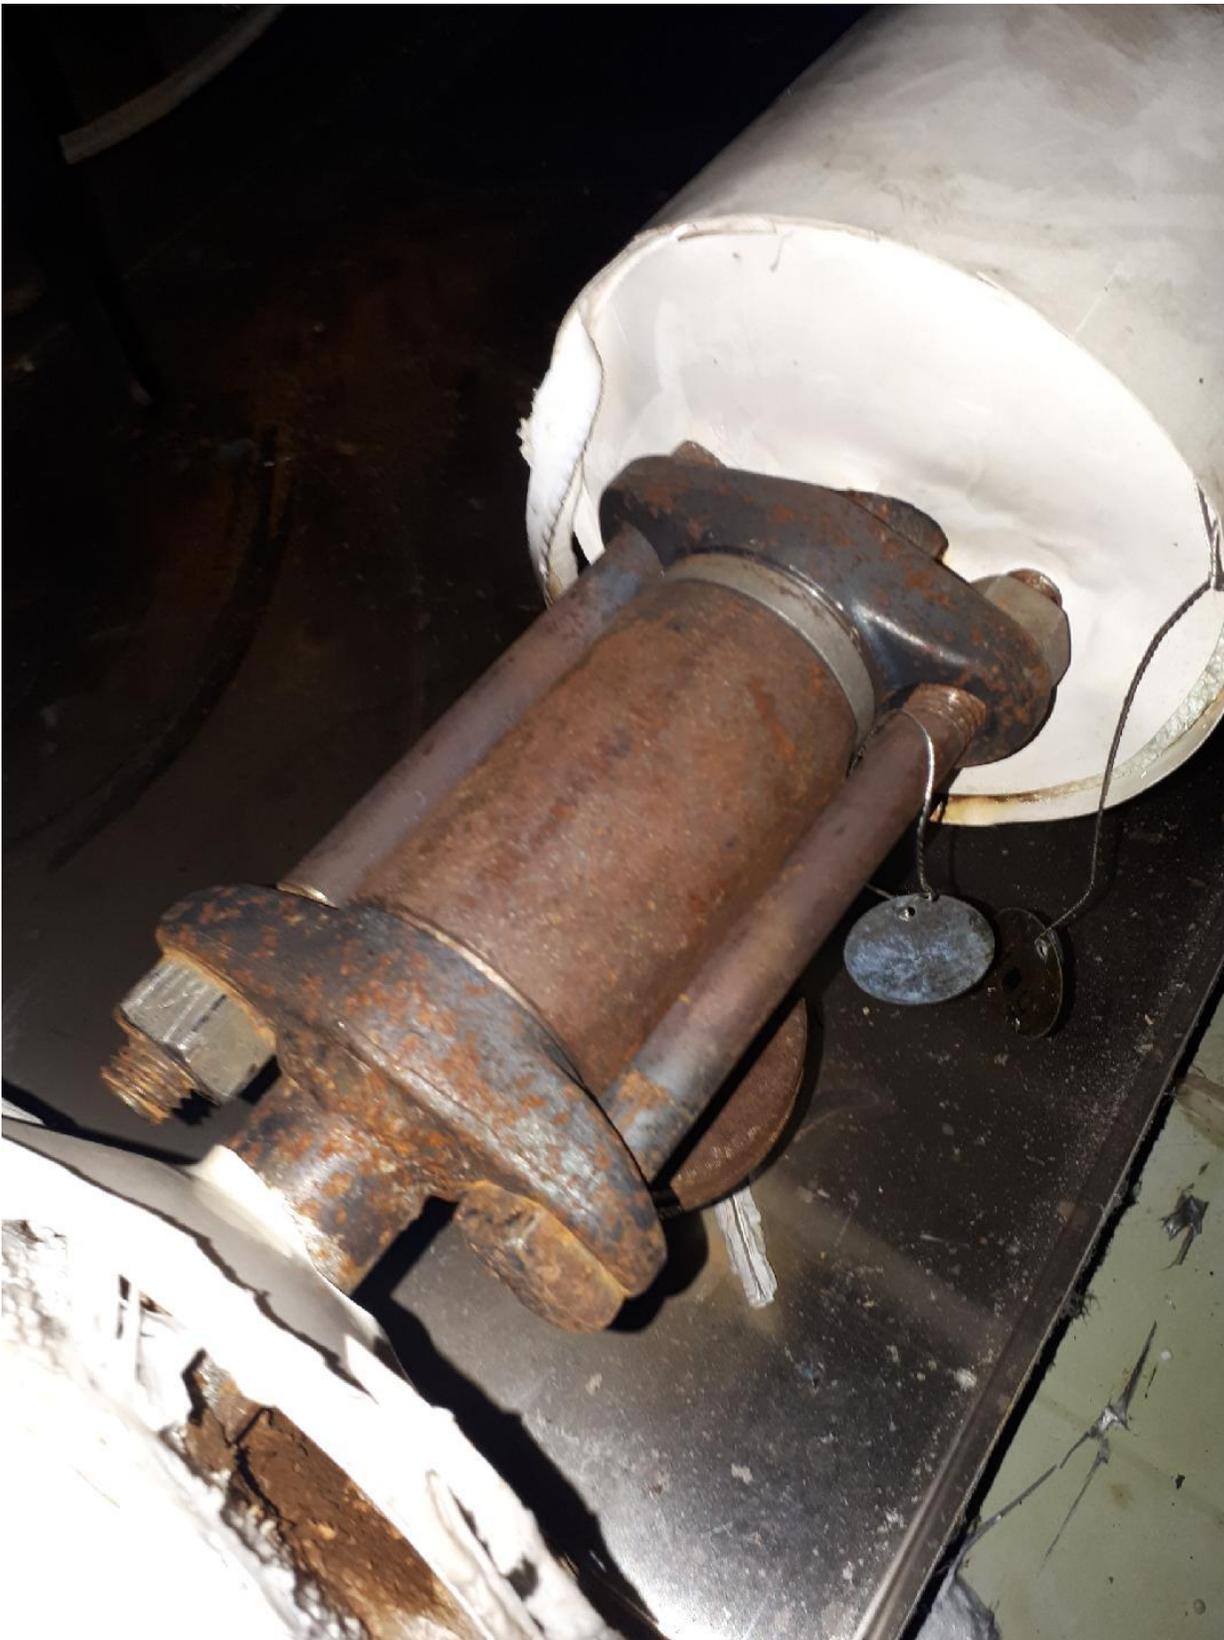
Photo 3 (Submitted by client) The ammonia strainer
