## Incident Summary #II-1032679-2020 (#18573) (FINAL)

SUPPORTING INFORMATION	Incident Date	June 27, 2020
	Location	Egmont
	Regulated industry sector	Gas - Propane system
	Qty injuries	2
	Impact Injury description	One individual deceased and one individual taken to hospital in critical condition.
	Impact Injury rating	Fatal
	Damage description	NA
	Damage rating	None
Incident rating		Severe
Incident overview		Two individuals were staying in a recreational cabin equipped with propane-fueled appliances. The occupants were exposed to high levels of carbon monoxide which were present in the cabin. The individuals were discovered inside unresponsive. One individual was deceased and the other was airlifted to hospital in critical condition.
INVESTIGATION CONCLUSIONS	<p>The lakefront cabin is accessible by boat or a rough dirt road. The cabin contains a wood stove for its main source of heat. There are no fixed gas or electrical utilities available in the area. Gas fuel is provided to the cabin by portable propane cylinders. Two propane cylinders are connected to a gas piping and tubing system which distributes the gas to appliances inside the cabin. Another propane cylinder is used to sup

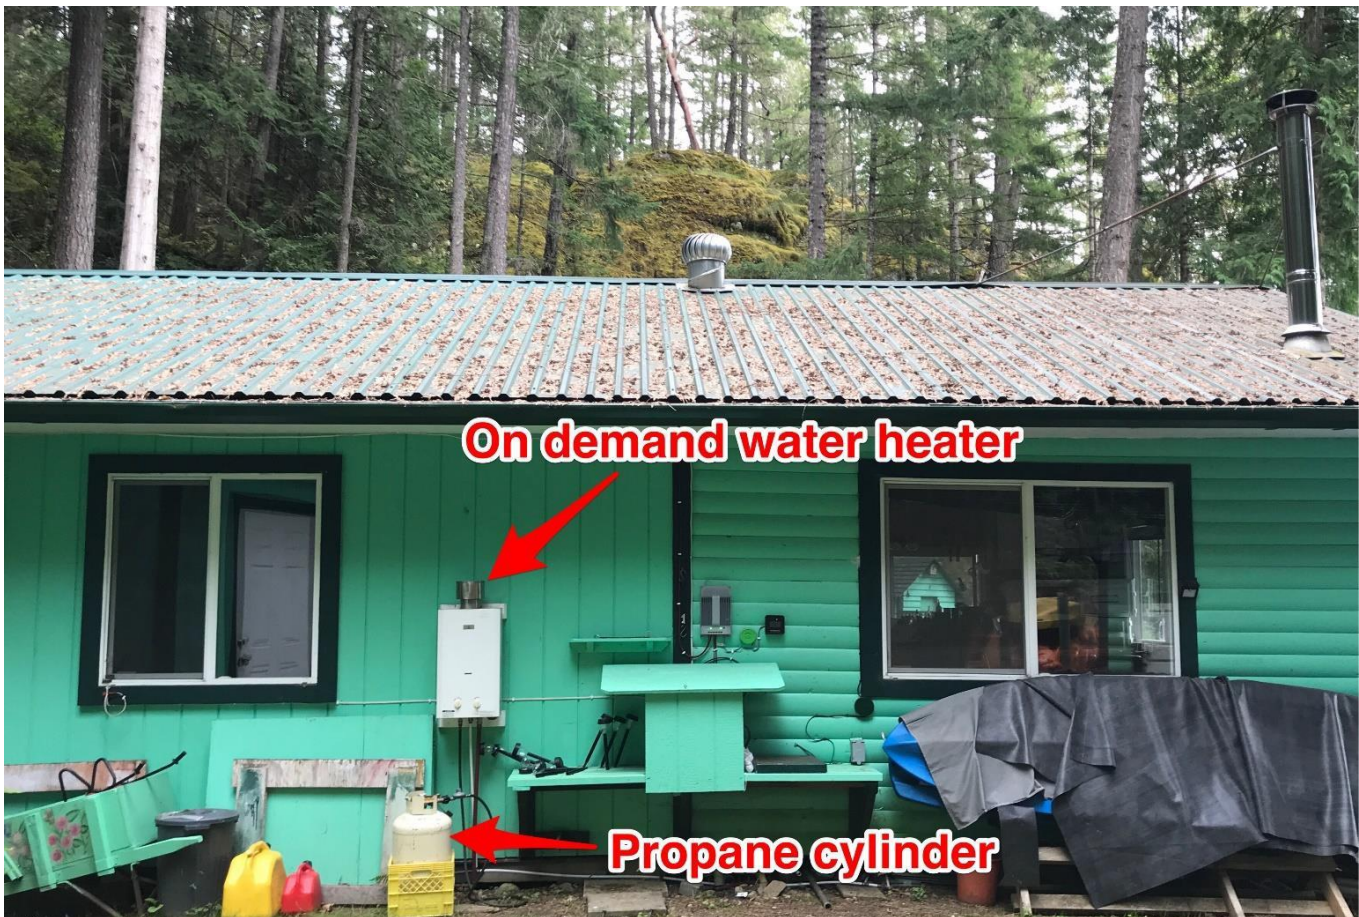
**Image 3** – Water heater location on exterior of cabin away from opening windows

Testing the flue gas of the water heater produced a measurement of 150 ppm of carbon monoxide. The water heater was used to supply hot water to the kitchen sink and an outdoor shower. The heater only operates when water is flowing through a hot water tap for the sink or shower. The appliance was installed outdoors and vents over 4.5 feet away from opening windows (Image 3). The amount of dilution in the outdoor environment would reduce the risk of high levels of carbon monoxide from entering the occupied space inside the cabin. At the time of the site examination, the water heater was connected to an empty propane cylinder and the service valve was found in the closed position. The water heater was determined not to be a significant source of carbon monoxide in the cabin.

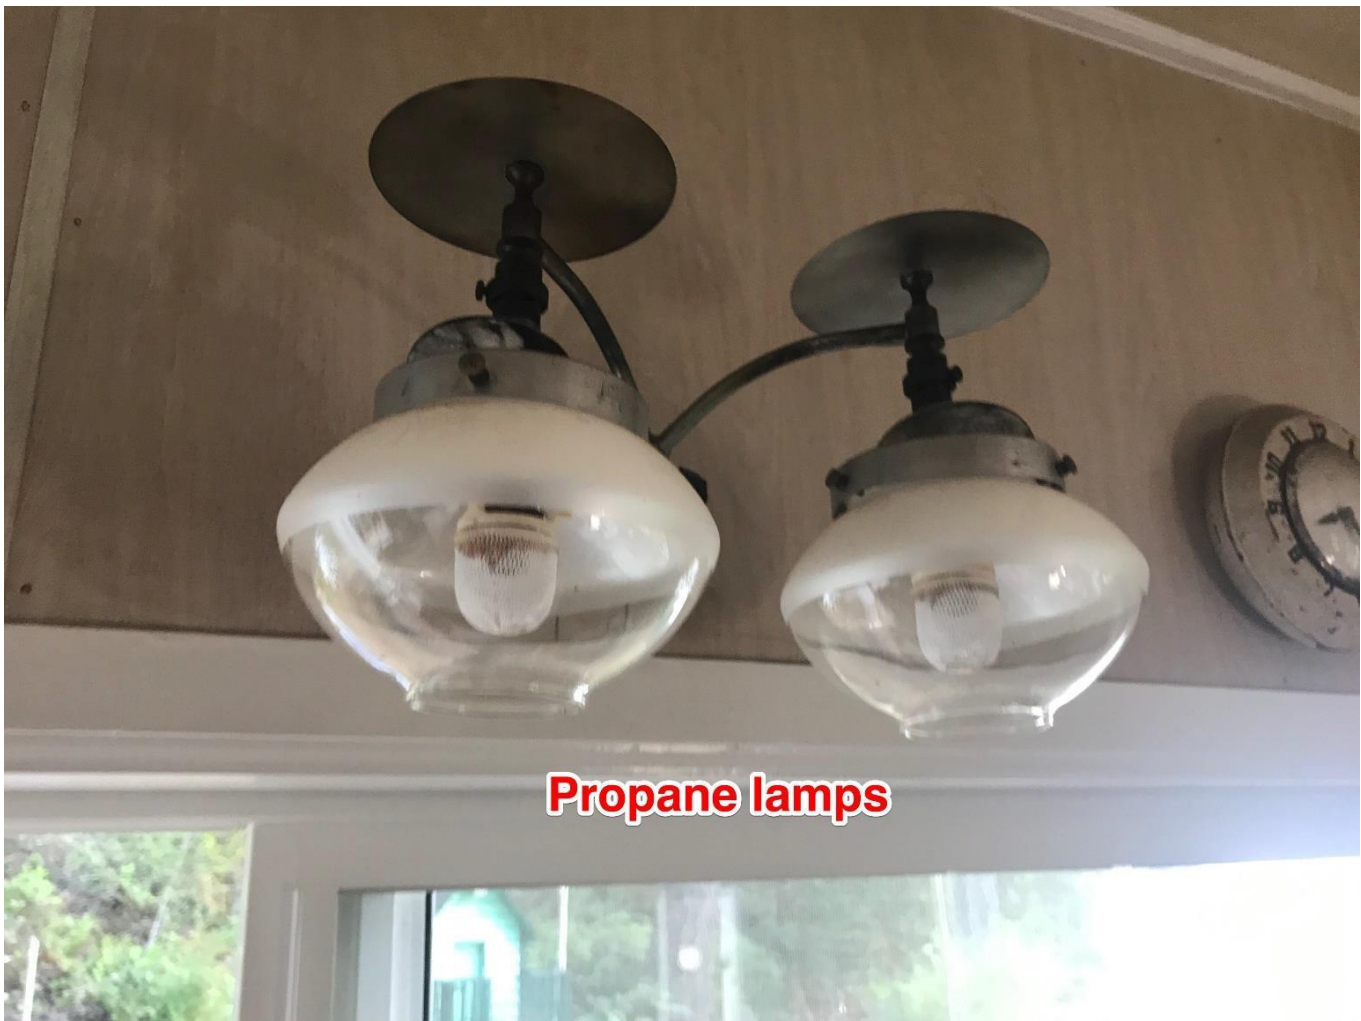
**Image 7** – Propane lamps installed in kitchen above sink

Testing the flue gas of the gas lamps produced a measurement of 87-113 ppm of carbon monoxide. The lamps were installed on the wall above the kitchen sink (Image 7). They were said to be rarely used and they most likely would not have been used during the daytime. There were electric lights powered by the battery and inverter system that most likely would have been used instead of the gas lamps, to conserve the limited propane supply. The time of year the incident occurred, daylight typically lasts until 8 to 9 pm. Although long-term exposure to carbon monoxide levels of 113 ppm can be hazardous, in this incident the gas lamps were determined not to be a significant source of carbon monoxide in the cabin.

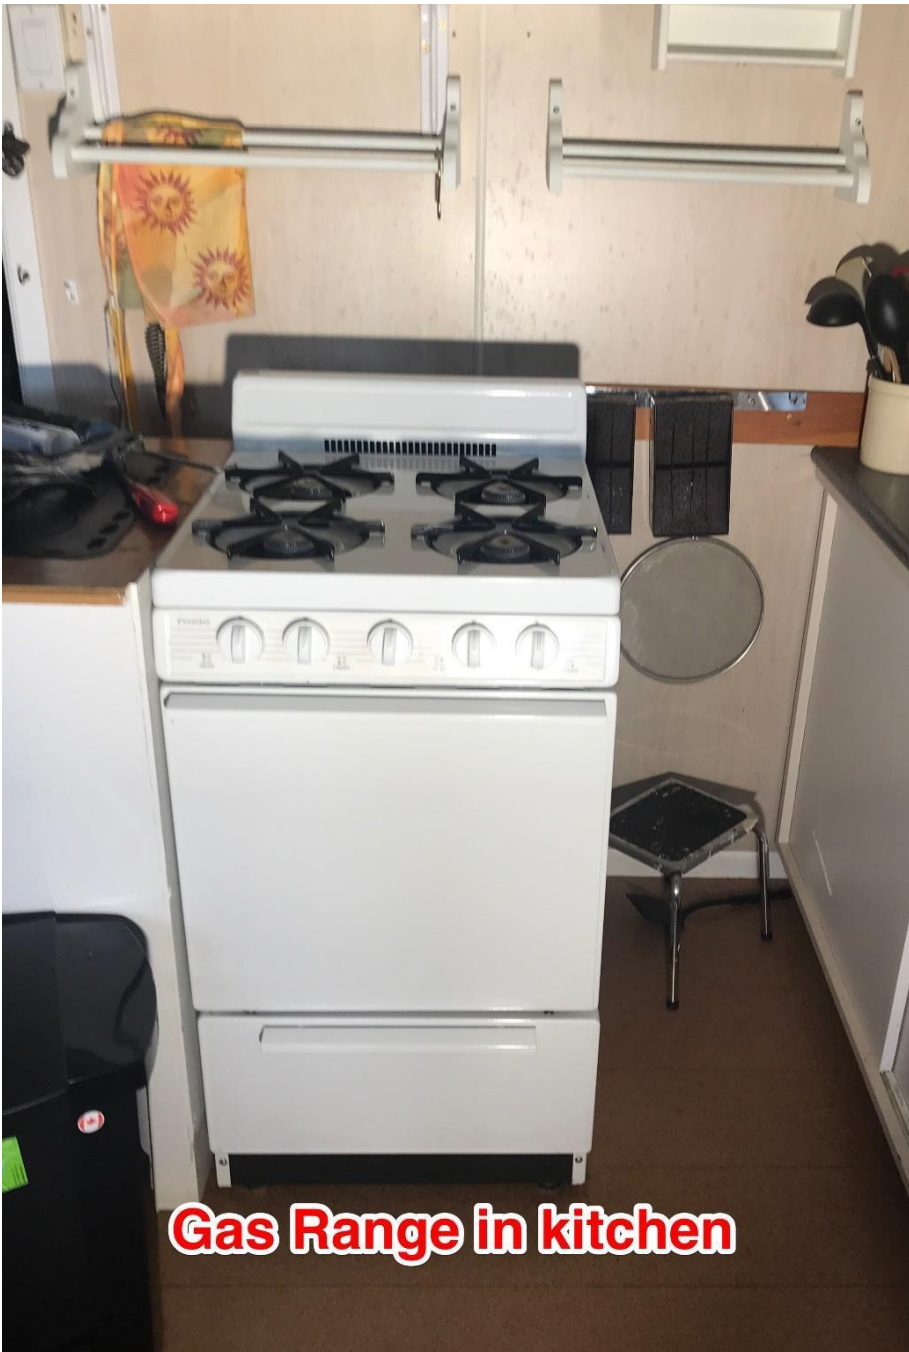
**Image 8** – Gas range installed in kitchen

Testing the flue gas of the gas range cooktop burners did not produce any measurable carbon monoxide. Testing of the flue gas of the oven produced a measurement of 180 ppm of carbon monoxide. The gas range was installed in the kitchen without a ventilating hood fan (Image 8). The oven on the gas range was said to be rarely used and the outdoor barbeque was mainly used to cook food. It is not believed the individuals were using the oven during their time in the cabin. The gas range was determined not to be a significant source of carbon monoxide in the cabin.

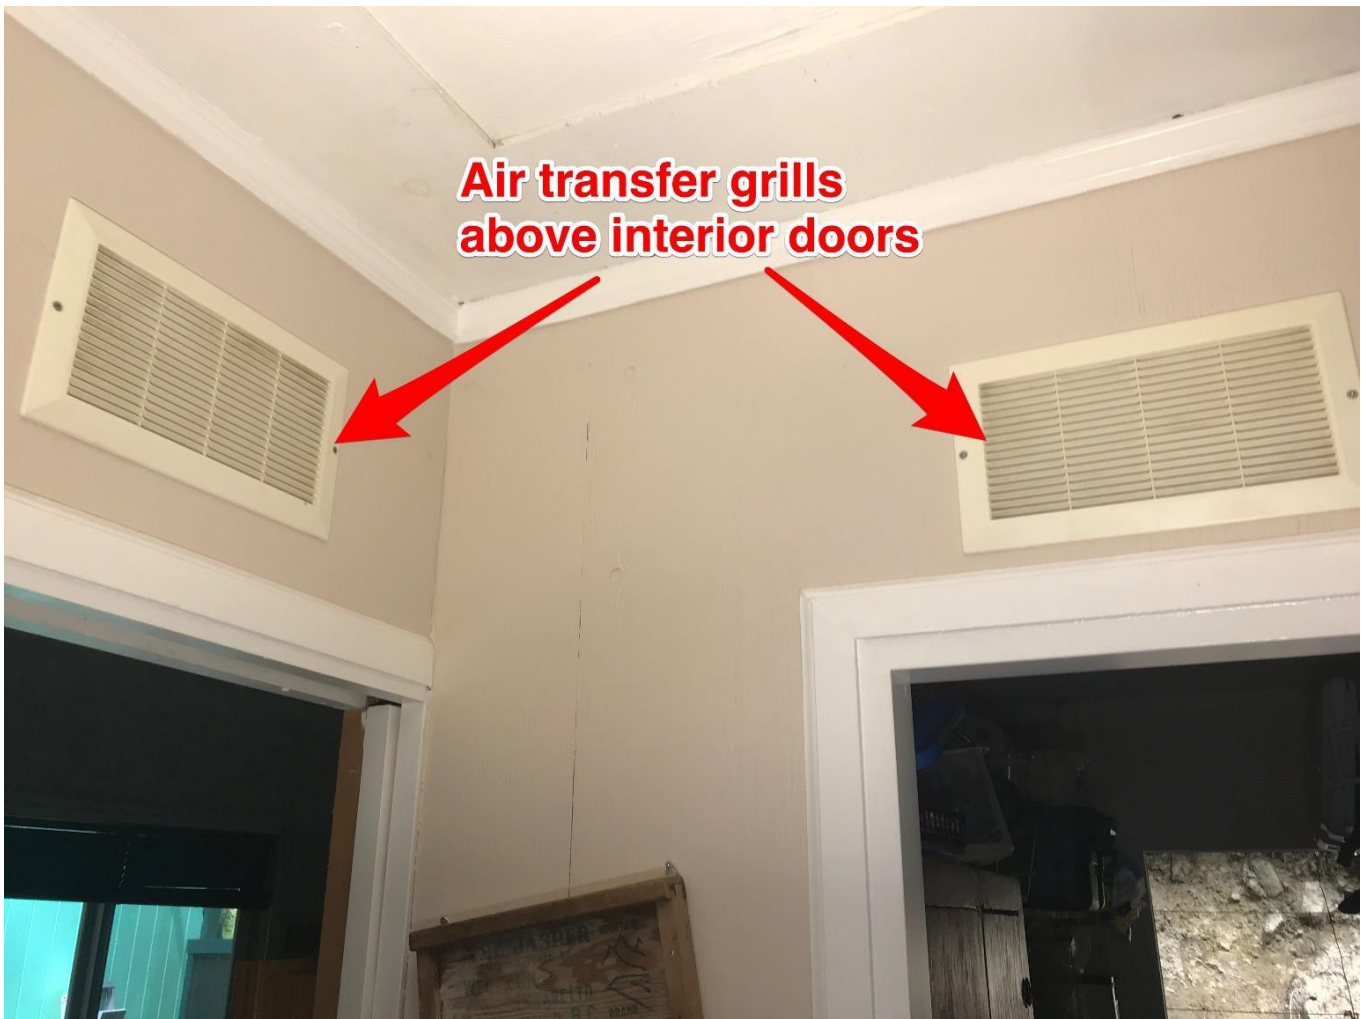
**Image 9** – Air transfer grills that are installed above all the interior doors allowing for air to circulate through the cabin

<p>for cooling has been satisfied. The refrigerator does not allow for an exhaust duct to attach to the flue pipe to vent the flue gases to the outdoors but they are instead distributed in the space the appliance is installed. The installation instructions and owner's manual ask for the installation of a carbon monoxide detector in the kitchen or dining room for safe operation of the refrigerator (Image 20).</p> <p>Carbon monoxide is a colourless, odourless, tasteless gas that is toxic to humans and animals (Chart 2). Exposure to carbon monoxide interferes with the body's ability to absorb oxygen, which can result in serious illness or death. Lower levels of carbon monoxide may result in serious health effects subject to the duration of exposure (Table 1). For example, exposure to carbon monoxide levels as low as 130 ppm can be lethal after exposure for eight hours. Symptoms of carbon monoxide poisoning can present similar to flu symptoms: headaches, nausea, dizziness, or vomiting. For more information on carbon monoxide, visit <a href="#">Carbon Monoxide Safety Tips</a>.</p> <p>Carbon monoxide is produced from incomplete combustion of fossil fuels including natural gas and propane. Incomplete combustion can be caused by an inadequate air supply or flame impingement. Flame impingement occurs when a flame strikes an object and cannot extend far enough to complete the combustion process. Impingement disrupts the flame pattern, but may not produce a yellow, sooty flame.</p> <p>Common practice in the recreational community where the cabin is located is to open doors and windows while operating unvented propane appliances to allow for fresh air to enter, providing air for combustion and diluting flue gases inside the occupied space.</p>

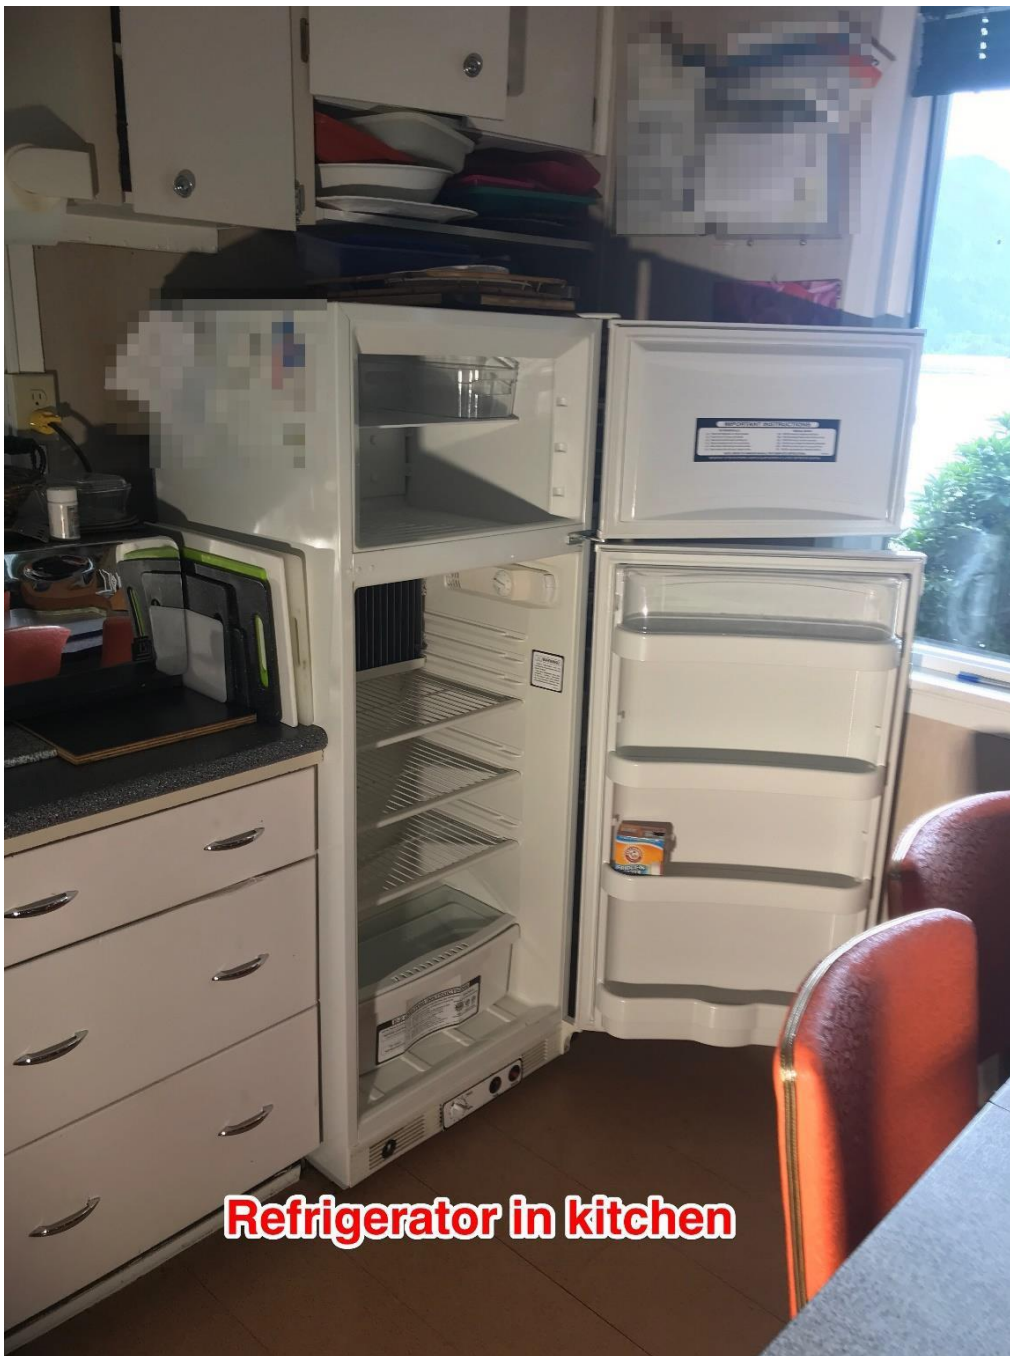
**Image 10** – Propane gas refrigerator installed in kitchen

Testing the flue gas of the refrigerator produced a measurement of 1306 ppm of carbon monoxide within ten seconds of the burner's initial start-up (Image 12). The gas-fueled refrigerator was installed in the kitchen (Image 10). The refrigerator design did not allow for the flue gases to be vented to the outdoors or incorporate a carbon monoxide detector and safety valve interlocked with the operation of the gas burner. The flame was examined while in operation and debris was observed lying

The refrigerator flue gas measured high levels of carbon monoxide and were exhausted directly into the cabin. The refrigerator operates with a constant flame that does not extinguish but transitions from high to low when the cooling temperature of the set point is satisfied. Therefore, the refrigerator was constantly exhausting high levels of carbon monoxide into the cabin while the refrigerator was in operation. The refrigerator was verified as being the most likely source of carbon monoxide and very likely created a hazardous environment inside the cabin.

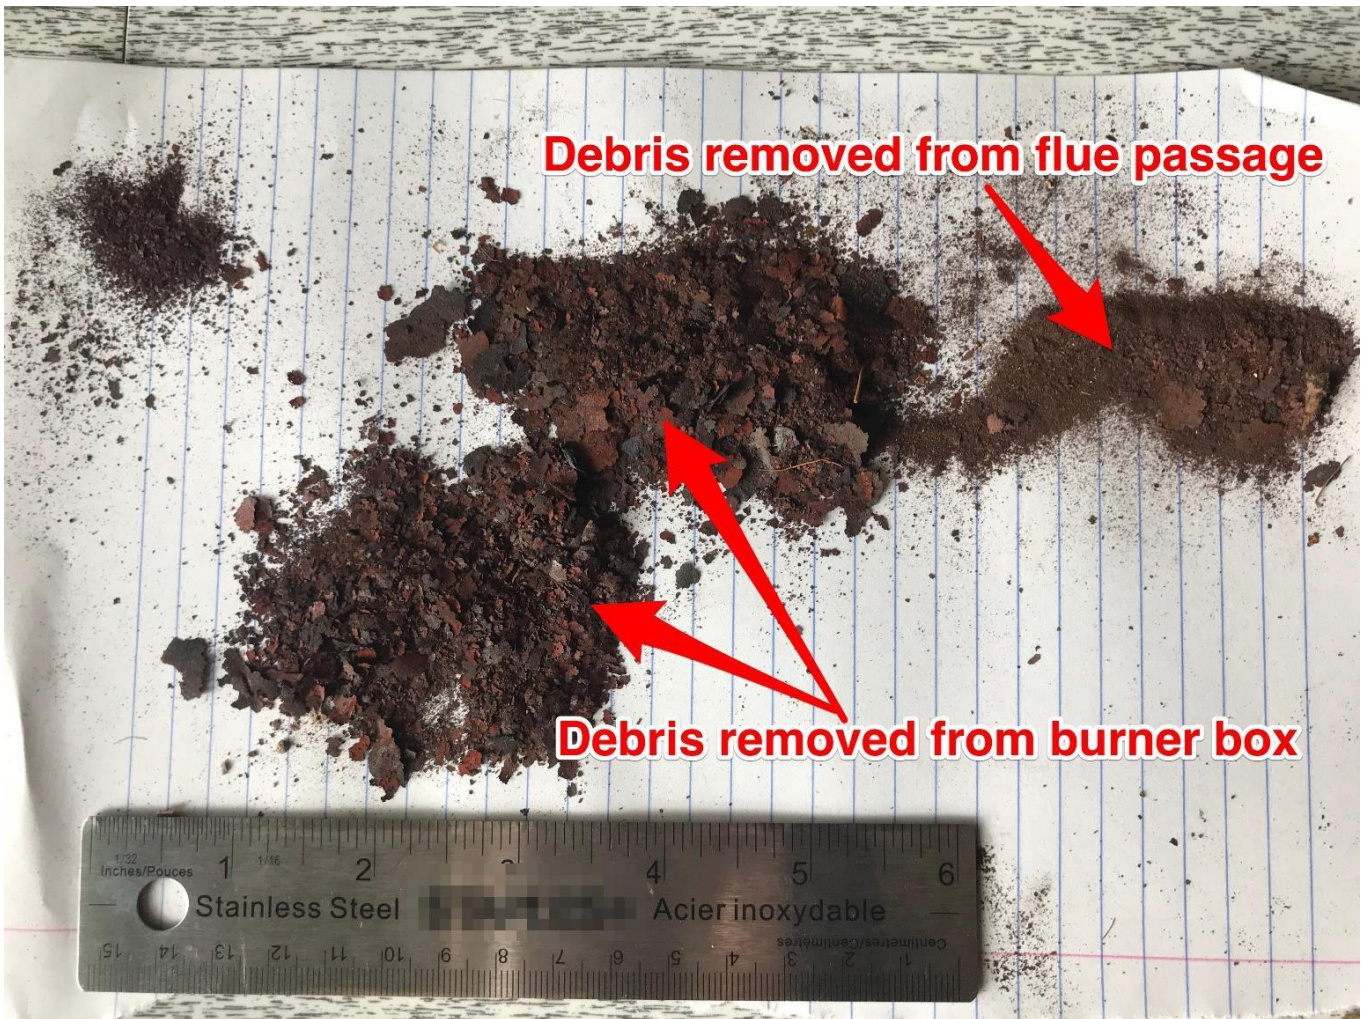
**Image 15** – Corrosion scale debris removed from burner box and flue

During testing, the debris was cleaned off the burner tube and burner assembly. The burner flame was relit and it produced a clean and stable flame (Images 15-16). Removal of debris lying on top of the burner had allowed the burner flame to return to the clean, stable flame pattern. The flue was observed to be clear with solid light passing through it. A flue brush was passed through the flue and fine particles were observed coming out the bottom. The burner box was reinstalled in its original location. Testing of the gas burner after it was cleaned produced a measurement of 15-28 ppm of carbon monoxide (Image 17). The carbon monoxide output of the propane refrigerator had reduced from a recorded 1306 ppm to 15-28 ppm after the debris was removed from the burner and the vent was cleaned out. The larger piece of debris can be seen laying off to the side but still touching the top of the burner (Image 14). It is suspected as this was the piece that was witnessed on top of the burner during its earlier operation when carbon monoxide levels were measured in the fridge flue in excess of 1300 ppm. It is suspected that this piece and possibly others shifted off the top of the burner during the manipulation of the burner housing away from the vent tube for closer examination. The corrosion debris on the burner was determined to be the cause of the production of high levels of carbon monoxide.

The owners stated that they would typically complete maintenance on the refrigerator at the beginning of every spring season. There was a painting style brush, labelled in felt marker "For cleaning back of fridge", along with a flue brush designed for cleaning the inside of the flue of a gas refrigerator, hanging beside the refrigerator on a wire rack. The installation instructions and owner's manual for the refrigerator were in a document holder on the wall next to the refrigerator and had highlighted passages in the instructions for defrosting. The manual's instructions strongly recommend maintenance and cleaning be completed every three months assuming the appliance is used full time year round. The manual's maintenance procedures includes pulling the fridge away from the wall, removing a single screw, moving the burner box away from the flue and using compressed air to blow away any dirt or debris from the flue passage and entire burner and gas orifice area. The owner stated they followed the maintenance instructions and every year in March during spring break they would use a vacuum cleaner, set to blow air, and blow air down the flue and removed the screw and pull the burner box out and clean the debris from the burner area with the labeled paint style brush. The owner was unable to make it to the cabin the spring before the incident and does not believe that the maintenance of the fridge took place. The amount of corrosion scale debris found in the flue and

burner area indicates the cleaning of the debris from the burner and orifice area had not been completed recently.

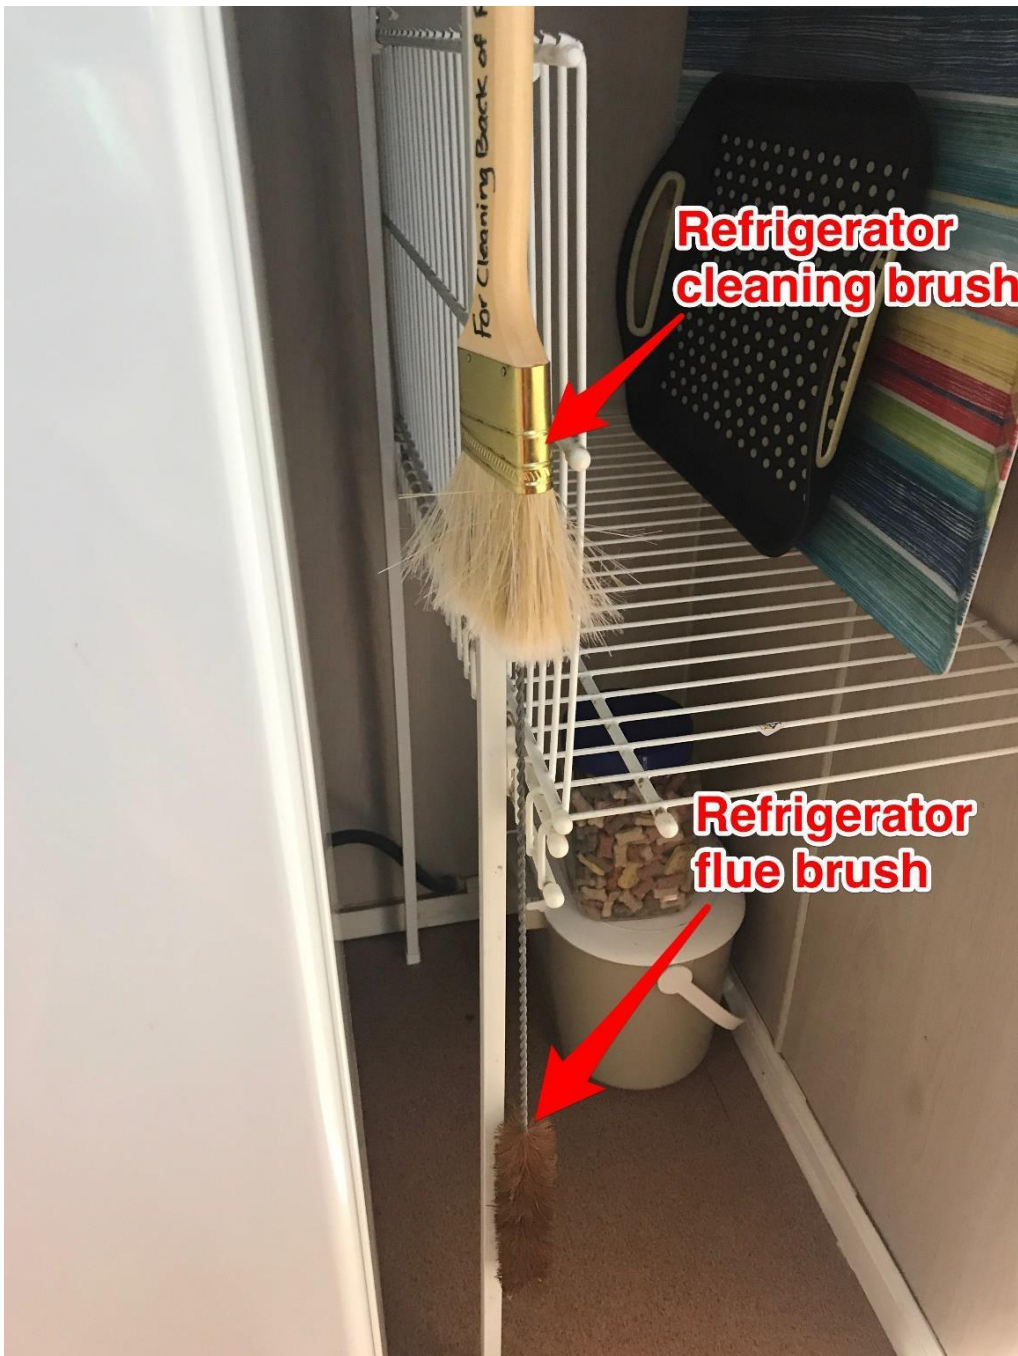
**Image 18** – Brushes used for refrigerator maintenance cleaning hanging beside refrigerator in kitchen
