Incident Summary #II-1253155-2021 (#23970) (FINAL)

Damage rating	Major
	Incident rating	Major	
Incident overview	An unsupported portion of a gas fired boiler's venting system was knocked off by a vehicle driving through the parkade. CO was released into the parkade and building exposing the occupants and was measured as high as 233 parts per million A gas fitter on site for an unrelated maintenance visit was exposed to CO, recognized the symptoms and notified emergency personnel.		
INVESTIGATION CONCLUSIONS	Site, system and components	<ul style="list-style-type: none"> • The apartment building is a 22 story high rise tower constructed of concrete. • Two natural gas fired boilers for hot water are located in the boiler room in the uppermost parkade floor. • The boilers have parallel exhaust venting systems which include metal venting with horizontal and vertical sections, hangers and fasteners for the venting. • The venting system for the boilers use a combination of the vertical atmospheric pressure difference between the boiler and the higher exit points along with power booster fans to ensure products of combustion exit the building safely. • The power booster fans are inline wi

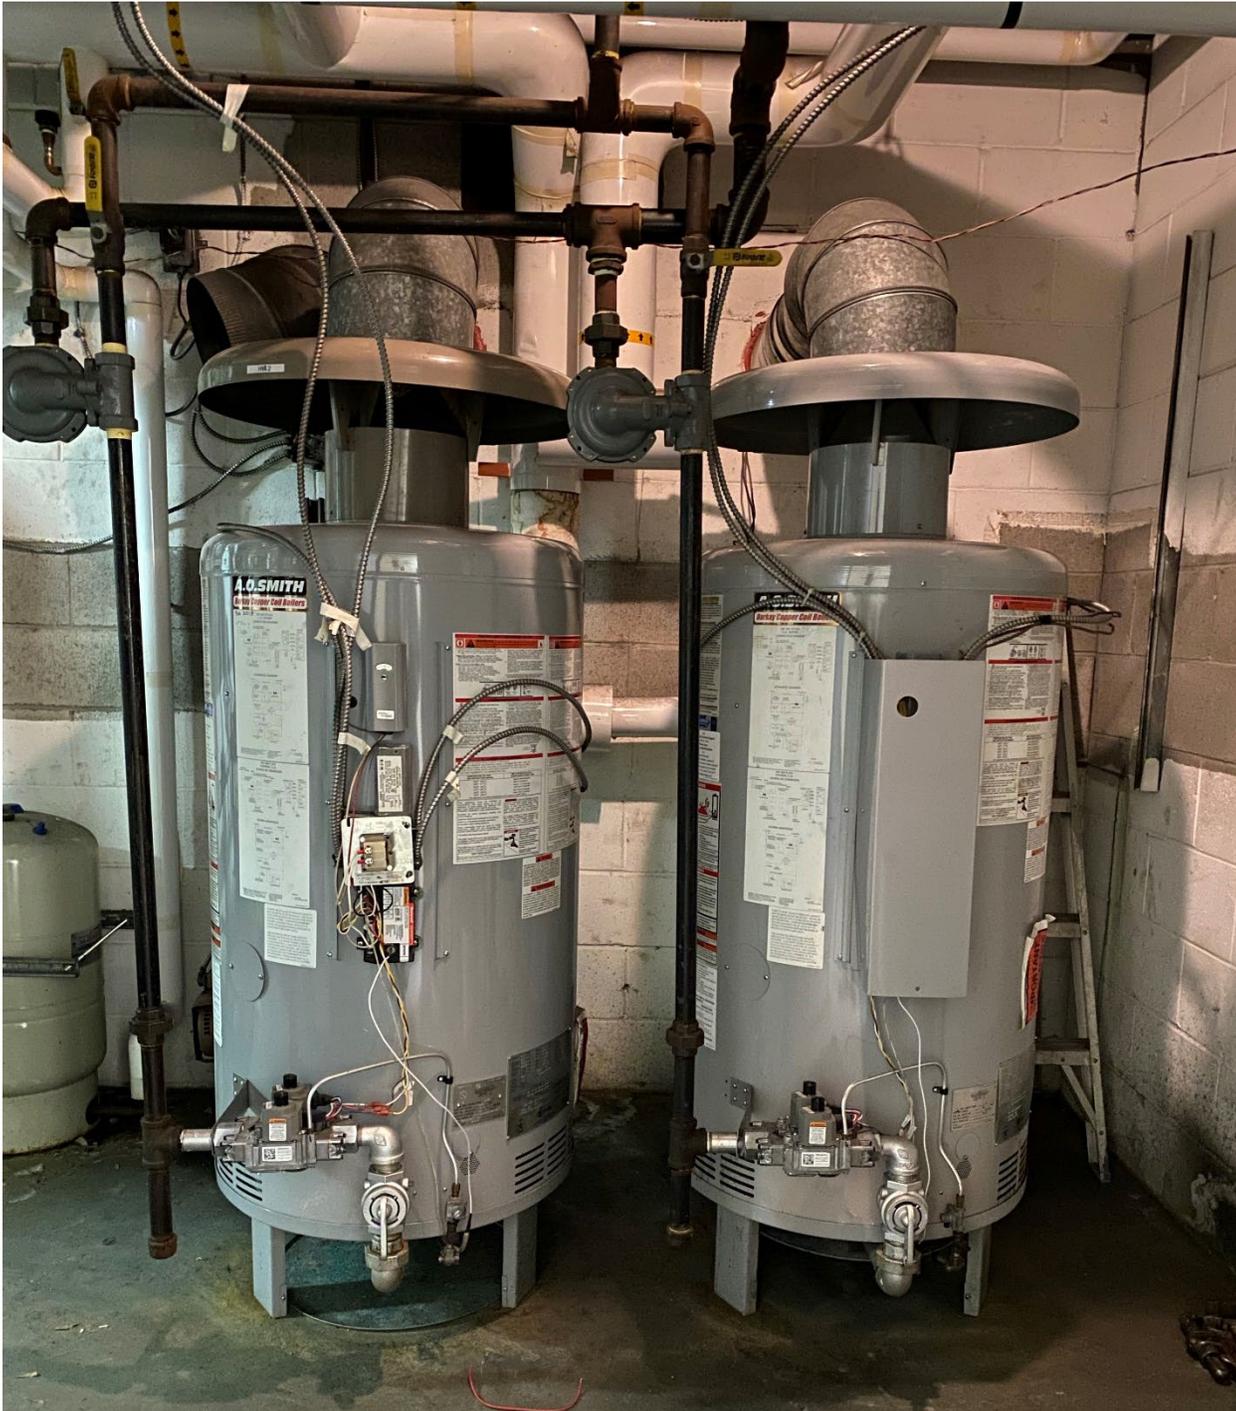
Image 1 - Gas fired water boilers

<p>Failure scenario(s)</p>	<p>Two boilers (Image 1) were installed in the parkade with their respective venting systems running horizontally through the parkade then up to the outside exhaust enclosure that contains two power booster fans. An unsupported section of one of the boilers venting systems was most likely knocked off (Images 2/3/4) by a truck with a luggage rack as it drove through the lowest part (Image 5) of the parkade in the night prior to the incident. Over the night, and until the boiler was identified and shut down the next day, products of combustion were intermittently released into the parkade, boiler room and eventually up through the building. Building staff noticed the piece of vent (Image 4) on the concrete parkade floor in the morning but were not aware what system it was for at that time. Unrelated to the knocked off vent piece, a gas contractor was scheduled to perform yearly maintenance the following morning. Products of combustion had entered the parkade boiler room through the boilers draft hood and/or from the exit corridor resulting in dangerous levels of CO in the boiler room. Recognizing the symptoms of CO poisoning while working in the space, the gas fitter vacated the boiler room and called 911.</p>

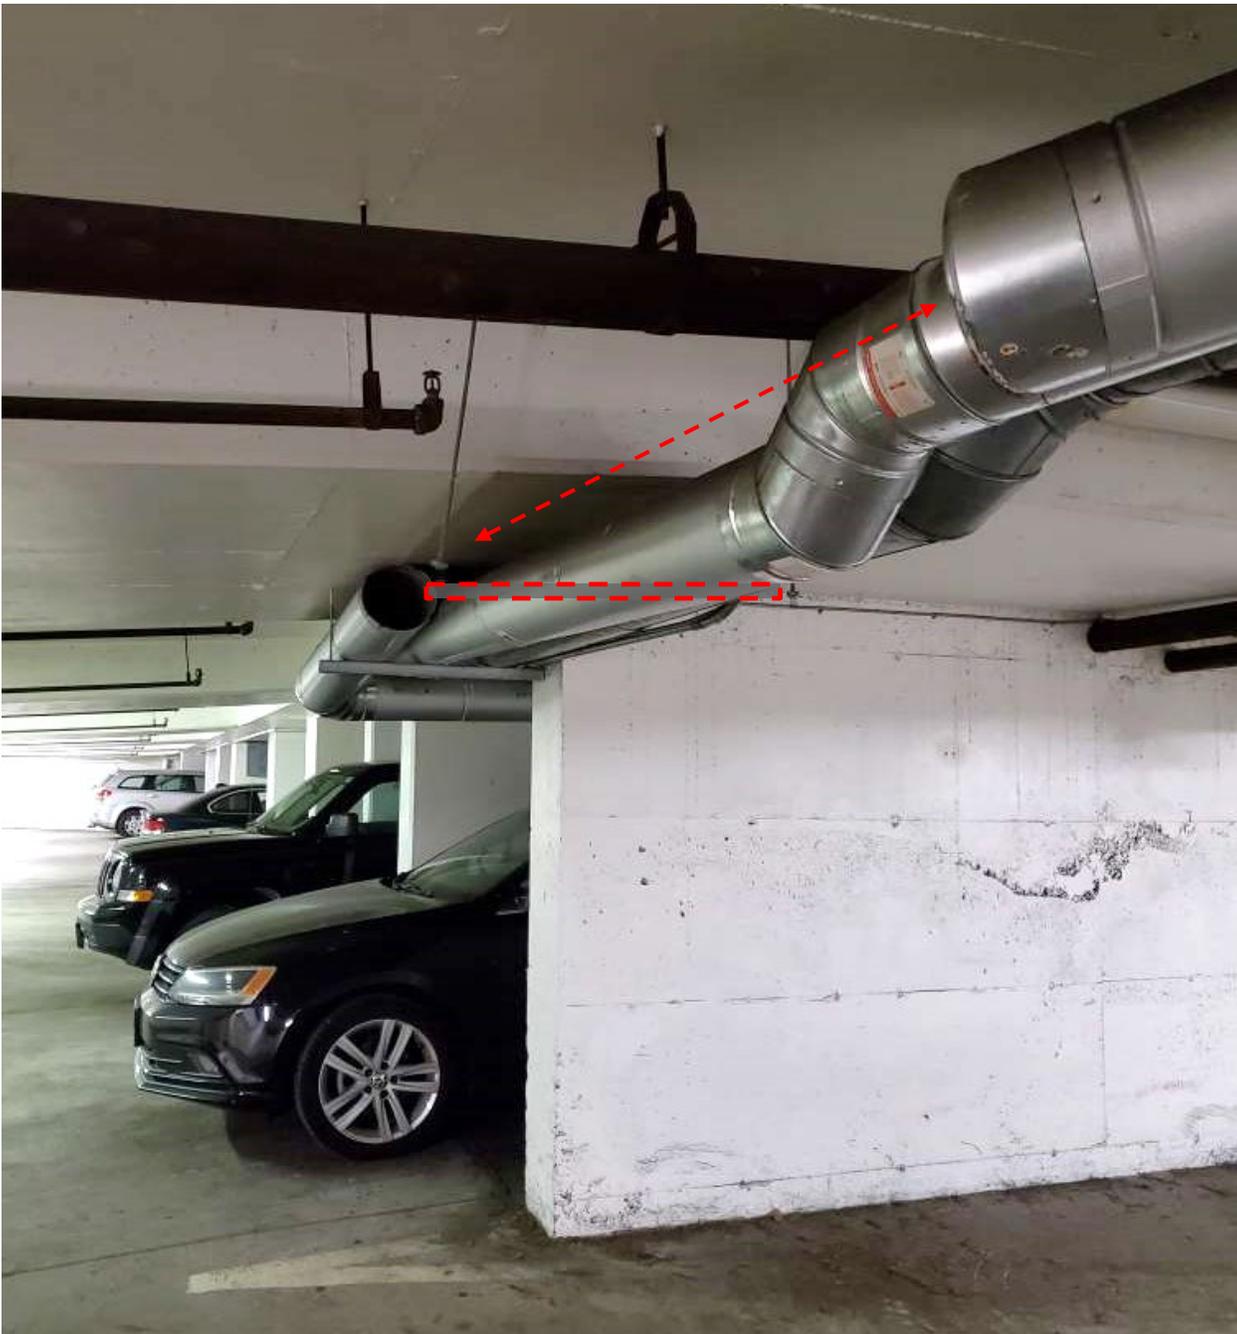
Image 2 - Vent piece down (red arrow) and hangers for vent gone (red rectangle).

- When reviewing on site in July 2021, they found the venting had corrosion and a dent near the location that it was later hit by the vehicle. They stated the rods and hangers had been removed in the location near to where the piece was later hit by the vehicle.
- They stated that the lack of support where the vehicle hit the vent left the vent vulnerable to being disconnected.
- They stated that while repairing the vent in the days following the incident, the fresh air intake fan for the parkade boiler room would run when the boiler was on.

<p>Causes and contributing factors</p>	<p>Conclusions</p> <p>A parkade boiler was due for its yearly cleaning and had a portion of the vent knocked off in a low area of the parkade where the venting was not properly supported. The open vent exhausted products of combustion including carbon monoxide into the parkade where there were inoperative intake air or exhaust fans. Throughout the night the hazardous levels of carbon monoxide accumulated in the parkade boiler room and eventually in the occupied areas of the building. The hazard was detected by the gas fitter identifying the exposure to carbon monoxide during the maintenance visit.</p> <p>Causes and contributing factors</p> <p>The carbon monoxide release was caused by the unsupported venting being hit by a vehicle in a low area of the parkade. The fact that there were no maximum vehicle height roll bars at the parkade entrance is a plausible contributing factor.</p>

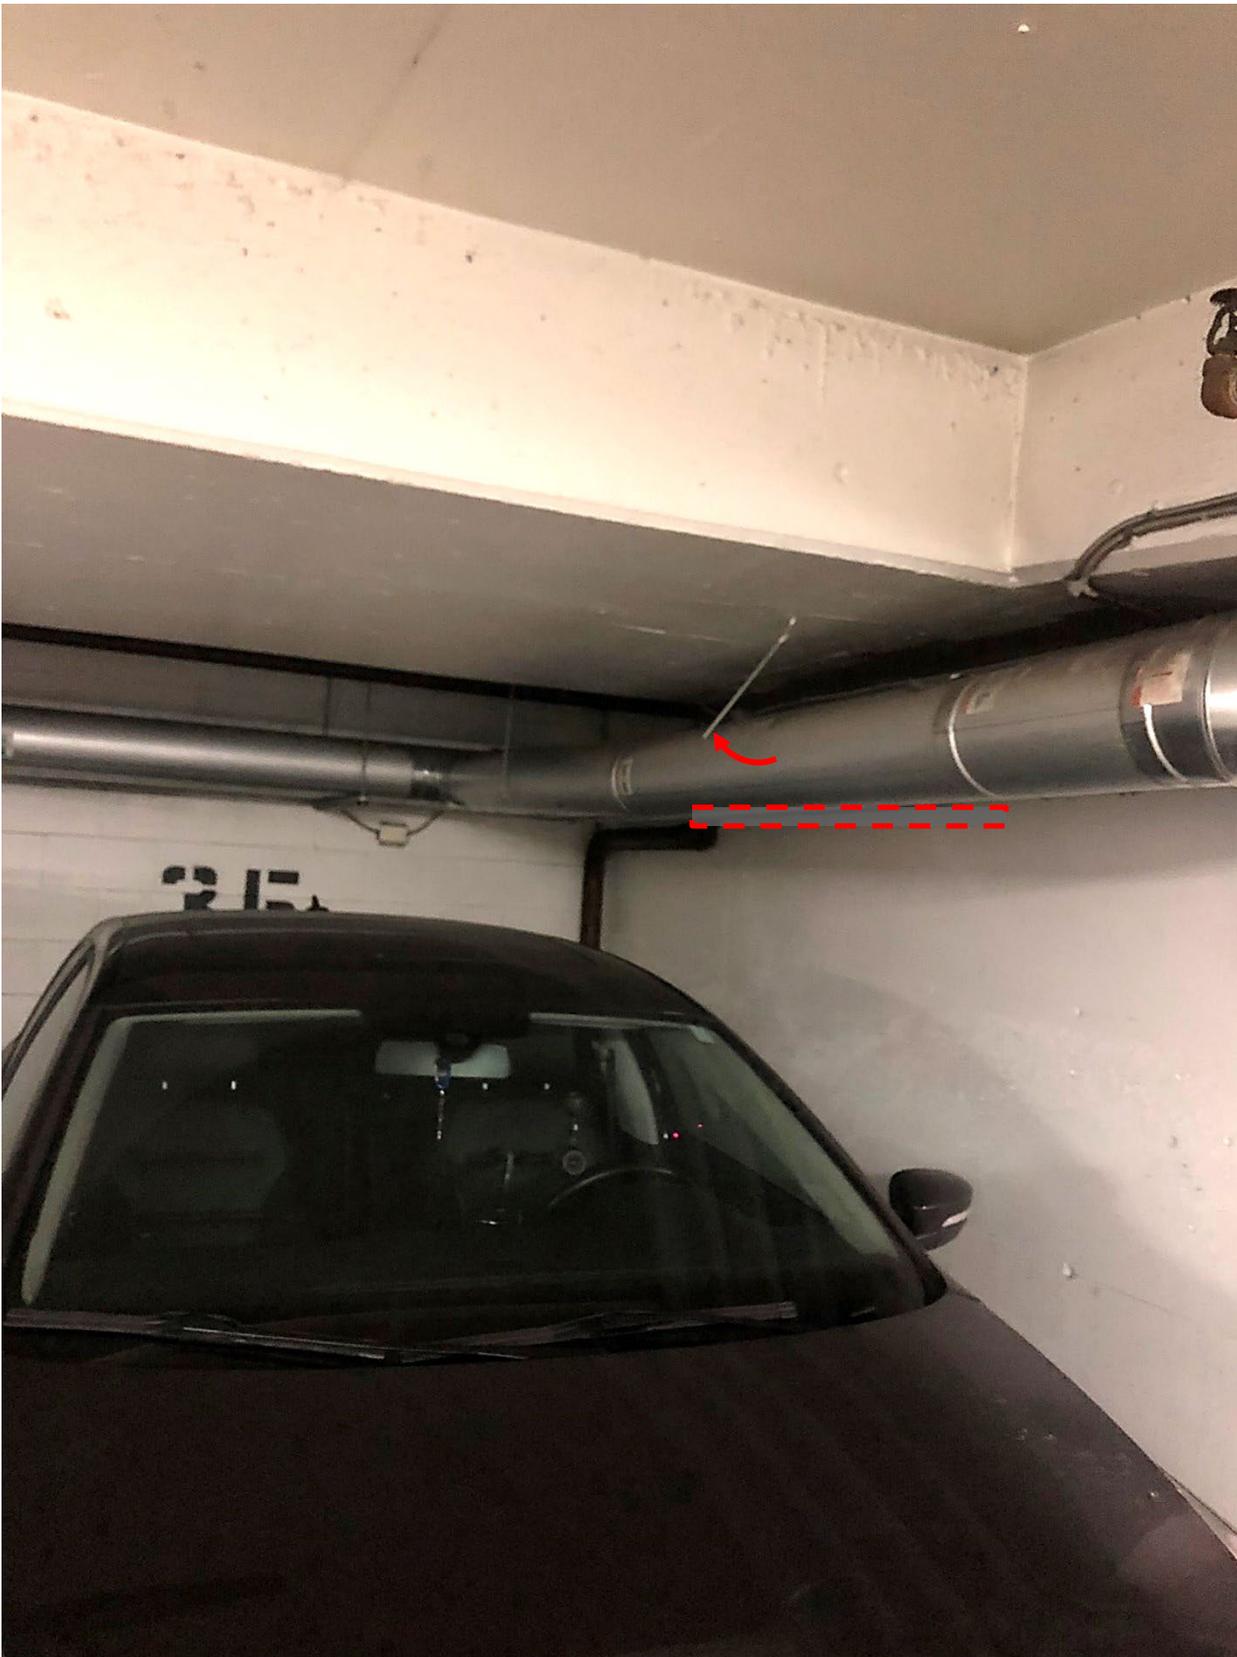
Image 3 - Hanger missing (red rectangle) and rod bent up (red arrow) near missing vent piece.

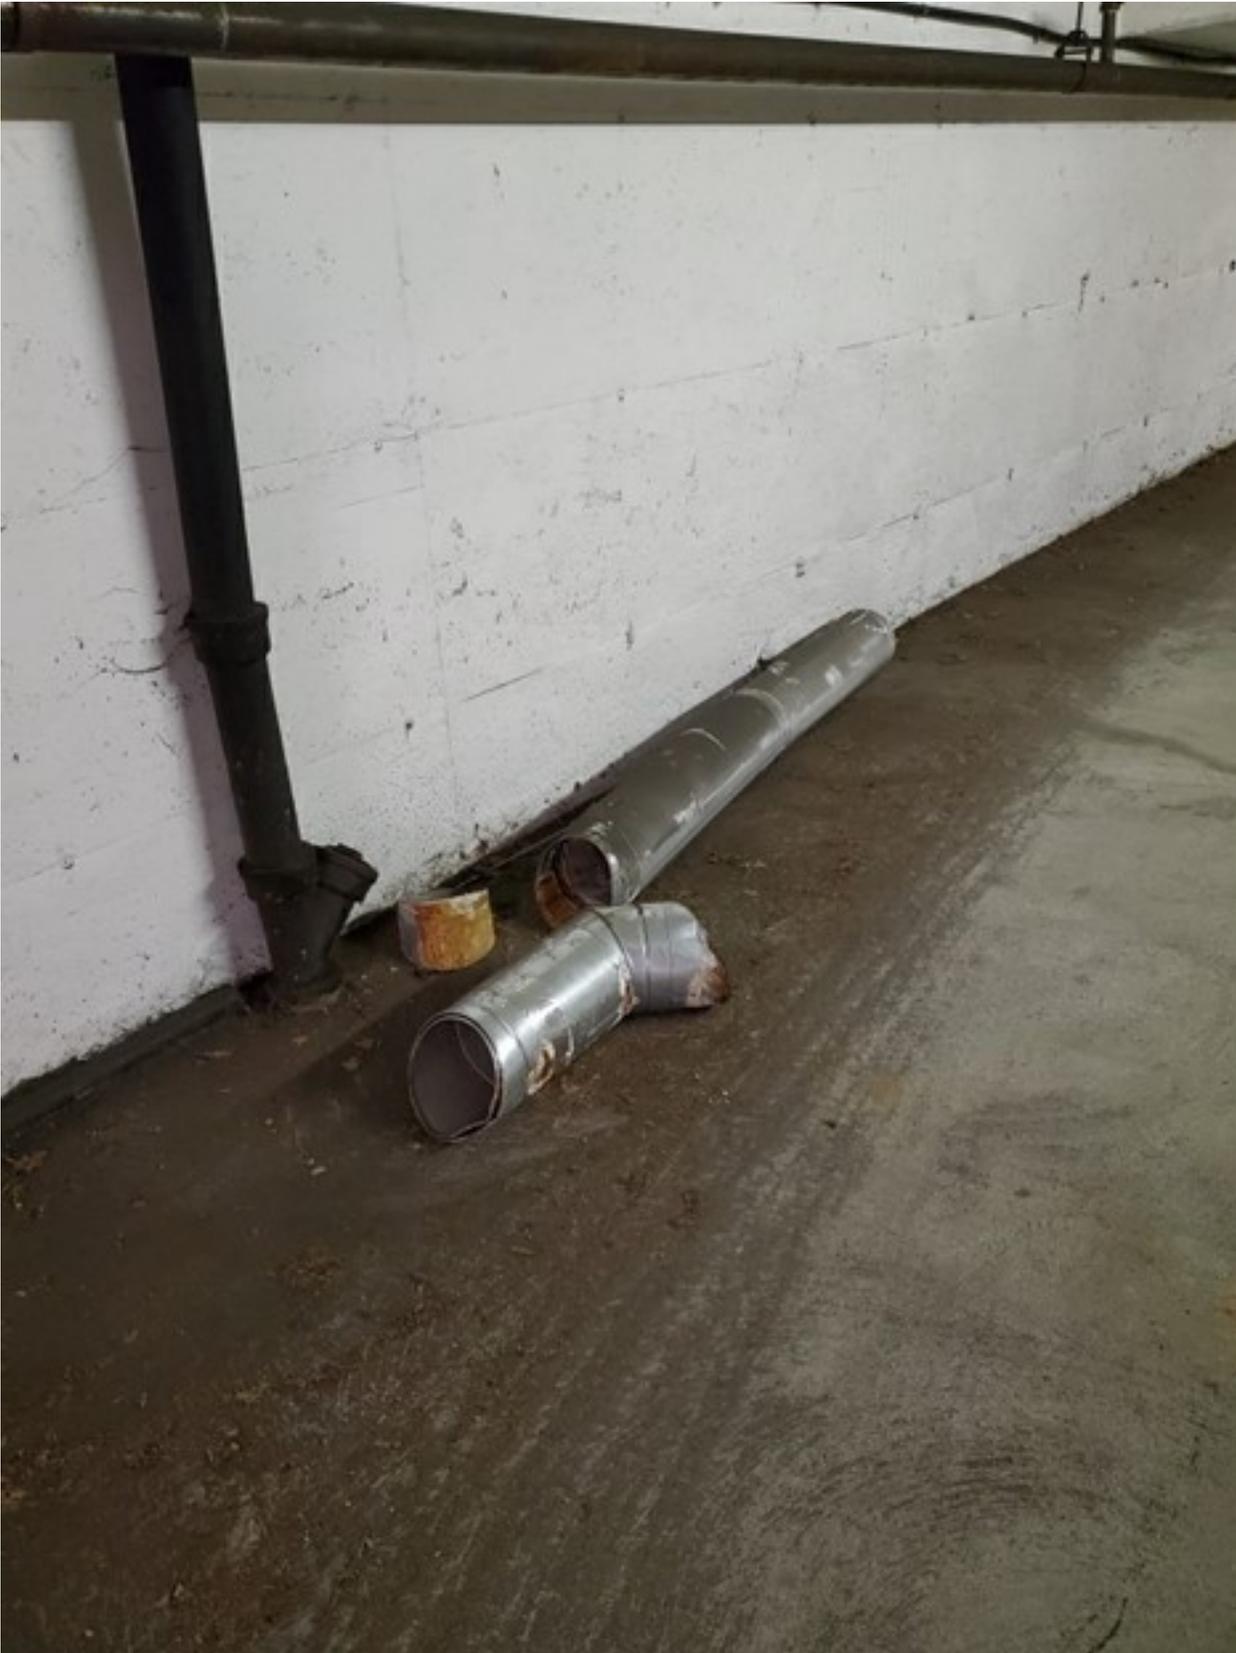
Image 4 - Vent pieces found on the parkade concrete floor.

- On the night before the incident and the morning of the incident, multiple site personnel noticed a piece of metal vent on the parkade concrete floor but were not aware of any hazard associated with it being down at that time.

- On Monday September 13th, 2021, after the gas fitter notified the building manager that there was an issue with CO in the parkade, they both went to the parkade to look at the vent piece that had been knocked down. The 6 foot piece of venting was found on the parkade drive off to the side.

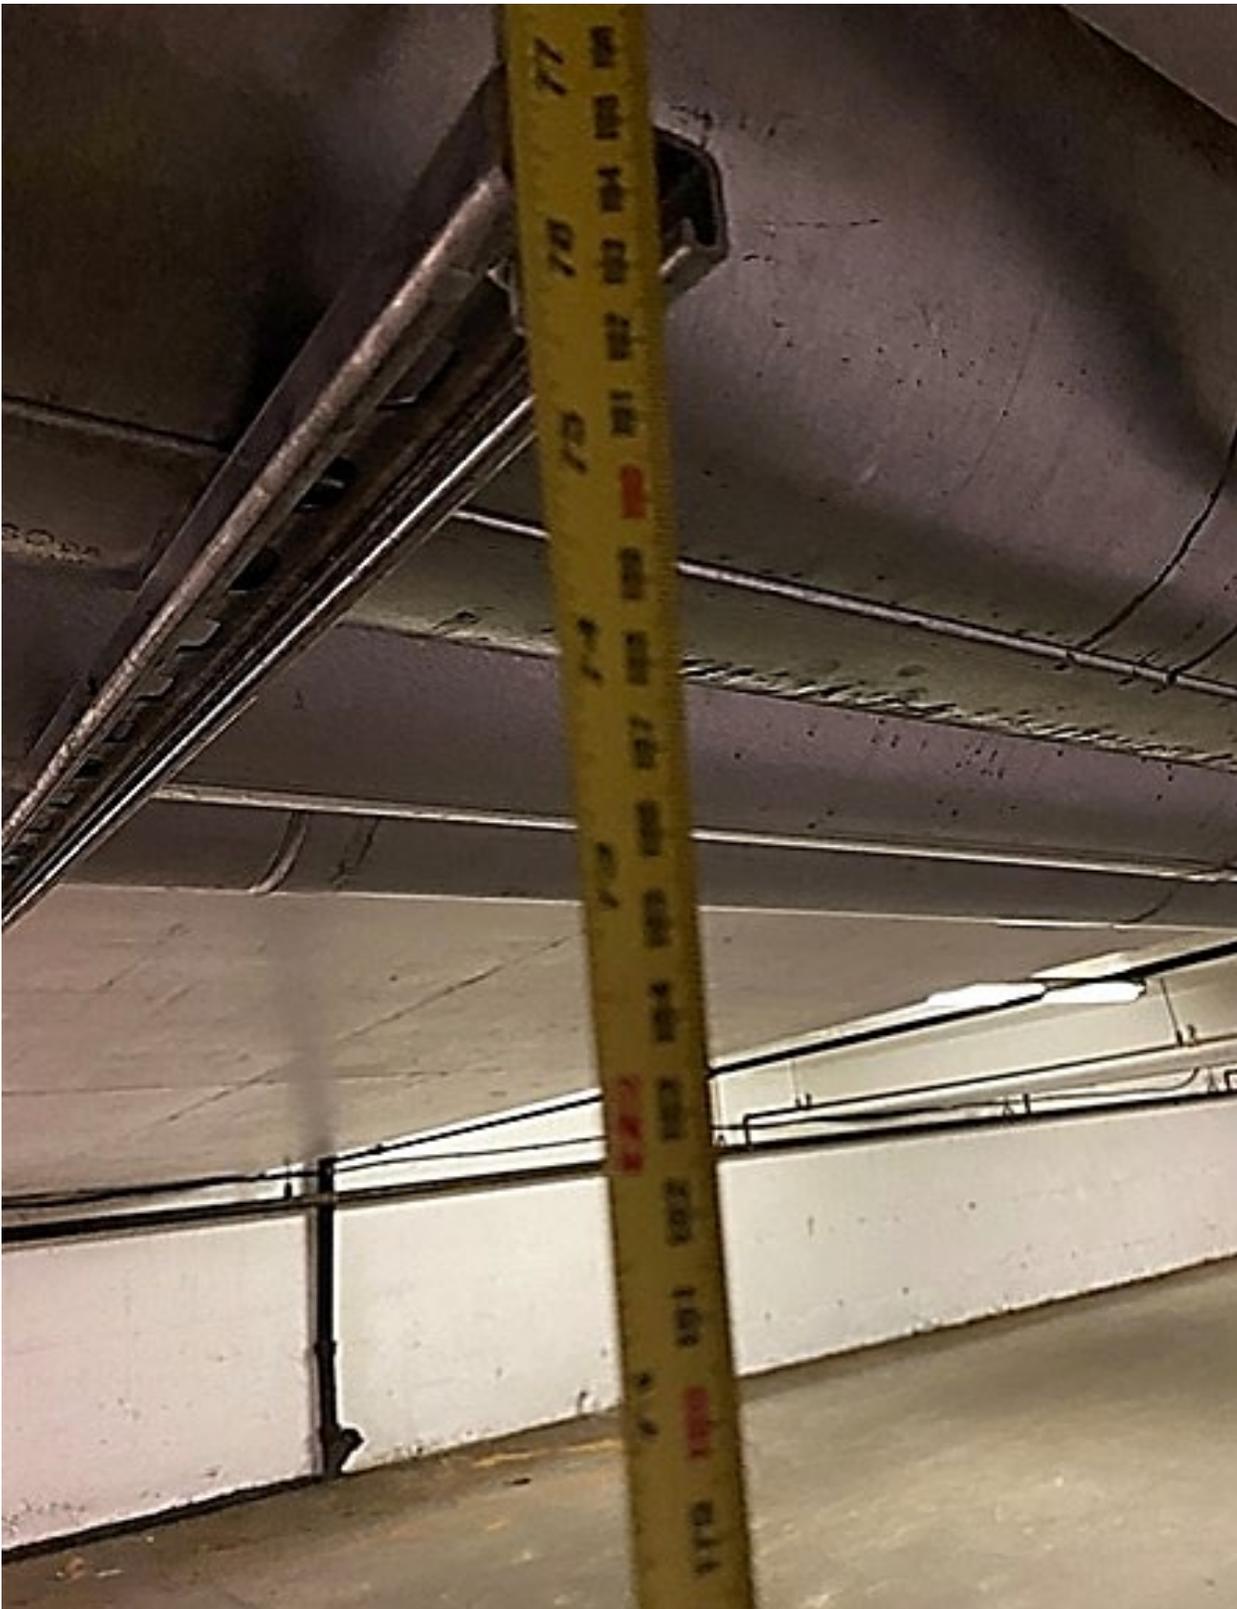
Image 5 - A measurement of 76 inch (6 foot 4 inch) taken by safety officer to the bottom of the vent hanger near to where vent was knocked down.

- They stated the truck with the roof rack is suspected to have hit the vent at the lowest point of the parkade at around 6 foot 3 inches/ 75 inches ([Image 5](#))

- They stated that there was no maximum height roll bar at the entrance to the parkade at the time of the incident.
- The parkade boiler room did not have a CO detector.
