Incident Summary Report- II-662147-2018 (ID: 6187) Final

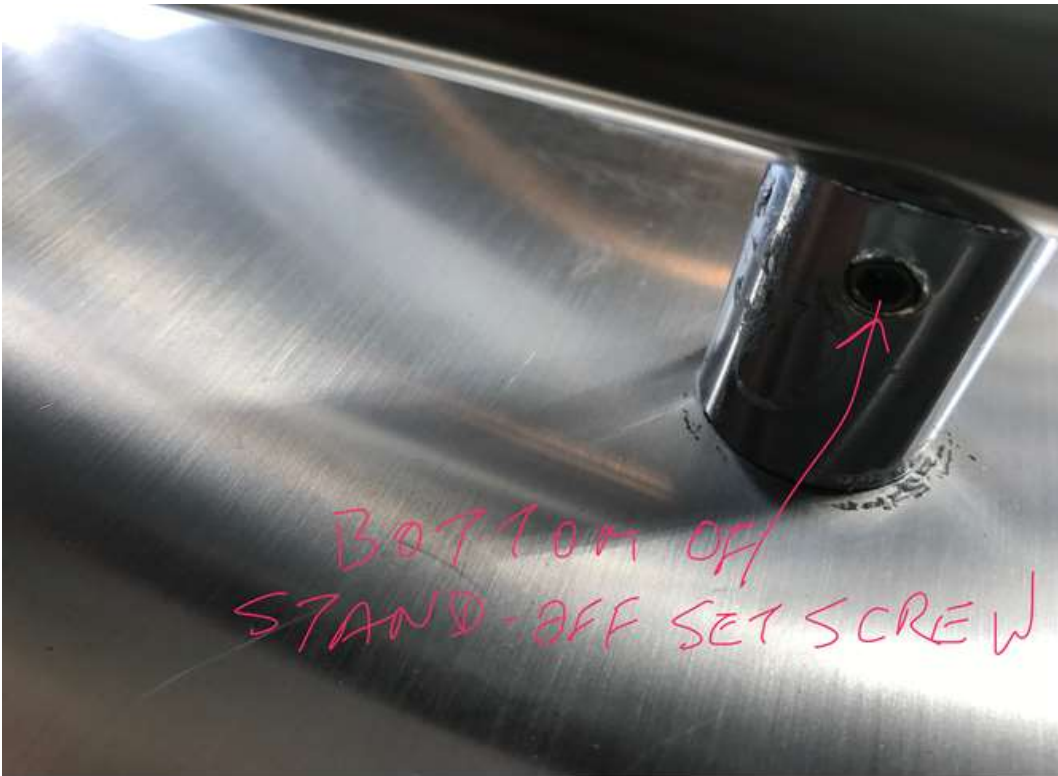
Failure scenario(s)	A building guest's left foot was injured while using the elevator, when one end of a handrail became dislodged from the elevator wall. This occurred due to a loose handrail fastener.	
	Facts and evidence	<ul style="list-style-type: none"> • Upon site inspection, one end of the handrail was found to be in contact with the ground due to a fastener coming loose. • No evidence of tampering with handrail was found upon investigation. • The fastener came loose but was still attached to the mount. • 3 pictures of the handrail mount and the handrail were taken when safety officer attended the site (see attached) • An email was received from the Building Manager Assistant with a forwarded email from the business of which the injured guest attended. In addition, the email included a brief description and 4 pictures (2 of her foot and 2 of the dislodged handrail). 	
	Causes and contributing factors	It is most probable that the handrail fastener became loose from regular use and occupants leaning on the handrail over the years. Then coincidentally the injured occupant's foot was hit when the handrail became dislodged from the wall.

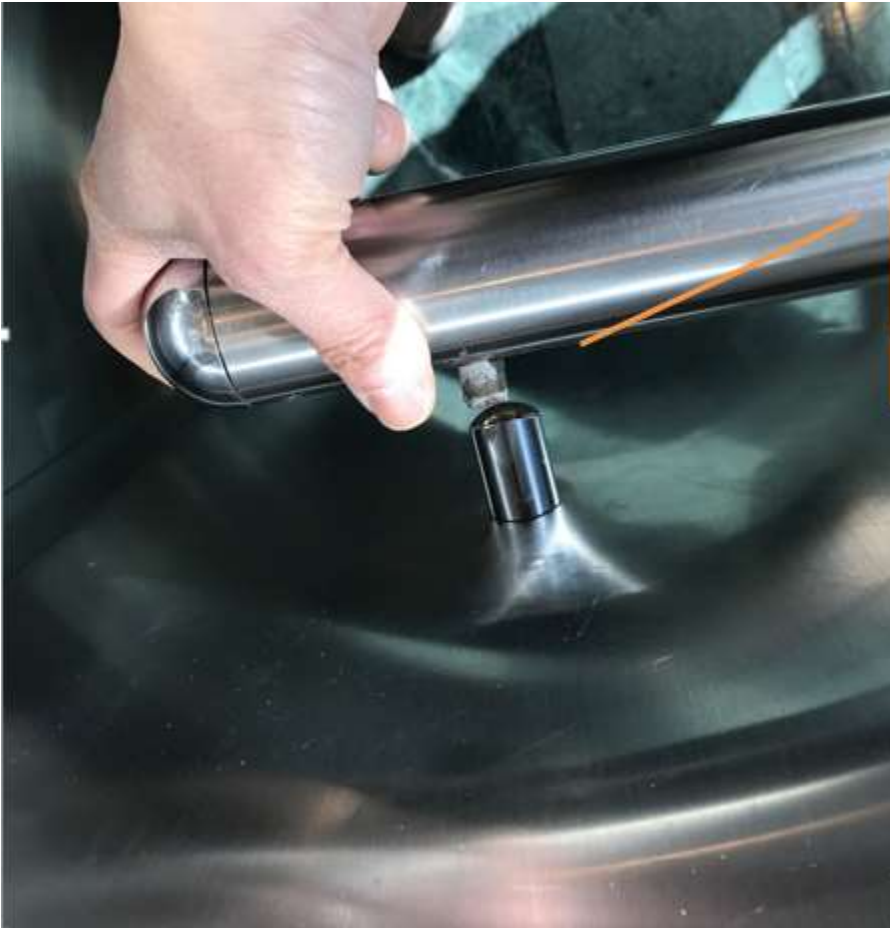
Hand Rail mount and where the railing is fastened with screw

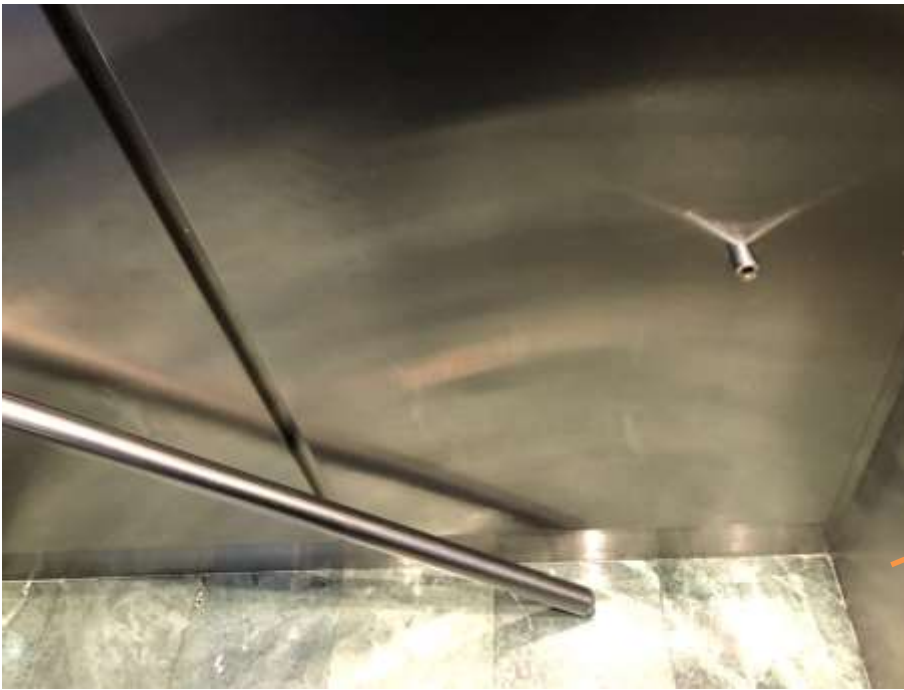
Railing on the floor of the elevator after it was dislodged from the wall
