Incident Summary #II-970401-2020 (#16429) (FINAL)

SUPPORTING INFORMATION	Incident Date	January 22, 2020	
	Location	Surrey	
	Regulated industry sector	Gas - Natural gas system	
	Impact	Qty injuries	0
		Injury description	NA
		Injury rating	None
	Damage	Damage description	An explosion blew the doors and vent stack off of a gas fired rooftop appliance. The explosion resulted in a large uncontrolled release of natural gas outdoors.
		Damage rating	Major
	Incident rating	Major	
	Incident overview	A natural gas fired make-up air appliance installed on the rooftop of a strip mall experienced a failure that resulted in an explosion within the appliance. The explosion damaged the appliance and caused a large release of natural gas outdoors that resulted in the area and adjacent businesses to be evacuated.	
INVESTIGATION CONCLUSIONS	Site, system and components	<p>A make-up air appliance is designed to be installed on buildings where exhaust fans are utilised. As an exhaust fan removes air from the building space, a make-up air appliance uses a blower fan to replace the same amount of air so the ambient pressure in the building remains balanced.</p> <p>An indirect gas fired make-up air unit

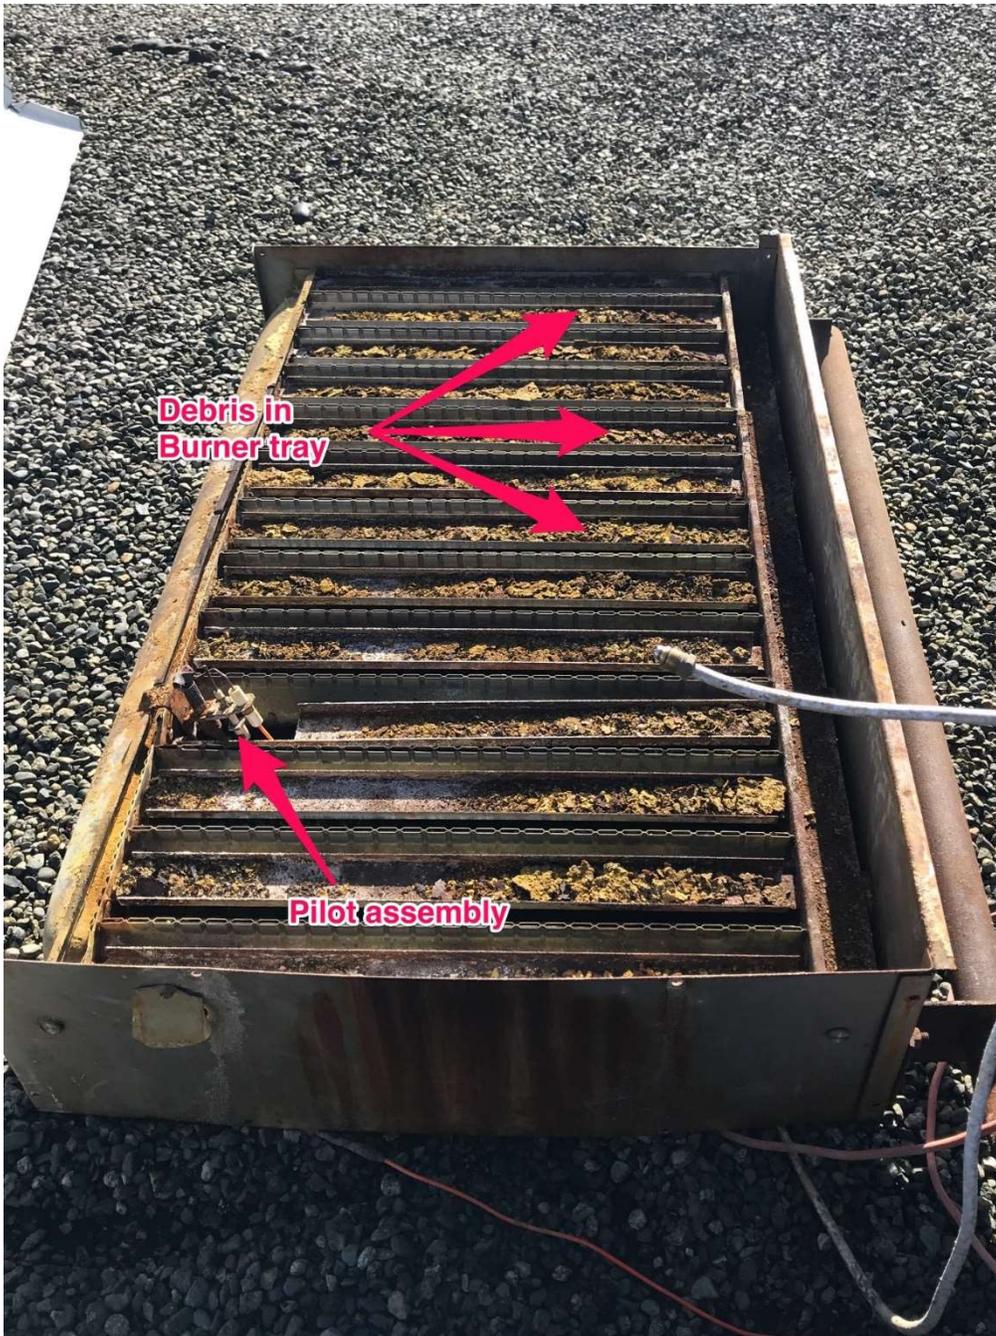
It is very likely that the owner not hiring a qualified contractor to perform the required service and maintenance on their appliance was the cause of the incident. The lack of service and maintenance allowed debris from corrosion to accumulate on top of the burners. This allowed unburnt gas to collect inside the appliance leading to the explosion.

Image #3 Burner tray after removal from appliance

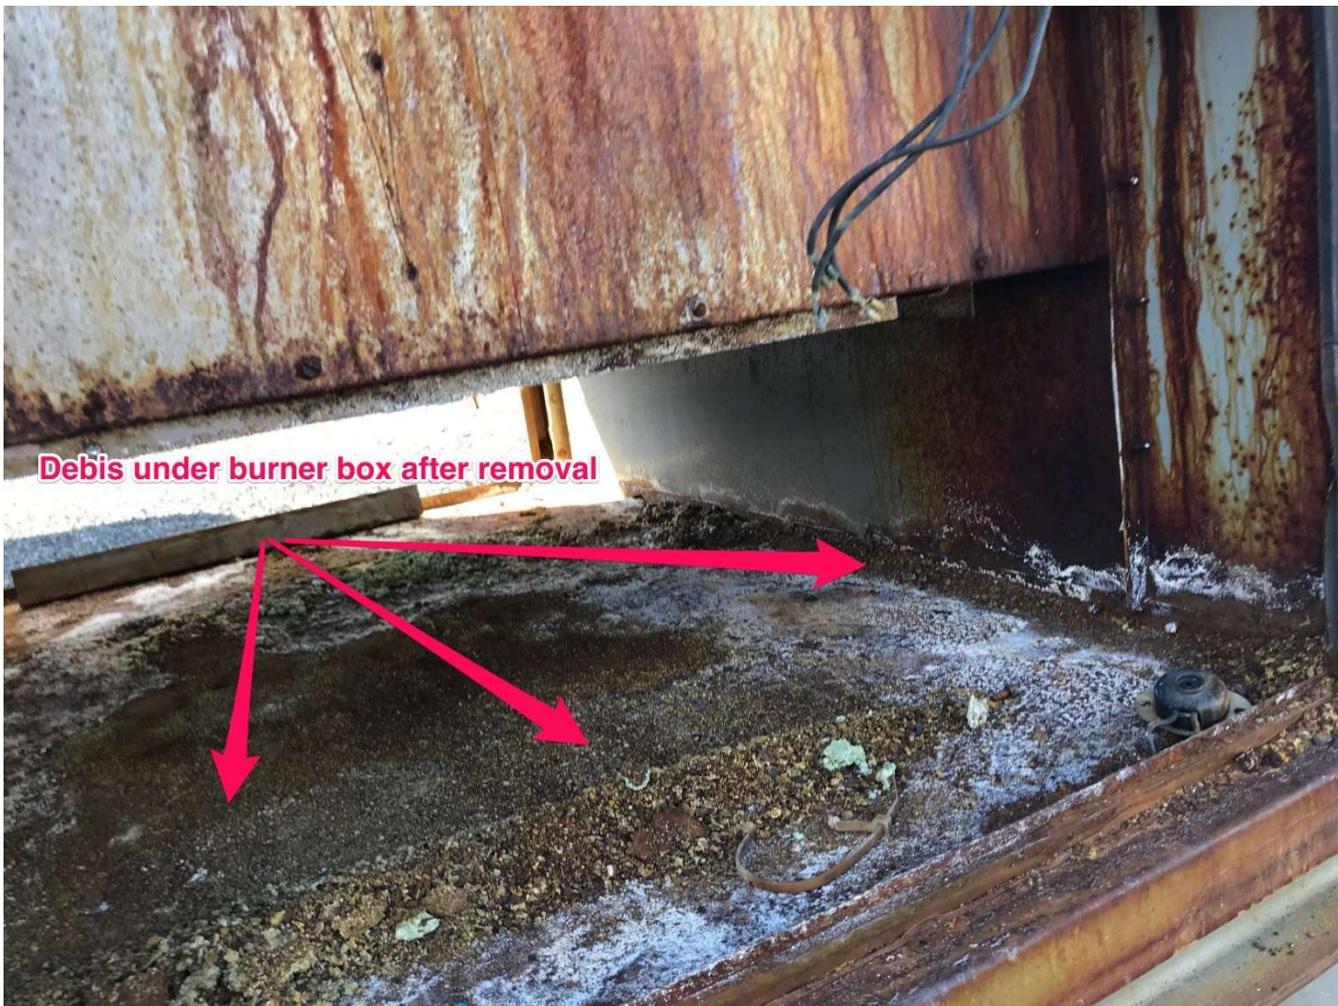
Image #4 Location of burner box after removal from appliance

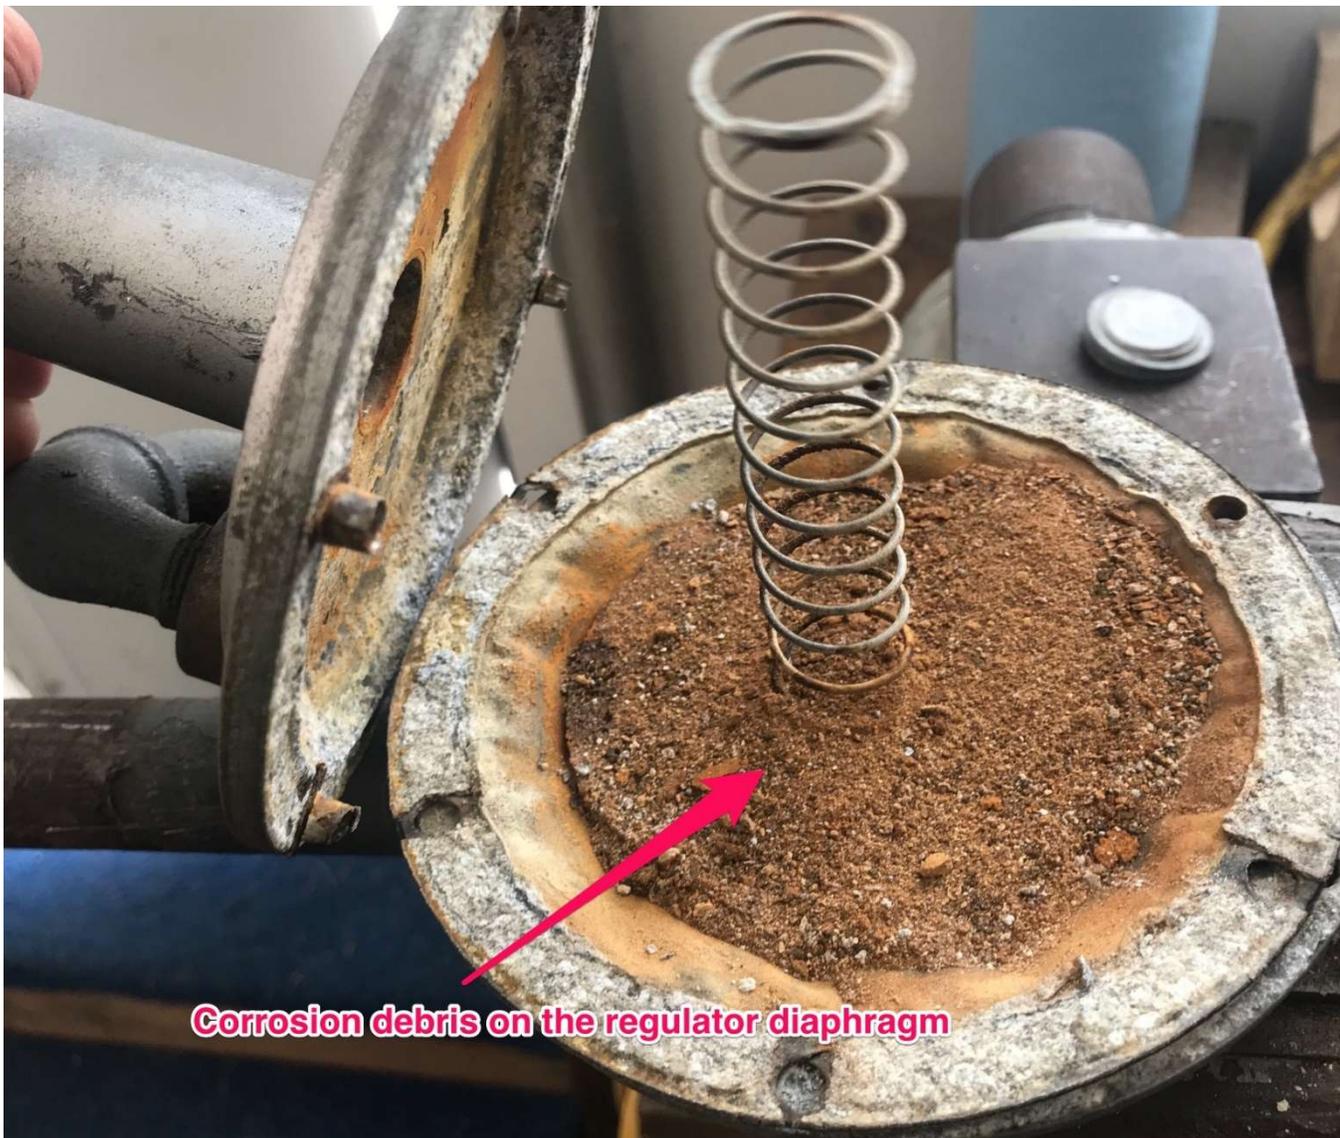
The gas pressure regulator that was installed just outside of the appliance was removed and disassembled for examination. A significant amount of debris from corrosion was found on top of the regulator diaphragm. (**Images 5-6**)

Image #5 Gas pressure regulator

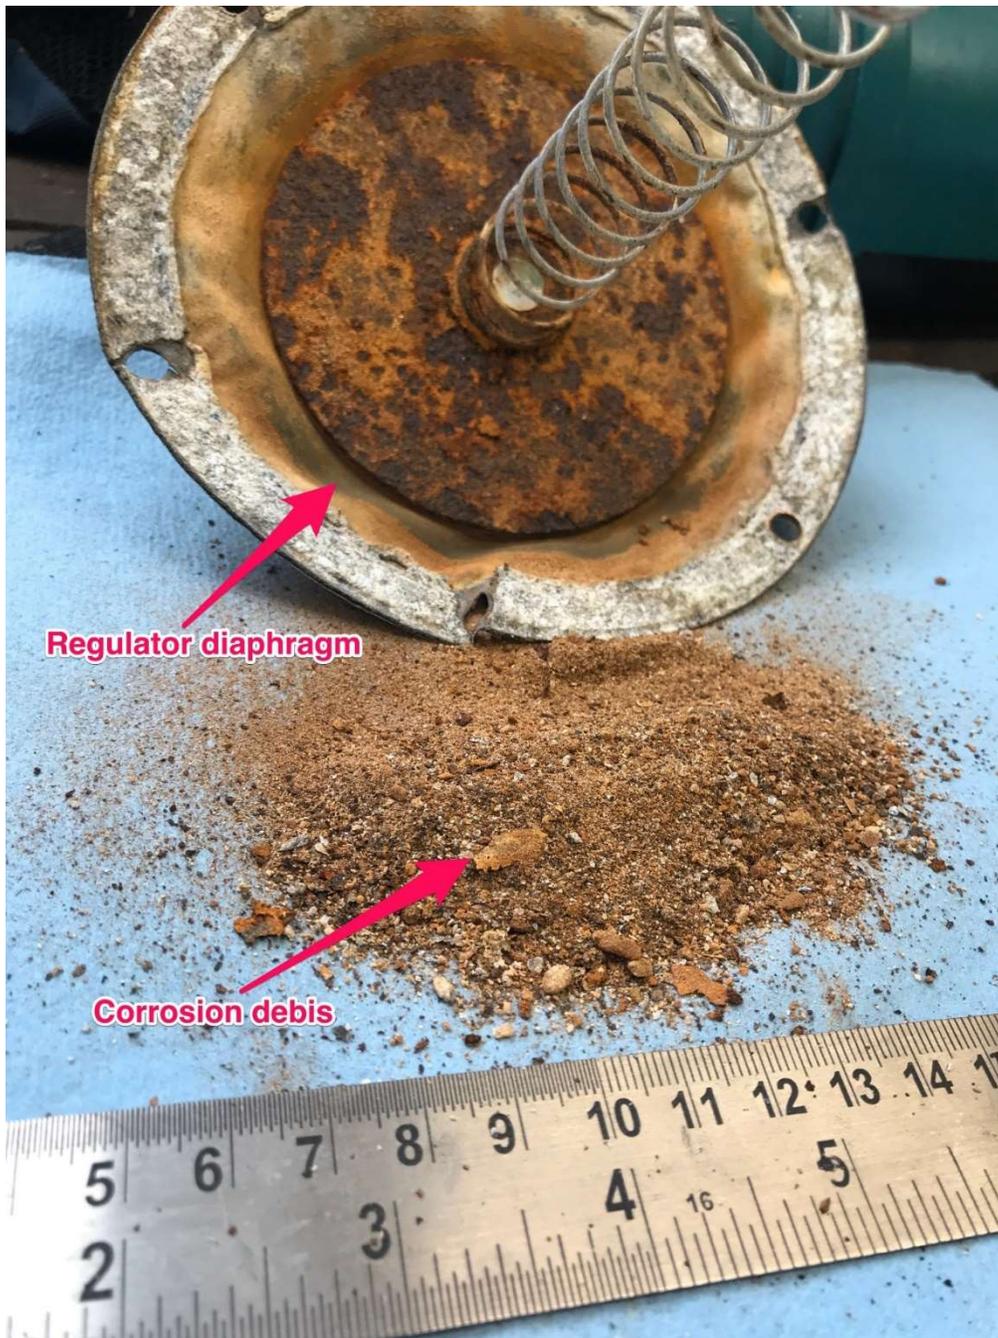
Image #6 Corrosion debris removed from regulator diaphragm
