Incident Summary #II-1052002-2020 (#ID:19022) (FINAL)

SUPPORTING INFORMATION	Incident Date	August 14, 2020	
	Location	Penticton, British Columbia	
	Regulated industry sector	Electrical - Low voltage electrical system (30V to 750V)	
	Impact	Qty injuries	0
		Injury description	No Injuries
		Injury rating	None
	Damage	Damage description	A complete loss of a residential distribution load center and all associated wiring including consumer service conductors. A Utility Cut Out switch was also lost at the time of incident when it was activated
		Damage rating	Major
	Incident rating	Major	
	Incident overview	An electrical fault was created within a residential load center, without proper system protection the fault caused a large power draw on the utility system until the Utility Cut Out switch was activated. As a result of this activation, a power loss for the surrounding downtown area was created.	
INVESTIGATION CONCLUSIONS	Site, system and components	<p>In a modern day electrical distribution system safety redundancies are placed within the system to create a tiered safety system should a fault occur within a residential home. (See Figure 1)</p> <p>A utility supplies electrical energy

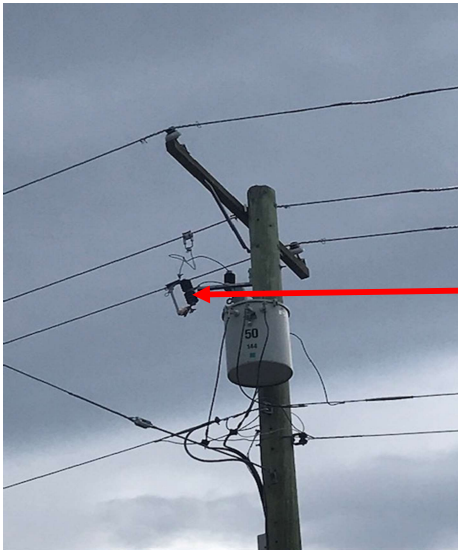
Figure 2. Site Systems and Components - Scenerio Two - WITHOUT Main Overcurrent Device

Distribution Cut-Out Fuse – The only point of protection between it and the much smaller branch circuit overcurrent devices (below) in this scenario. A large amount of energy is required to cause this fuse to disconnect

Important!

No Main Overcurrent Device. There is NO ability to safely disconnect a consumers system should a fault occur. This system is relying on the Distribution Cut-Out Fuse (above) for protection which is installed for the protection of multiple homes and businesses with their power consumption not just one individual consumer system.

Branch Circuit Overcurrent Devices - Installed for consumers individual branch circuit protection (The electrical they use in their home).

<p>that the Cutout switch is meant to protect entire neighbourhoods electrical energy and not just individual homes. It requires a large release of electrical energy before sensing a fault and activating. (See Figure 2)</p>
<p>Failure scenario(s)</p>	<p>The home in this incident was undergoing a service change to incorporate a new panel with a main breaker for modern protection. This new system was installed in parallel to the existing system as the original was on overhead system and the new system was underground</p> <p>Without having the hydro disconnected for safety the electrical contractor began moving circuits from the existing load center to the new panel for later energization of the new system</p> <p>Contact was made while moving these circuits within the existing panel between energized components and a fault occurred.</p> <p>The release of large amounts of energy caused extensive damage to the existing electrical load center and surrounding area within the home</p> <p>After an unknown length of time the Utility Cutout switch was activated (tripped) notifying the utility as the grid had now lost power and clearing the fault at the same time.</p>

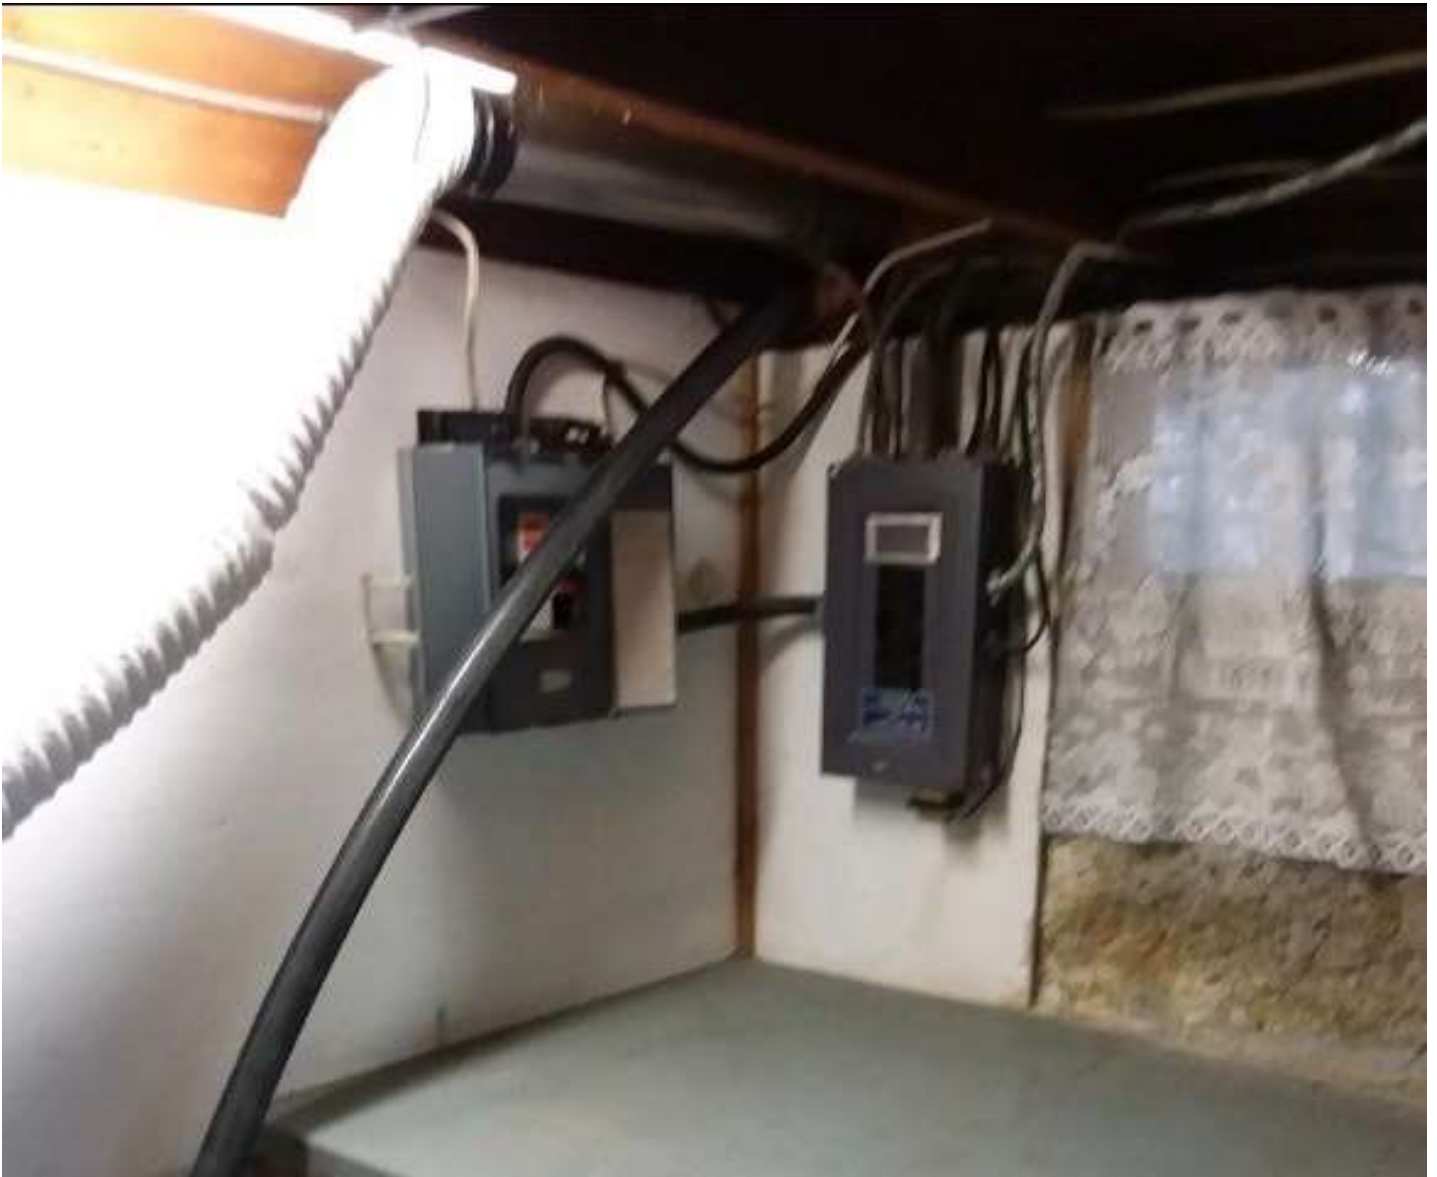
A photo taken previous to the incident with the original equipment installed

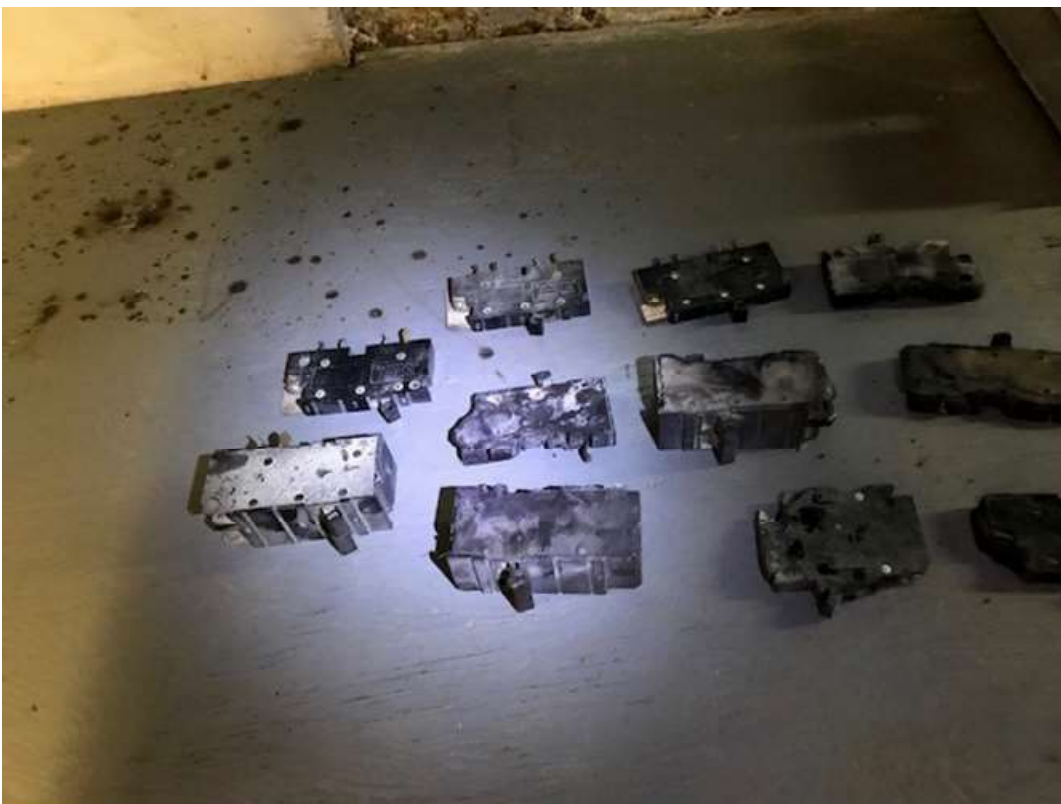
Photo of the damaged breakers that were installed within the load center

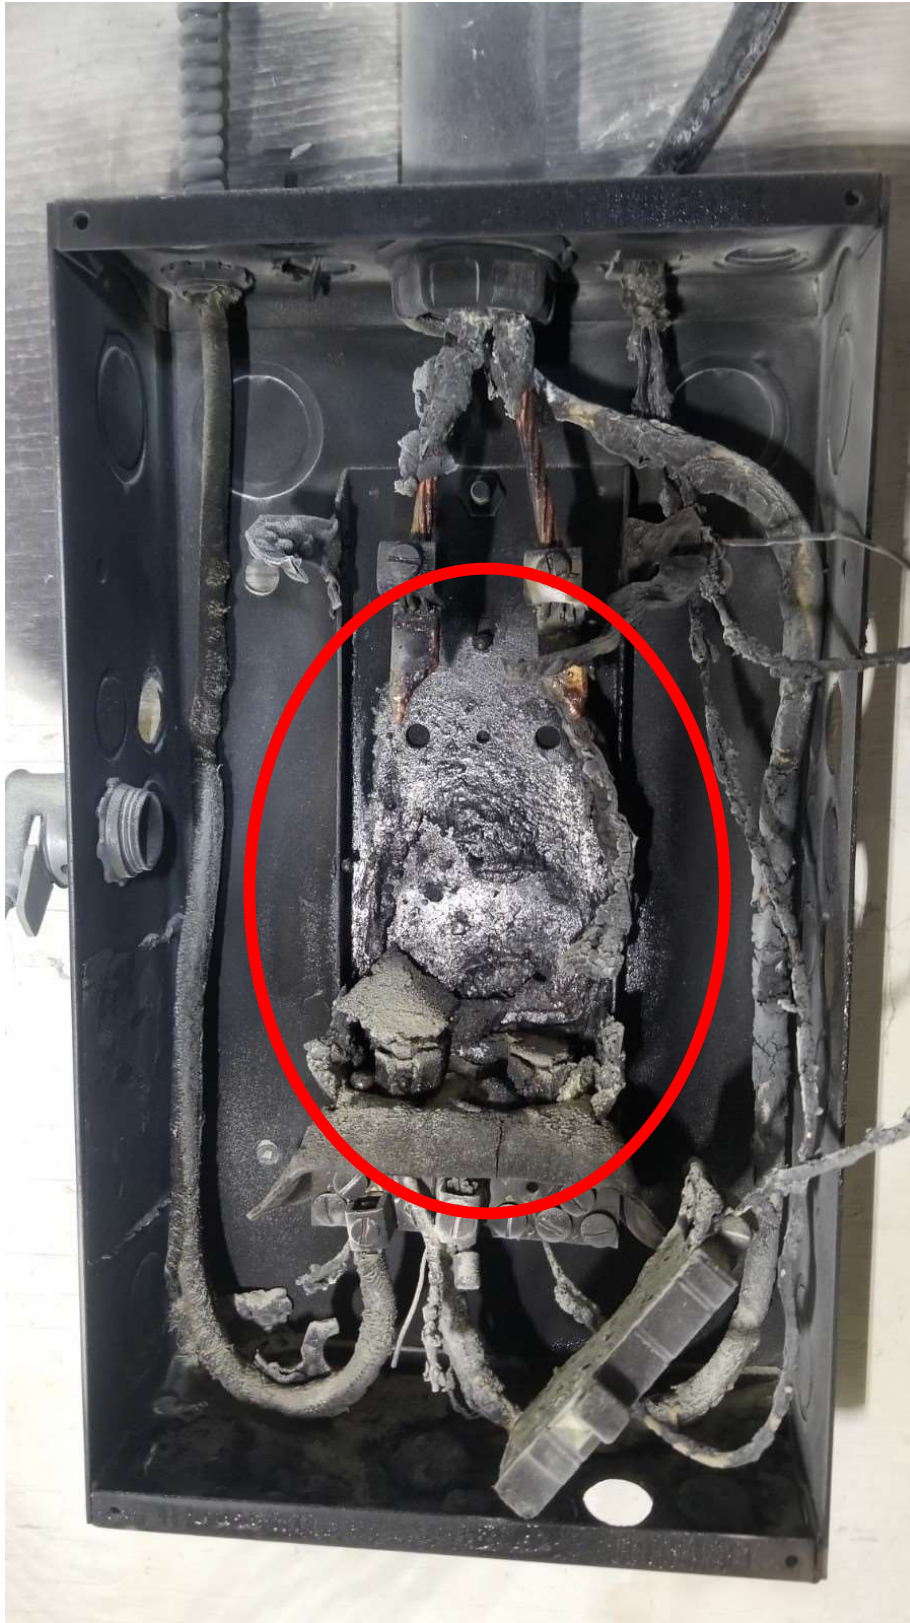
Photo taken of the inside of the panel after the incident. Observe within the red - the area of the large fault occurrence and rapid energy release.
