# Security Implications from Improper De-acquisition of Medical Infusion Pumps

## Research Report

Deral Heiland - Principal Security Researcher (IoT), Rapid7

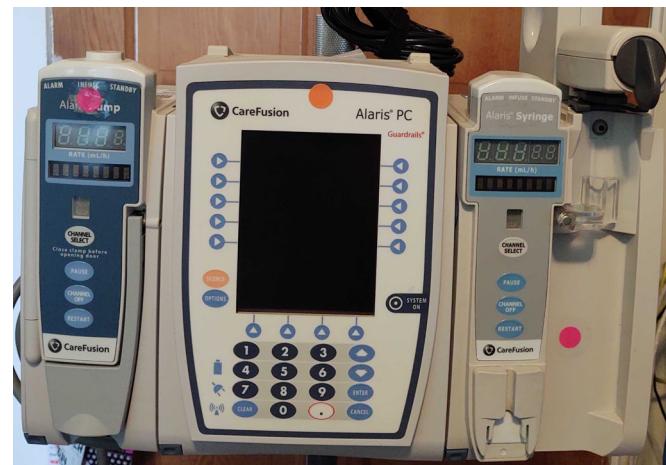
The first device examined during this study was the Alaris 8015. This device is currently in use in many medical organizations and can also be purchased on the secondary market. During the examination of this device we explored several methods that can be used to extract data from the device's memory storage. These methods included: (1) removal and examination of the internal Compact Flash card, (2) capture of serial communication while using the product's maintenance software, and (3) the physical removal and extraction of data from the flash memory chip on the main circuit

board of the device. These three methods are discussed in the following sections and detail how data can be recovered from this product if proper processes are not carried out to flush this critical data prior to the product being de-acquisitioned and sold on the secondary markets.

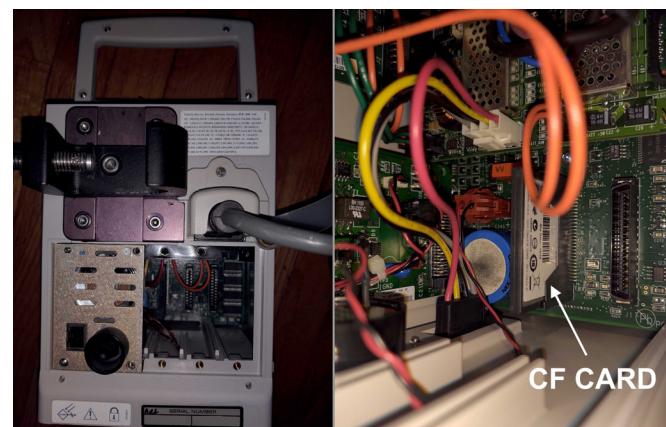
Examination of the Alaris device showed that the infusion pump used a 64MB Compact Flash<sup>6</sup> (CF) card for the purpose of storing application and configuration data. The CF card is accessible through the back of the unit by removing a small cover plate and unplugging the card as shown below.

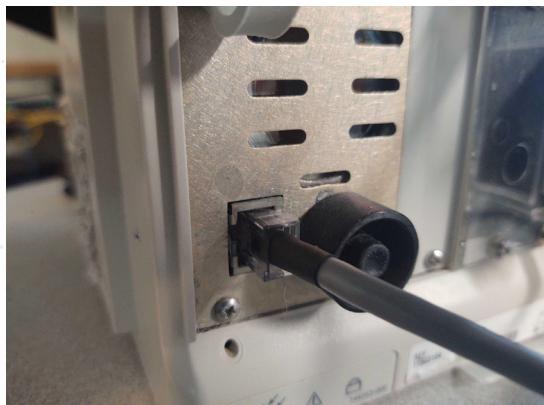
Another non-destructive method for extracting data is via the serial communication port on the back of the device. The device has a RJ45 connection port on the back that supports serial communication. By using the Alaris System Maintenance Software<sup>9</sup>, it is possible to interact with the infusion pump to conduct maintenance, perform firmware updates, create device configuration backups, and flush the device settings and logs.

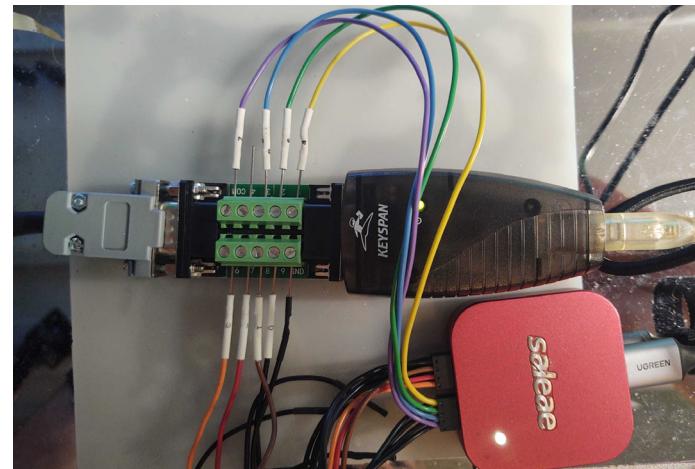
When the maintenance software is used for performing backups of network and Wi-Fi configuration, the software does prevent visual access to critical data such as passwords and keys. This software also forces some form of encryption or encoding of the configuration data before allowing this data to be saved to the local hard drive. The easiest non-destructive recovery method to gain access to the data is to monitor the serial communication while the software is requesting the configuration data from the infusion pump. An example of this is shown below, where we have placed a serial breakout board and a logic analyzer to decode the traffic between the infusion pump and the laptop running the maintenance software.

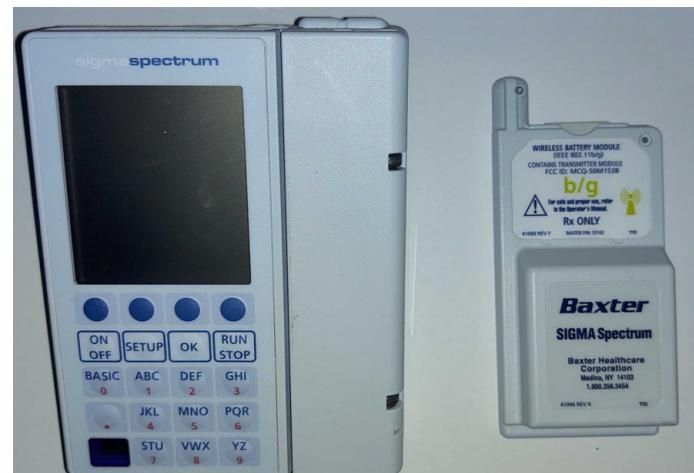
The next device examined during this study focused on the Baxter Sigma Spectrum model 35700BAX2 and associated Wireless Battery Module (WBM) running different software versions. Like the Alaris infusion pump these devices are currently in use in many medical organizations and can also be purchased on the secondary market. During the examination of this device we explored a number of methods that can be used to extract data from the devices memory storage. This infusion pump unit consisted of two independent running systems, which included the infusion pump and the WBM. This allowed for duplicate extraction points of configuration data. In the following section

we examine these methods which included destructive examination, JTAG and serial communication between the Infusion pump and the WBM.

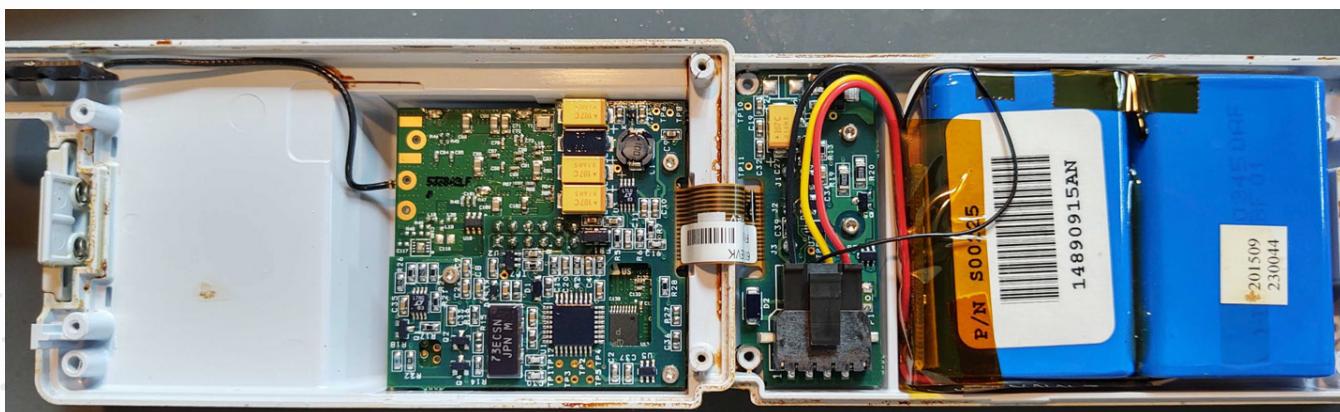
Once disassembled, we determined that the 35162 battery module had a Digikey processor and was using an STMicroelectronic M29DW323DB 32Mbit TFBGA48 Flash memory chip for data storage.

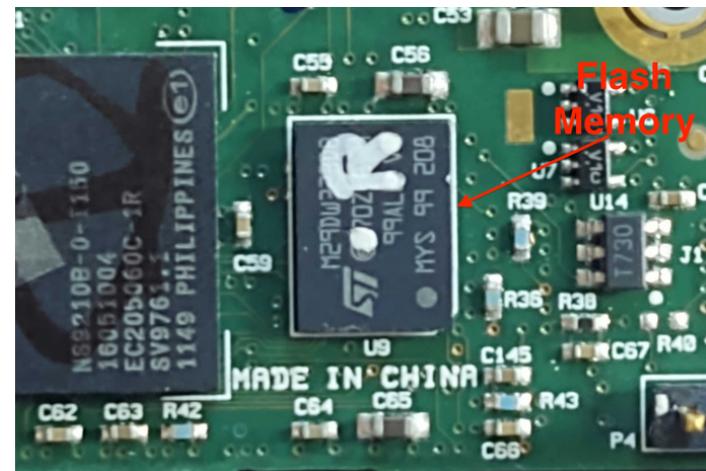
To examine the content of this flash memory device we used an infrared reflow oven to heat the circuit board and remove the flash memory chip. Once removed we used an RT809H chip programmer to extract the data from the flash chip. We then examined the binary data by conducting a search using the Linux command "strings" to locate SSID information. This initial test returned no results. So next we examined the binary using the Linux application "hexedit". During this examination we noticed that ascii string data appeared garbled, under further examination it was determined that the device was storing the data using a big endian<sup>16</sup> method where two-byte data pairs are swapped making the ascii data difficult to read. An example of this is shown below.

003C0840	2C	37	32	33	36	37	2C	38	6F	56	75	6C	65	6D	49	20	, 72367, 80VulemI
003C0850	63	6E	65	72	65	6D	74	6E	2F	3C	56	45	4E	45	3E	54	cneremtn/<VENE>T
003C0860	44	3C	55	52	3E	47	2C	31	53	4E	28	20	6F	4E	6D	72	D<UR>G, 1SN( oNm
003C0870	6C	61	53	20	6C	61	6E	69	29	65	33	2C	33	37	32	39	laS lani)e3, 3729

To resolve this issue the following command was used on a Linux platform to swap the two-byte pairs to place it in order that could be evaluated and decoded.

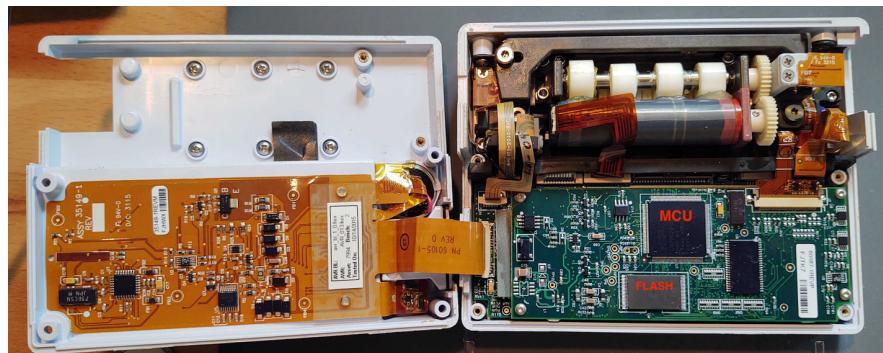
Now that we found the Wi-Fi credentials stored on the WBM the next test was to evaluate the main Baxter infusion pump unit to see if that data is also being stored there. To accomplish this we again conducted a destructive approach by disassembling the infusion pump to identify flash memory chips used to store device firmware and data.

The main circuit board located above on the right side was found to contain the primary microcontroller unit (MCU), an NXP LH79520, along with a flash memory chip, a Spansion S29JL064J 64Mbit TSOP48. Prior to removing the flash memory chip, we found that all circuit boards inside the infusion pump had been coated with a conformal<sup>17</sup> coating to protect the circuits from moisture. So, prior to desoldering the coating had to be scrapped away from solder joints on the flash memory chip. Once this had been completed, we de-soldered the 48-pin flash memory chip and placed it in a RT809H chip programmer and extracted the stored memory for offline analysis.

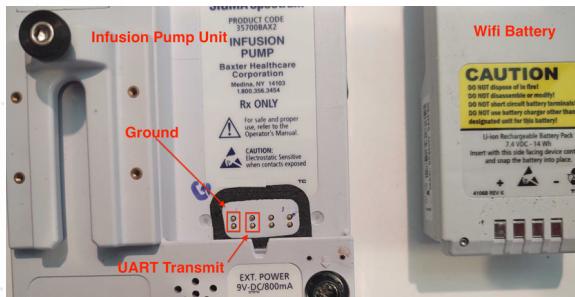
During testing it was found that the infusion pump unit transfers Wi-Fi configuration data to the WBM during initial power up. This was discovered by using a logic analyzer to monitor the contact points between the units. Examples of these connections are shown in figure below. It was determined that the communication between the main infusion pump and WBM was using UART.

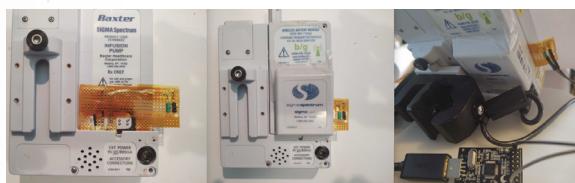
To capture the UART communication between the devices we created a simple shim using a flexible<sup>20</sup> development breakout board. This was done so the battery module could be properly installed for normal operations, but still allow us the ability to tap into and capture that communication in real time. An example of the shim and how it was placed between units is shown in the following figures.

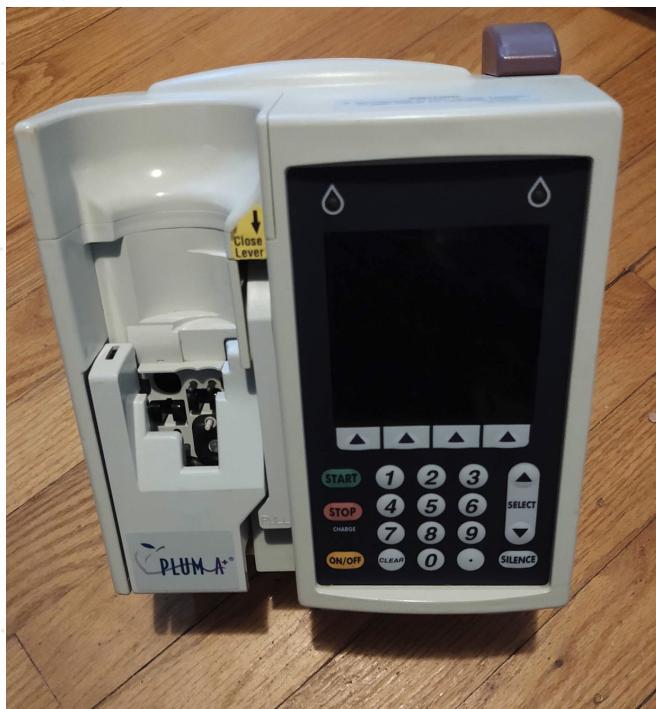
The last device examined during this study focused on the Hospira Abbott PLUM A+ with MedNet running software version 13.40. Like the other devices this infusion pump, although no longer manufactured, is still currently in use in many medical organizations and can also be purchased on the secondary markets. The Hospira devices, being examined in this writeup, were purchased off of eBay for the purpose of data examination using various methods. The methods covered in this section include JTAG, RS232, and destructive extraction of the flash memory chips.

In the initial testing the first device was disassembled to identify flash memory, MCUs, and connection headers. Analysis showed that the main board for the MedNet communication board could be extracted by removing two screws and unplugging it. This board was found to contain two flash memory chips.

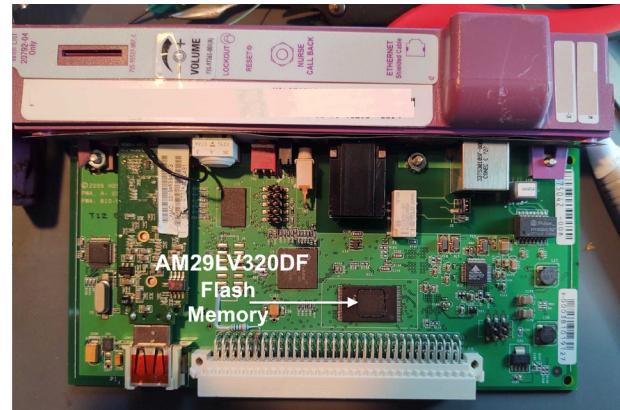
The first flash memory chip identified was a TSOP48 package type. After removing the sticker from its surface we identified

the flash memory chip as an AMD AM29LV320DT-90EC 32 Megabit flash memory.

To examine the content of this flash memory device we used ChipQuick<sup>23</sup> a low temperature desoldering metal to remove the TSOP48 device. Once removed we used an RT809H chip programmer to extract the data from the flash chip. Next we used Linux command strings to examine the binary file and found this to contain what appeared to be infusion pump drug library data and user interface and pump operational control code. No configuration data was identified on the flash memory chip.
