Appendix J - Complete Climate Control Report

COMPLETE CLIMATE CONTROL INC.

Report on findings and work performed at:

Arctic Glacier facility,
790 Sarcee St.
E Kamloops

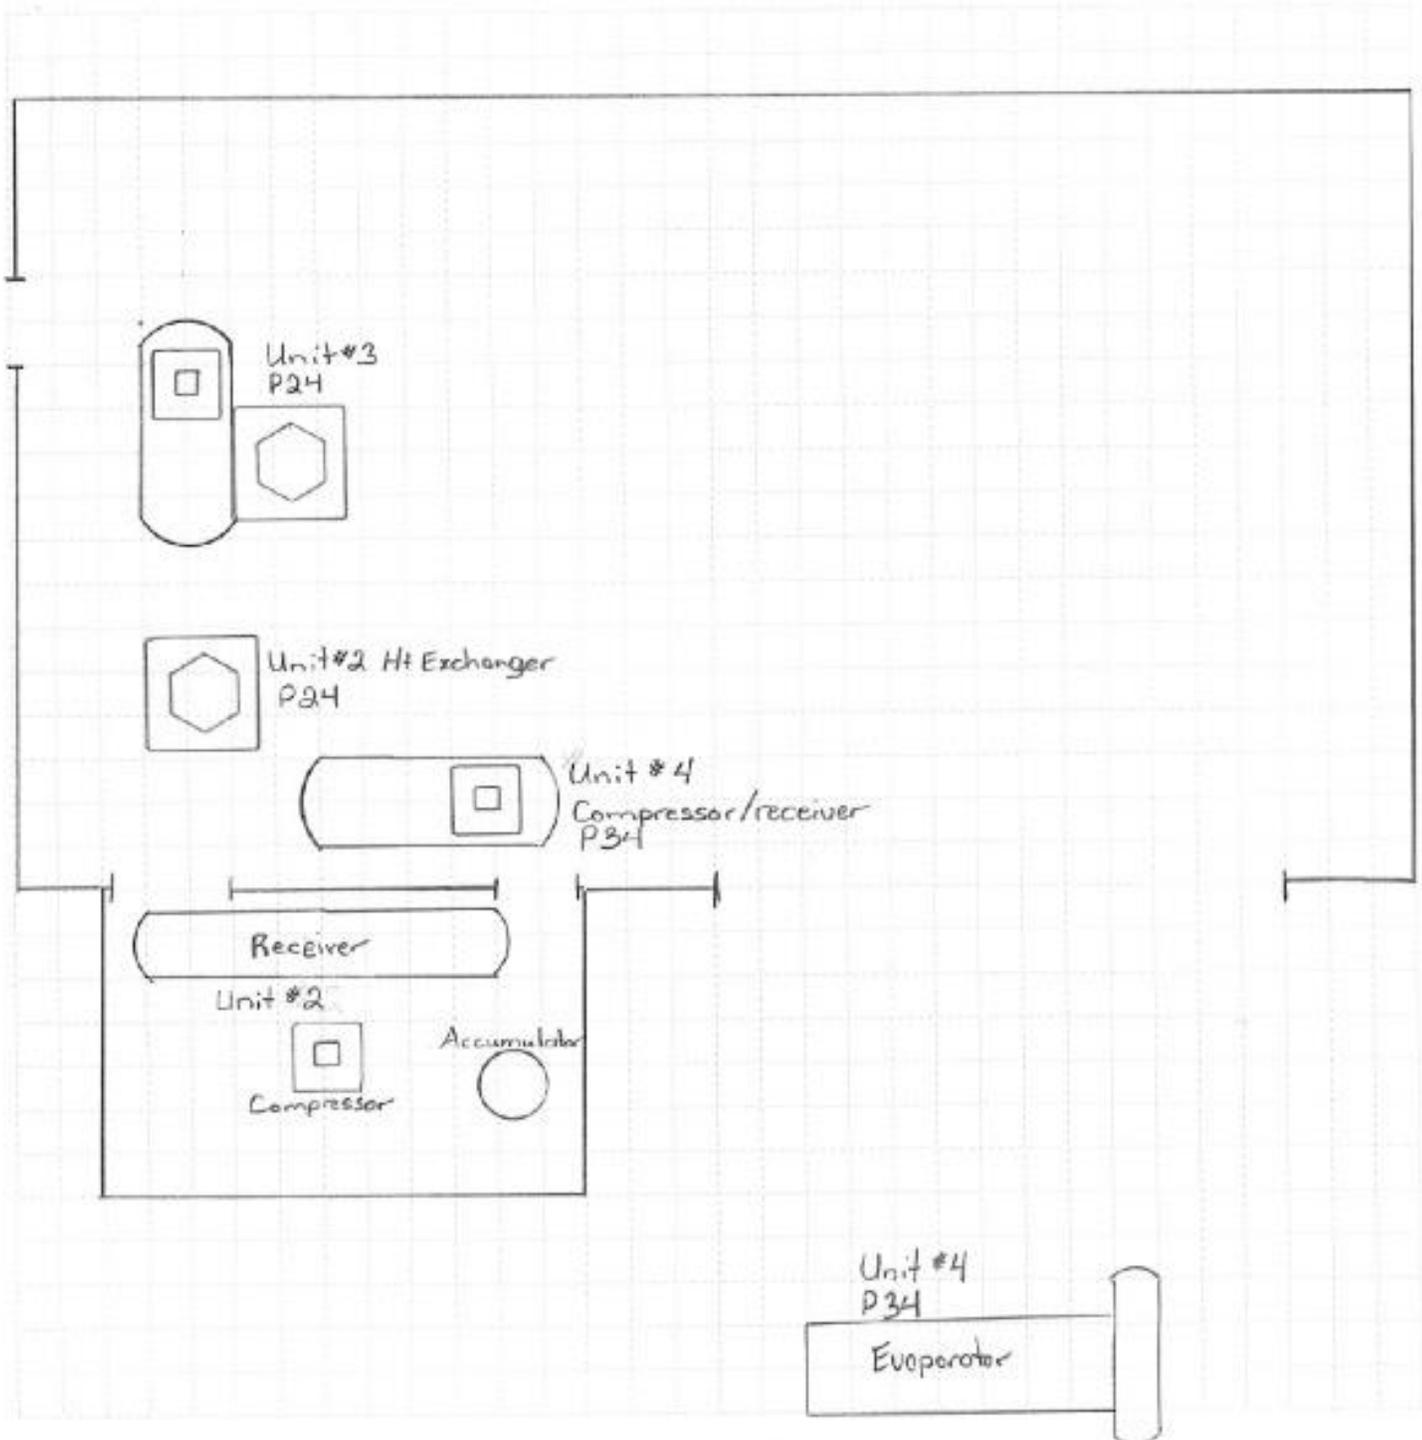
- A lot of cut ammonia piping.
- Valves in use that in my opinion, are not typically ammonia valves. They were Stainless steel ball valves. Refer to picture #1 and #2. (Pictures were taken on the next day.)
Note valve #1 was open.
- Lots of pipe was taken apart and left open.
- Most gauges were not legible.
- An Evap BAC Condenser outside with no valves or piping hooked up to it. (Open to atmosphere)
- Lots of destruction (melting and black burn marks) from a fire.

We first removed the open ball valve installed on the side of the receiver. Refer to Picture #1. We then hooked up the High-pressure nitrogen bottle to receiver at the access port where the ball valve was removed from.

- All valve when checked whether they were open or closed. Were first checked whether they were closed and then cracked open to double check for pressure. Then were fully opened and left open. All valves were found in the closed position. Except for the ball valve in picture #1.
- All component valves of Units #2, 3, and 4. Were left open to atmosphere and no pressure in systems.
- All valves circled in the pictures were left open to atmosphere.
