Incident Summary #II-774658-2018 (#9731) (FINAL)

SUPPORTING INFORMATION	Incident Date	November 11, 2018	
	Location	Delta, BC	
	Regulated industry sector	Gas - Natural gas system	
	Impact	Qty injuries	0
		Injury description	N/A
		Injury rating	None
	Damage	Damage description	Damaged unit heater and venting system, both are a total loss.
		Damage rating	Moderate
	Incident rating	Moderate	
Incident overview	A unit heater which was used to heat a garage bay, had a very hard light off (When the appliance attempted to ignite, rather than lighting off smoothly as designed, factors caused a small explosion in the combustion chamber), this blew off the bottom access cover and damaged the appliance.		
INVESTIGATION CONCLUSIONS	Site, system and components	<p>Direct vented appliances have their combustion air ducted directly into the burner chamber from the outdoors. Often a concentric venting kit, where a pipe installed within a second pipe, is used. The outer pipe draws the combustion air into the appliance, while the inner pipe conducts the products of combustion outdoors. This venting system is made out of materials which should resist corrosion from the elements which they are subjected

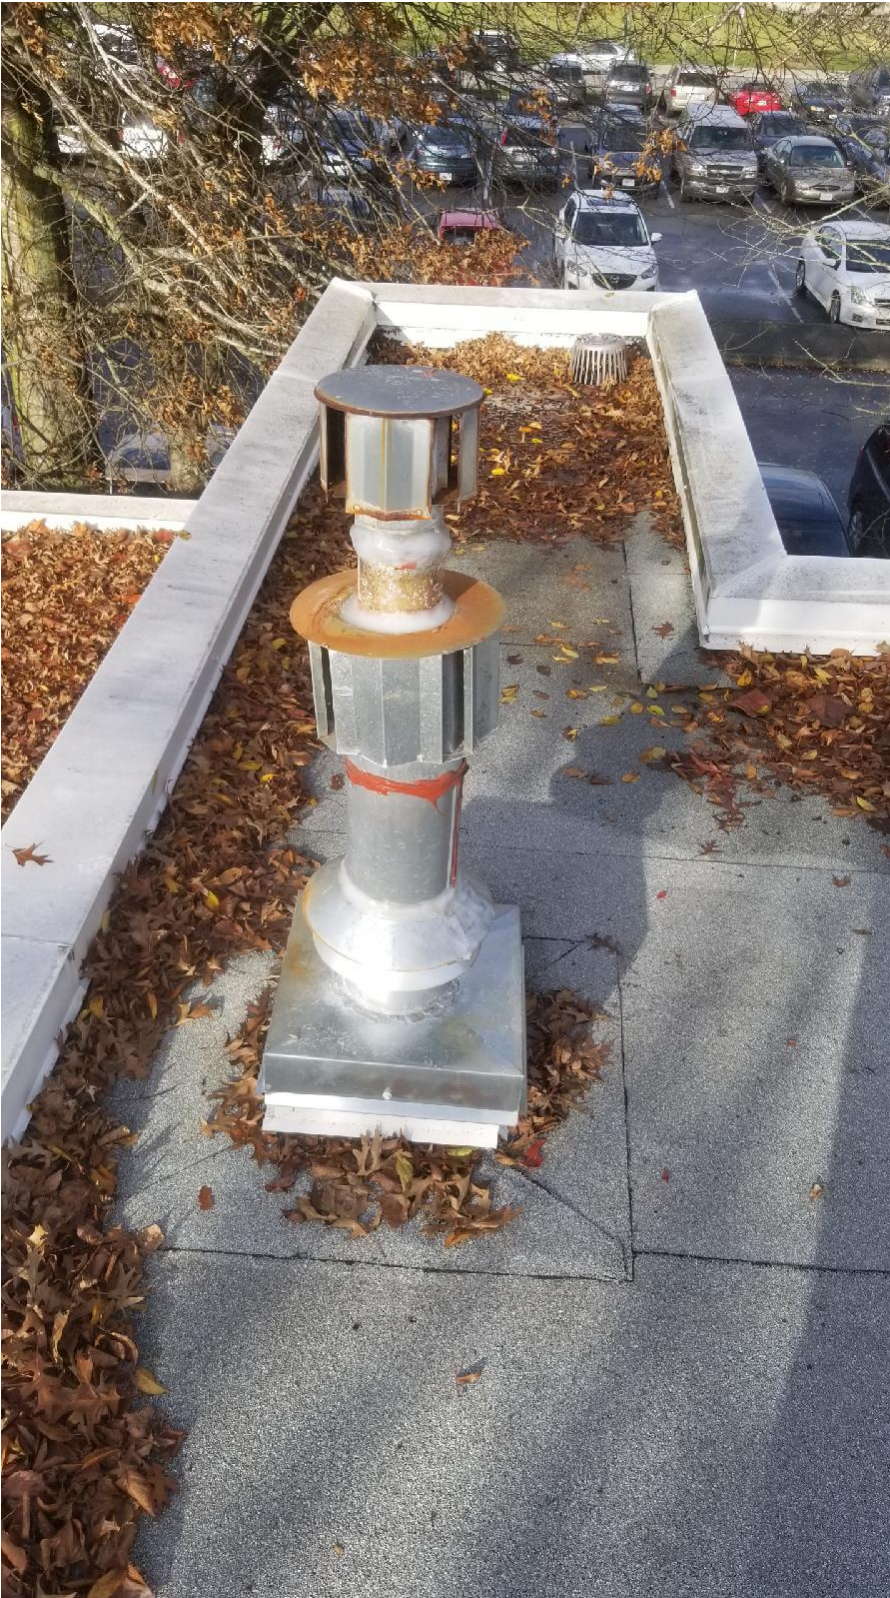
<p>Facts and evidence</p>	<ul style="list-style-type: none"> -Assessment of the vent pipe within the concentric venting kit found the vent pipe was extremely corroded. Although a hard light off may have perpetuated the damage to the venting system. - Signs of charring were found on the ignition wire at the point where it passes very close to one of the appliance burners. -The ignition module for this appliance was a “continuous retry” type, so every time the pilot flame failed to ignite, the appliance purged the chamber, and attempted its “trial for ignition” again.
<p>Causes and contributing factors</p>	<ul style="list-style-type: none"> -It is very likely that the cold air being drawn in for combustion caused the warm flue products to condense in the vent pipe, corroding the inner piping of the vent kit -It is very likely that the burnt ignition wire caused the appliance to spark somewhere other than the ignition electrode. Since the appliance was recycling back into itself, the gas would have been able to build up until it found the spark elsewhere in the appliance, igniting the explosive mixture. -It is very likely that during pre-purge cycle the appliance was cycling gas back into the combustion chamber, when the appliance attempted to operate the explosive mixture ignited damaging the unit. -It is possible that a lack of inspection of the venting system during routine maintenance of this appliance may have contributed to this failure. This highlights the importance of not only servicing and inspecting the appliance, burner, and ignition system, but also the venting system which serves the appliance.

Figure 4. Appliance concentric termination. The top cap vents products of combustion. The bottom cap brings in fresh air for combustion.

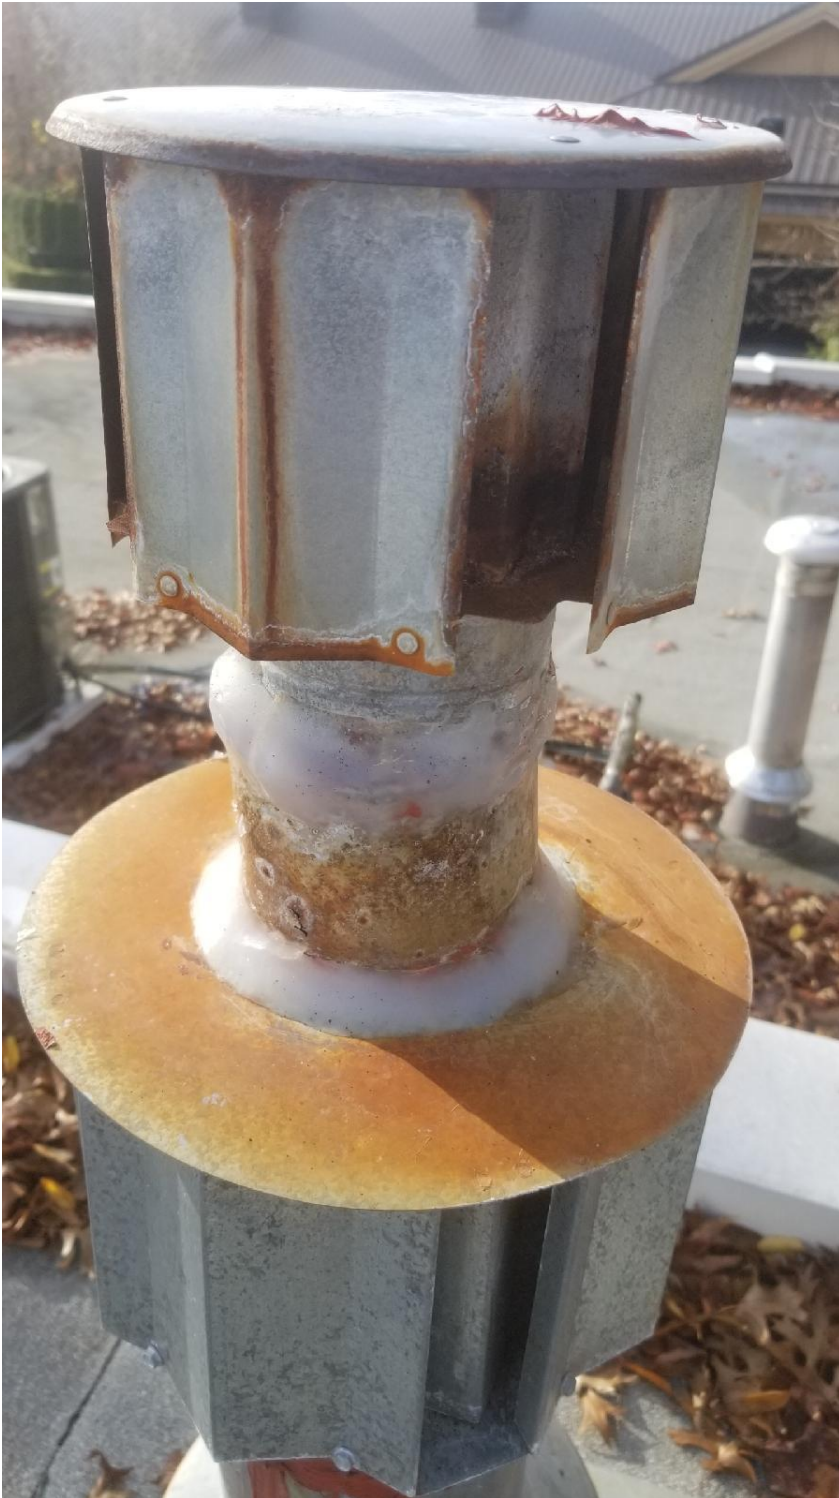
Figure 5. Picture of the vent cap.
