Investigation Report

Babine Forest Products – Explosion and Fire – January 20, 2012

BC Safety Authority – Incident Investigation – Jurisdiction and Role

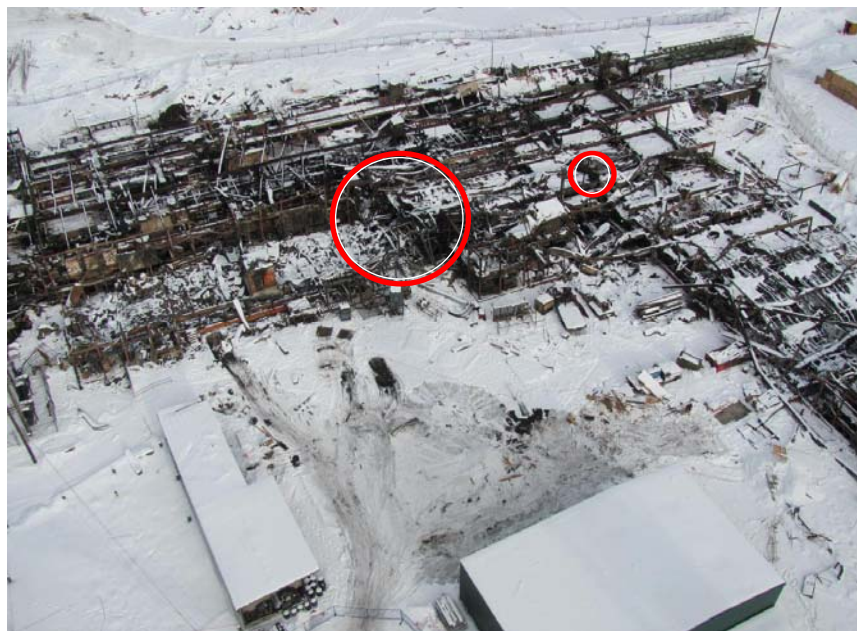
SAMAC Engineering Ltd. was contracted by the BC Safety Authority to provide fire and explosion investigation expertise. A possible area of explosion origin was identified in the basement below the band saw. This area's determination is discussed in the appended fire and explosion investigation report (Appendix A). WorkSafeBC identified a possible area of origin in the basement near a waste conveyor motor assembly labeled 8R-26³. On the evidence currently available, the BC Safety Authority accepts that the explosion could have originated from either of these areas. These areas are identified in Photograph 2.

Photograph 2: Aerial view of the sawmill site after the explosion and fire of January 20, 2012. The circles indicate the possible areas within the basement where the explosion originated.

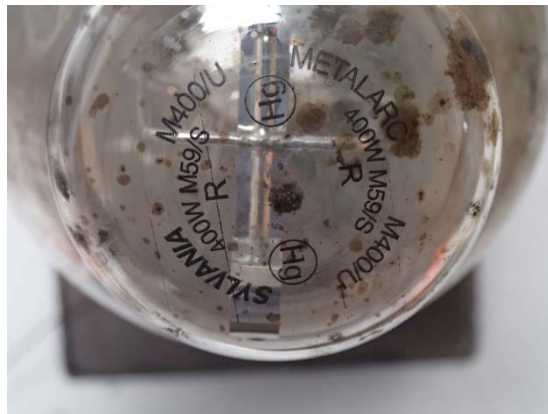
Photograph 7: Metal halide bulb product markings

Manufacturer's specifications associated with the bulb part number depicted in photograph 7 indicate a maximum bulb temperature of 400°C and a maximum base temperature of 250°C.

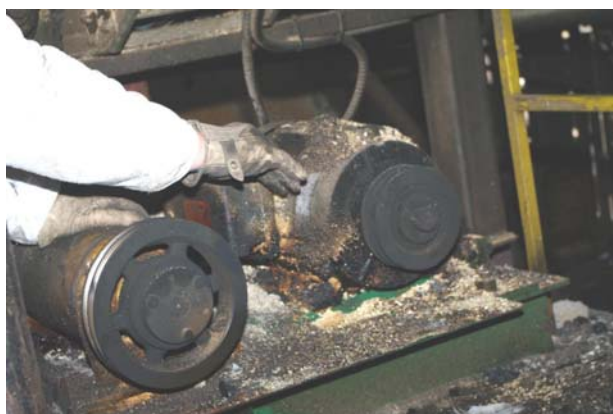
No evidence of arcing or electrical failure was observed on any other electrical equipment found within either area of origin. A detailed evaluation of conveyor motor labeled 8R-26 was commissioned by WorksafeBC and BC Safety Authority investigators witnessed that the motor functioned with no indications of an appliance failure prior to the incident. Hazardous accumulations of wood dust were found within the junction box and cooling fins of the motor as shown in Photographs 8 and 9.

Photograph 9: Wood dust accumulation around conveyor motor labeled 8R-26.

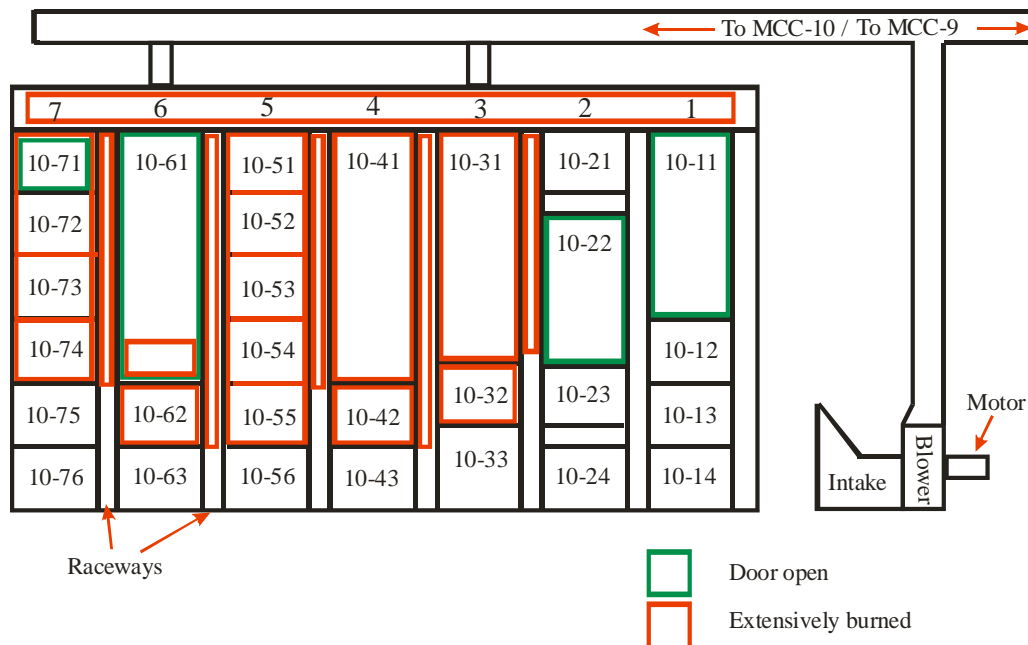
Figure 4: MCC-10
(not to scale)

In the area of origin a large electrical panel identified as MCC-10 stood out as a possible source of the primary explosion. In a major fire such as this it would be normal to see a relatively uniform horizontal burn pattern on the front of MCC-10, had it been a result of the main fire. However, the burn pattern on the front of MCC-10 (Photograph 5) was irregularly shaped and tended to follow the shapes of individual cabinets. MCC-9 was in the same general area as MCC-10 (Figure 1) yet, in contrast to MCC-10 there was a relatively uniform horizontal burn pattern on the front of MCC-9. This suggests the burn pattern on MCC-10 was the result of an internal fire. All of the cabinets were interconnected via raceways for wiring (Figure 4). It is likely that an internal fire or explosion occurred inside MCC-10 and only became established in certain cabinets, possibly those that contained more wood dust, and the internal burning produced the burn pattern observed on the outside.

Most of the wood dust inside MCC-10 was burned away. However, wood dust accumulations were present in the less damaged cabinets of MCC-10 (Photograph 11) and wood dust deposits were observed in MCC-9 and MCC-12 which were less damaged. The intake for the air pressurizing system for MCCs 9 and 10 was on the floor next to MCC-10. Because the intake was in the dust contaminated environment, the pressurizing system could have introduced wood dust into the MCCs had it been used prior to the explosion without conducting a cleaning of the cabinets.

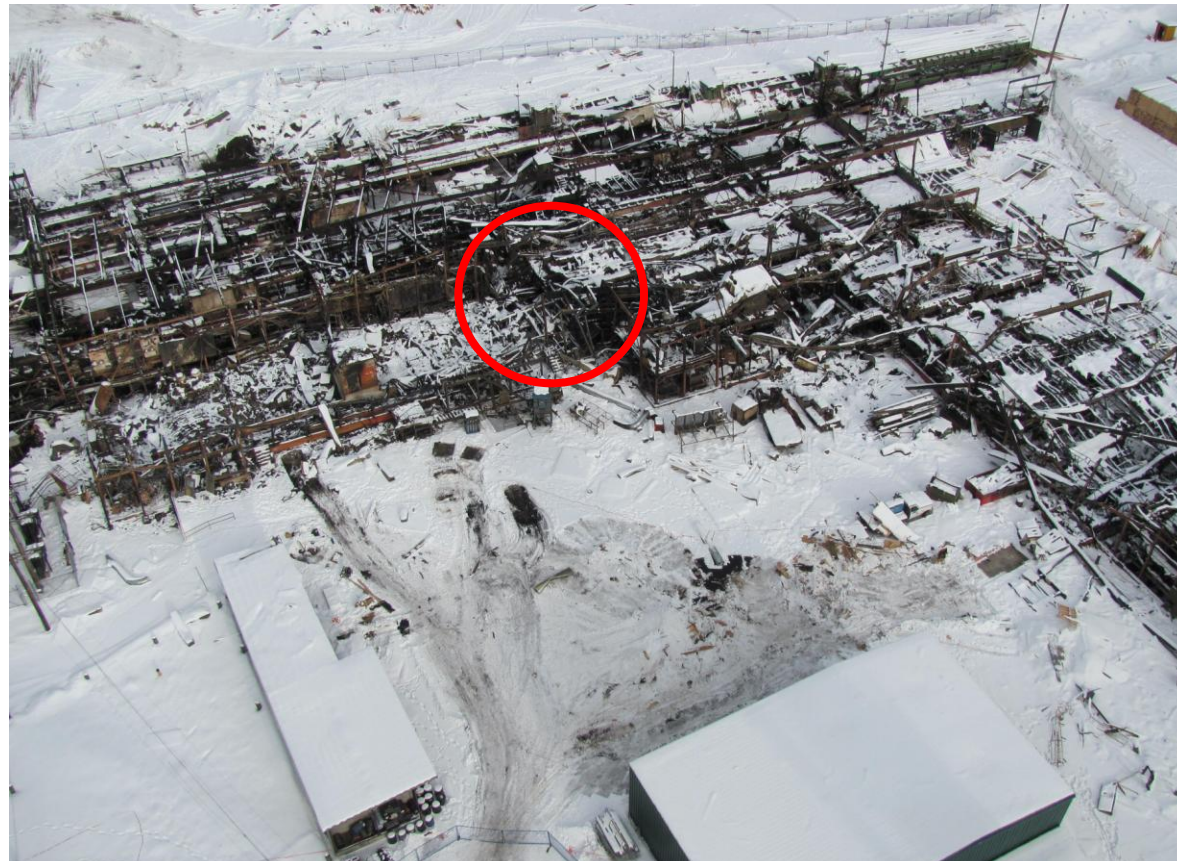
Photograph 2

Looking at a post-fire view of the sawmill.

Note: the circled area corresponds to the circled area in Figure 1 of the attached report.

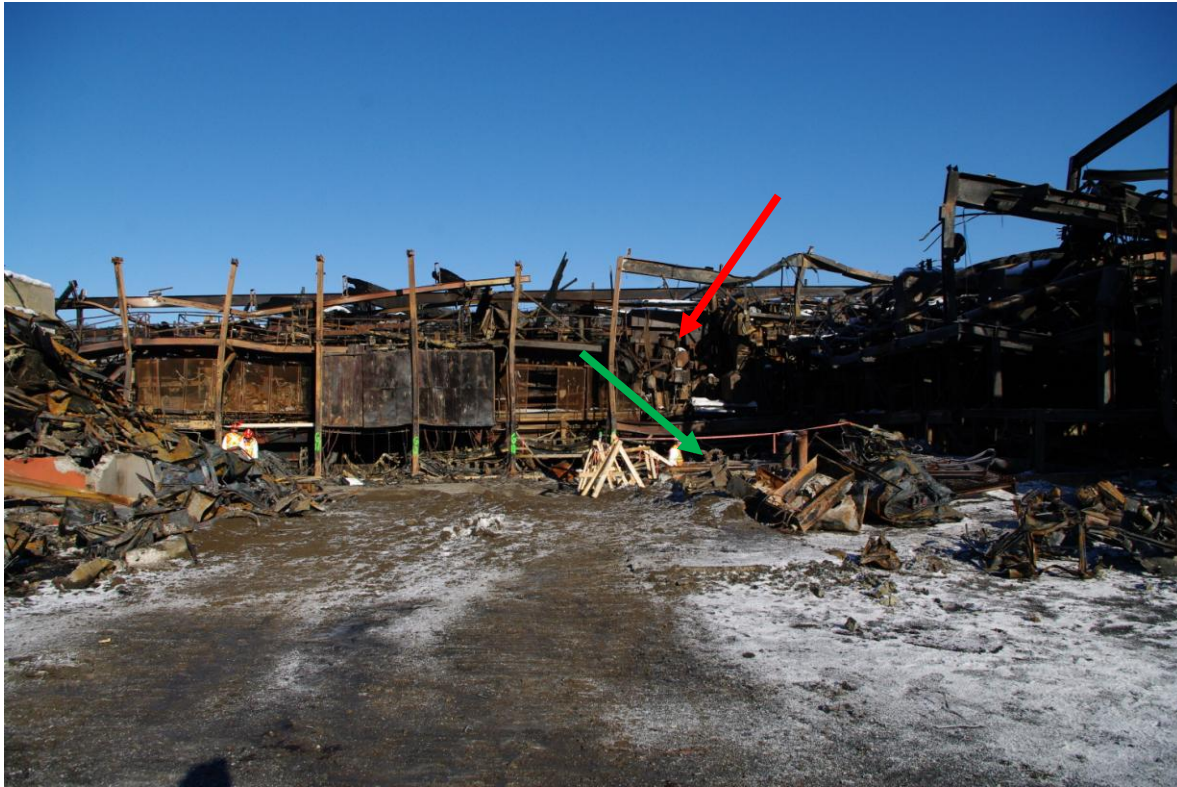
Photograph 3

Facing north looking at the area indicated by the red circle in Photograph 2.

Note: the location of the band saw (red arrow).

Note also: the boiler and MCC-10 are located in the basement (green arrow).

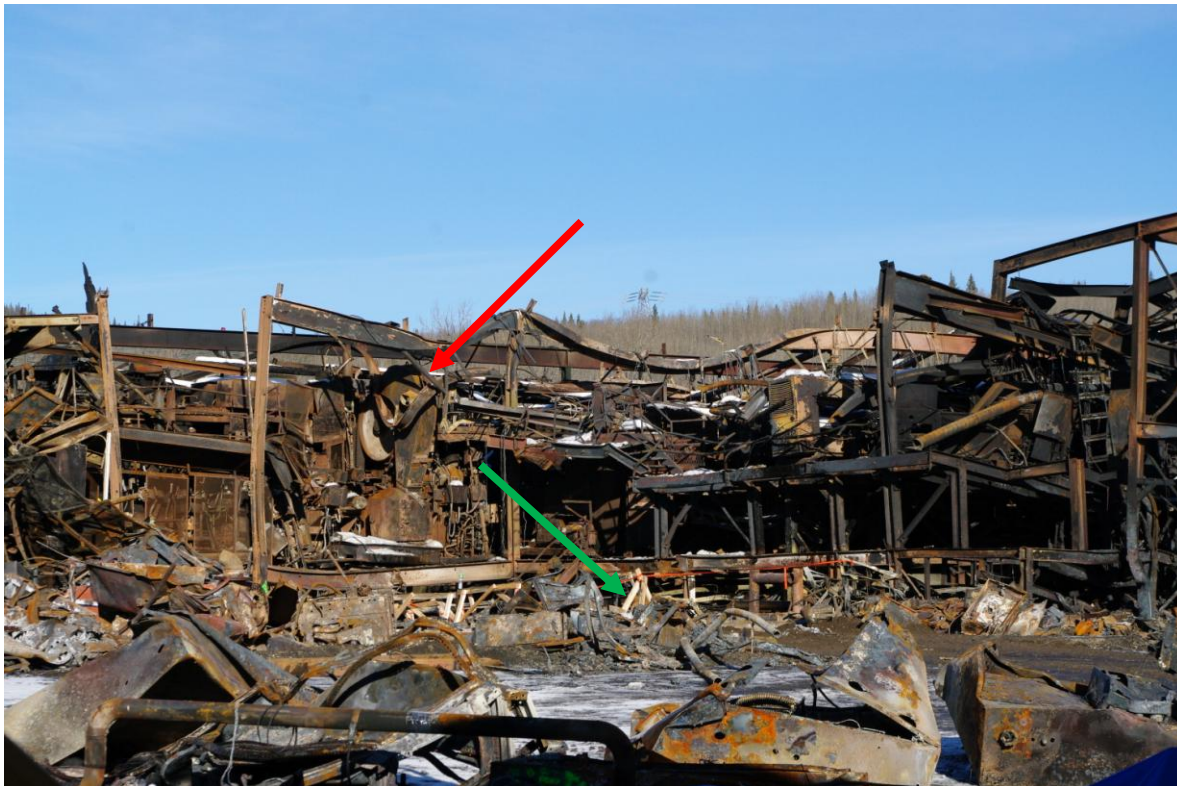
Photograph 4

Facing northeast looking at a closer view of the areas referred to in Photograph 3.

Note: the band saw (red arrow) and the boiler room and MCC-10 located in the basement (green arrow).

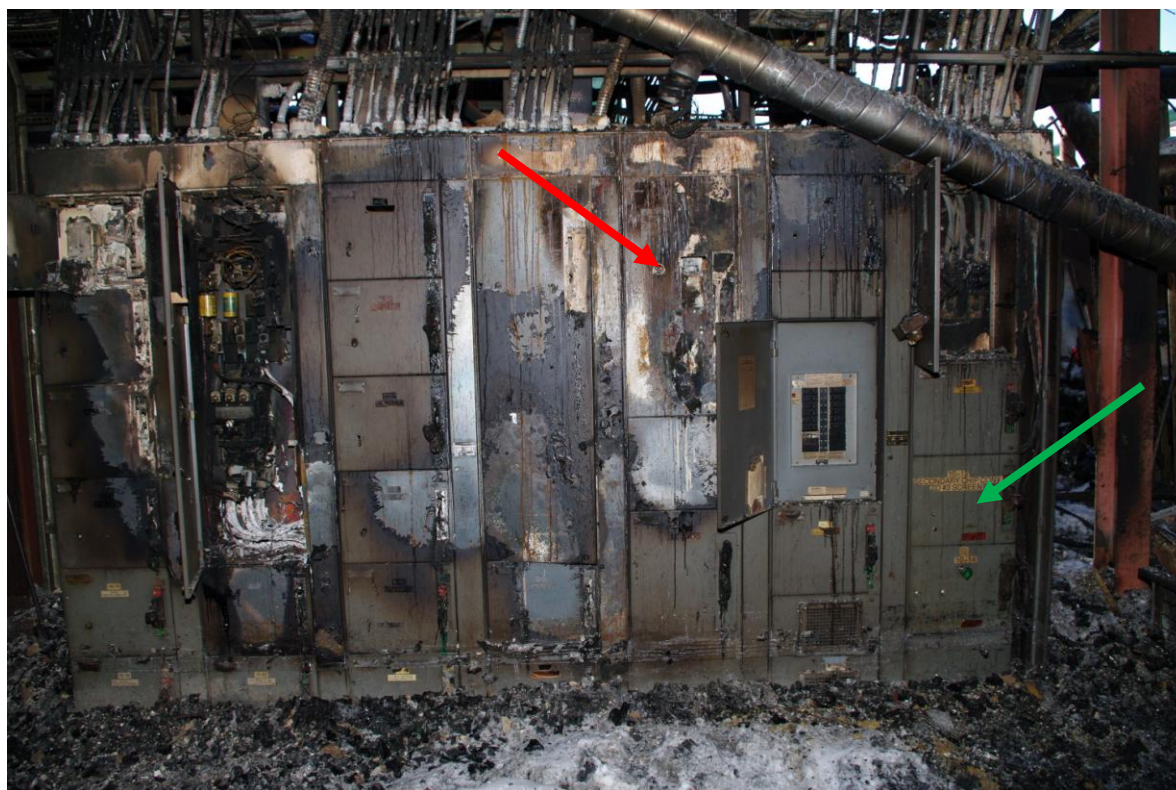
Photograph 5

Looking at the front of MCC-10.

Note: rather than being a uniform V pattern the burn pattern on the front of the panel follows the shapes of individual cabinets.

Note also: the locations of sub panels 10-31 (red arrow) and 10-13 (green arrow). Cabinet 10-13 is further referred to in Photograph 11.

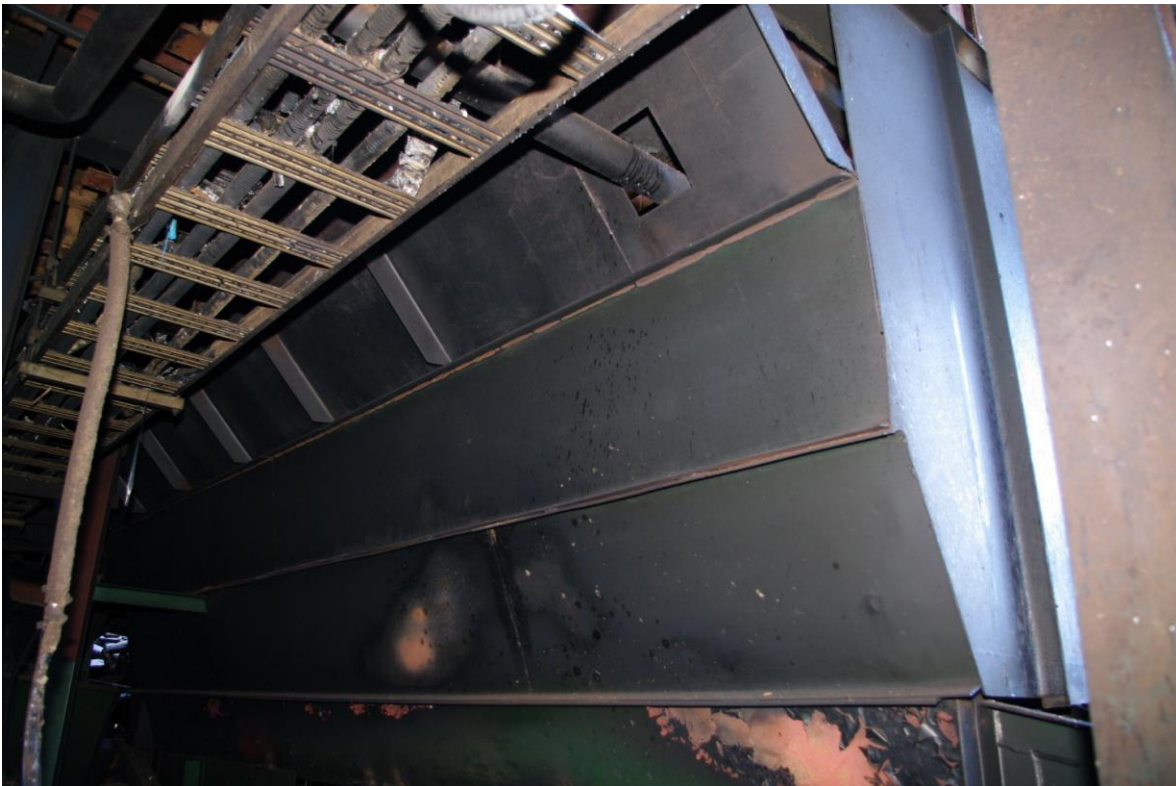
Photograph 10

- the wire cable trays in most of the basement were coated with charred wood dust on the upper side (Photograph 8); however, there was minimal charred wood dust on the cable trays above MCC-10 (Photographs 9 and 10),

Looking at the cable trays by the conveyer next to MCC-10.

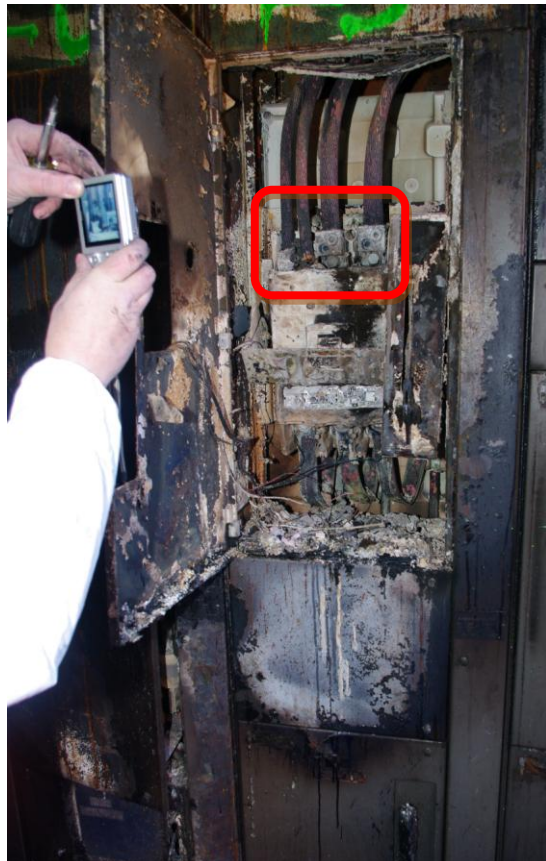
Photograph 14

Looking at the interior of MCC-10, subpanel 10-31.

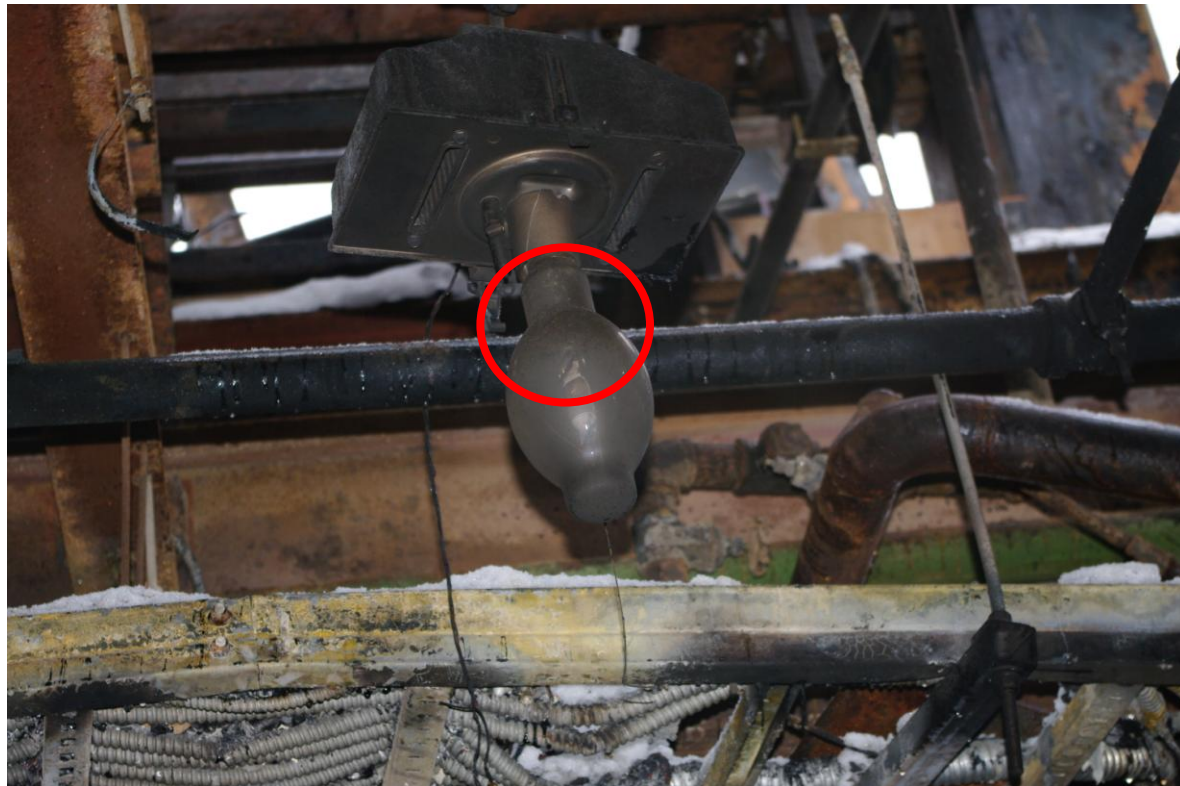
Photograph 16

- there was an open bulb 400 watt metal halide light fixture suspended above MCC-10; the bulb was intact but the shade was found on the floor in front of MCC-10, several of these metal halide lights were located in the basement of the mill, and

Looking at the metal halide light above MCC-10.

Note: residue on the upper bulb surface (circle).

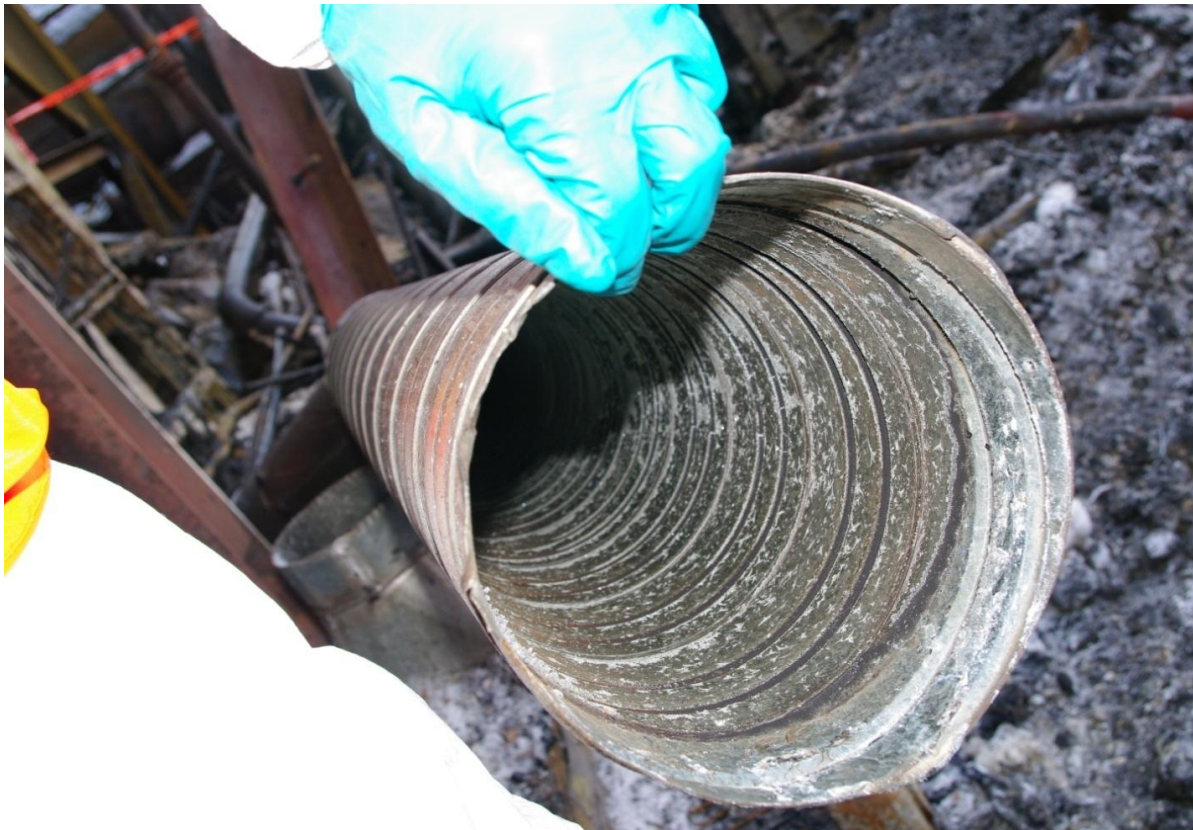
Photograph 18

Looking at the interior of the ventilation ducting for MCC-10.

Note: the charred deposits on the inner surface.

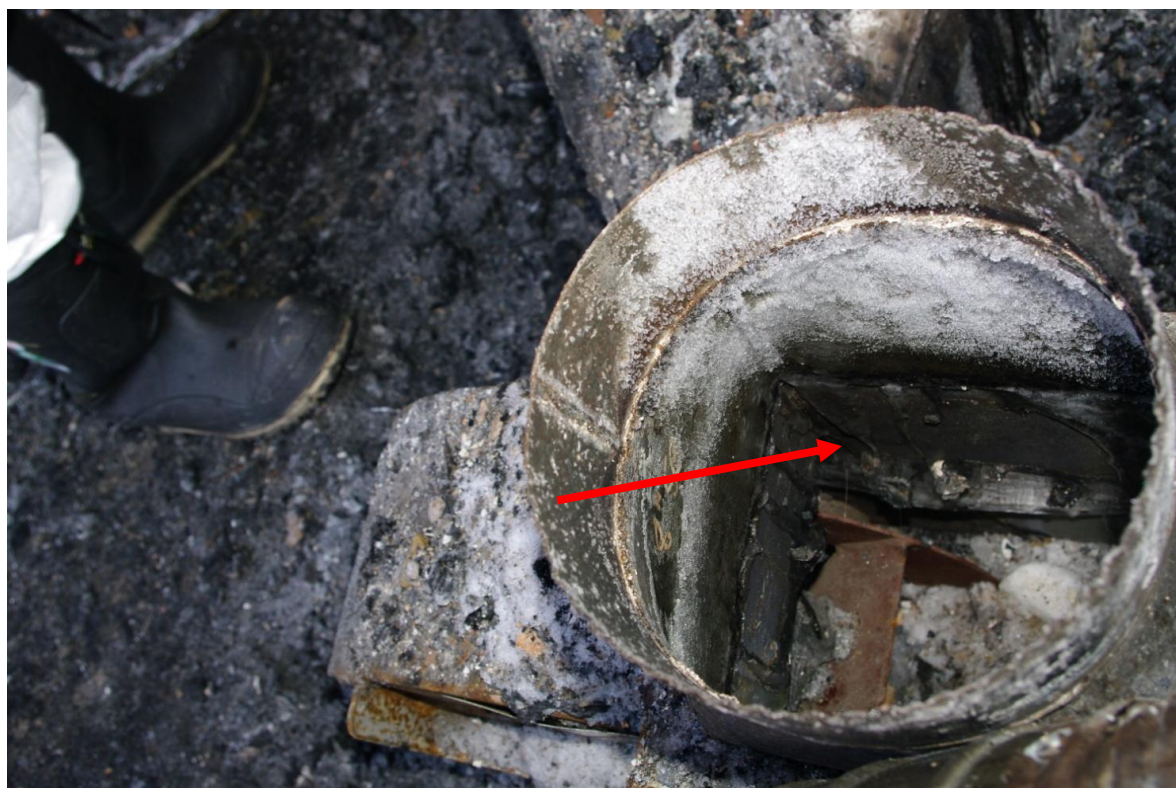
Photograph 19

Looking at the interior of the transition on the blower for the ventilation system for MCC-10.

Note: the charred deposits on the inner surface (arrow).

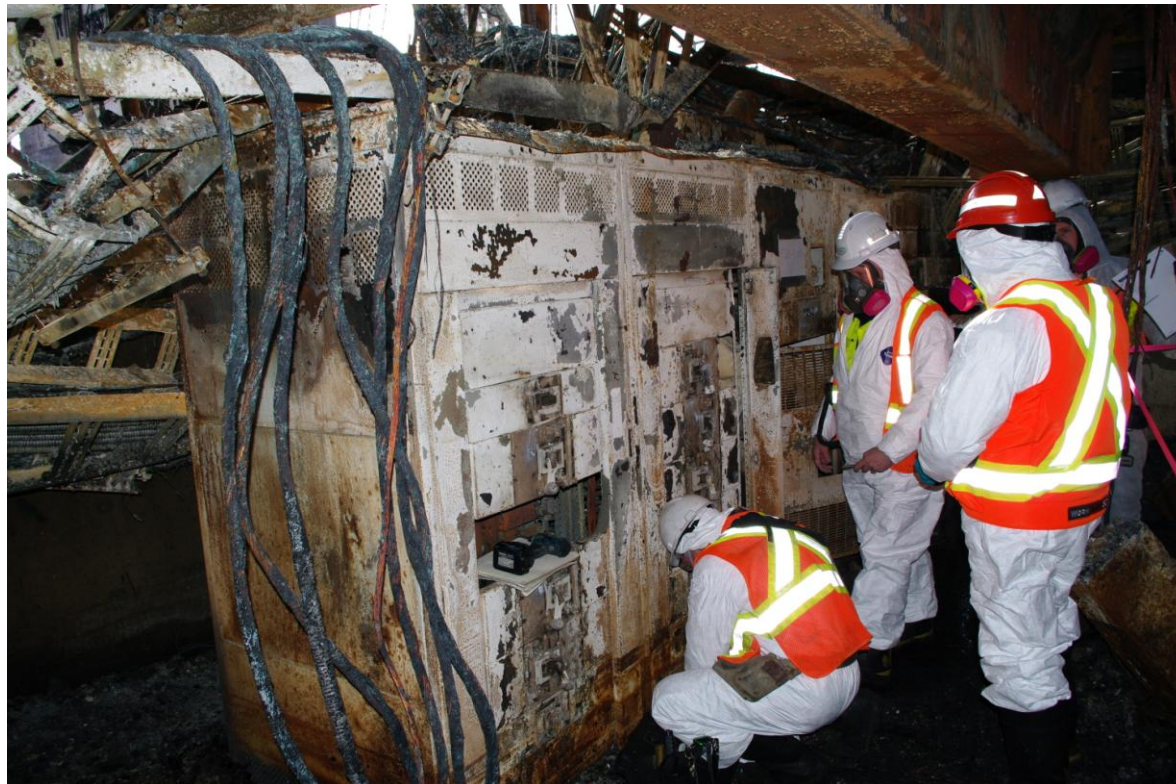
Photograph 20

Looking at the PDC.

Note: before the explosion the PDC was in a fully enclosed room.

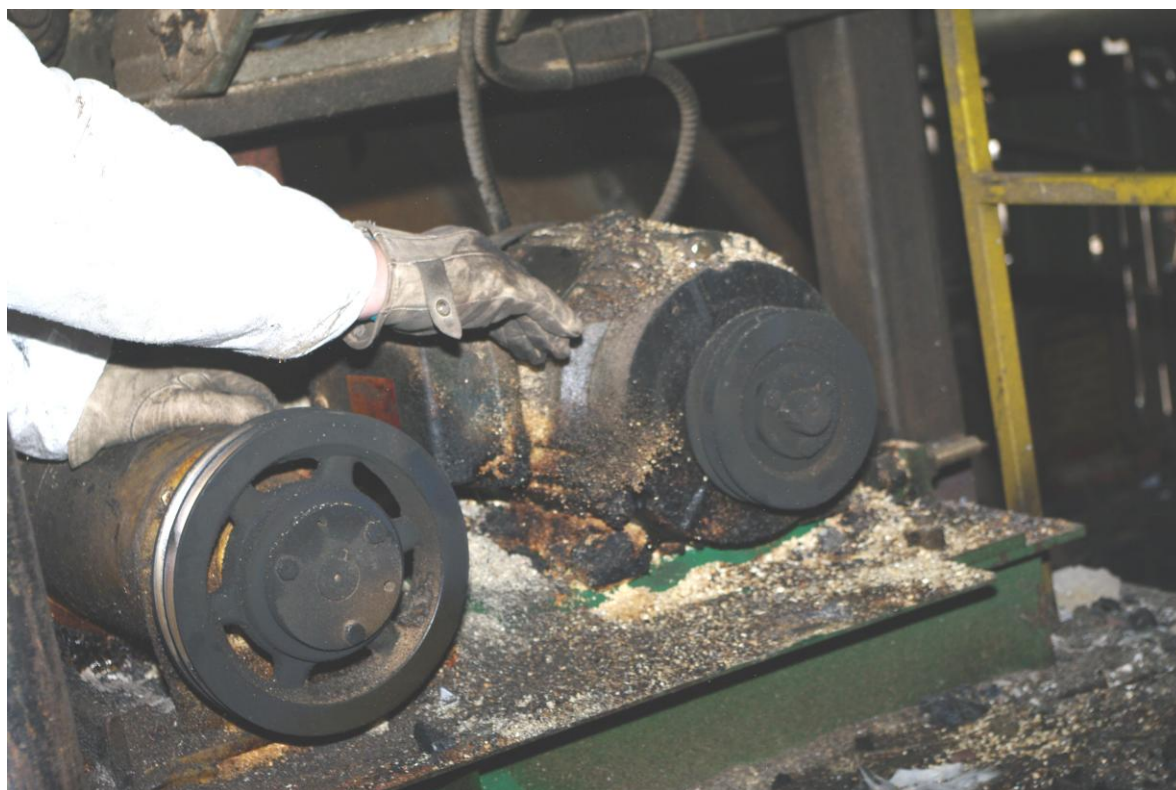
Photograph 21

Looking at the motor taken into evidence by Worksafe BC from the east side of the mill basement.

Note: the sawdust on and around the motor.

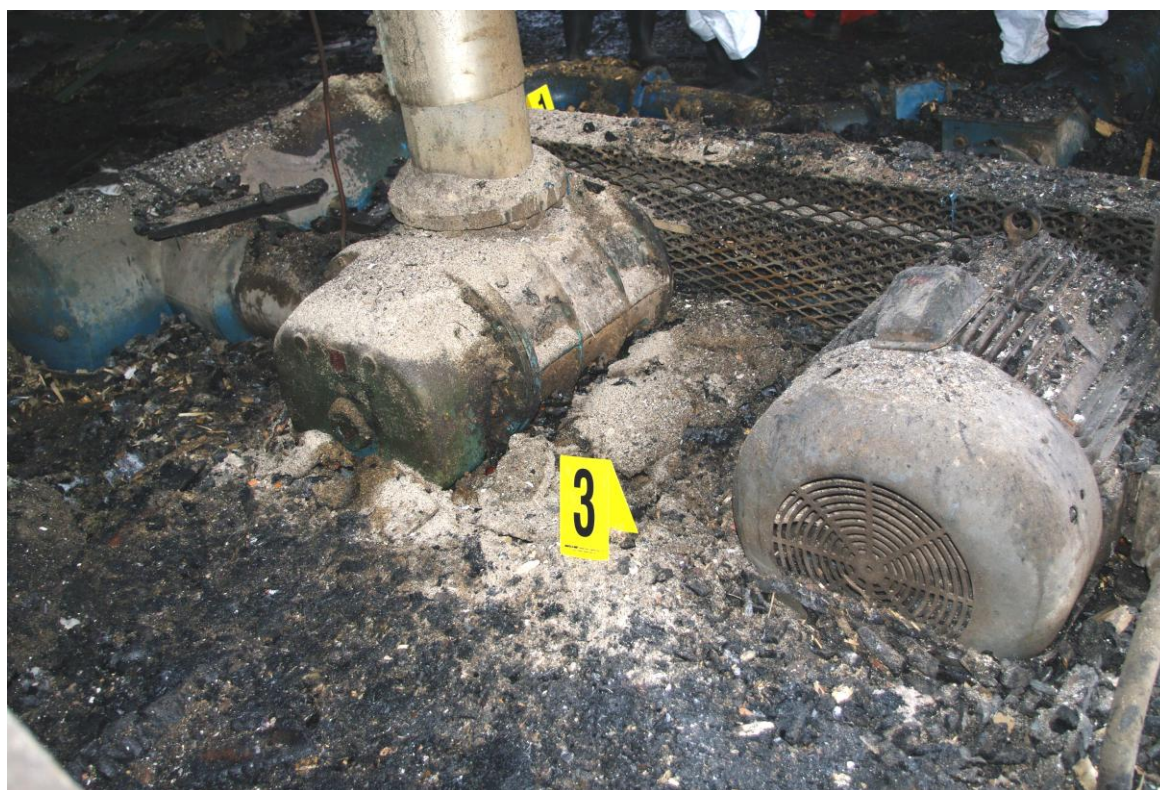
Photograph 22

Looking at an example of the dust levels in the basement of the mill. This photograph was taken in the east side of the basement.

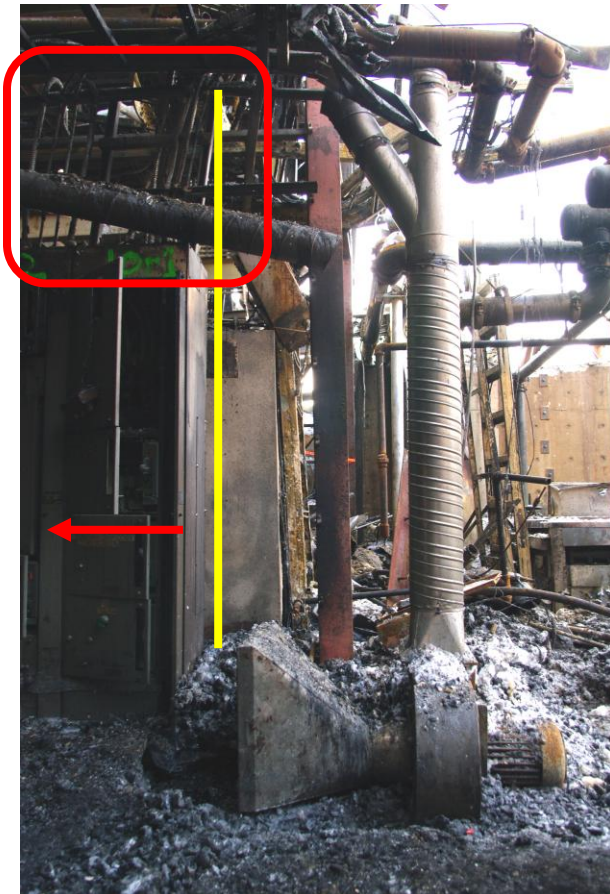
Photograph V1

Looking at the west end of MCC-10 from the front.

Note: the angle of the wires at the top of the panel (red outline) indicates an eastward movement of the panel.

Note also: the red arrows in photographs V1 to V20 indicate the blast direction and correspond to the numbered arrows in Figure 4 of the report.

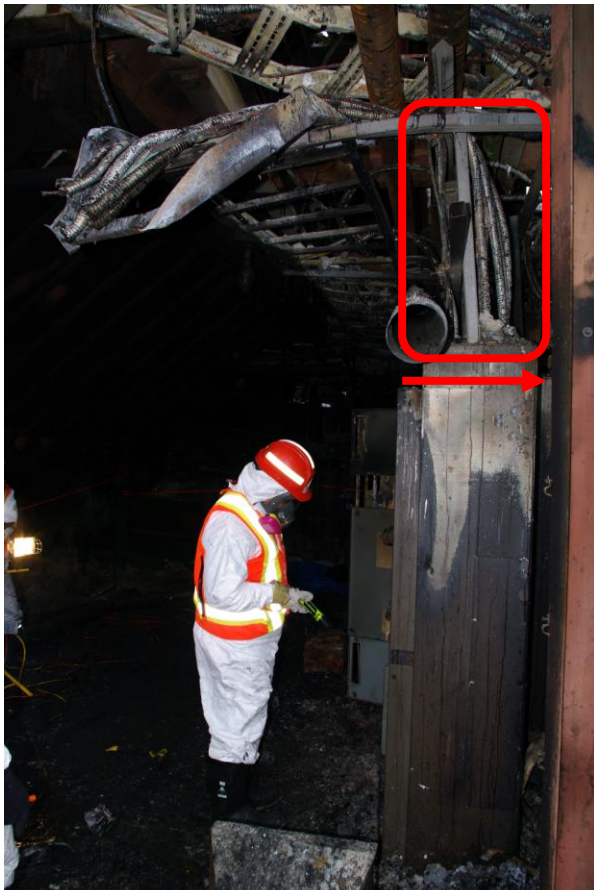
Photograph V2

Looking at the west end of MCC-10 from the end.

Note: the angle of the wires at the top of the panel (red outline) indicates a southward movement of the panel.

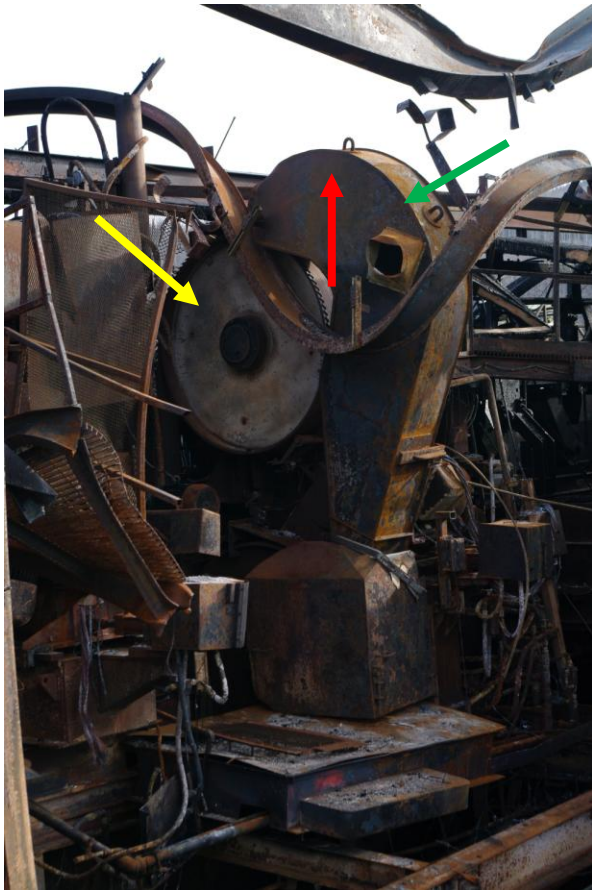
Photograph V3

Looking at the band saw.

Note: the blade shield (green arrow) would normally cover the wheel (yellow arrow).

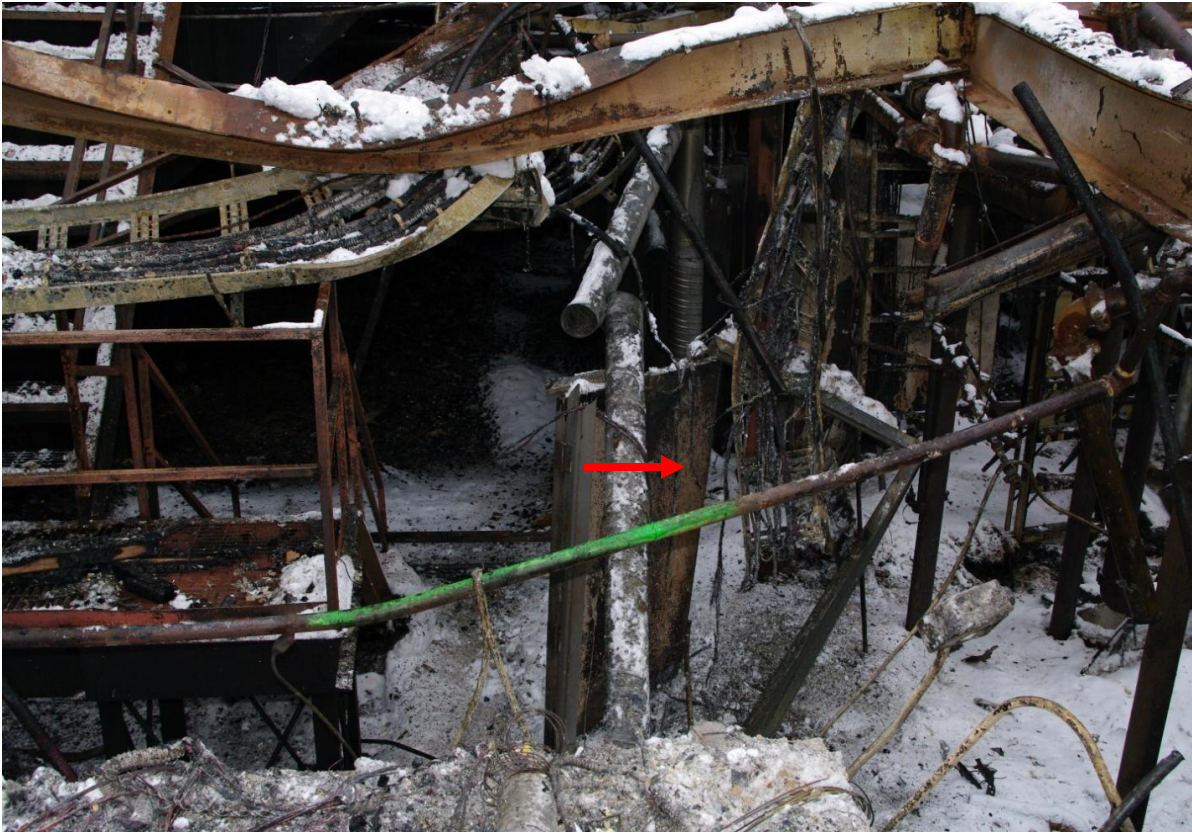
Photograph V5

Looking at the door to the boiler room.

Note: the door which would normally have opened out, was found open into the boiler room as indicated by the red vector arrow.

Note also: before the explosion the boiler room was completely enclosed.

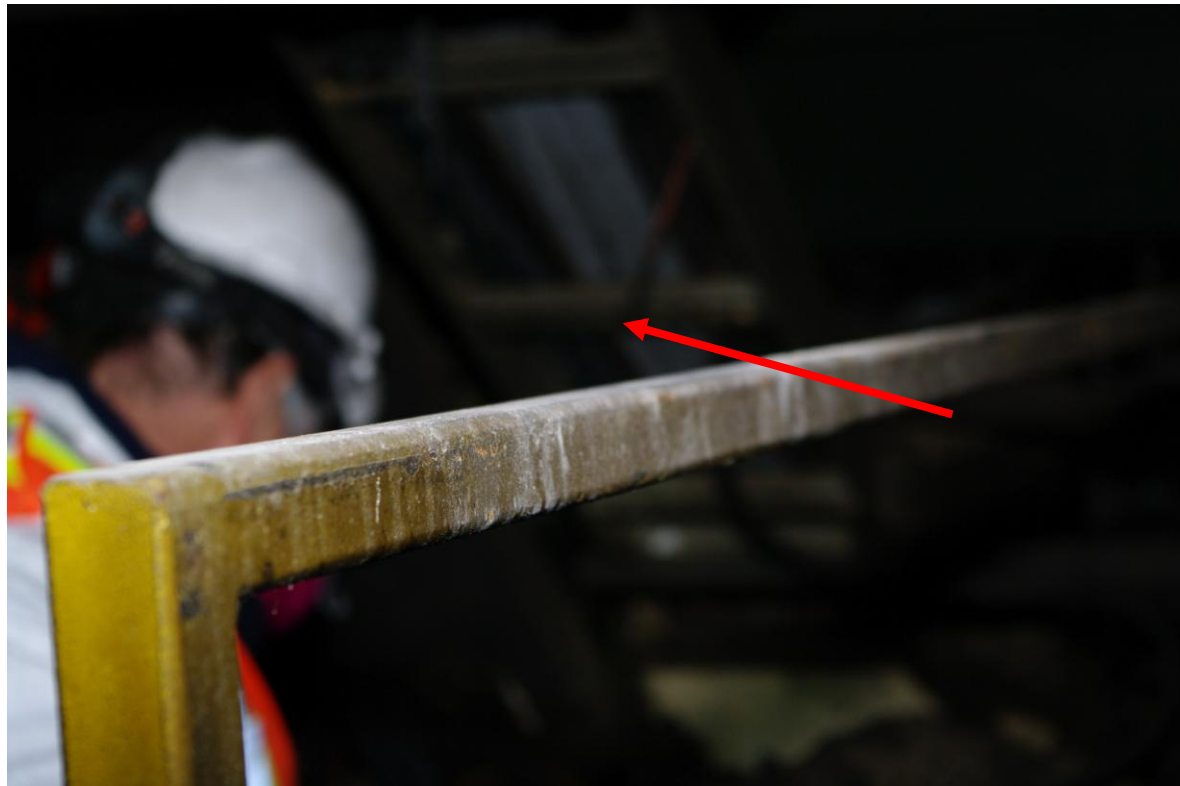
Photograph V14

Looking at the west side of the railing shown in photograph V13.

Note: the condition of this side of the rail in comparison to the other side.

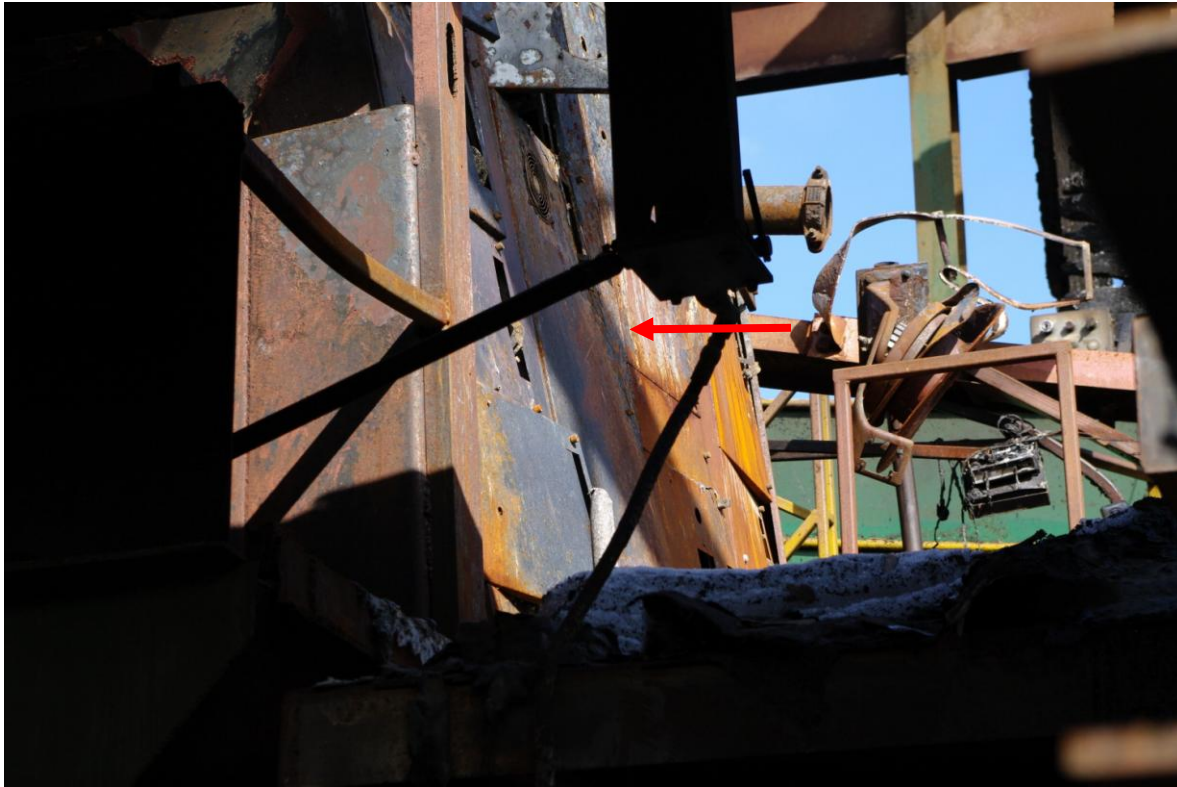
Photograph V15

Looking at the MCC panel for the eliminator.

Note: this panel was in the east side of the building and the top of the panel was pushed toward the west (arrow).

Note also: this photograph was taken through the opening through which a blast from the basement would have travelled striking the MCC panel .

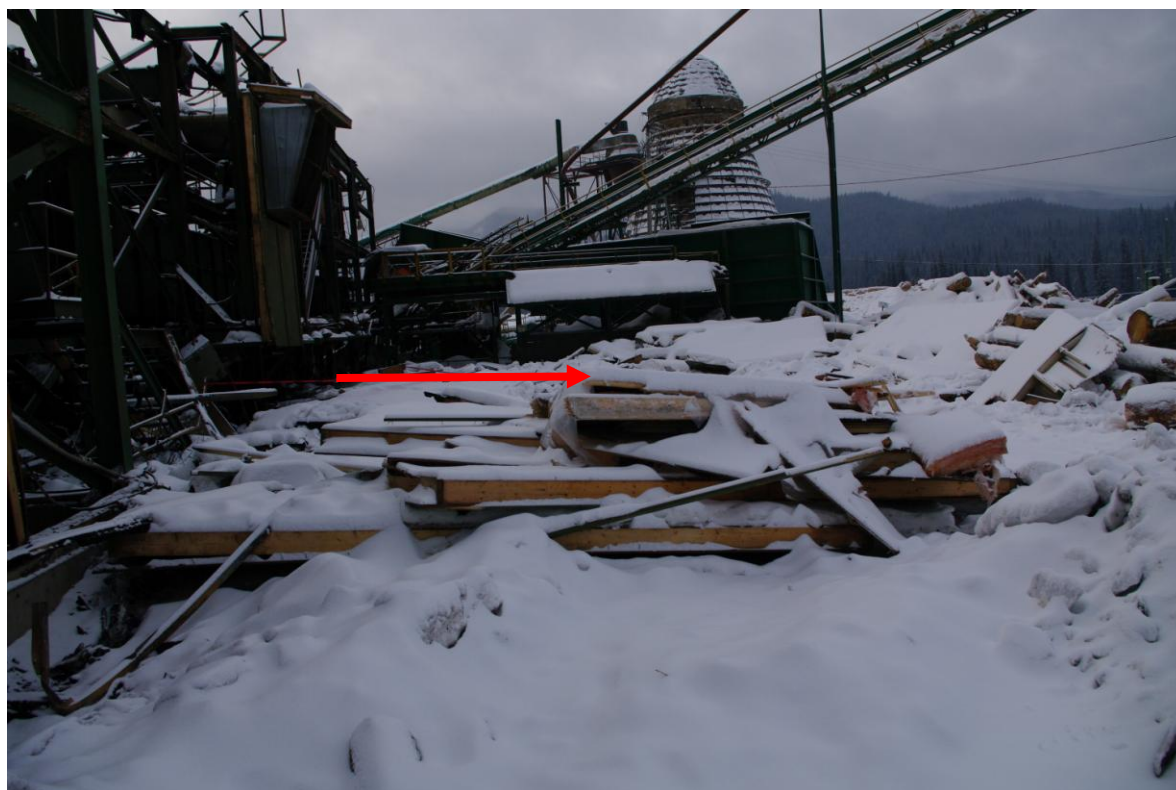
Photograph V17

Looking at the west end of the mill.

Note: the debris on the ground is the west exterior wall which was blown out to the west.

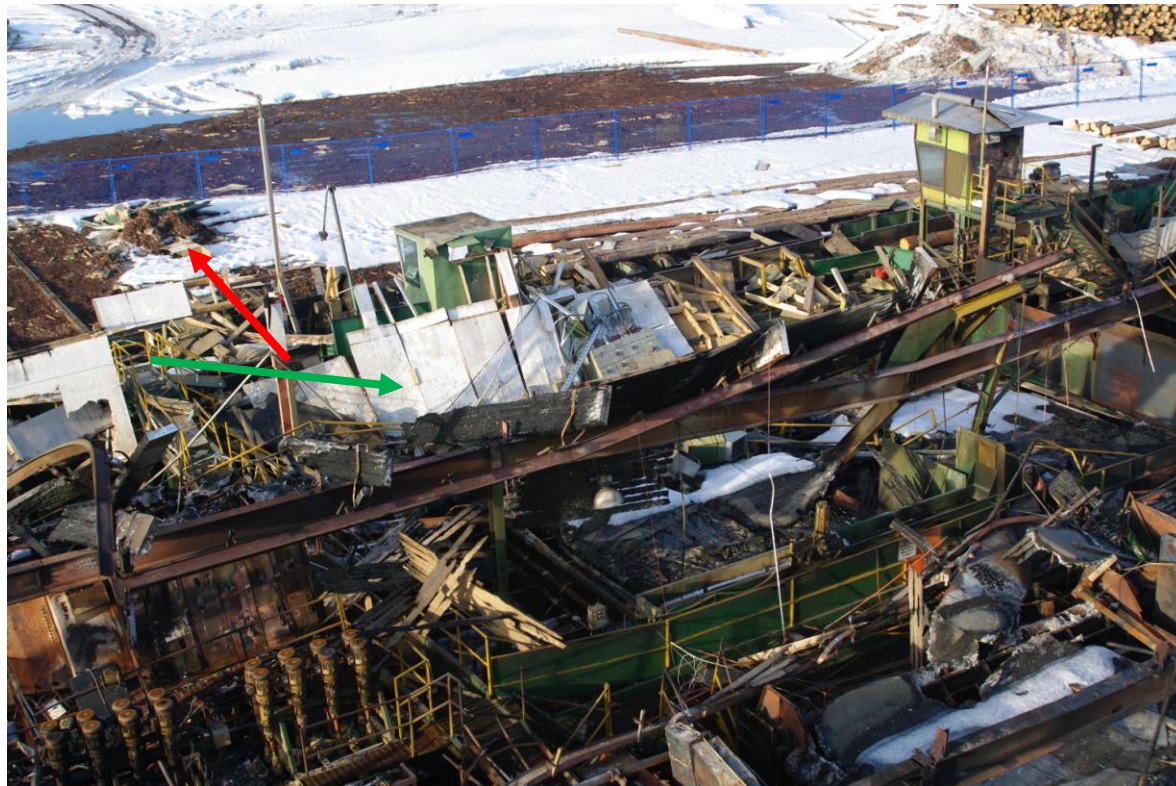
Photograph V18

Looking north from above the mill.

Note: the north walls (green arrow) were blown out to the north.

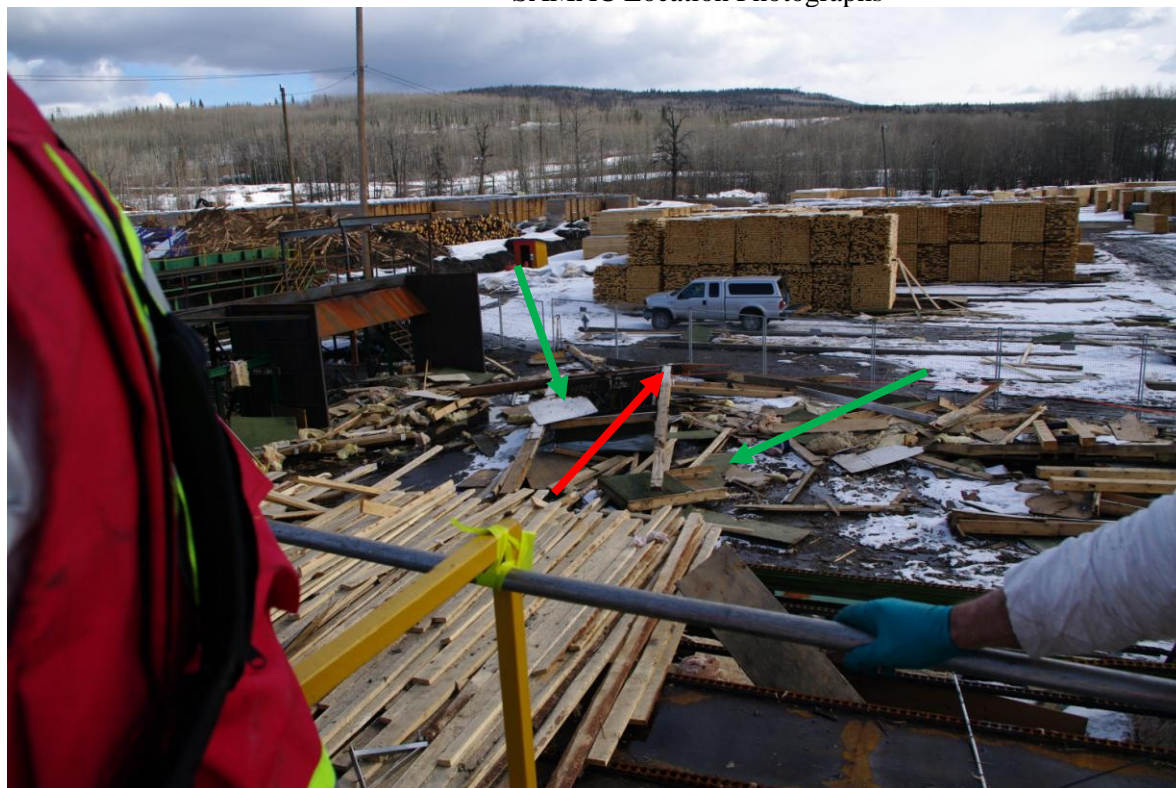
Photograph V19

Looking east from the east end of the mill.

Note: the east walls (green arrows) were blown out to the east.

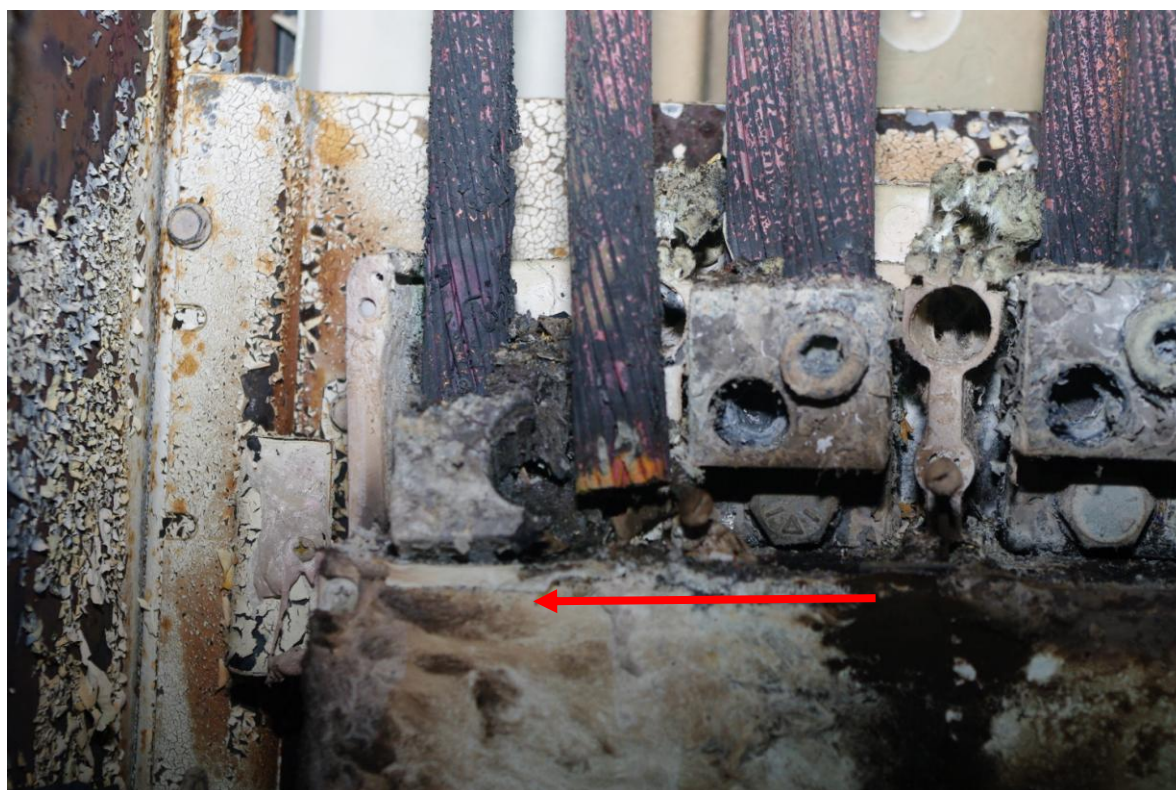
Photograph V20

Looking at the damaged lug in cabinet 10-31.
