Investigation Report

Babine Forest Products – Explosion and Fire – January 20, 2012

BC Safety Authority – Incident Investigation – Jurisdiction and Role

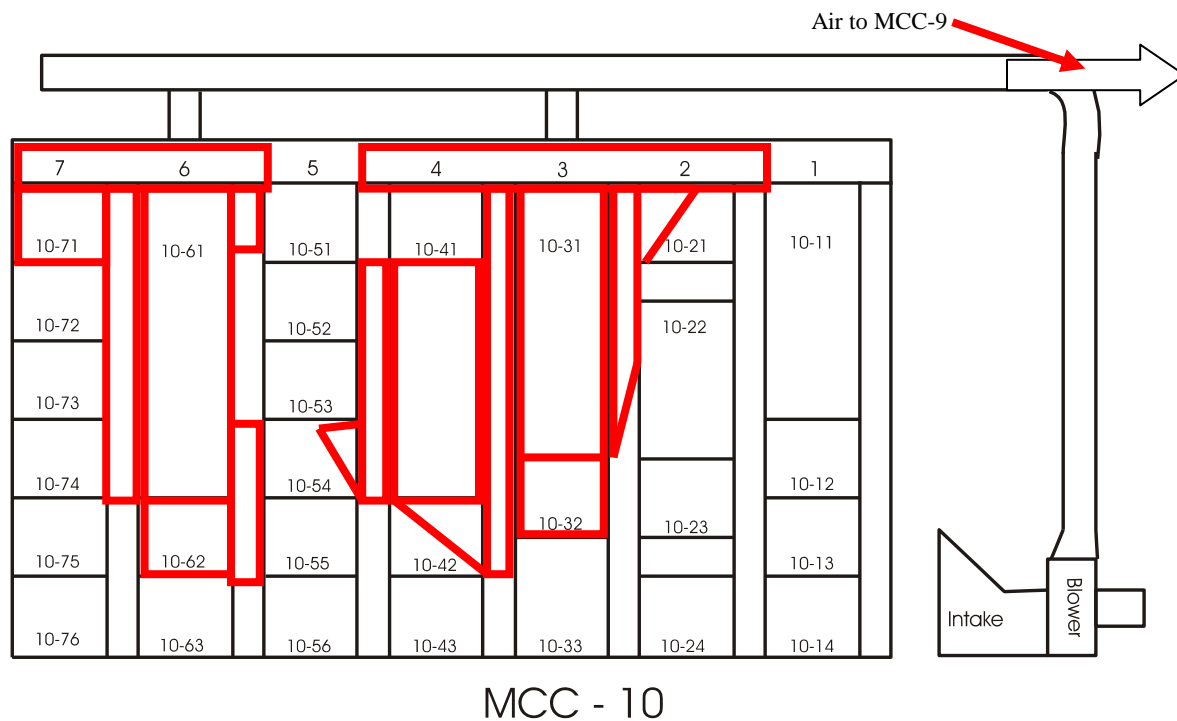
Photograph M2

Looking at a line drawing of MCC-10.

Note: the red outlines are intended to duplicate the burn pattern on the MCC as shown in Photograph M1.

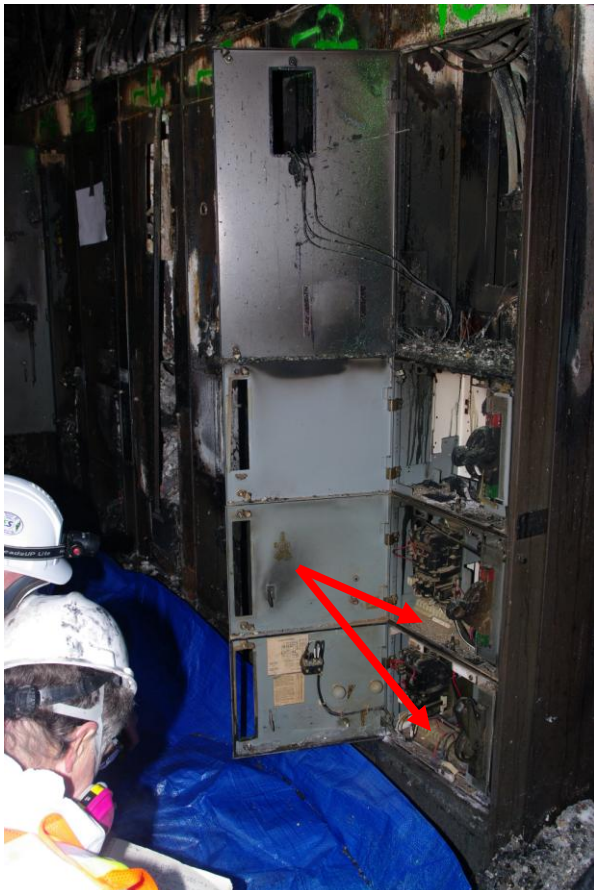
Photograph M4

Looking at cabinets 10-11 (top) to 10-14 (Bottom).

Note: the condition of cabinets 10-12 to 10-14 as compared to 10-11.

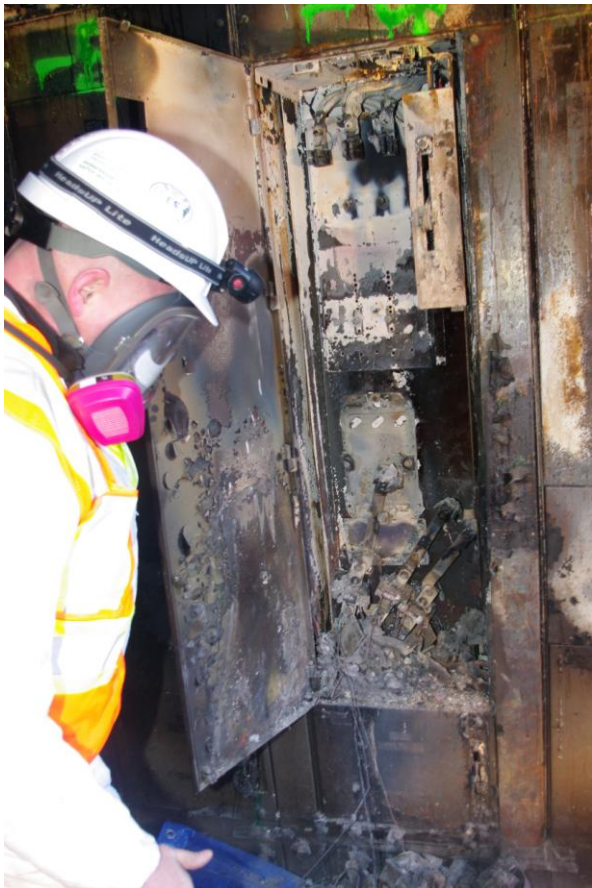
Photograph M6

Looking at cabinet 10-41

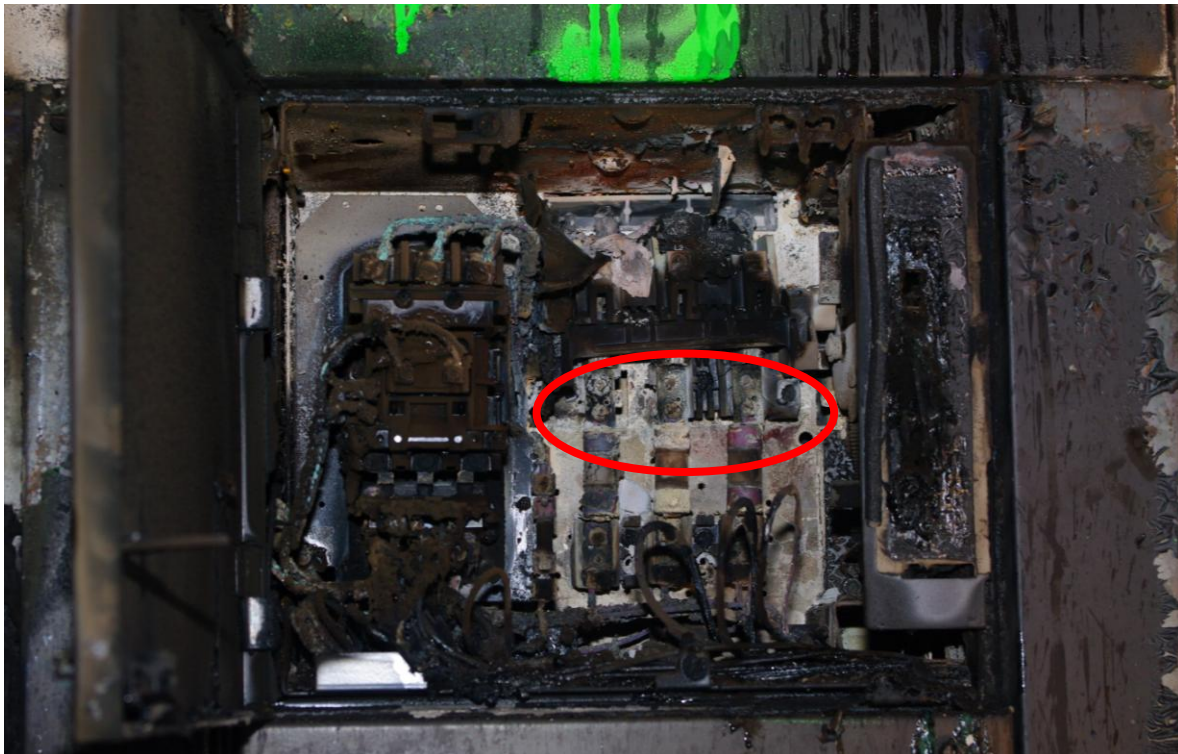
Photograph M8

Looking at cabinet 10-51.

Note: the interior of the cabinet was completely burned however all components were present; also the fuse holders (circle) were separated from the base.

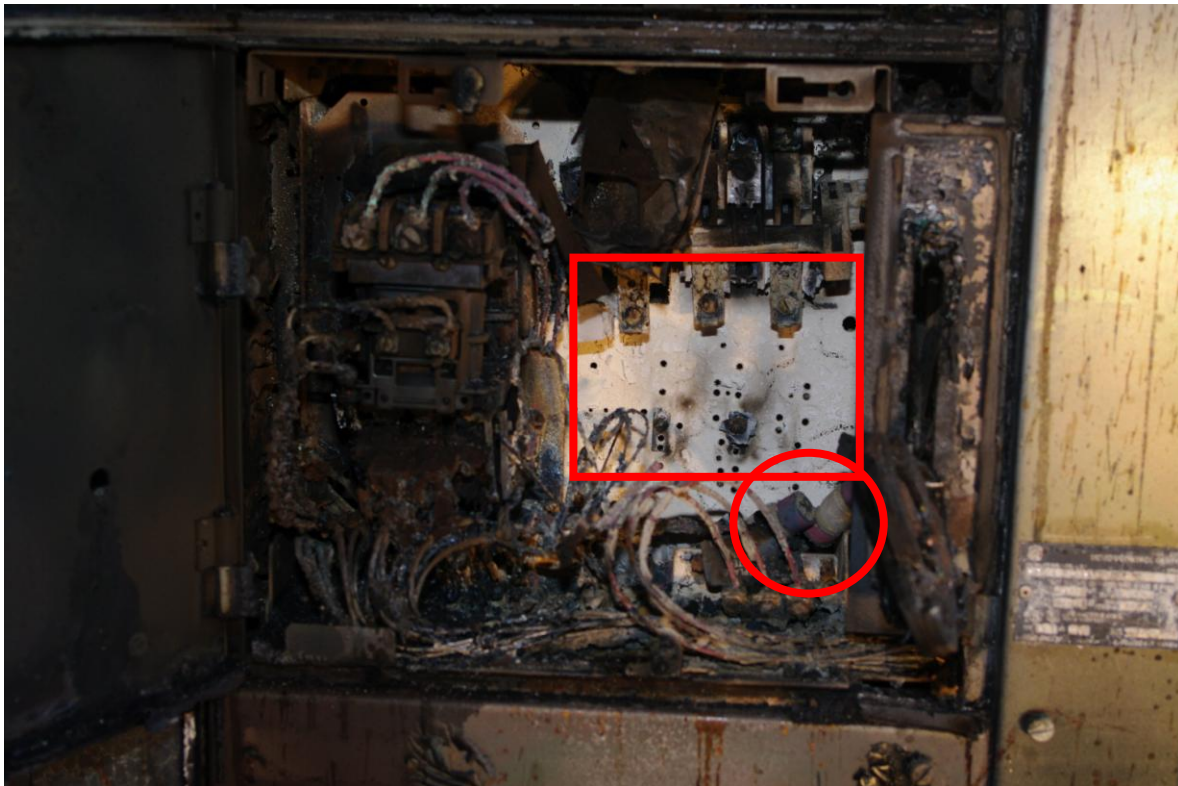
Photograph M10

Looking at cabinet 10-53.

Note: in this cabinet the fuse mountings were destroyed (rectangle), two fuses were present (circle) and one fuse was missing.

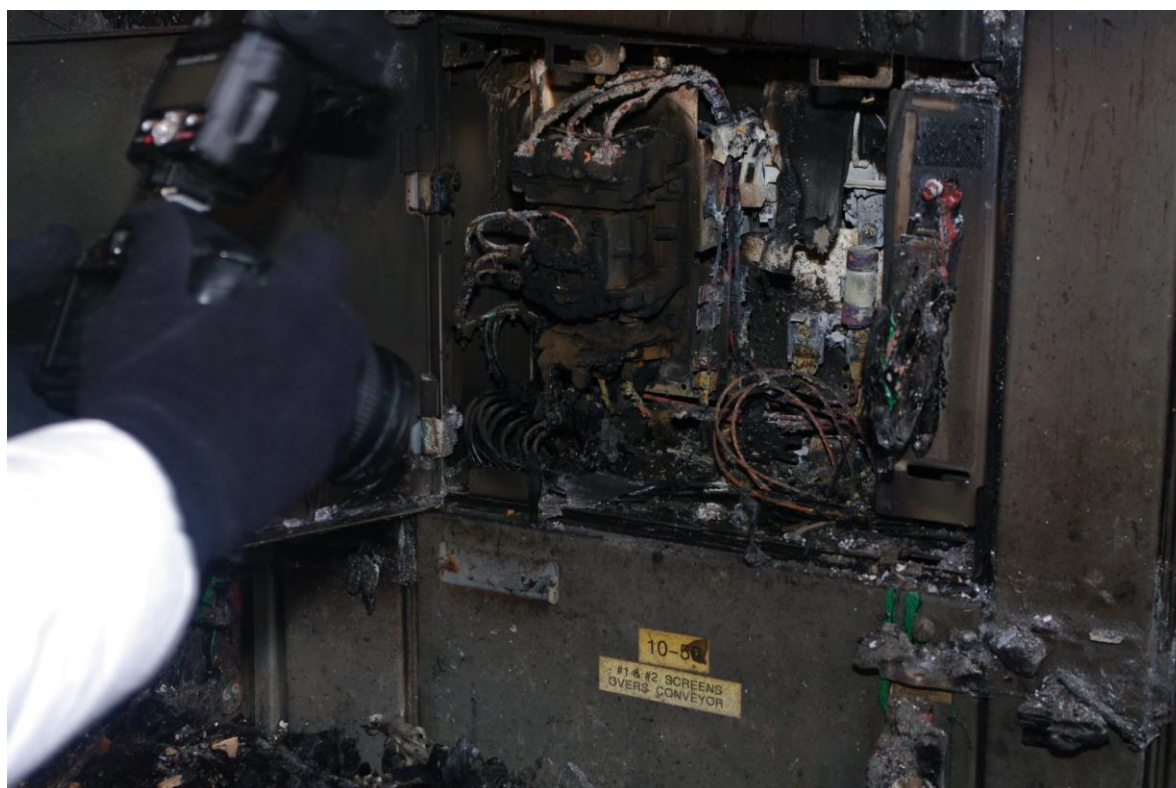
Photograph M12

Looking at cabinet 10-55.

Note: as with the previously shown cabinets the interior of this one was heavily damaged.

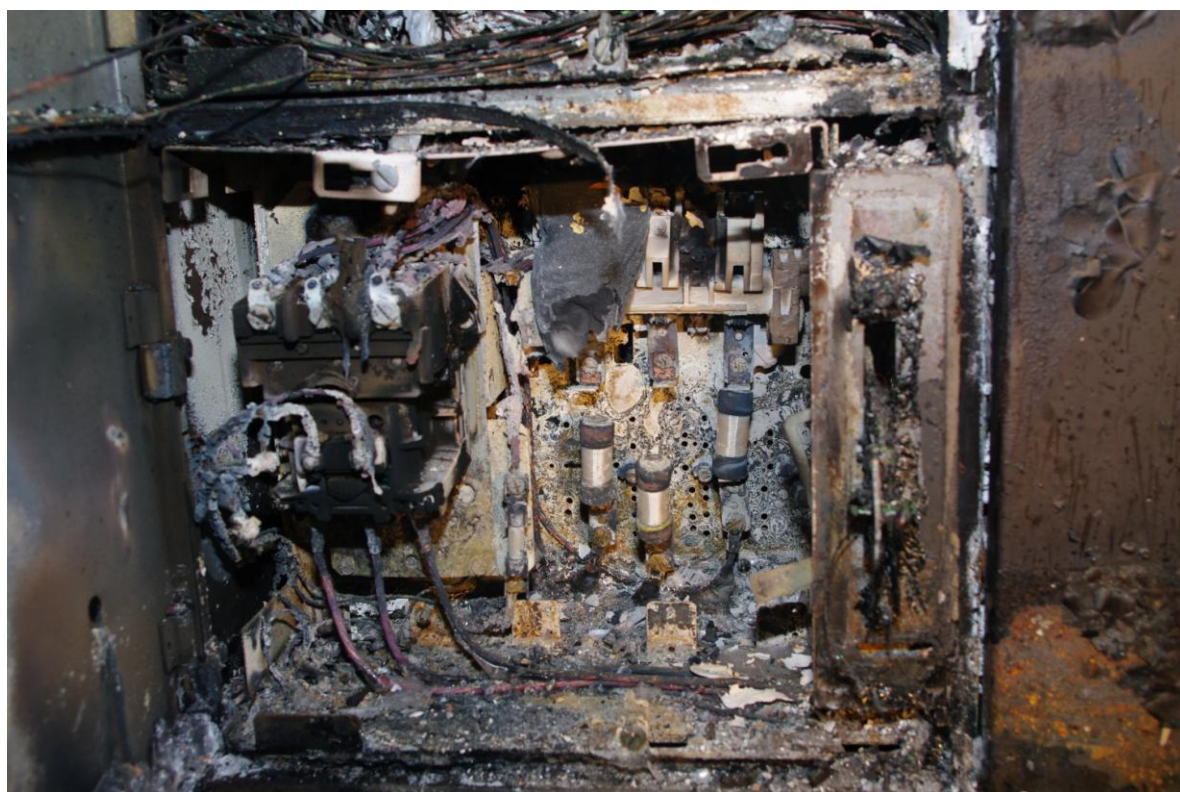
Photograph M14

Looking at cabinet 10-62.

Note: damage to this cabinet coincides with the damage to the bottom of cabinet 10-61.

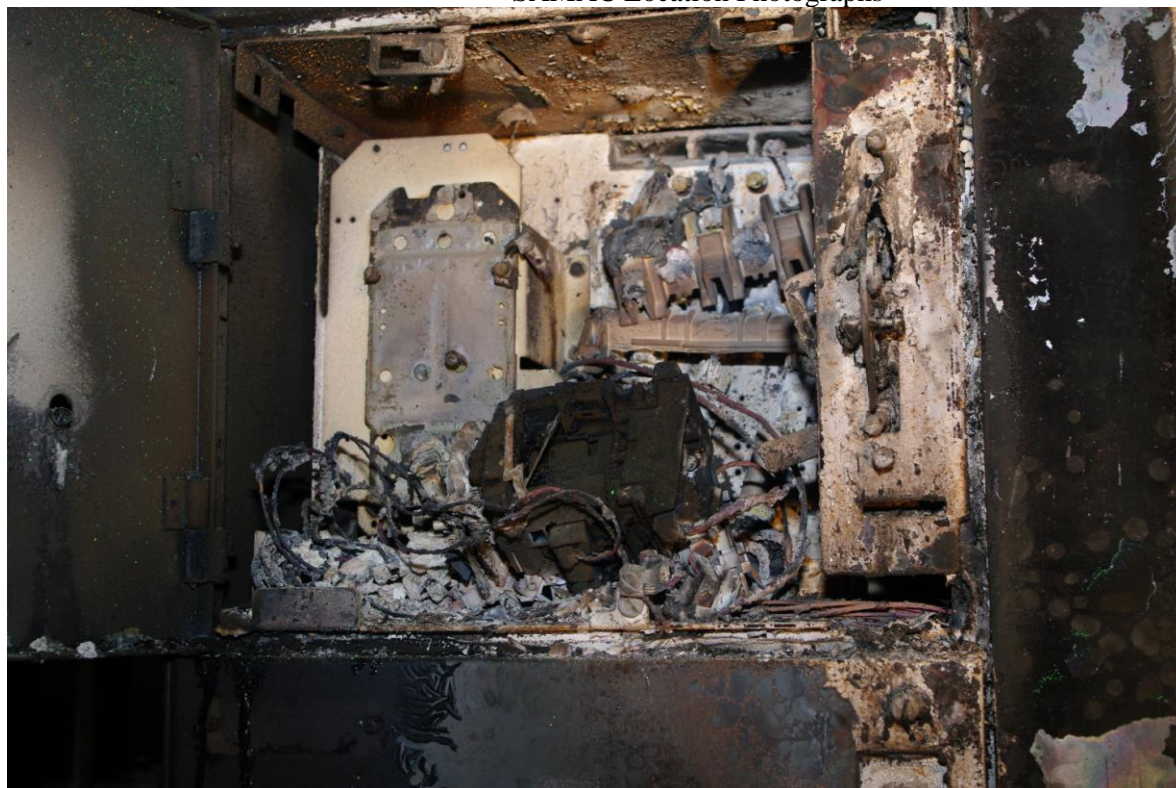
Photograph M15

Looking at cabinet
10-71.

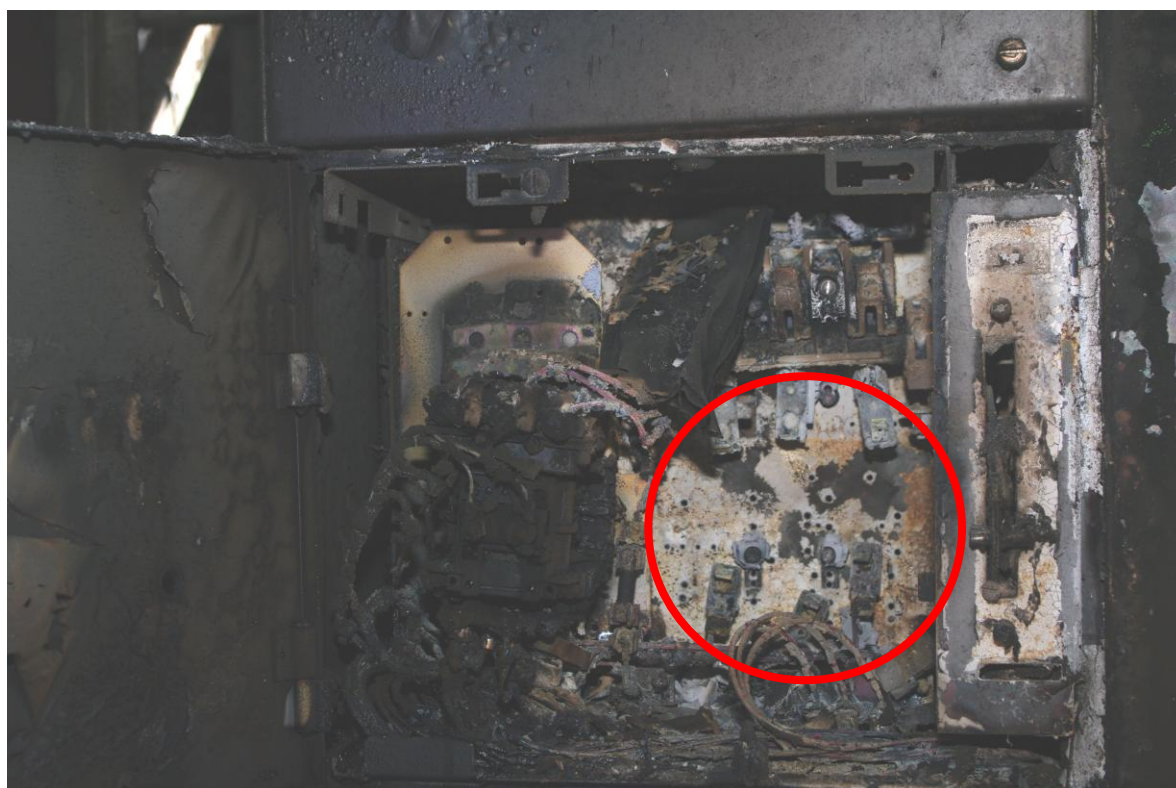
Photograph M16

Looking at cabinet
10-72.

Note: the extensive
damage and
destruction of the
fuse mounts
(circle).

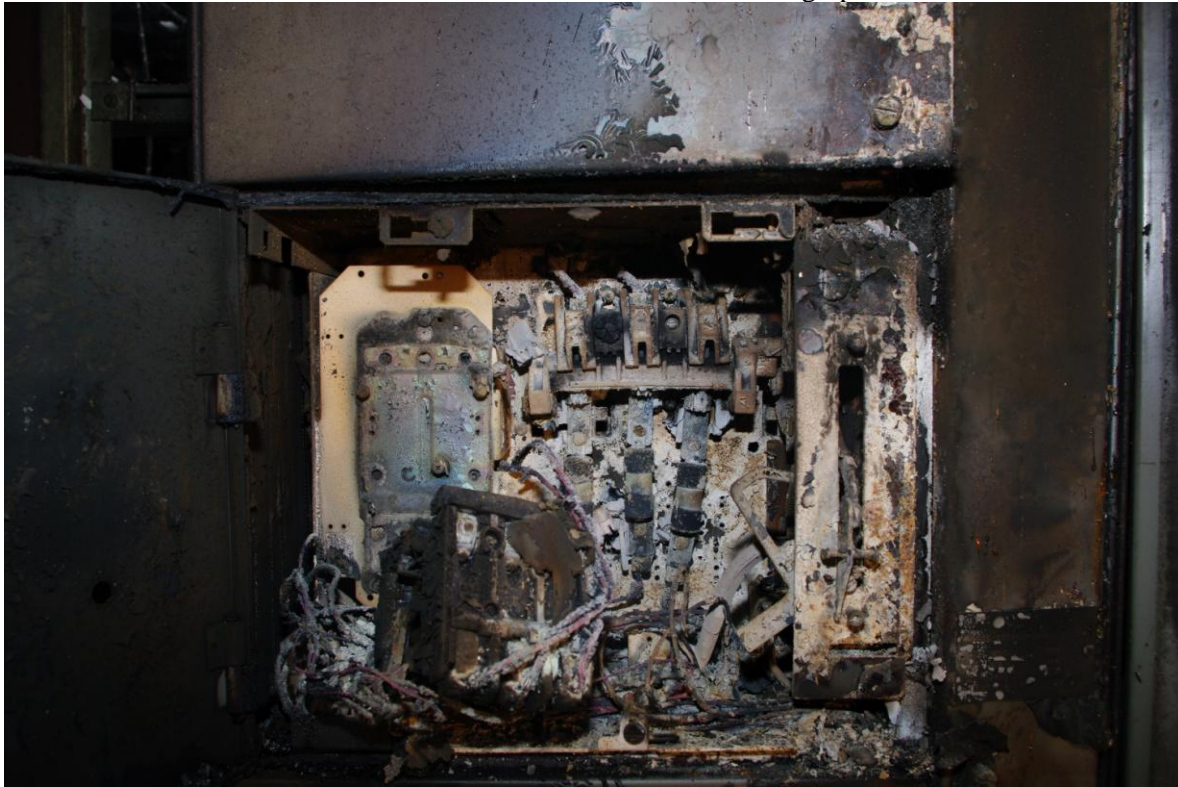
Photograph M17

Looking at cabinet
10-73.

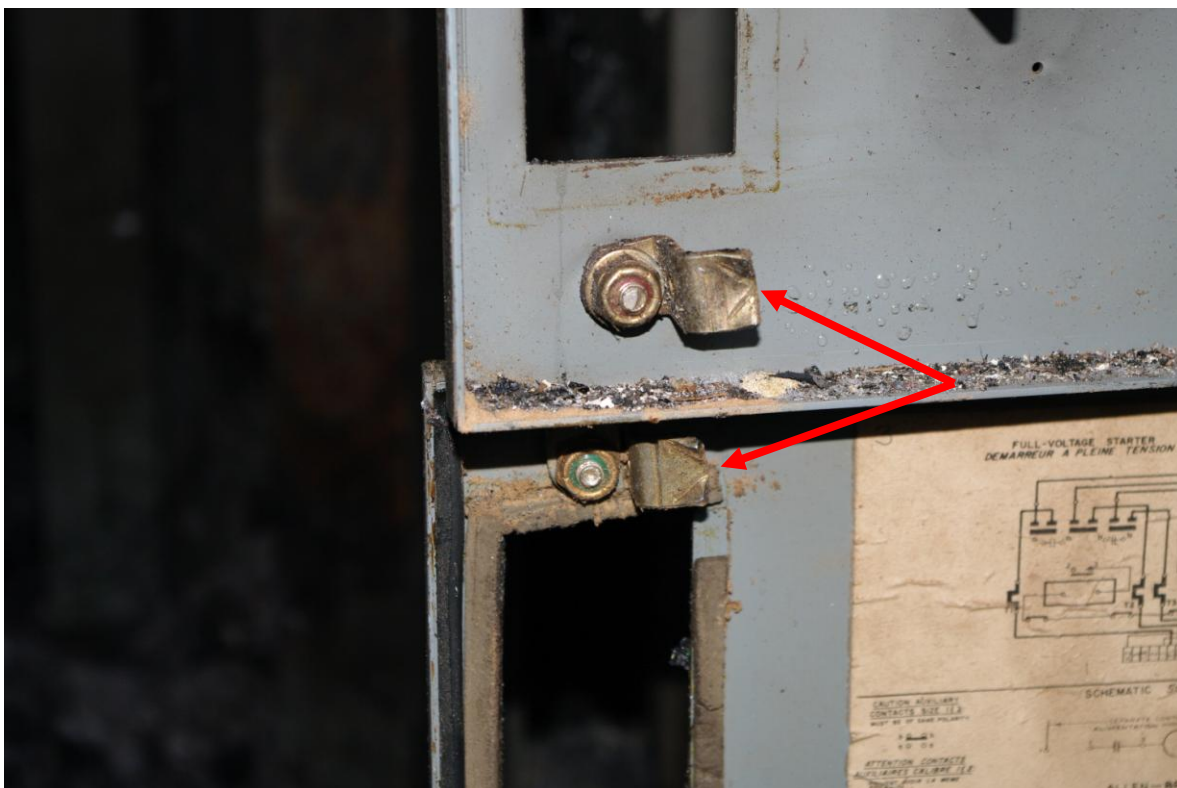
Looking at the door latch bars on cabinets 10-12 and 10-13.

Note: the V shape
of the latch bars
(arrows).

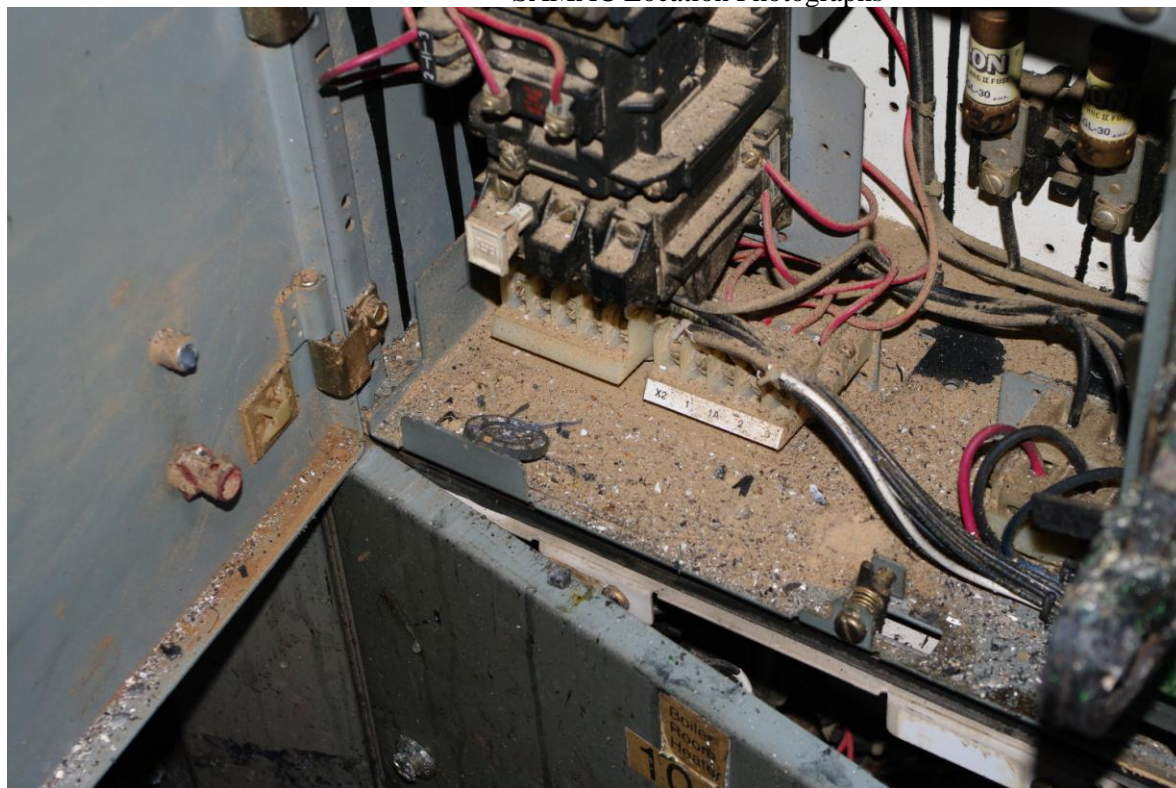
Photograph M21

Looking at the bottom interior of cabinet 10-13.

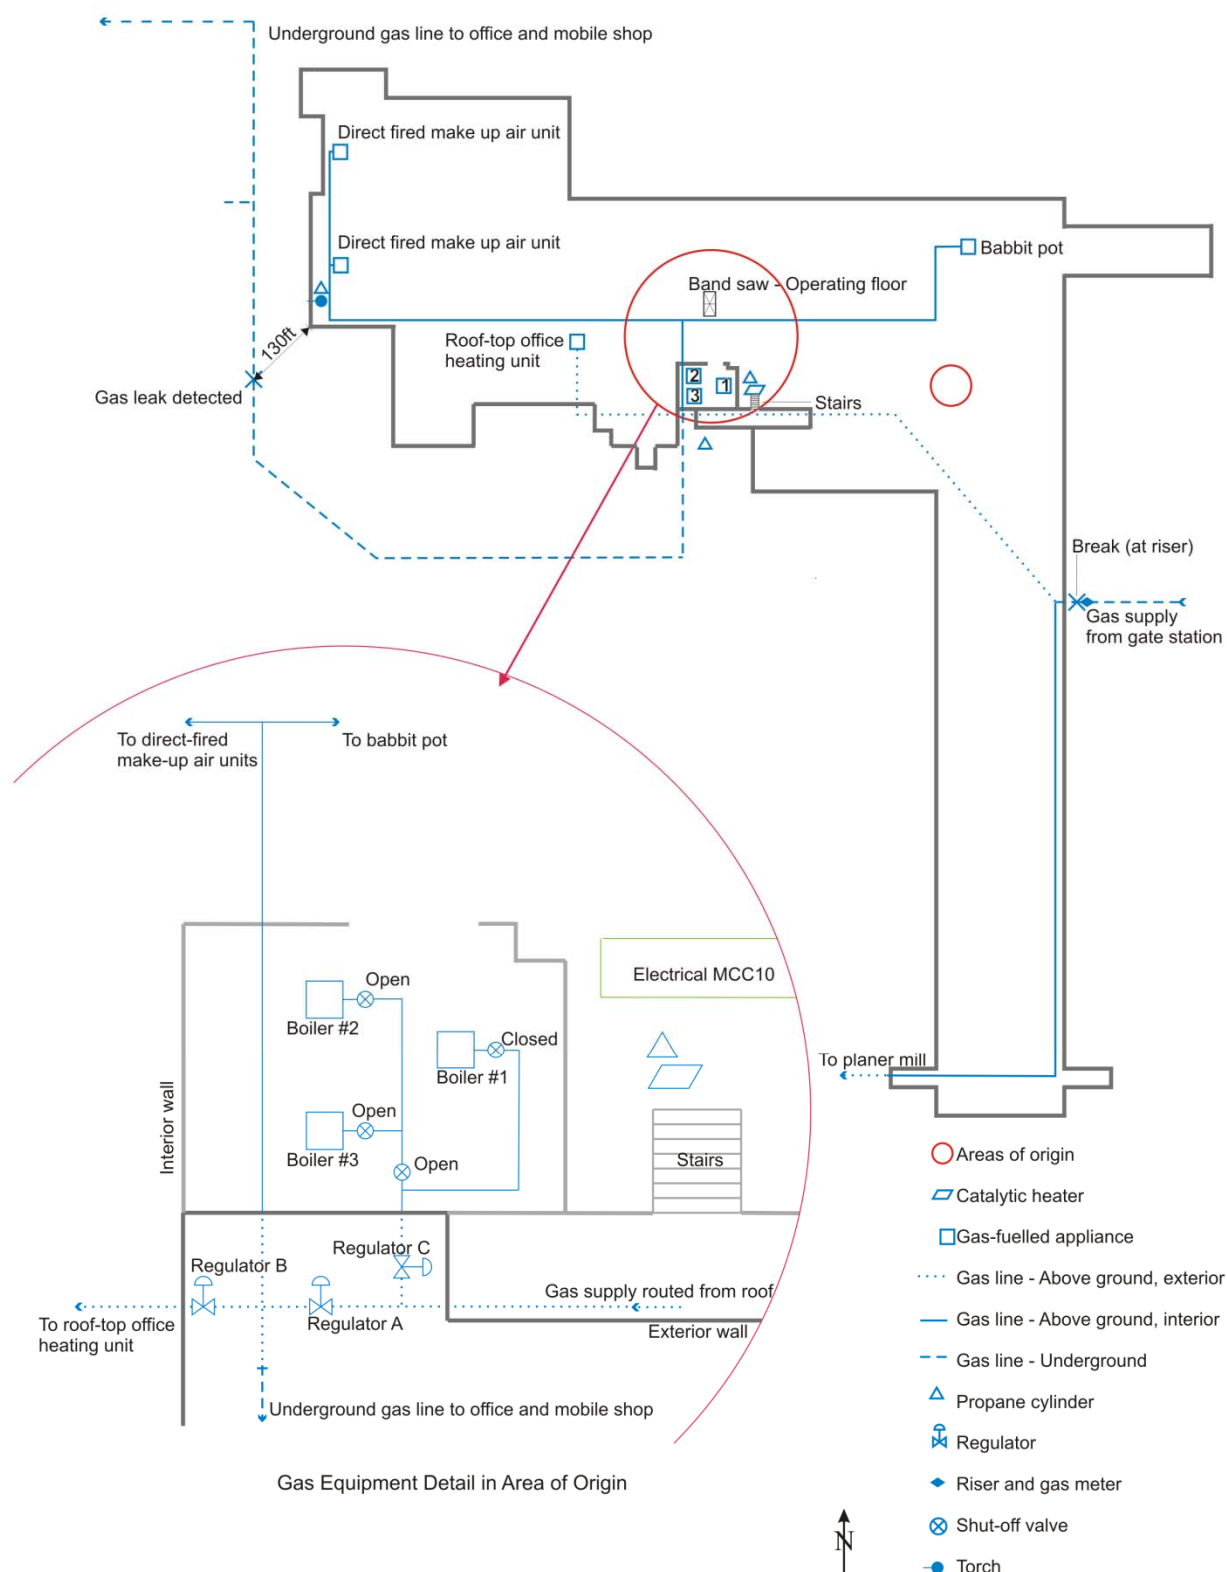
Figure B1: Plan view of mill - gas system and equipment

Underground gas piping outside of the sawmill was pressurized and tested for leaks. One leak was detected west of the sawmill, approximately 40m (130ft) from the structure (and 150m (500ft) from the nearest potential area of origin) as indicated in Figure B1. The underground leak was found to be venting to the surface, next to a hydrant shed. The leakage rate was estimated in the field to have been approximately three cubic feet per hour. The investigation revealed no migration paths into the sawmill structure other than through atmosphere.

The distances of 40m between the leakage location and the nearest sawmill structure and approximately 150m to the nearest area of origin are significant when considering the migration of a low flow of natural gas through an unrestricted atmospheric environment.

This natural gas leak did not supply a combustible fuel mixture to the area of origin in the sawmill basement.

Gas regulator assemblies installed on the outside wall of the sawmill, near the area of origin as shown in Figure B1, were found destroyed or severely damaged.

Although near the area of origin in the basement under the band saw, the regulators were installed outside of the sawmill structure. There was no evidence suggesting a possible leak from a regulator assembly prior to the incident. Any leakage from a regulator assembly prior to the incident would likely have been vented to outside atmosphere as there were no likely migration paths into the sawmill from this location. The location of the regulators against the outside wall of the area under the band saw exposed them to the effects of the explosion. The explosion probably caused the regulator assembly damage.

The natural gas supply line was found broken at the riser location, outside of the sawmill along the east wall approximately four feet above ground as shown in Figure B1.

The sawmill gas supply riser travelled directly from the riser to the roof outside of the east wall of the sawmill. A leak at this location would be vented directly to atmosphere. During interviews, witnesses stated that the sawmill roof was lifted several feet in the air by the explosion which could have applied a vertical force to the natural gas supply pipe at the riser location.

It is unlikely that a natural gas leak at this location could have supplied a combustible fuel mixture to the areas of origin in the sawmill basement.

It is likely that the explosion caused the break in the natural gas supply pipe at this location.

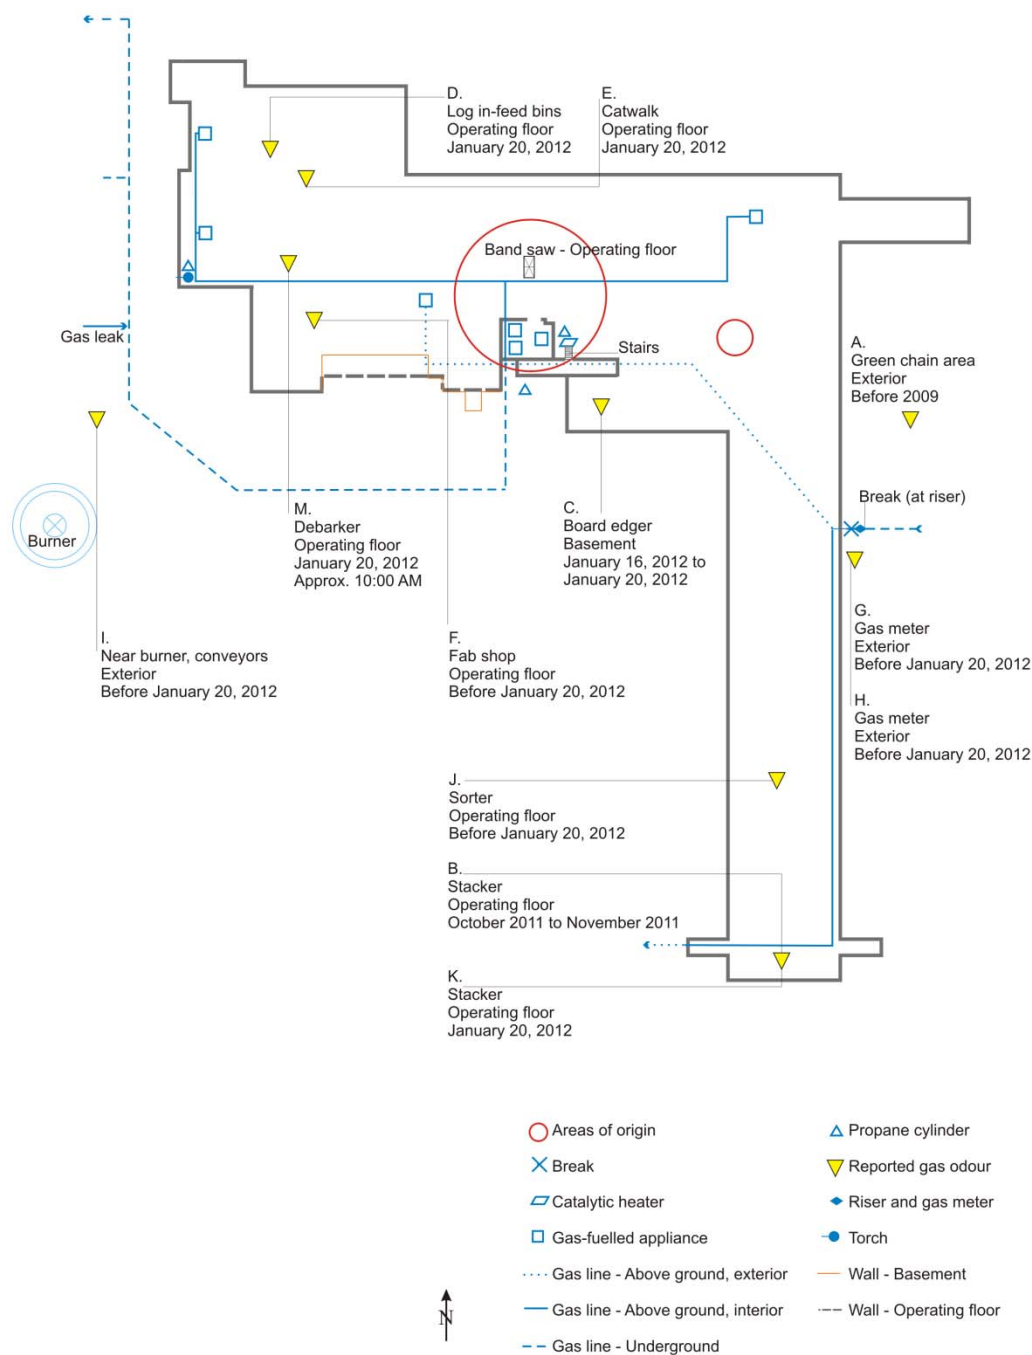
Figure B2: Plan view of mill - gas odor reports from interview statements

During interviews, twelve employees reported smelling a gas like odor at the sawmill before or on the date of the incident. A total of 46 employees stated they did not notice any gas odors prior to or on the day of the incident. Figure B2 represents the general areas associated with these odor reports.
