## Incident Summary (Reference #5621423 ) (FINAL)

SUPPORTING INFORMATION	Incident Date		<i>August 05, 2017</i>	
	Location		<i>Burnaby</i>	
	Regulated industry sector		<i>Elevating Devices</i>	
	Impact	Injury	Qty injuries	<i>0</i>
			Injury description	<i>No injury to person(s).</i>
			Injury rating	<i>None</i>
	Damage	Damage description	<i>Damage to Escalator; Handrail drive sprocket, handrail track, step chain, step track, step axial(s) and steps.</i>	
			Damage rating	<i>Moderate</i>
Incident rating		<i>Minor</i>		
Incident overview		<i>A piece of the handrail track broke and was able to rotate with the handrail. The plastic track was pushed/pulled along with the handrail and eventually became caught into the handrail drive sprocket. This caused the handrail drive sprocket to flex and make contact with an escalator step. This contact caused a chain reaction on the underside of the step carriage and brought the escalator to a stop.</i>		
INVESTIGATION CONCLUSIONS	Site, system and components		<i>The handrail track is installed under the handrail. This track works as a guide and allows the handrail to rotate with minimal friction continuously around the escalator. The handrail spro

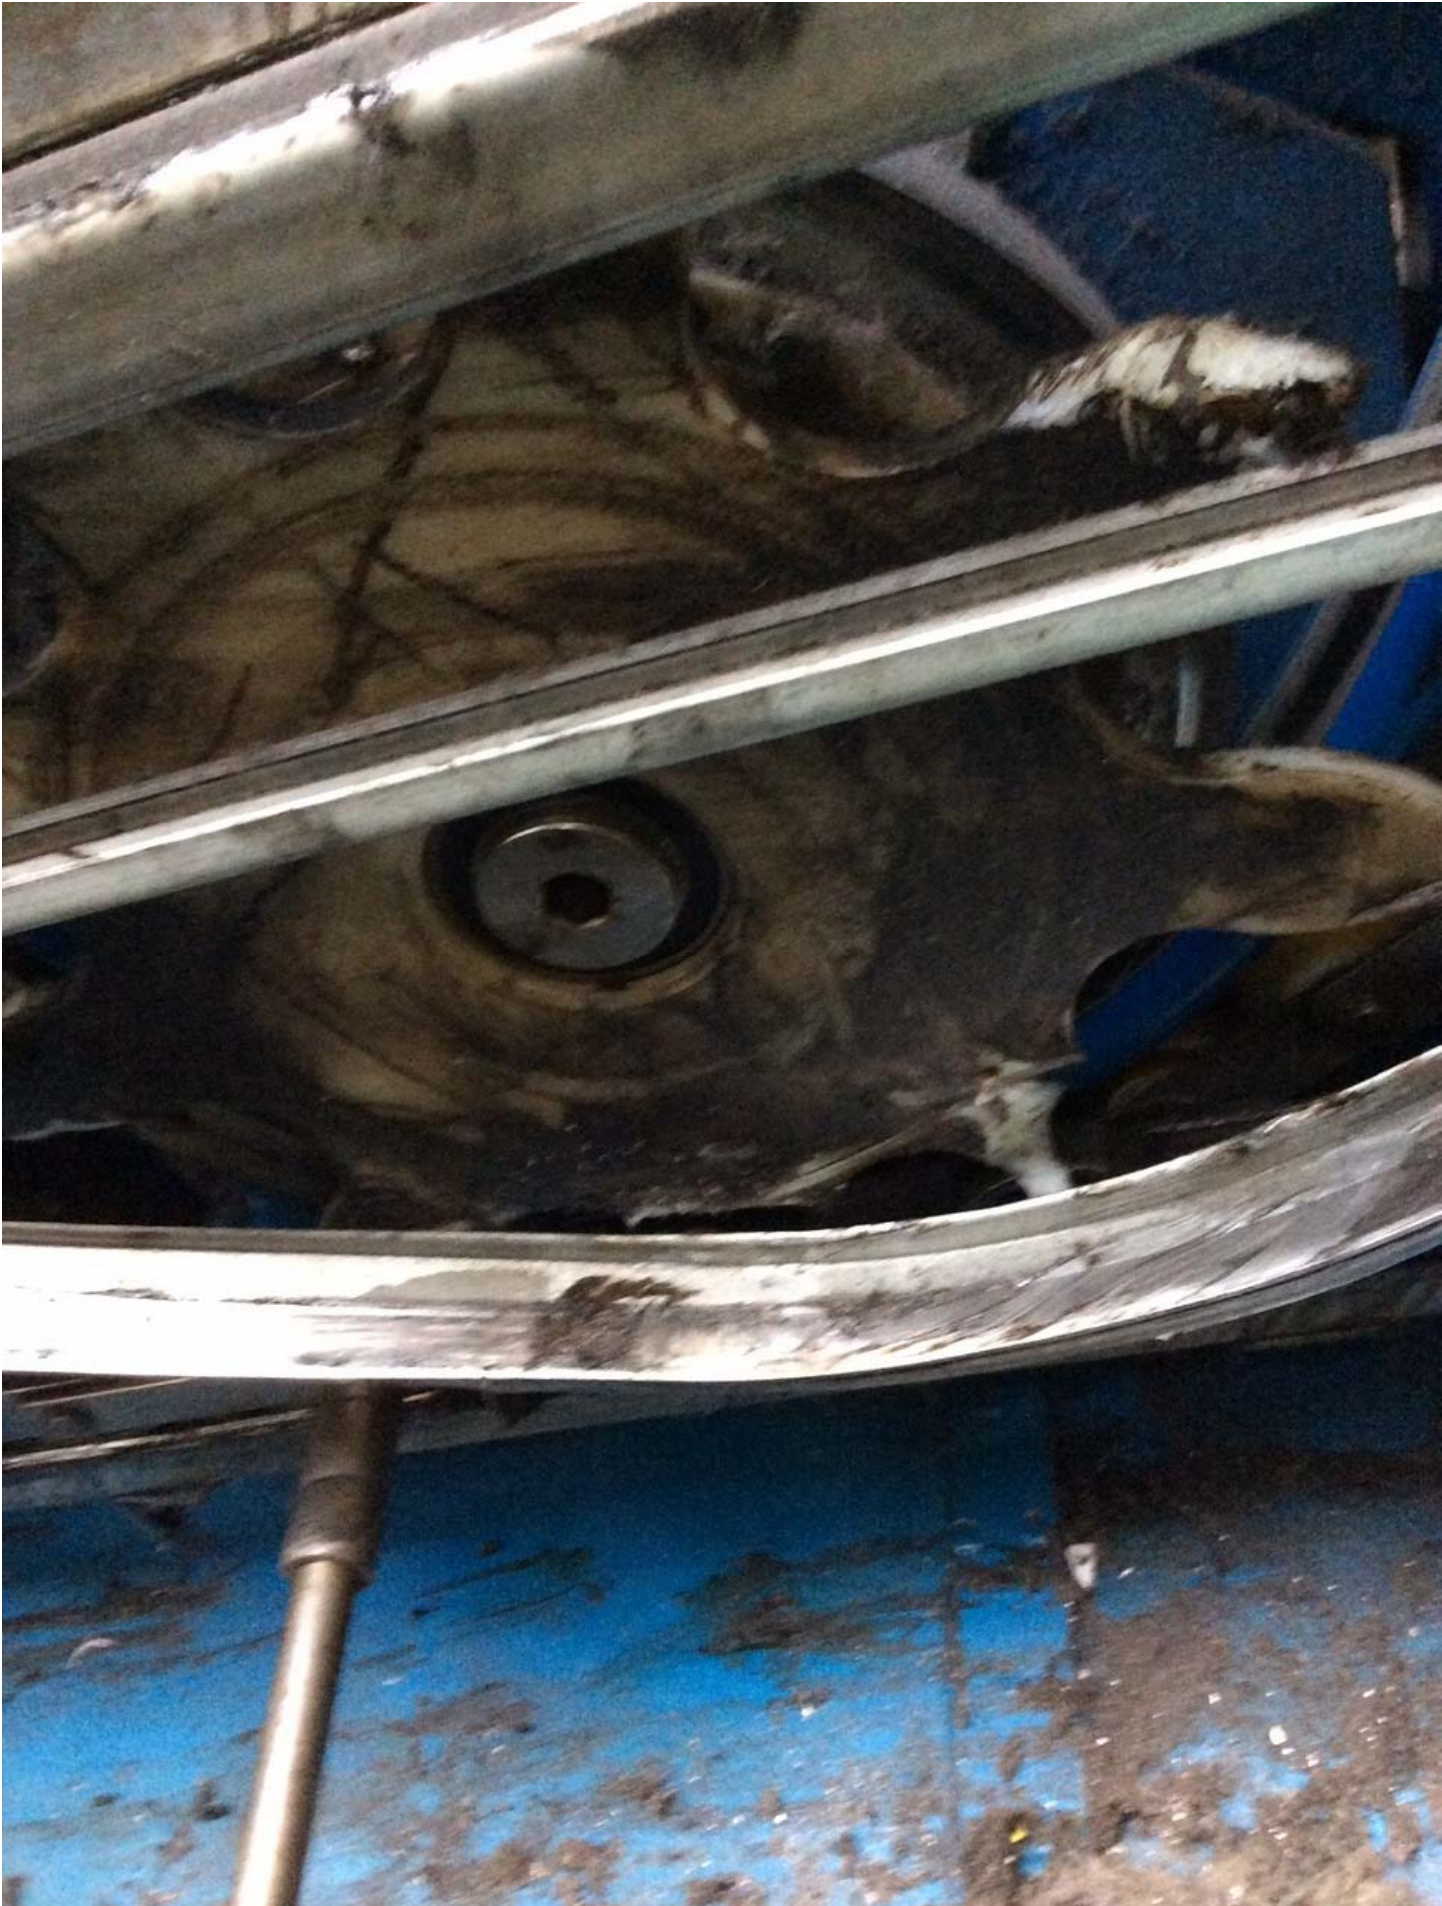
Failure scenario(s)		<i>A piece of handrail track broke and was able to become tangled into the handrail drive system.</i>	
	Facts and evidence		<i>Broken handrail track in handrail drive system.</i>	
	Causes and contributing factors		<i>Integrity of handrail track compromised over the years of service.</i>
