Engineering Analysis
Fernie Memorial Arena Investigation
Cold Dynamics Ltd.

Fernie Memorial Arena Investigation

REPORT FOR TECHNICAL SAFETY BC
FERNIE MEMORIAL ARENA

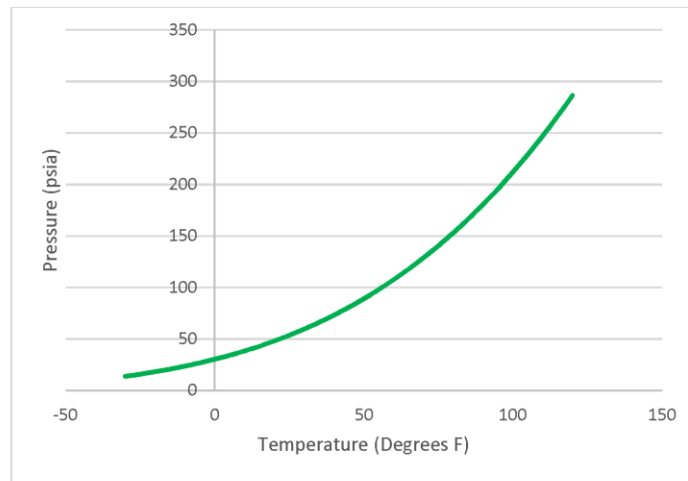
Figure 8: The pressure temperature relationship of saturated ammonia

The ammonia remaining in the chiller was in a saturated state and the pressure corresponded to its temperature (Figure 8 illustrates this relationship). When the chiller was isolated, the pressure would have been approximately 36 psig [248 kPag] as this corresponds to a 22°F (-5.6°C) brine temperature. The pressure of the the shell side of the vessel would have continued to increase as the temperature increased. The brine pressure would have been approximately 0 psig [0 kPag] when the system was shut down because the pump was not running.

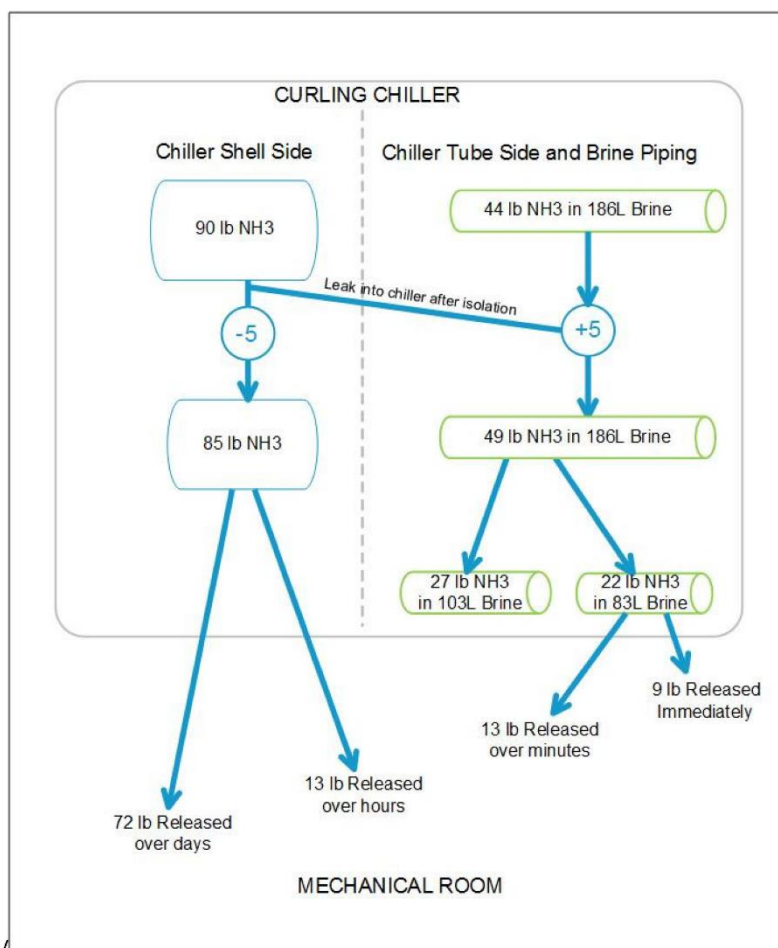
In the described scenario, it is reasonable to expect that most of the estimated 22 lb [10 kg] of ammonia contained in the brine solution was released into the room and vaporized/evaporated. When the release happened suddenly, it is likely that the majority of the 9 lb [4 kg] of ammonia contained in the most highly concentrated solution would have been released almost immediately along with a portion of the remaining ammonia in the less concentrated solution. As some of the ammonia may have stayed in solution and evaporated more slowly in the room, an 18 lb [8 kg] release was used as the upper bound in the dispersion analysis that follows below.

Figure 13: Flow diagram summarizing ammonia and brine mass quantities from the time the system was isolated. Based on the scenario assumptions described in this report. The brine quantities in this figure represent the approximate brine piping and chiller volume between the separated coupling and isolation valves on the inlet side of the chiller.

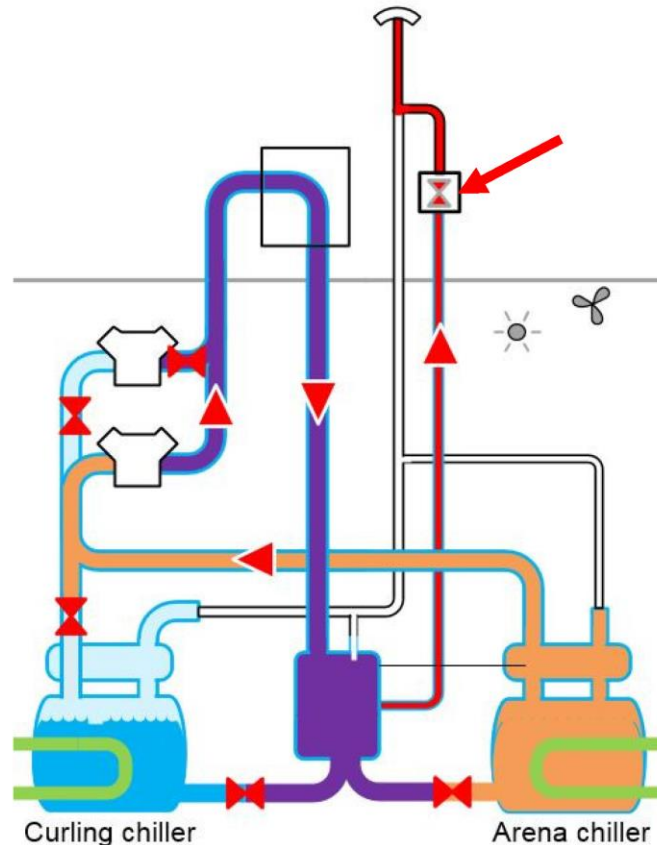
At approximately 1:50 PM on October 17, 2017, during the emergency response, the emergency discharge valve was opened. This valve is provided on some refrigeration systems to allow the refrigerant to be released to the atmosphere. In this case it was connected to the receiver as shown in Figure 16.

Figure 16: A simplified piping diagram showing the configuration of the emergency discharge valve. The purple components contained refrigerant that would have been released relatively quickly. The orange components would have released more slowly because they did not have a direct path to the discharge point. The red arrow is pointing at the emergency relief valve.

As can be seen in Figure 16, the high side of the system that included the condenser, high pressure receiver, and the associated piping would have been depressurized quickly. The arena chiller would have depressurized more slowly because the refrigerant had to move through the compressor. Based on the ammonia charge calculations summarized earlier in this report and the amount of ammonia that was assumed to leak into the brine, the high side of the system would have contained approximately 360 lb [163 kg] of ammonia and the arena chiller and oil
