## Incident Summary (5604643)

SUPPORTING INFORMATION	Incident Date		September 6, 2016	
	Location		Abbotsford	
	Regulated industry sector		Low voltage electrical system (30V to 750V)	
	Impact	Injury	Qty injuries	0
			Injury description	N/A
			Injury rating	None
	Damage	Damage	Damage description	Electrical arcing damage to a child's play tent, a portable fan's attachment cord, and a cablevision outlet. Fire damage to the bed, play tent, and fire and smoke damage to the contents of a bedroom in a house.
			Damage rating	Moderate
	Incident rating		Moderate	
Incident overview		<p>A child woke to find his bed on fire. He called out to his mother who evacuated the family from the house and called the fire department.</p> <p>The fire occurred near an electrical outlet that a portable fan was plugged into and a cable vision outlet that were located on the wall adjacent to the bed.</p>		
INVESTIGATION CONCLUSIONS	Site, system and components		<p>A portable fan was plugged into a receptacle that was rated at 15 Amperes and 120 Volts. The fan cord attachment blades are intended to be fully inserted into a receptacle to provide positive electrical contact with the receptacle contacts and to pre

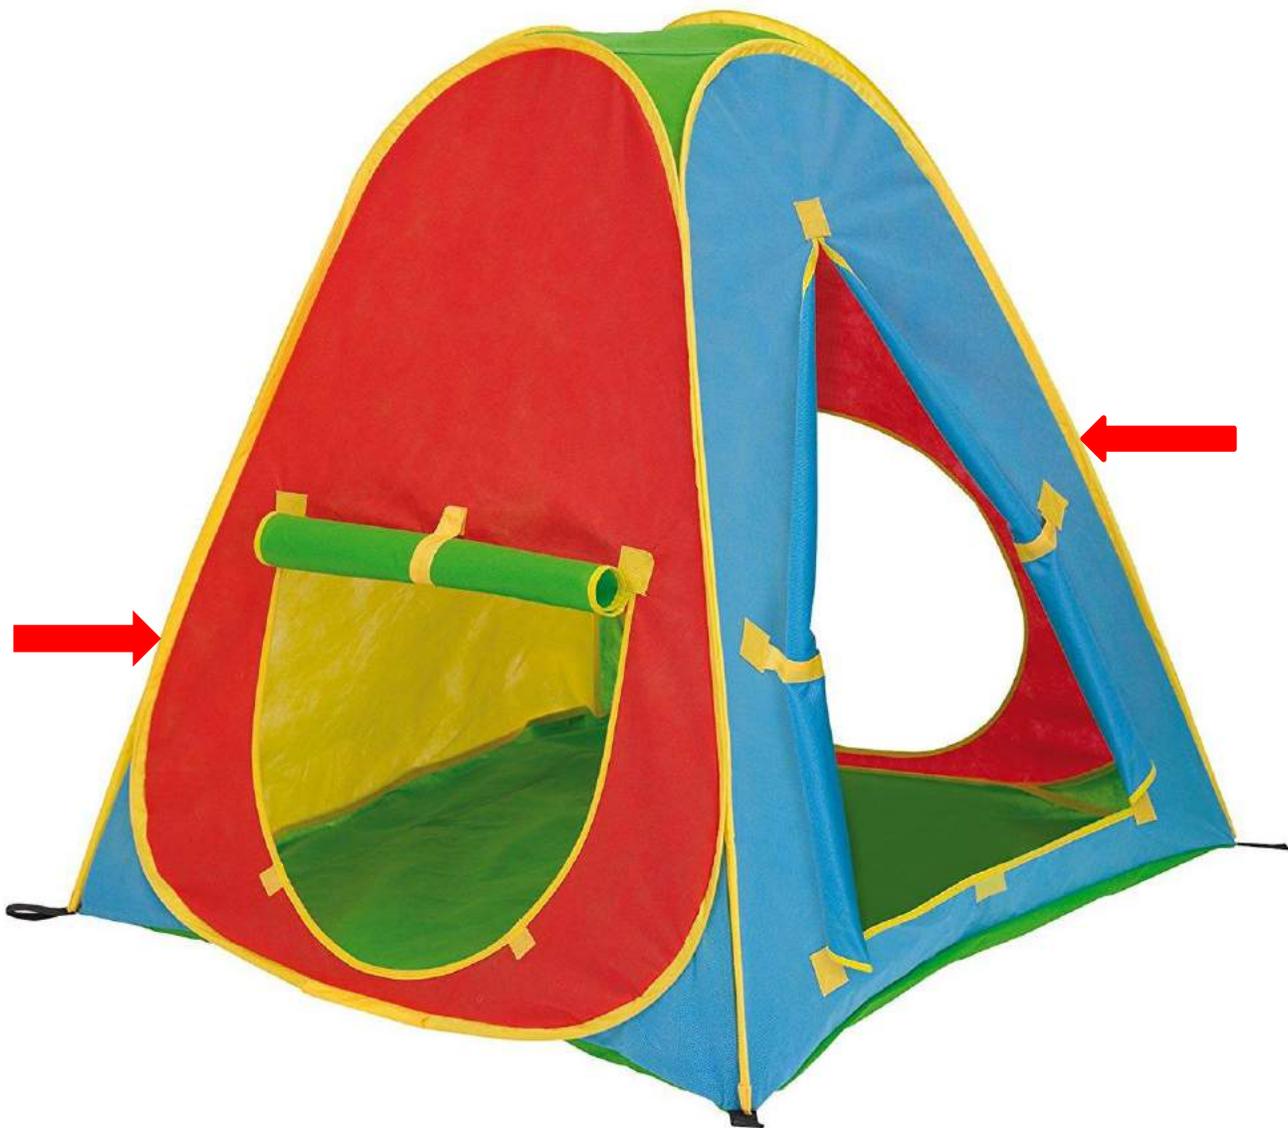
**FIGURE 6**

A photo of a child's play tent is included for reference only. This photo shows an exemplar collapsible play tent similar to the tents referenced in this report. There are numerous variations of this product widely available in the market place, in various colours and with various images and characters from popular children's stories and TV shows. This type of tent is generally made with lightweight materials with a flexible metal frame sewn into the edges (see red arrows). The tents fold flat for storage when not in use. Two similar tents were stored by the tenants between the south wall and the child's bed prior to the incident.

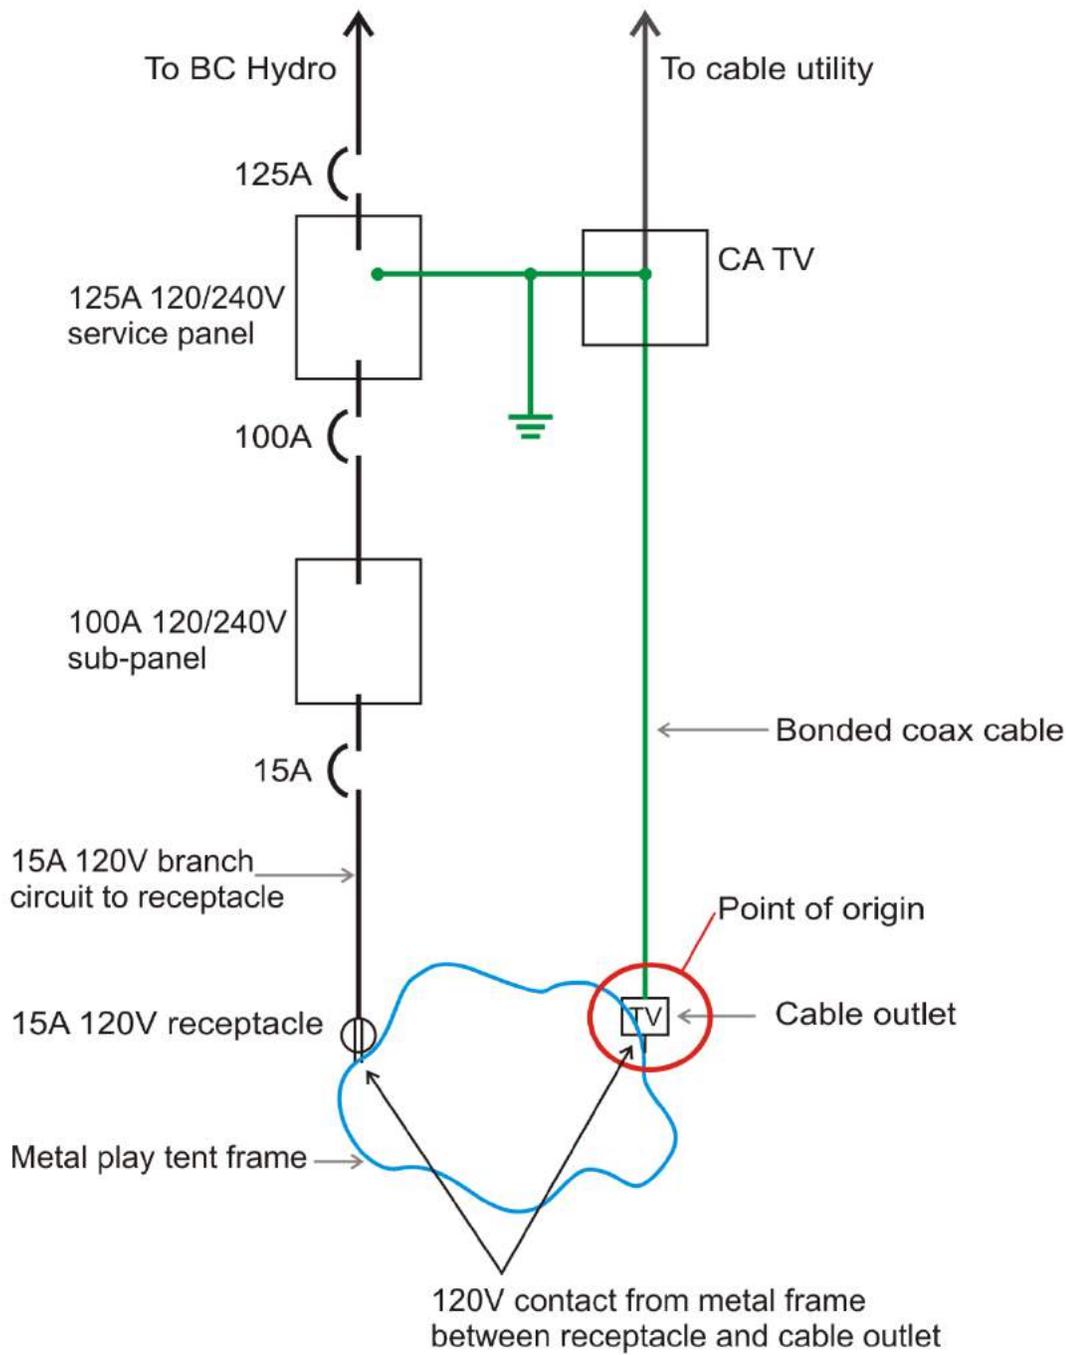
FIGURE 12 - CIRCUIT DIAGRAM. THE DIAGRAM IS INCLUDED FOR ILLUSTRATIVE PURPOSES ONLY AND IS NOT TO SCALE.

<p>Causes and contributing factors</p>	<p>It is very likely that the cause of this incident is the conductive metal frame of a children’s play tent contacting the energized attachment cord blade from a plugged in fan and a grounded cablevision outlet. A short circuit between the attachment cord blade and the cablevision outlet caused an electrical arc and the resulting heat that ignited the tent material and the bed.</p>

The cable vision cable was found to be bonded to the house electrical system at the cable utilities demarcation box with a green #10 awg copper bonding conductor. This conductor installed between the demarcation box and the main electrical system ground (shown by the red arrow) provided a path to ground for the current to flow during the fault between the attachment cord blade and the cable outlet.
