Incident Summary #II-1447197-2022 (#30043) (FINAL)

SUPPORTING INFORMATION	Incident Date	October 3, 2022	
	Location	New Westminster	
	Regulated industry sector	Elevating devices - Elevator	
	Impact	Qty injuries	0
		Injury description	None
		Injury rating	None
	Damage	Damage description	Burn damage to the elevator braking resistor bank, wires, toggle switches, and metal enclosure. Extended downtime for one of the two elevators.
		Damage rating	Moderate
	Incident rating	Moderate	
Incident overview	An elevator braking resistor bank overheated when exposed to continuous power related to a motor control drive transistor failure.		
INVESTIGATION CONCLUSIONS	Site, system and components	<p>The site is a 14-floor high rise apartment building with two separate passenger elevators of the electric traction type. The elevator power equipment, motors, drives, and resistor banks are located in the upper floor elevator machine room. Each elevator motor has a controller cabinet (Image 1) which houses a variable frequency drive (VFD) and the braking resistor components.</p> <p>The VFD takes the 480-volt alternating current (AC) power supply and inverts it to roughly 680-volts direct current (DC) wit

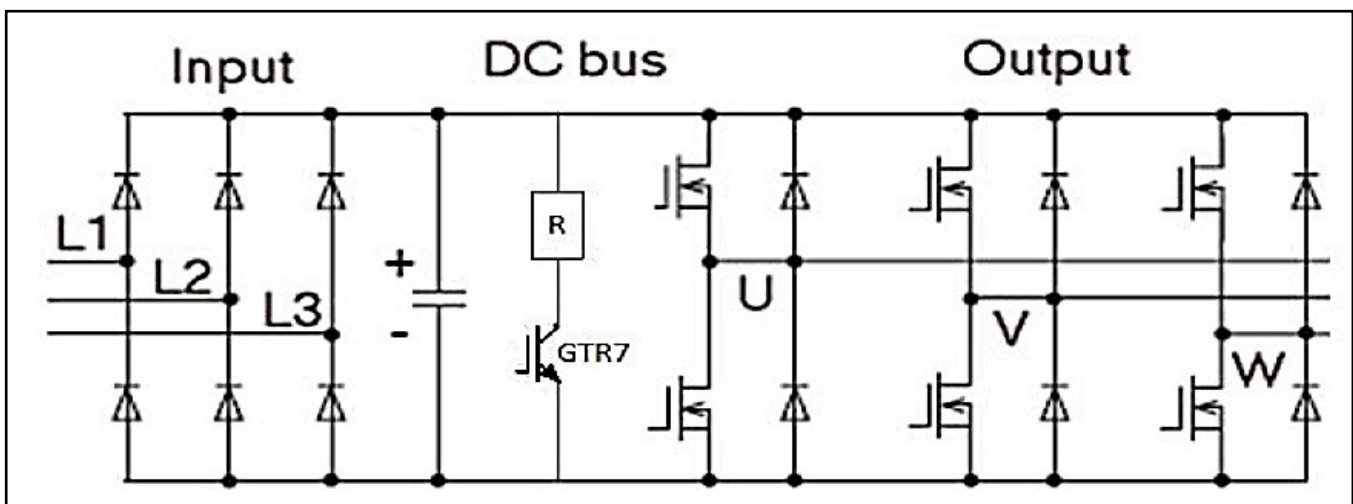
The cause of the incident was the transistor failing internally, during normal operating conditions, allowing continuous current to overheat the braking resistor bank until the fire occurred.

Image 9 – VFD single line diagram. R label is the resistor bank, GTR7 label is the braking transistor.

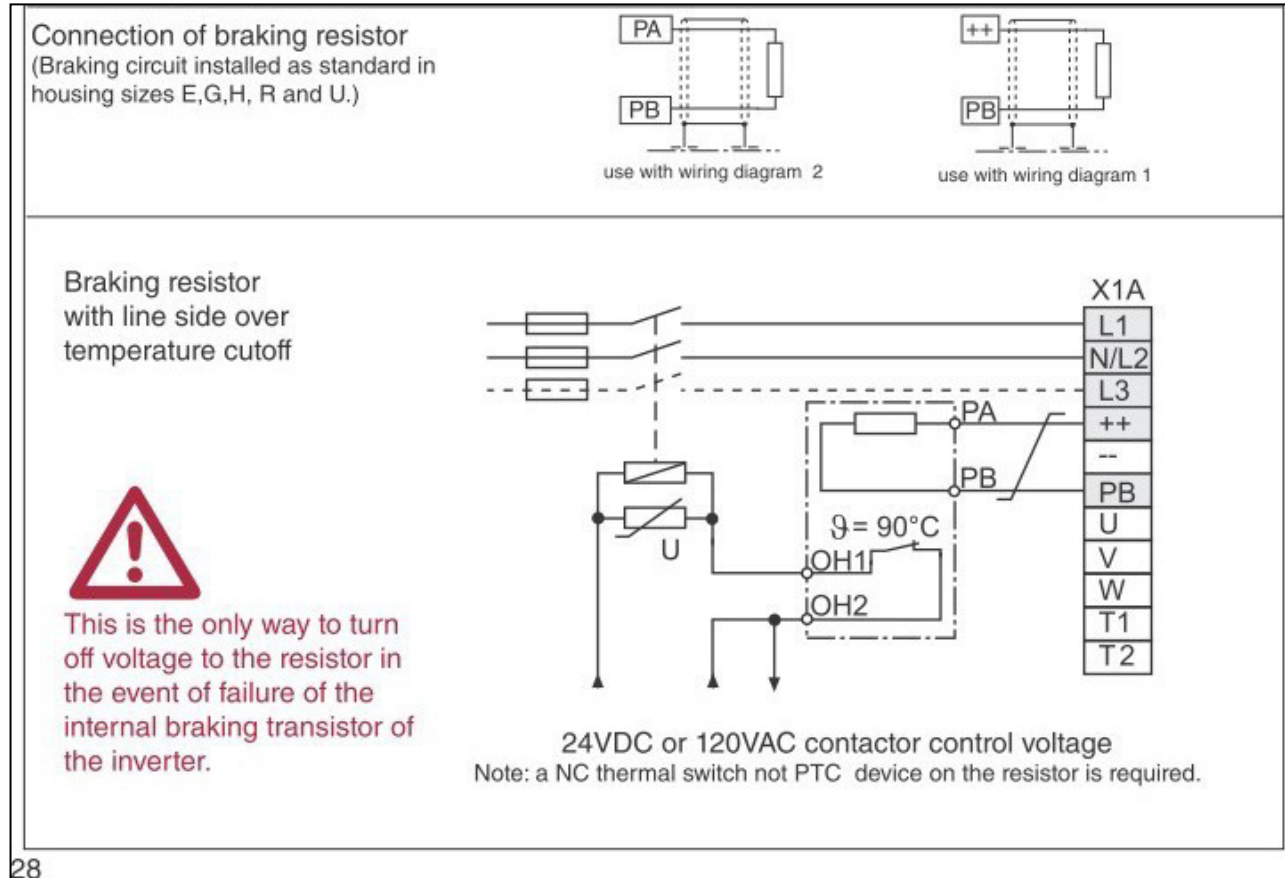
- KEB has always included a statement in its instruction manual which informs direct and end customers about the need to provide thermal protection for the braking resistor ([Image 13](#)).

Image 13 – Excerpt of KEB instruction manual, circa 2016 timeframe, regarding thermal protection of braking resistors.

The incident most likely would have been prevented if a thermal monitoring circuit was installed and operating for the elevator controller.
